# Barclaycard headquarters

One of the greenest corporate headquarters of the 1990s has been subject to a rigorous PROBE investigation. How has the building performed and has it lived up to its environmental qualifications?

BY THE PROBE TEAM

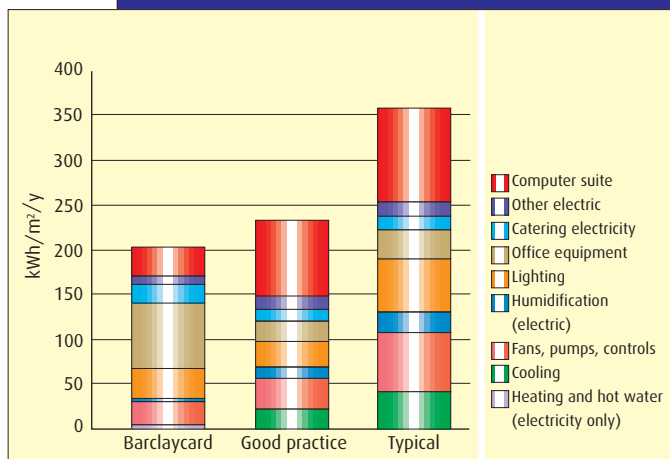
A detailed analysis of electricity bills shows that, in the 12 months from November 1998, actual electricity consumption was 204 kWh/m<sup>2</sup> (treated floor area). This means that electricity consumption is 13% below the unadjusted Type 4 good practice benchmark of 234 kWh/m<sup>2</sup> and only 57% of the typical figure of 358 kWh/m<sup>2</sup>.

FIGURE 1: End-use electricity breakdown at the Barclaycard head office.

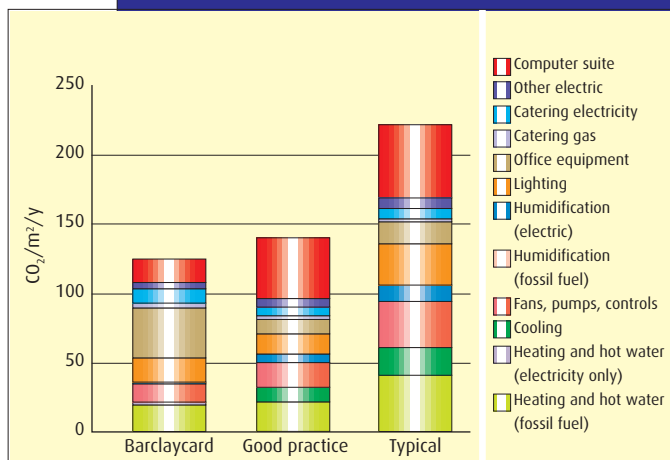
FIGURE 2: Carbon emissions at Barclaycard by end use. The conversion factors are 0.46 kg CO<sub>2</sub>/kWh for electricity and 0.19 kg CO<sub>2</sub>/kWh for natural gas (*Econ 19*, January 2000).

In terms of CO<sub>2</sub> emissions, the building comes in at 114 kg CO<sub>2</sub>/m<sup>2</sup> – 9% below the good practice figure. Compared with other Type 4 offices studied by the PROBE Team, this is excellent performance.

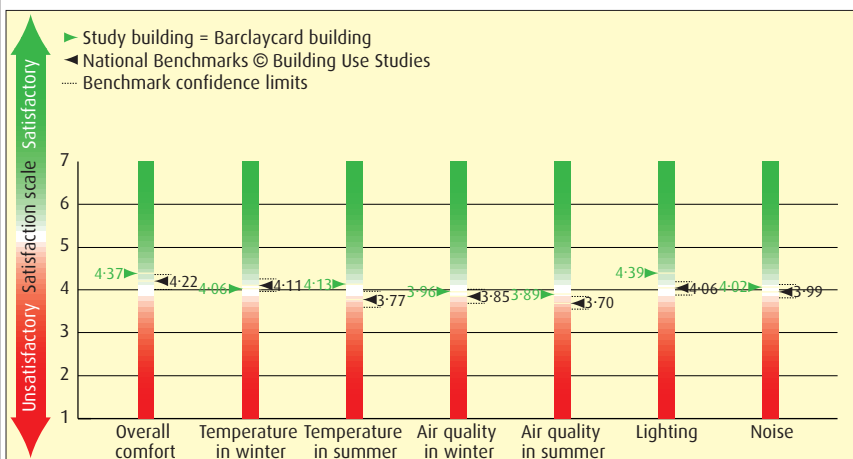
Figure 3 (below left) shows the levels of occupant satisfaction with the building's environment. The benchmarks shown are based on scores from a recent sample of 50 UK buildings studied by Building Use Studies, so they represent average rather than good UK conditions.

On comfort, Barclaycard scores consistently better than the benchmarks, with summer temperature and air quality, and lighting all being significantly better. Negative observations include lack of temperature stability (which some respondents said affected productivity), lower floors too cool while upper floors are too warm, and the seeming indifference of system settings to weather conditions.

Figure 3: Overall satisfaction with comfort conditions at the Barclaycard head office.

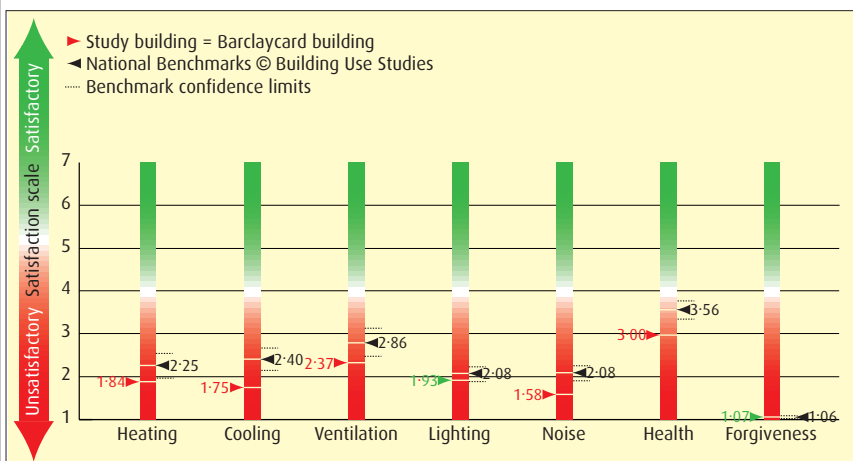
Scores for perceived control are all significantly lower than the benchmark figures, which themselves are well below the scale mid-point (figure 4, left). This is balanced by good scores for quickness of response, with that for cooling being significantly better than the benchmark.

Figure 4: Overall satisfaction with health and perceived control over the environment.

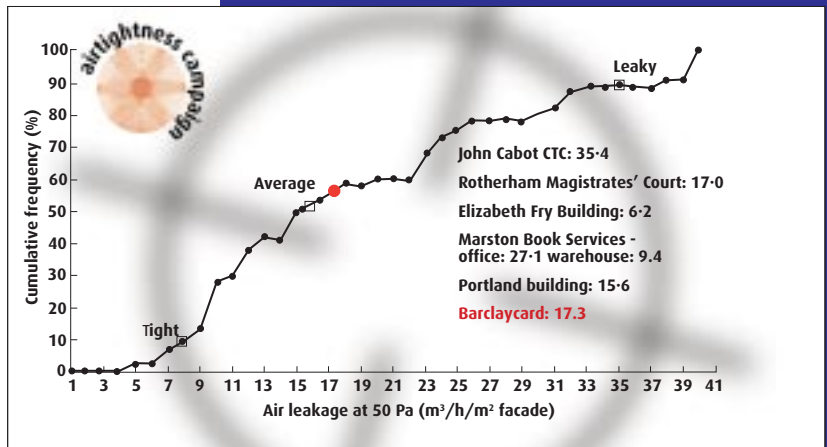
**FIGURE 5:** The air leakage data for the Barclaycard head office, plotted on the BRE/BSRIA database. The cumulative distribution represents a sample of three building types: those designed to be airtight, buildings designed without airtightness as a design criteria, and some older buildings.

The results of the test gave an air leakage index for the building of 17.8 m<sup>3</sup>/h/m<sup>2</sup> at a pressure differential of 50 Pa. As plotted on the BRE/BSRIA database, the building is classified as just above the average benchmark value (figure 5, above).
