Orchard Learning Resources Centre

The Orchard Learning Resources Centre at the University of Birmingham attempted to develop the genre for low energy, naturally ventilated academic buildings. How did the design and construction team get on?

BY THE PROBE TEAM

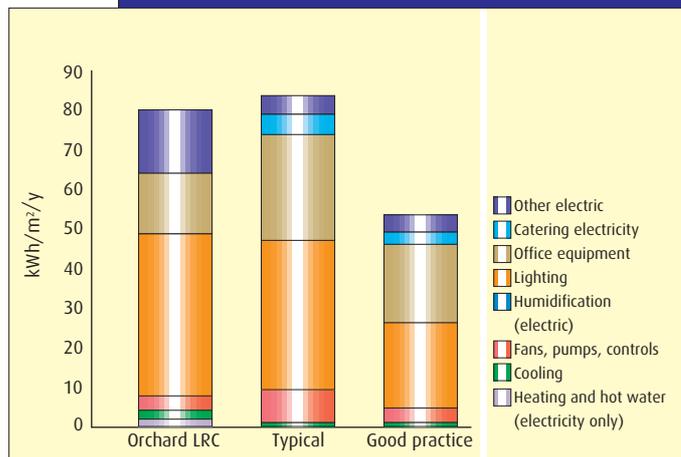
FIGURE 1: End-use electricity breakdown at the Orchard Learning Resources Centre.

An analysis of electricity bills shows that in the year from April 1999 to March 2000, actual total electricity consumption was 356 MWh or 80 kWh/m² (tfa). Total unadjusted electricity consumption is about 50% above the Type 2 good practice benchmark of 54 kWh/m² and 6% below the typical figure of 85 kWh/m².

The Office Assessment Method analysis considers performance against benchmarks. It excludes the floor areas and energy consumptions of the Mingana manuscript room and the book stack rooms to recognise that the type 2 benchmark building does not allow for such loads. The result of this analysis puts the adjusted electricity consumption at 69 kWh/m² tfa, which is about 28% above Type 2 good practice and 18% below typical (figure 1).

It seems appropriate to take into account that the energy consumption by office equipment at 11 kWh/m² is substantially below the type 2 office good practice and typical figures of 20 and 27 kWh/m². For benchmarking the Orchard Learning Resource Centre, those for office equipment load should be adjusted downwards to the building's actual figure of 11 kWh/m². This would make the adjusted electricity use (excluding the Mingana room) exactly the same as the adjusted type 2 typical value of 69 kWh/m²/y.

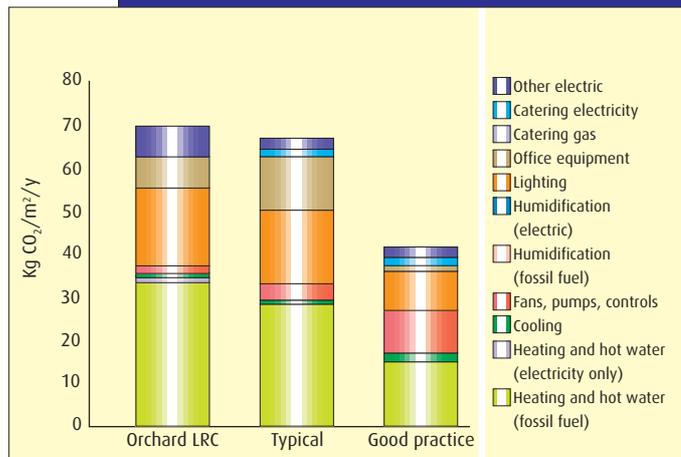
FIGURE 2: Carbon emissions at the Orchard Learning Resources Centre by end use. The conversion factors are 0.46 kg CO₂/kWh for electricity and 0.19 kg CO₂/kWh for natural gas (Econ 19, January 2000).

The building emits 74 kg CO₂/m². This is 12% above the level considered typical for a Type 2 office building – the nearest benchmark.

Total annual CO₂ emissions (after adjustment for weather) are 74 kg CO₂/m²/y, 12% above the typical level (figure 2). In comparison with the Anglia Polytechnic University learning resources centre, examined by the PROBE team in 1996³, the Orchard Learning Resources Centre uses twice the amount of gas, 50% more electricity and emits 82% more CO₂.

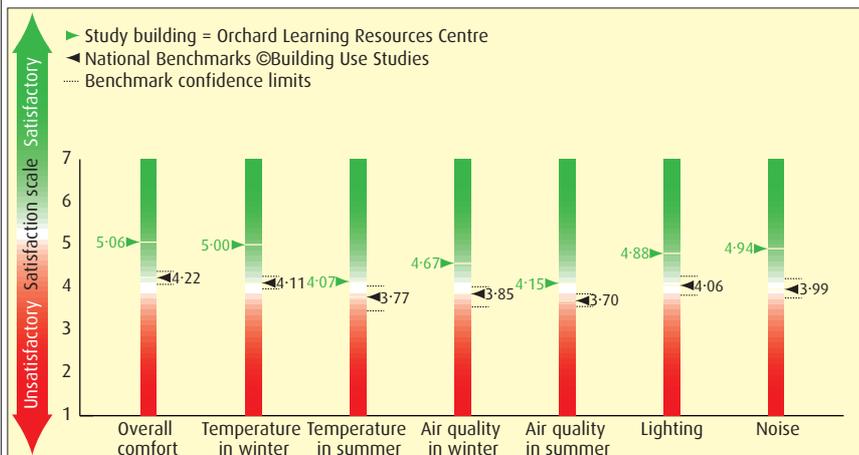
FIGURE 3: Overall satisfaction with comfort conditions at the Orchard Learning Resources Centre. A green arrow signifies a performance at or better than benchmark, a red arrow below benchmark. These scores are relative to the benchmark dataset of 50 buildings. They are therefore not absolute.

For comfort, the building is significantly better than the UK benchmarks for both winter and summer. These benchmarks are based on the 50 most recent buildings studied by Building Use Studies, so they represent average (not necessarily good) UK conditions.

On temperature and air quality, the building is perceived to be neither too hot nor too cold, although there were localised complaints. In winter it is considered stable, still, dry, fresh and odourless. Winter air quality is also perceived to be satisfactory. For summer, the building is comfortable overall, but too hot, stable, still, dry and stuffy. Again, air quality is satisfactory.

Overall, these results are what might be expected from a naturally ventilated building (figure 3).

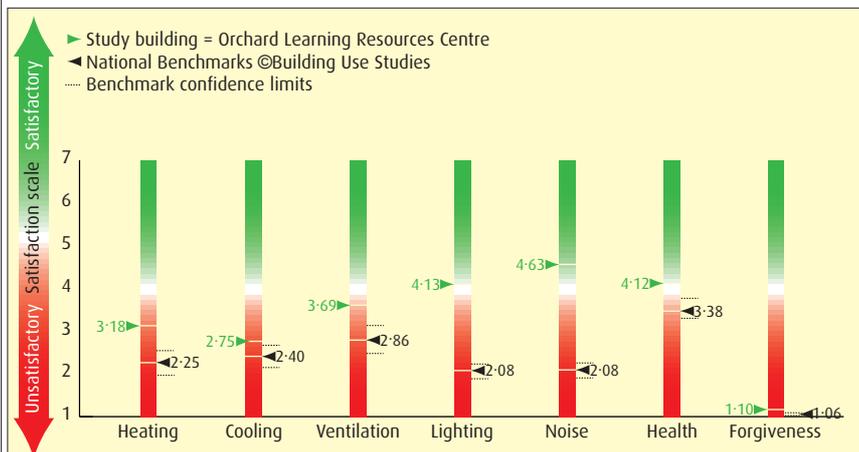
FIGURE 4: Occupants' perceived control over their environment, plus scores for their perception of the building as a healthy place, and their level of 'forgiveness' stemming from architectural delight.

Every one of the scores for perceived control and quickness of response is significantly better than the dataset benchmarks. The score for occupants' view of the building as a healthy environment are also high (figure 4).

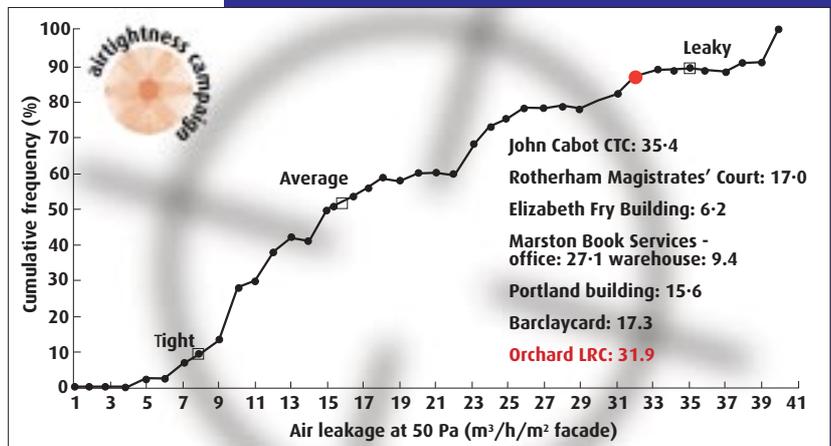
FIGURE 5: The air leakage data for the Orchard Learning Resources Centre, plotted on the BRE/BSRIA database. The cumulative distribution represents a sample of three building types: those designed to be airtight, buildings designed without airtightness as a design criteria, and some older buildings.

The resulting air leakage test (at a reference pressure of 50 Pa) was calculated to be 31.9 m³/h per m² of envelope area. As a tight non-domestic building would have an air leakage index of less than 7.5 m³/h per m² of envelope area, and a leaky one 34 m³/h per m² of envelope area, then the Orchard Learning Resources Centre can be considered to be close to the leaky benchmark on the BRE/BSRIA database.

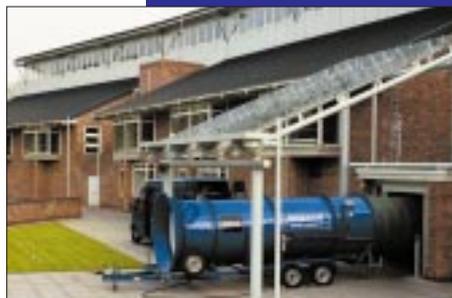
A brief air leakage audit using hand-held smoke tubes identified the leakage paths in the envelope. Significant air leakage occurred at the coffered ceiling/external wall junction. The top and bottom of the columns also leaked.

Much of the roof/wall interface could not be checked, but the areas that were tested proved to be leaky, especially at one point where a roof beam penetrated the external wall.

The building's windows had a variety of leakage points, such as around their frames, pivots and under the window cills. Air leakage was detected underneath the skirting boards on the first floor and down through the gaps around the heating pipes.

The centre-pivoted clerestory windows were found to be very leaky. This was because the automatic controllers did not close them up tightly against the draughtproofing.

External doors were quite leaky especially the rear double loading-bay doors, where daylight could be seen around its perimeter.

Even closed trickle ventilators were a source of air leakage, and a few of them even had to be forced shut before the test.

The BREFAN Large Fan Pressurisation System during the BRE pressure test at the Orchard Learning Resources Centre.
