BRE Scotland Innovation Park Visitor Centre

Innovate UK project number	450086
Project lead and author	BRE Scotland
Report date	2014
InnovateUK Evaluator	Unknown (Contact www.bpe-specialists.org.uk)

Building sector	Location	Form of contract	Opened
Visitor centre	Glasgow	Unknown	2012
Floor area	Storeys	EPC / DEC	BREEAM rating
110 m ²	Single	A / N/A	Outstanding

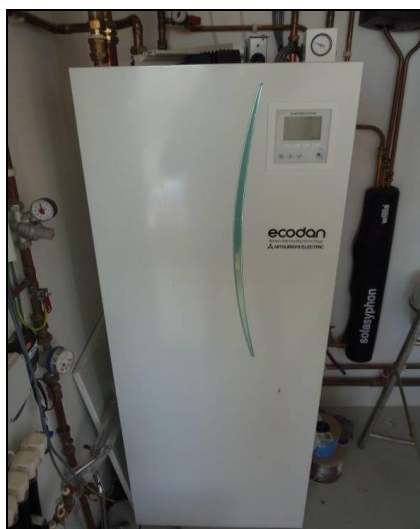
Figure 2: ASHP Cylinder Unit

Following a fault in communication between the Mitsubishi ASHP and cylinder, both were replaced in April 2014. The new ASHP is a Glow worm EnviroSorb 5, with a Glow worm Fluryoc₂ cylinder and associated hydraulic module. These new units have been commissioned to work as before, providing heating to the Visitor Centre via the underfloor heating.

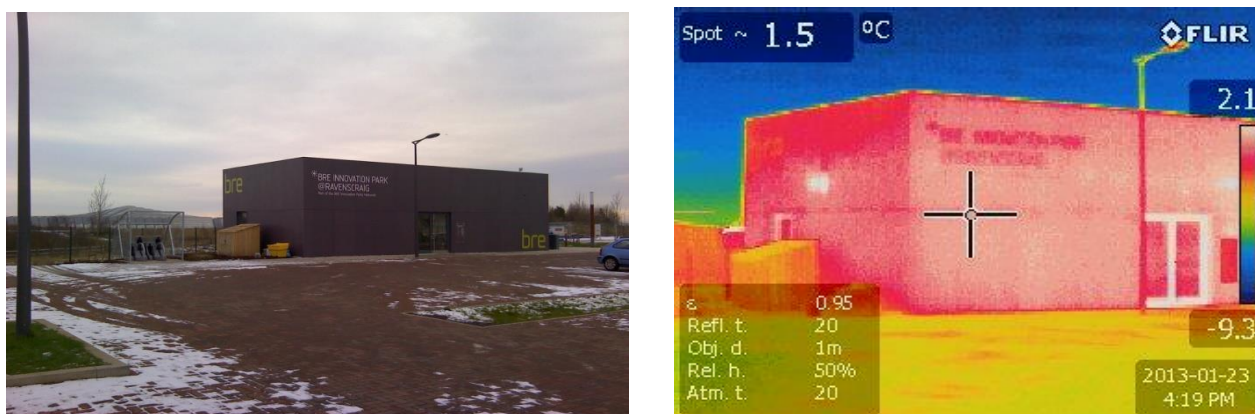
Figure 48: External Thermal Image 1

In Figure 48, a considerably warmer surface temperature was detected at two concentrated points located above the battery shed. This was further investigated and was found to be mechanical ventilation openings, as is shown in Figure 49.

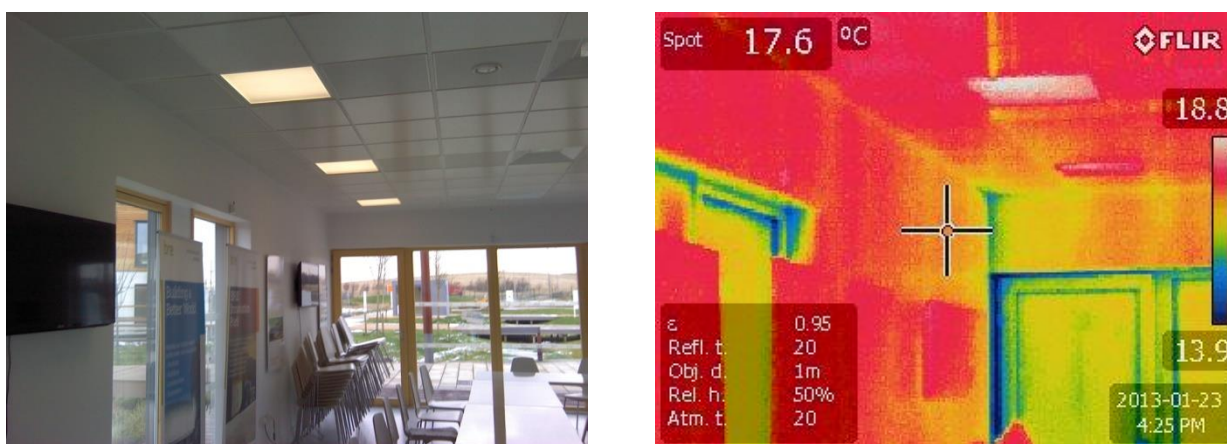
Figure 52: Internal Thermal Image 1

A number of areas were identified as having lower surface temperatures throughout the inside of the building, primarily at junctions where some cracks have appeared. This is particularly clear in Figure 52 and Figure 53. The significance of these cracks, when compared with the as designed performance, will be determined through the air tightness testing results, but recorded temperatures are considered lower than would be expected.

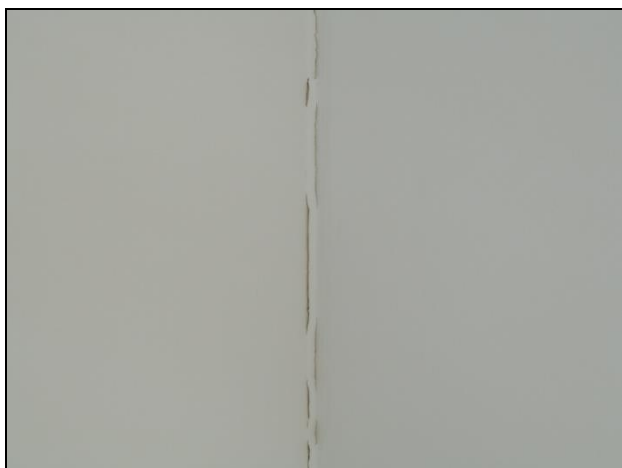
Figure 65: Crack in Wall Joint 1

There are two key issues related to airtightness, which are often found with timber frame buildings. Firstly, hairline cracks between the plasterboard are generally due to differential movement and general settling of the building. Over time the cracks can expand and result in higher heat loss through infiltration. Structural movement, which is a normal occurrence in new buildings, can also cause or worsen this effect.

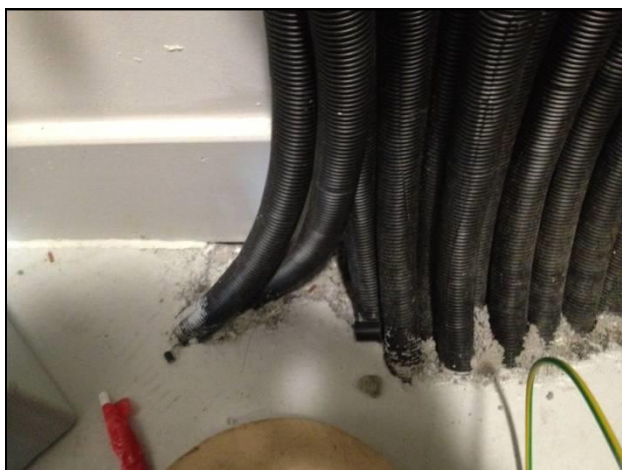
Figure 67: Under-floor Heating Connection

In addition to the possible gaps within the air barrier, there are also a number of penetrations that could be negatively affecting the air tightness performance of the building. While the majority of the building has a fairly clean finish, the plant room has a number of penetrations in the floor, roof and walls. It should be noted that some work in the plant room has been undertaken retrospectively, for various projects and purposes, following handover and therefore the building may have been handed over to BRE with a better level of air tightness than has been measured at this stage in the project. A number of the building fabric penetrations have been documented; see Figure 67, Figure 68, Figure 69 and Figure 70.
