This document contains a Building Performance Evaluation report from the £8 million Building Performance Evaluation research programme funded by the Department of Business Innovation and Skills between 2010 and 2015. The report was originally published by InnovateUK and made available for public use via the building data exchange website hosted by InnovateUK until 2019. This website is now hosting the BPE reports as a research archive. Although no support or further information on the reports is available from the host, further information may be available from the original InnovateUK project evaluator using the link below¹.

InnovateUK project number	450054
Project author	ECD Architects for Hanover (Scotland) Housing Association Ltd
Report date	2014
¹InnovateUK Evaluator	N/A

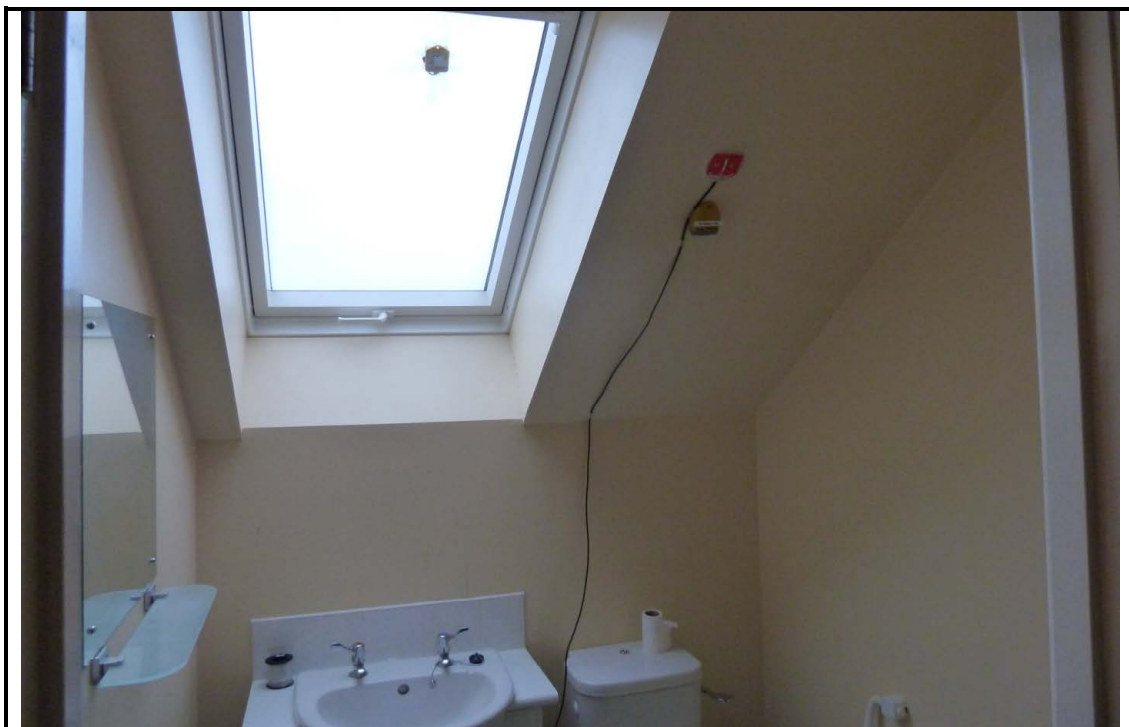
U-value kit sensor arrangement testing the heat transfer through the roof. Unfortunately the flux plate in this location became dislodged during the test.

On collecting the equipment from the testing it was apparent that, despite careful installation, the flux plate had become dislodged from the roof element. Further investigation found that two other flux plates installed in the dwelling as part of the co-heating testing had also become dislodged during this time period. It has been assumed that the very warm and dry conditions created for the co-heating test contributed to this failure and may have dried out the fixing tape, reduced its adhesion and ultimately caused the plates to fall off.

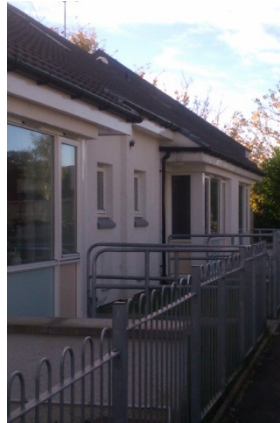
Most of the tenants thought that the natural lighting was good, although they felt overlooked by the proximity of the path at the front of the property, requiring the partial closing of blinds or curtains which affected the quality of natural light. Other rooms and bedrooms had adequate natural light. Positive mention of the sun pipe to the upstairs internal landing was made by several of the tenants.

Proximity of path to Living room

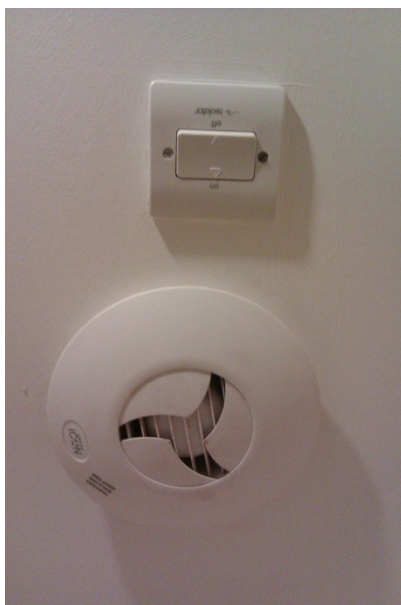
Extract fans: All tenants complained that the mechanical extract fan to the downstairs shower room was not effective, Draw from fan very poor. This was undoubtedly the biggest cause for concern among all tenants and had been reported to Hanover who were presently looking at solutions. The upstairs extract fan (same as ground floor) worked well, possibly indicating a blockage in the duct work from the ground floor shower room to the vent. This required further investigation. See separate detailed report on extract fan operation in Section 9.

Shower room Extract Fan

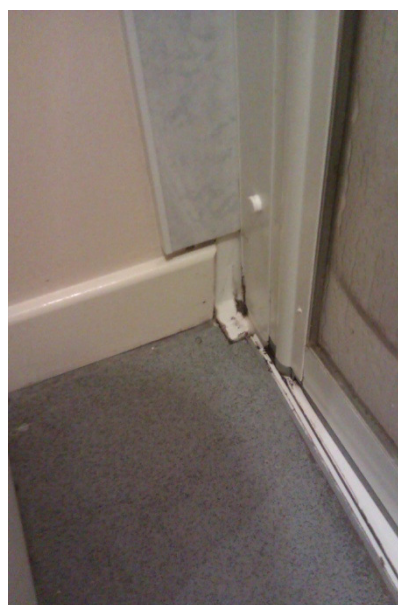
Shower room damp

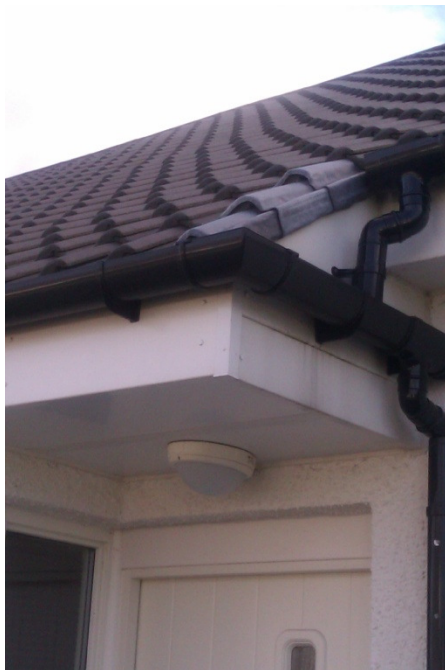
- Kitchen window handle replaced
- Roof leak
- Steep roof pitch. Overshooting of gutter in instances of heavy rain
- Well insulated roof – Snow build up – Falls off damaging gutter
- Two door handles replaced
- Boiler was replaced due to defective heat exchanger
- Main issue revolved around the ground floor shower room ventilation.

Steep roof pitch

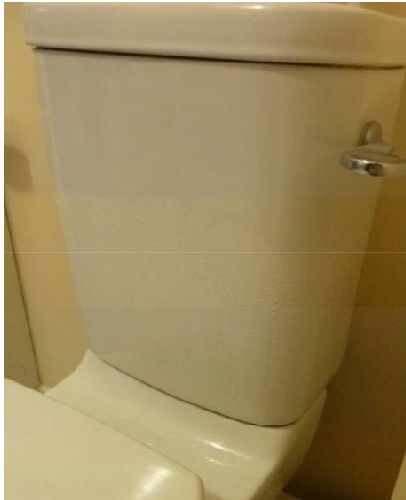
The toilet cisterns were found to be very cold and to present a condensation risk. Moves should be made to insulate these and mitigate the effects of damp and mould growth of adjacent materials. Note, this issue was only viewed in LA5 but is likely to exist in other dwellings when under normal occupancy conditions.

Figure 9.4: Condensation of WC cistern with pooling just visible at cistern and seat.

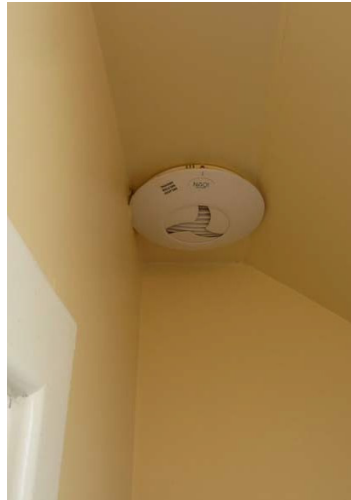
Figure 9.5: Inaccessible (for testing) WC extract fan
