# **Bryan House**

InnovateUK project number	450100
Project author	Low Carbon Building Group, Oxford Brookes University for Sanctuary Green Technologies
Report date	2014
<sup>1</sup> InnovateUK Evaluator	N/A

Low Carbon Building Group (LCBG) of Oxford Institute for Sustainable Development (OISD) at Oxford Brookes University was commissioned to monitor and evaluate the social housing project during its *Post construction and initial occupancy* phase and provide key comments and recommendations.

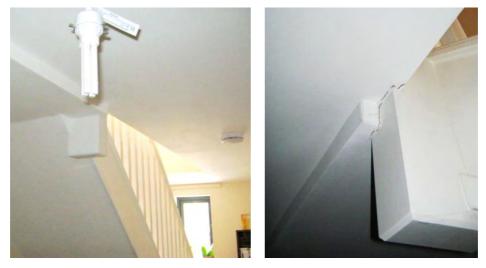
- In House 2 some additional plasterboard soffits were used to cover a construction flaw in the staircase leading to second floor (Figure 7).
- The mechanical equipment is located in cupboards that are accessible to the occupants and are being used as storage space. After discussion with the architects it has been pointed out that due to changes in the energy strategy of the houses (decision to use ASHP instead of gas boilers), space that was originally designed for storage had to be used as space for the ASHP mechanical equipment and the hot water cylinder. This resulted in the MVHR unit being placed in the loft and the hot cylinder in the dedicated storage space (Figure 9).

Figure 7 House 2: additional plasterboard soffits used to cover a construction flaw in the staircase

- Provide adequate space for mechanical equipment and extra dedicated storage space from the initial design stage.
- Take extra care in detailing and finishes during construction to avoid air leakage paths and construction flaws.

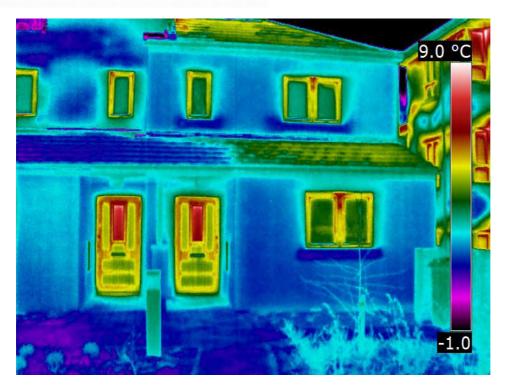
Figure 22 No.1 front (east) elevation thermogram. Note: No thermal abnormalities are evident in the walls. The elevated temperature in the front door is typical for design, and the elevated temperatures in the upper centre of the windows is likely to be due to poor fitting.

- No thermal anomalies are evident in the walls with the exception of the party walls between the properties of different height where some heat loss was observed.
- Elevated temperatures around the window frames are likely to be due to poor fitting.
- Front door heat loss is due to low insulation and design of door.

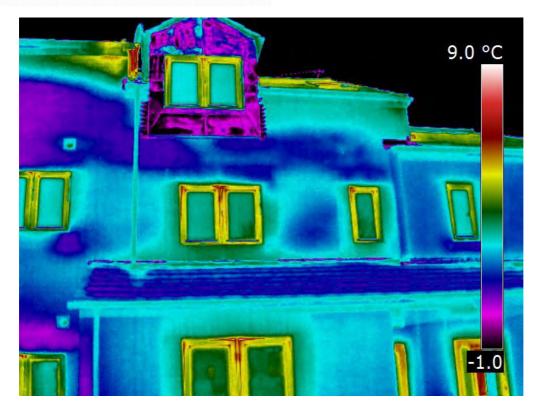
Figure 28 No.2 front upper (east) elevation thermogram. Note: The upper bedroom temperatures show as being low due to the material of construction and the reflectance of the sky temperature. Similarly the upper wall appears to be a lower temperature due to reflectance from the sky temperature.

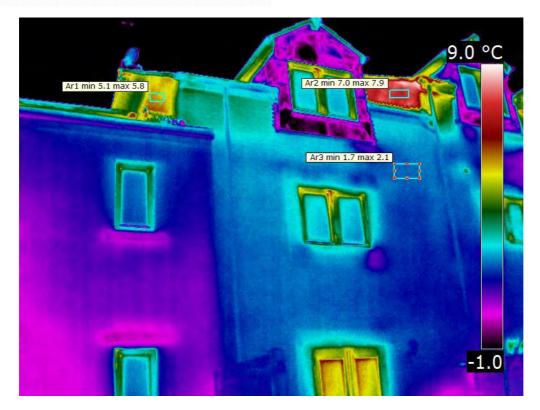
Figure 30 No. 2 rear upper (west) elevation thermogram. Note: Elevated temperatures were observed on the north walls between properties 1 & 2 as well as 2 & 3. Area temperature boxes are shown on the image for comparative purposes.

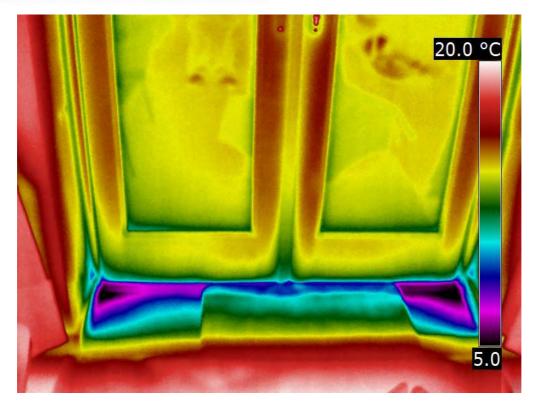
Figure 32 No. 2 rear patio doors lower (internal) thermogram. Note: Thermal bridging across threshold and different temperature scale used from image 17. Similar characteristics also observed in property No. 1.

- Thermal bridging across threshold was observed in both properties.
- A cold bridge from a beam in the ceiling of the kitchen was identified in both houses. This is due to the detailing of the kitchen roof. It should be noted that part of the kitchen ceiling is exposed as the kitchen extends beyond the floor above it. The steel beam was not insulated resulting in a cold bridge.

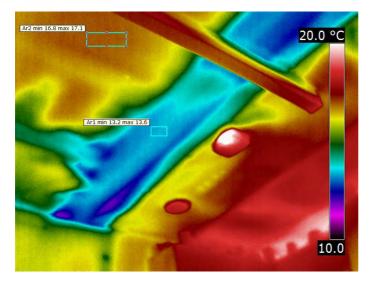
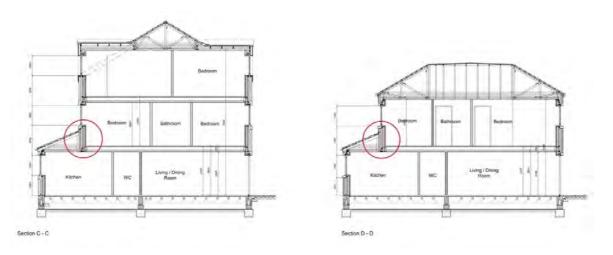
Figure 34 No. 2 kitchen ceiling thermograph (south view). Note: Image shows cold bridging from structural beam in ceiling. The same was observed in House 1 kitchen ceiling

Figure 36 Section through dwelling kitchens with the bean above the ceiling highlighted

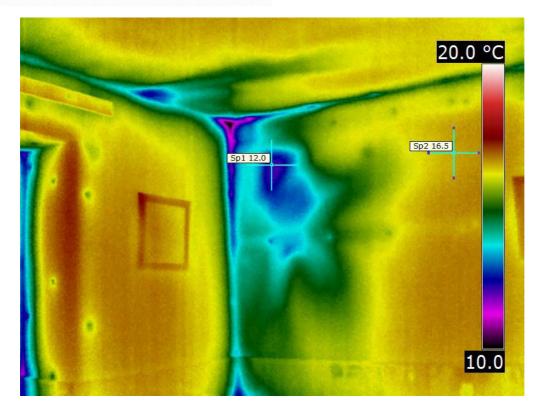
Figure 37 No. 2 kitchen wall thermograph (south view). Note: Cold spot identified on wall is an irregular shape probably due to air movement within the structure

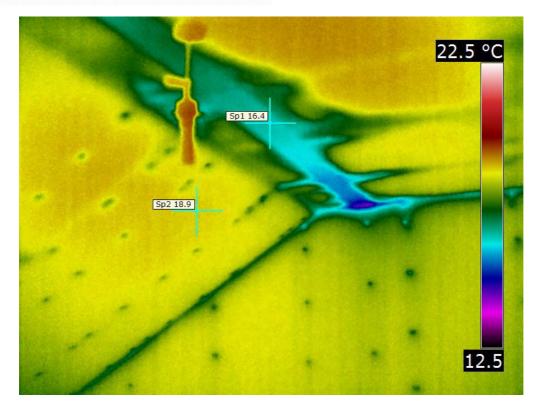
Figure 39 No. 3 bedroom ceiling (north) thermograph. Note: Image shows cold bridging from beam above ceiling. Similar image also is viewed (south) towards other end of room and similar characteristics were observed in bedroom 4.

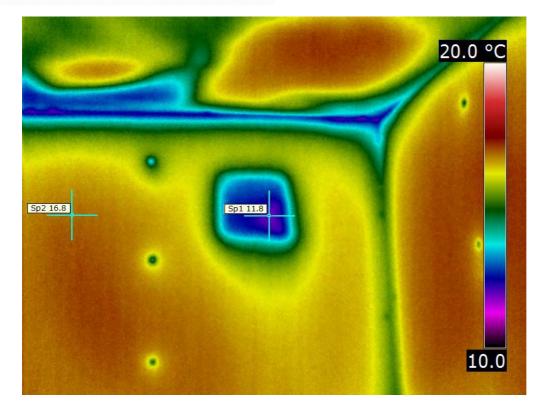
Figure 41 No. 1 Kitchen wall thermograph (north view). Note: Cold area identified on wall in an area similar to property No. 2.

- Square solid area in House 1 kitchen wall indicates that an insulation panel is missing. This is possibly due to a mistake during construction.
- Cold spots identified on House 1 ceilings indicate that roof insulation is missing. This was
  further investigated during the commissioning review and a visit in the loft revealed that the loft
  insulation has been misplaced, possibly be the occupants, to make room for storage. It could
  also be that the insulation was never distributed in the roof space properly.

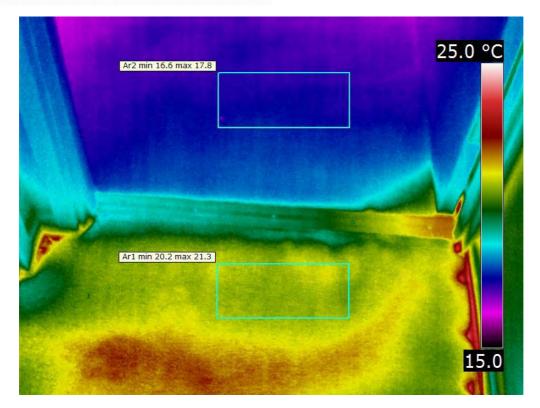
Figure 43 No. 1 landing to bedroom 1 floor interface thermogram. Note: Resident of property 1 commented during survey that bedroom 1 was always cold compared to remainder of house. The thermogram confirmed that this phenomena despite the controller within the space calling for heat. Further investigation of this fault is therefore recommended.

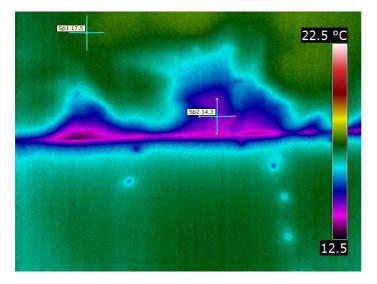
Figure 45 No. 1 bedroom 2 ceiling (centre north) thermogram. Note: Cold area possibly due to missing roof insulation or insulation not located correctly between roof joists. No digital image available of area.

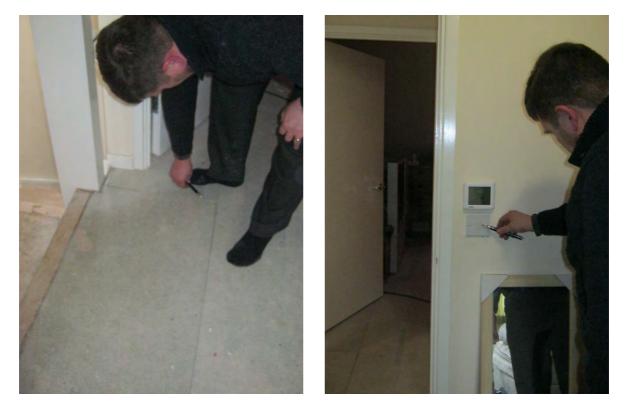
A fan pressurisation test is a useful quantity assessment indicator of air leakage in a building although it does not directly identify its location. In order to attain an overall image of air leakage paths in the building envelope it can be combined with visualization methods such as smoke visualization. The smoke pencil test revealed several air leakage paths (Figure 53) (Tables 8, 9).

Figure 53 Smoke pencil test

- Both houses failed to meet the design air permeability of 3 m<sup>3</sup>/hm<sup>2</sup> and were measured to have between 5.27-5.91 m<sup>3</sup>/hm<sup>2</sup>.
- However, they were both significantly less than the national building standard of 10 m<sup>3</sup>/hm<sup>2</sup>.
- High air permeability might indicate that there is no need for the use of the MVHR system.
- The smoke pencil test revealed several air leakage paths through skirting boards, electrical outlets, plasterboards, light fittings loft hatch.

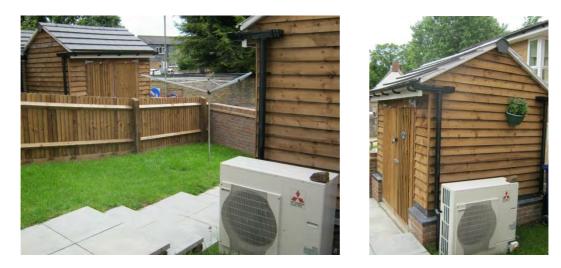
Occupants are not satisfied with the size of the garden and believe that the shed is too big and that it takes up vital space. Also, occupants are not satisfied with the privacy of the gardens and would have preferred the fences to be higher (Figure 87).

Figure 87 Back garden. The shed takes up a lot of space. Occupants do not like the position of the ASHP.

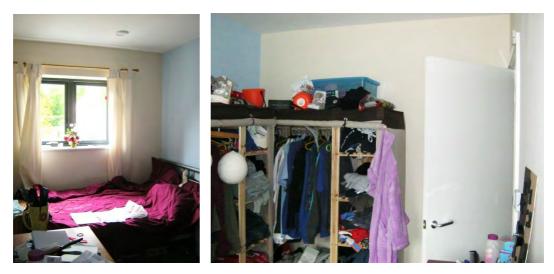
Occupants are satisfied with the temperatures, daylight levels and air quality of the space. They are satisfied with the size of the room but complain that there was no built-in storage space. They appreciate the fact that the windows are well designed and easy to clean. The worst aspect of this space is the MVHR vent that is positioned directly above the bed thus creating annoying draughts (Figure 90). The occupants have shut the vent to avoid the draughts and the noise coming from the system. This is common in other bedrooms in the house and has led to the unbalancing of the MVHR system.

Figure 90 Parent's bedroom. The MVHR vent is located directly above the bed leading to annoying draughts.

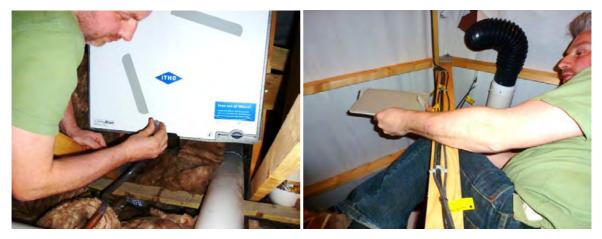
that this issue was common in many houses and the manufacturer was called to repair the units. The MVHR breakdown in House 2 has still not been resolved and air flow measurements could not be taken.

Figure 101 Condensation pipe not draining
