# Castle Hill Primary School

<b>Innovate UK project number</b>	450035
<b>Project lead and author</b>	ECD Architects
<b>Report date</b>	2014
<b>InnovateUK Evaluator</b>	Robert Cohen (Contact via <a href="http://www.bpe-specialists.org.uk">www.bpe-specialists.org.uk</a> )

## Purpose of evaluation

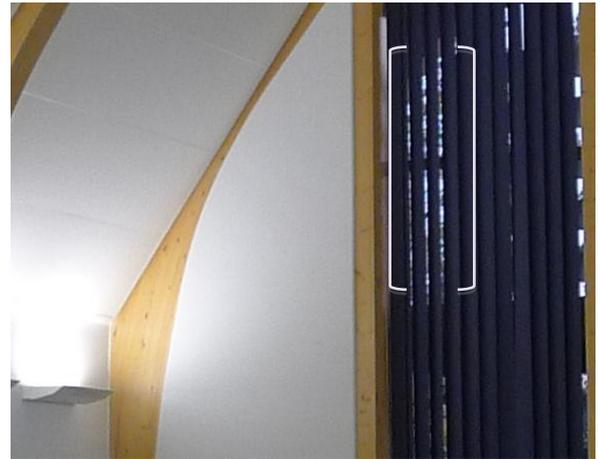
- There were no signs of condensation or mould around the window panes or frames although some cracking of the paintwork to one of the window reveals was spotted on the East of the main space [Figure 2.8]. It was unclear whether it was historic damage (perhaps caused by incorrect application of the paintwork), or whether this signified a more significant fault in the window junction.

Figure 2.8: Cracked paintwork was observed to the reveal of one of the East facing windows

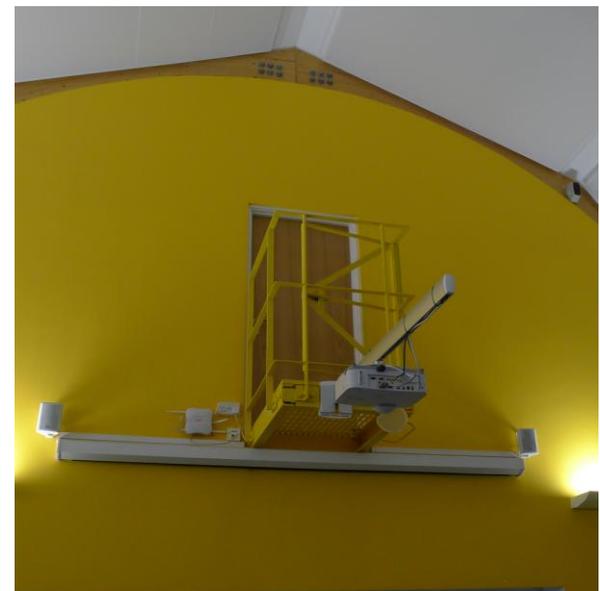
- The visual intrusion of the access platform has been exacerbated by the later addition of an overhead projector. It appears that the installer has used a part intended for wall mounting, and so approx. 1-2 metres is redundant. This could have been solved by cutting down the bracket or sourcing a different mount.

Figure 2.9: A bulky service access platform and overhead projector overhang the servery window

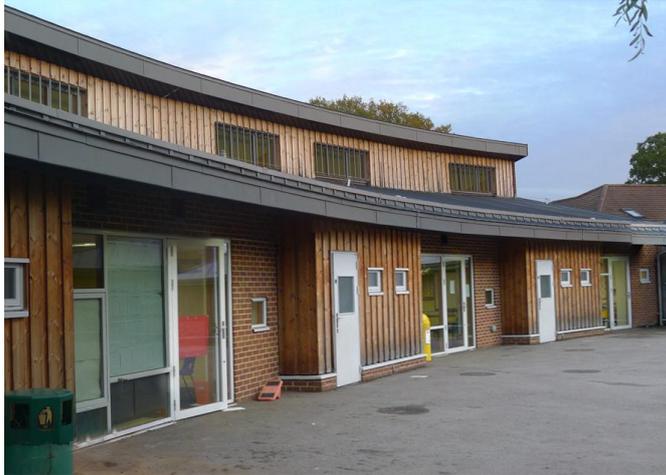
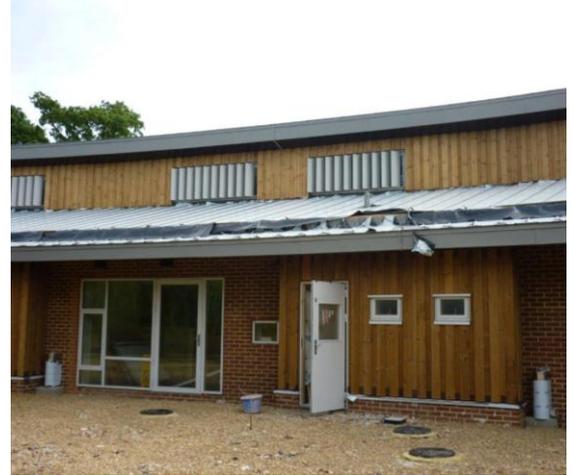
- The Junior Block extension was in occupation by September 2010 and so by the date of the walkthrough had been in use for a little over 3 years. During this time, the timber cladding has started to naturally weather to a silver grey and this process has already evened out the differences in shade that were initially visible between upper and lower façades during construction **[Figure 2.12]**. The silvering of the timber has been most accelerated at the base of the lower façade, where the overhanging roof provides the least amount of protection from the weather. The staff seemed aware that the material would weather naturally, although they did question whether this particular pattern was normal. It was explained that in time the weathering effect will even out across the façade.

Figure 2.12: Photographs of West façade, taken Nov 13 during walkthrough (left), & Aug 2010 during construction (right)

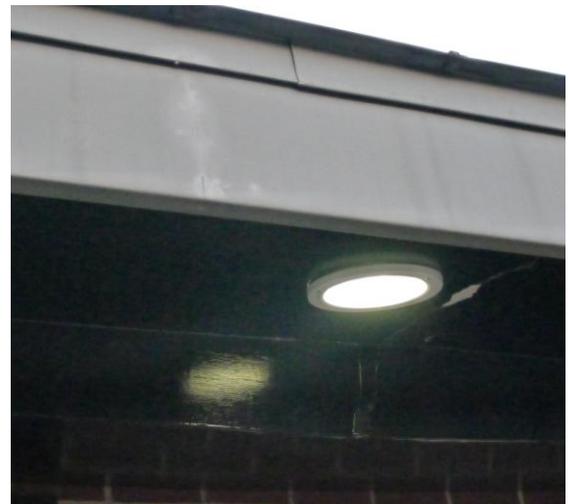
- The external lighting was already on at 16:20, when the 5<sup>th</sup> Nov 13 official hours of darkness (for vehicle lights) did not begin until 16:56 **[Figure 2.13]**. It is proposed that the control setting should be investigated further as an outcome of this report.

Figure 2.13: External lighting for the Junior Block extension was on outside the hours of darkness.

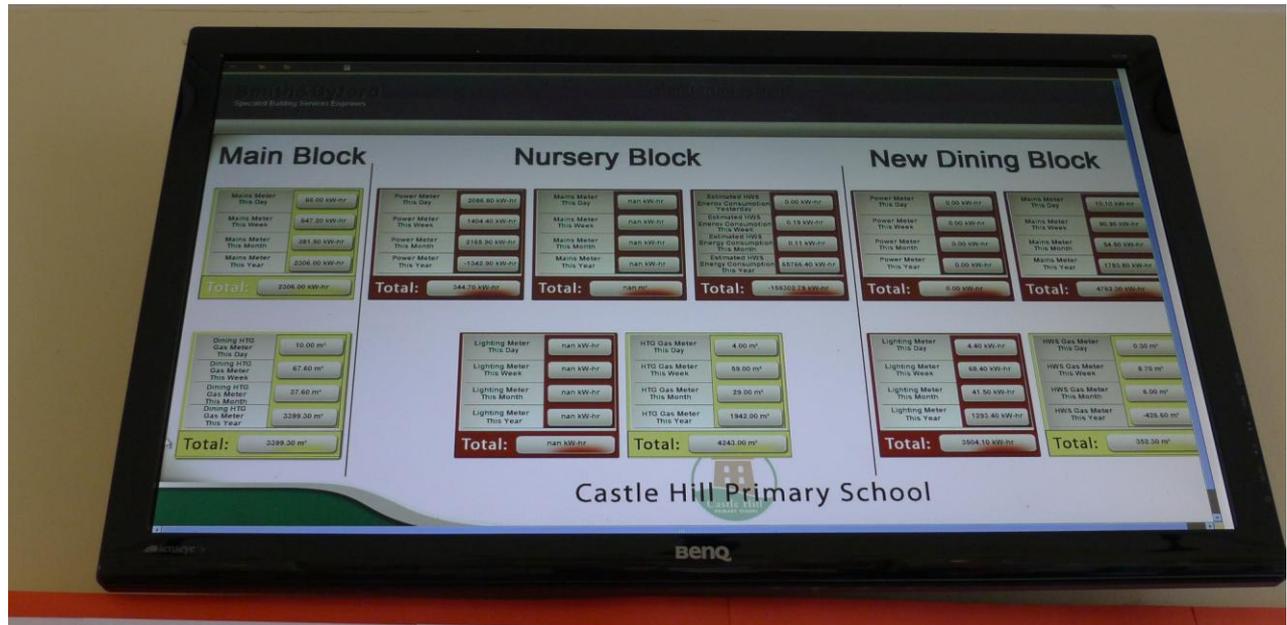
Figure 5.2: The energy display in the school reception provides building performance data to users, but is rarely in working order. The information is laid out in a format that is difficult for non-technical users and children to interpret.

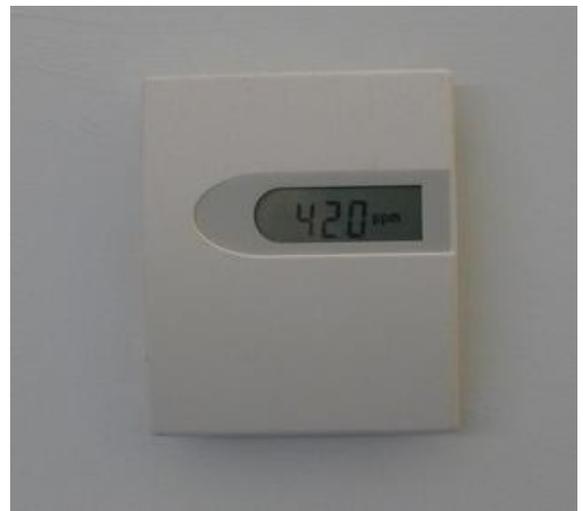
Figure 7.7: CO<sub>2</sub> sensors in the Dining room (taken when room was unoccupied), appeared to be registering a sensible reading, 420 parts per million. Temperature for the same sensor appeared slightly

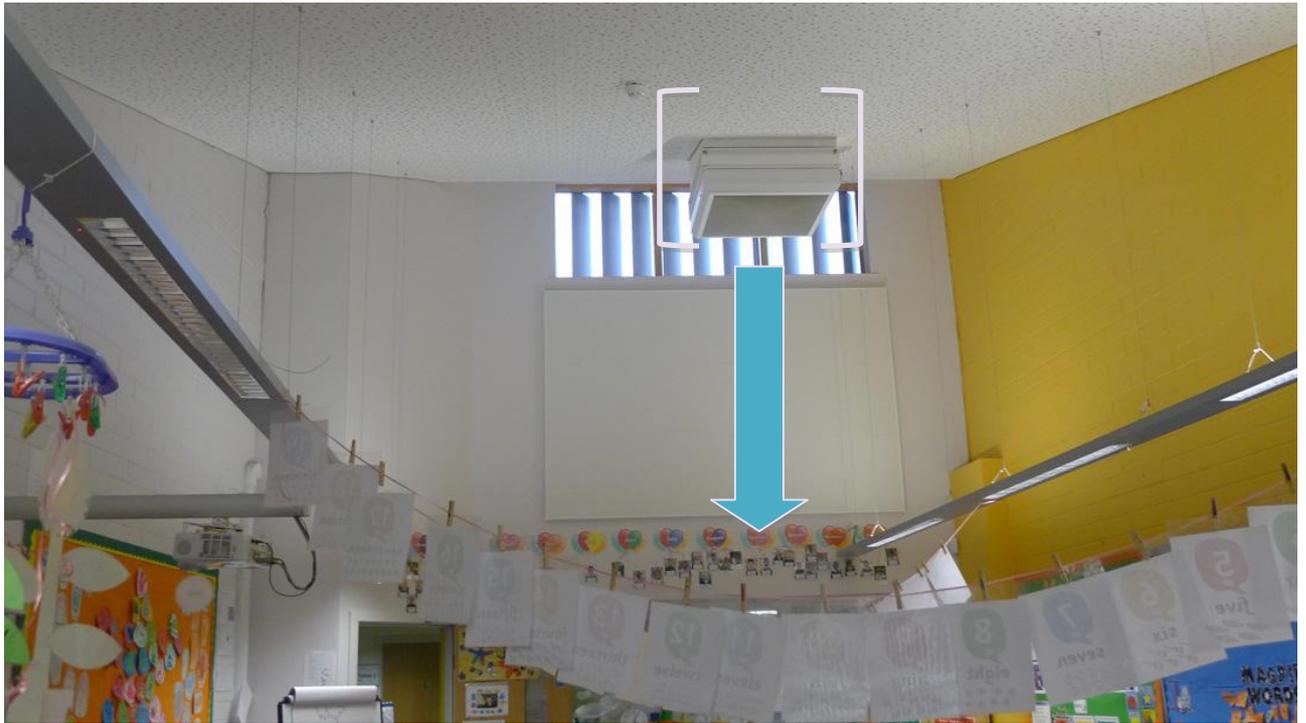
Figure 7.8 - Passive stack ventilation system in classroom, overlay indicates effect of cold draught as reported by staff member.

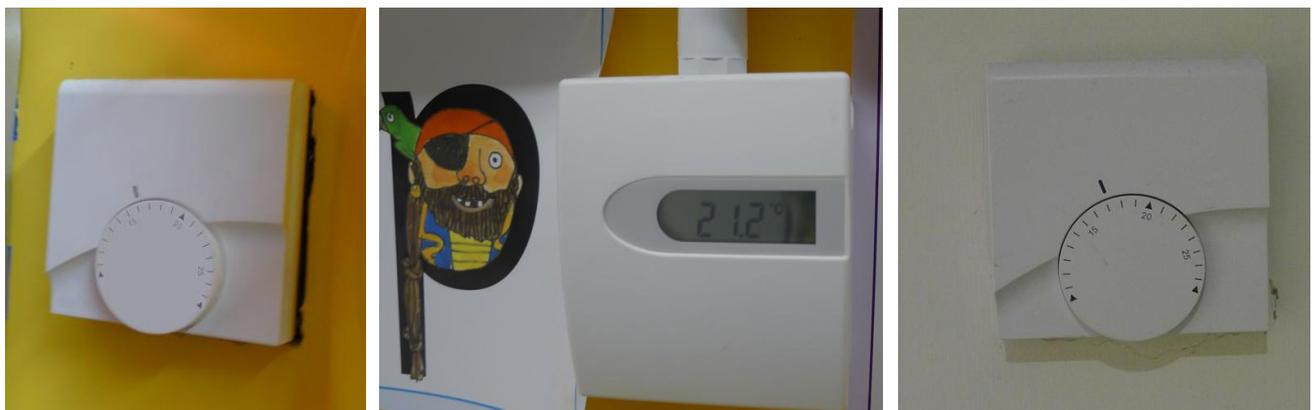
**Figure 7.12: A vast difference was noted between the room thermostats and the display readings in the classrooms**

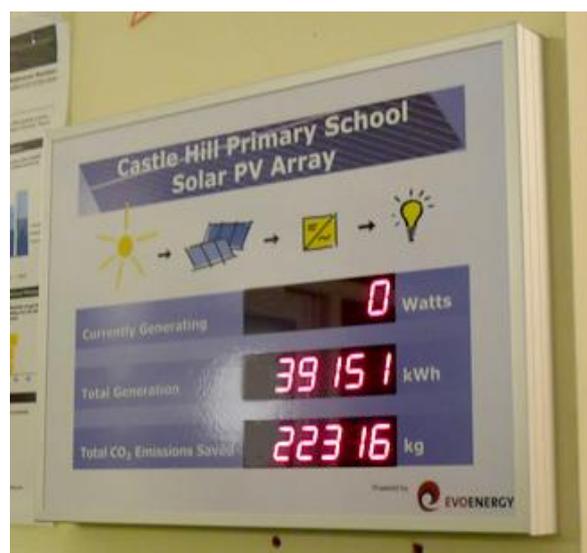
Figure 7.14: The photovoltaic array was not working at the time of the walkthrough. The Display panel in the hallway was reading correctly, and it was this that had alerted the school to the problem.

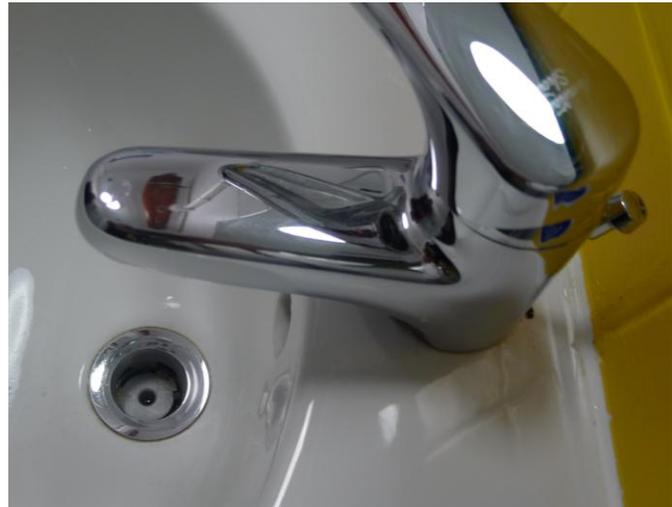
**Figure 7.15: The school has removed the pop-up wastes in all of the WCs. The children do not need them to wash their hands, and they cause additional maintenance issues.**

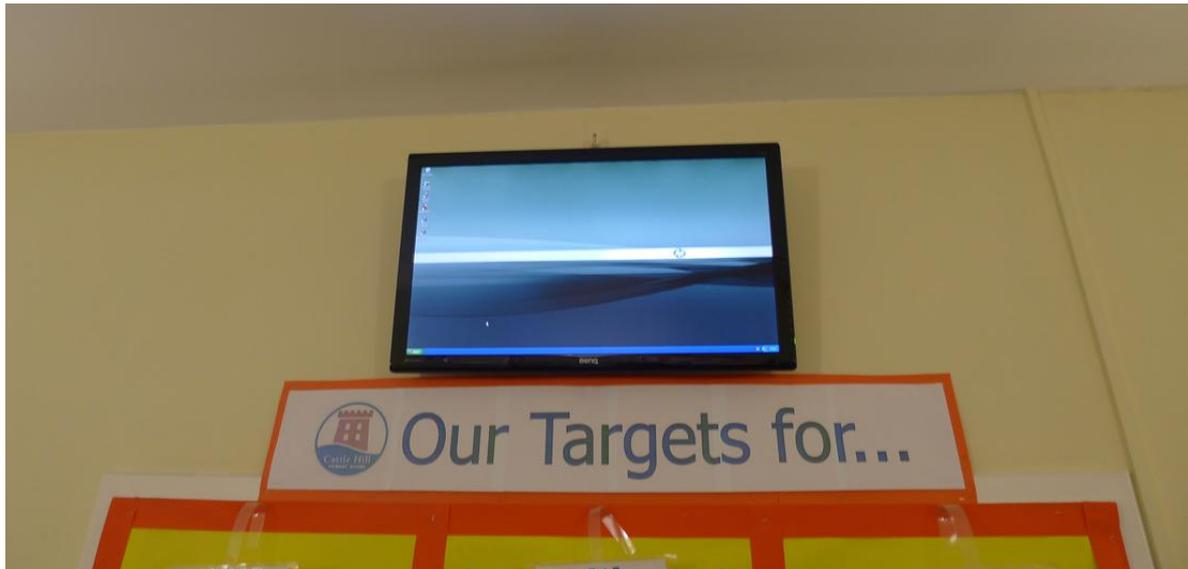
Figure 7.18: The BMS 'energy usage' display was using energy, but it was not displaying energy usage
