Community In A Cube

InnovateUK project number	450052
Project author	Leeds Beckett University for the Good Homes Alliance
Report date	2013
¹InnovateUK Evaluator	N/A

No of dwellings	Location	Type	Constructed
Single apartment	Middlesbrough	Flat	2011
Area (TFA measured)	Construction form	Space heating target	Certification level
42.9 m ²	Concrete frame	N/A	Building Regulations

Background to evaluation

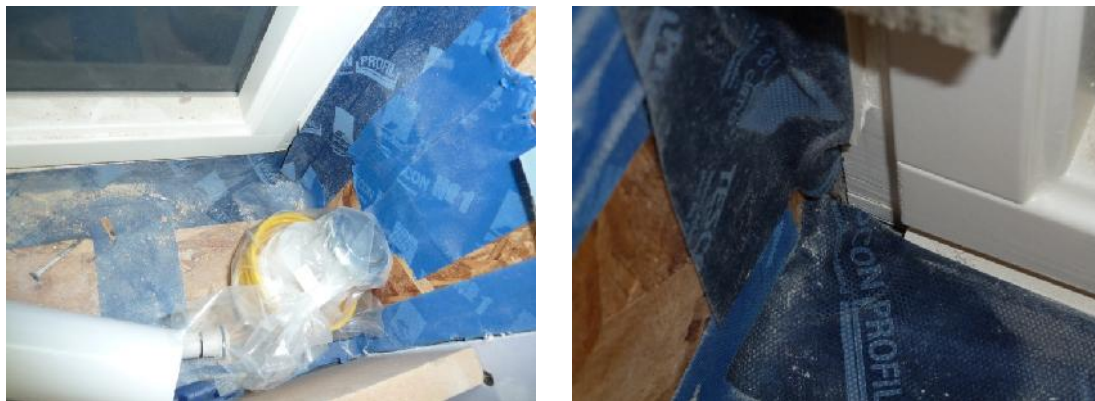
- **Application of airtightness tapes** – Various tapes and membranes had not been used to seal various interfaces within the apartments. In a number of places, the tape had either begun to lose adhesion or had only been fixed at the edge and had not been stuck down across the entire width of the tape, leaving an air gap behind, increasing the risk of failure. If not addressed, this is likely to result in an increased in air leakage through the building envelope.
- **Holes in timber-frame in-fill panel** – Additional holes had been cut into the timber-frame in-fill panel for the MVHR extracts. Removal of the OSB and original tape raises questions on how these will be re-sealed in order to maintain continuity of the air barrier, particularly given that the extract is now sealed to the frame and not the OSB. This may result in an increase in air leakage at this junction.

Figure 3 Loss of adhesion from tape and gaps in tape at corners of windows.

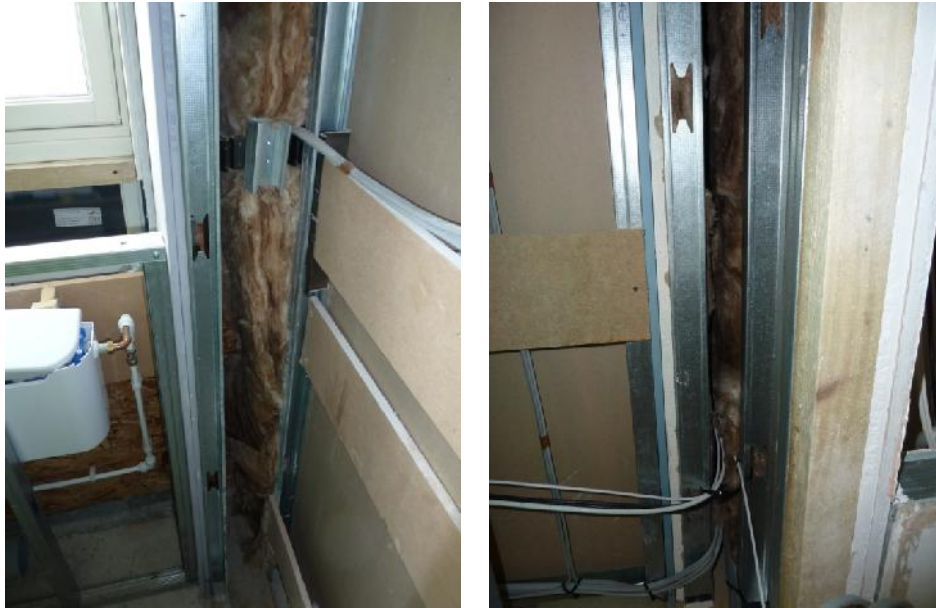
- **Insulation bridging across party wall** – Insulation was observed bridging across party wall, rather than being restrained within the individual frame sections on party wall, limiting its effectiveness.

Figure 4 Insulation bridging across party wall.

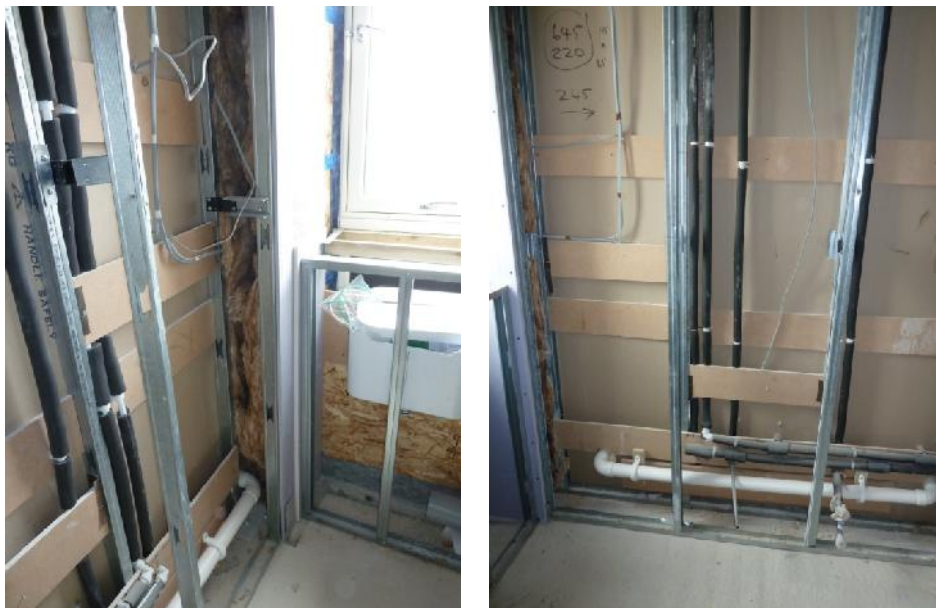
- **Holes in party elements** – A number of holes from services that penetrate through party elements remain, allowing indirect air leakage paths.
- **Retention of partial fill insulation** – Partial fill insulation is not securely retained against inner face of blockwork at ground floor level. Retaining clips for insulation are also missing. There is the potential for a thermal bypass to form between the insulation and the inner leaf of blockwork, limiting the effectiveness of the insulation.

Figure 5 Services installed within party wall.

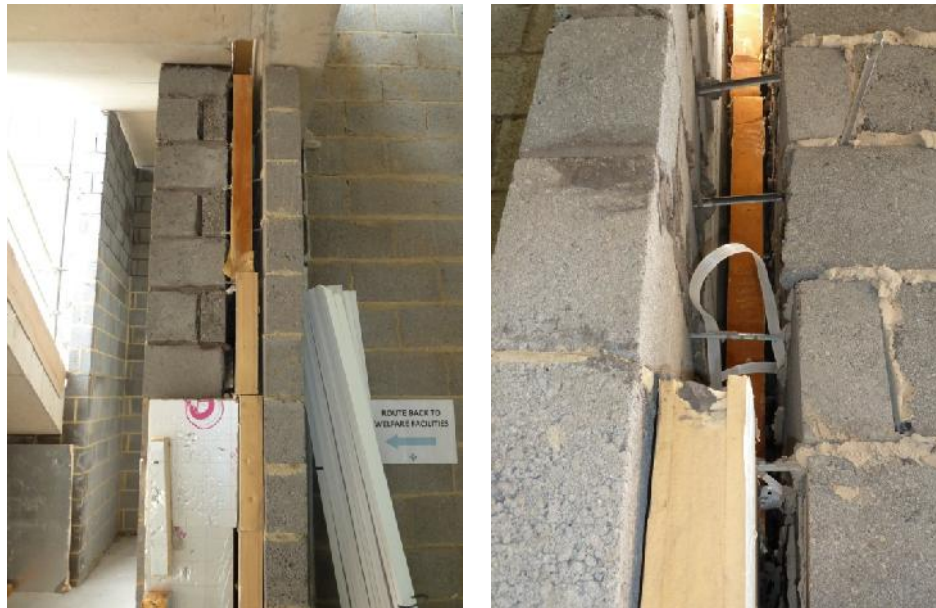
Figure 6 Partial fill insulation not securely retained at ground floor.

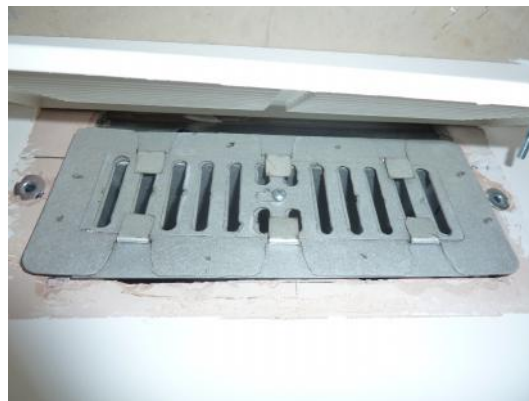
area are located directly above the doors (see Figure 9) and are adjustable (see Figure 10), although they can only be adjusted once the grille has been unscrewed from the wall. Given the type of air valve used, it is difficult to see how adjustments could be made during commissioning to achieve a particular flow rate, as the main grille would have to be continually removed from the wall to make any fine adjustments. The supply air valves also incorporate a thin filter medium (see Figure 11), which can only be accessed by unscrewing the supply air valve from the wall. The exact purpose of this filter is not known, as the main unit also incorporates a supply and extract filter. The position of the supply air valves within the apartment also means that there is a risk, particularly in the bedroom, that a significant proportion of this room will be inadequately ventilated as the type of supply air valve used is not capable of supplying air deep into the room. Instead, it is likely that the supply air will be drawn directly into the corridor towards the extract valves located in the bathroom and/or open plan living room/kitchen area. The use of a directional throw valve designed to exploit the 'coanda effect' would have been more appropriate. Alternatively, the air supply valve should have ideally been located diagonally opposite the doors to each room to maximise cross flow. However, this would have meant that the exposed soffit feature would have to have been compromised. Initial feedback from the occupants has revealed that they perceive there to be stale regions of air within the apartment, suggesting that the current design and configuration of the MVHR system is not providing adequate ventilation to all areas of the apartment.

Figure 10 Adjustable grille on supply air valve.

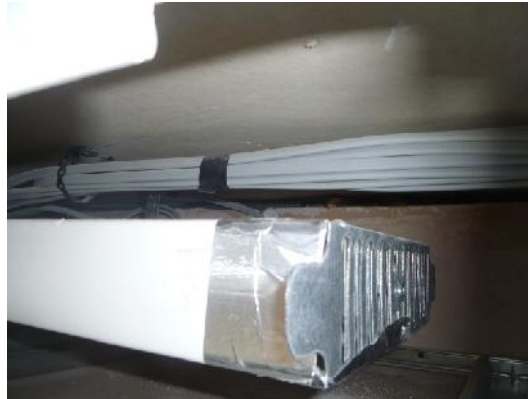
Figure 12 Grille taped to the end of the extract ductwork above the kitchen cupboards.

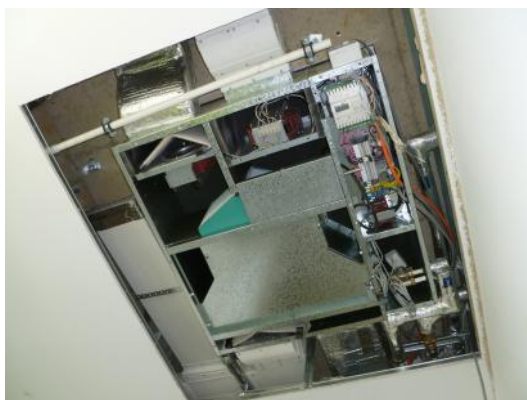
Further inspection of the MVHR system revealed that the main filters are located within the main MVHR unit installed in the bathroom ceiling void and that these filters can only be accessed by unscrewing the base plate from the unit (see Figure 14), so there are issues regarding accessibility. There is also no filter change, maintenance or service indicator light on the unit, and even if there were, it is not easily read by the occupants of the apartment. Therefore, apart from undertaking a periodic service and filter change, there is no mechanism of knowing whether the unit is functioning correctly. This is not unusual for MVHR systems. The implications in terms of maintenance are mitigated to a degree, as the maintenance team at CIAC will be responsible for replacing the MVHR filters on a yearly basis. However, if this situation were to change, and responsibility were to be passed back to the occupants of the apartments, there would be significant issues associate within maintenance, as it is highly likely that the occupants would never change the MVHR system filters.

Figure 14 Base plate of MVHR unit removed to access filters.

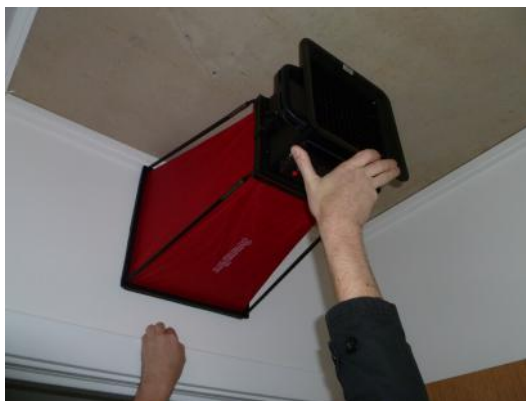
A series of duct flow measurements were also undertaken on the test apartment on the 16th October 2012 using a Swemaflow 125D hot wire lattice anemometer (see Figure 15). Unfortunately, due to the configuration of the extract valves, it was not possible to obtain any extract readings using the flow hood. It was possible to undertake a number of supply air valve readings at various different fan speeds (see Table 4), although these readings are of little value without the corresponding extract valve flow rates. The measurements revealed very low flow rates in both the living/kitchen area and bedroom 1 at fan speed settings 2 and 3 (boost) and no measurable flow was recorded at trickle fan speed settings (1 and auto). These readings suggest that the MVHR system is not delivering the required flow rates to the individual rooms and fails to comply with Part F of the Building Regulations. This is not unusual for MVHR systems. A recent study undertaken by BSRIA on the airflow performance of MVHR systems (see Gilbert, 2013) found that 95% of systems failed to meet the

requirements contained within the Building Regulations. Further investigation of the MVHR unit and ductwork also revealed that no pilot holes exist to undertake other duct flow measurements, such as pitot tube measurements. This suggests that the MVHR unit has not been commissioned in situ.

Figure 15 MVHR duct grille flow measurements undertaken using a Swemaflow 125D.
