# Crawley Library

<b>Innovate UK project number</b>	450003
<b>Project lead and author</b>	Low Carbon Building Group, Oxford Brookes University for West Sussex County Council
<b>Report date</b>	2014
<b>InnovateUK Evaluator</b>	Peter Tse (Contact via <a href="http://www.bpe-specialists.org.uk">www.bpe-specialists.org.uk</a> )

<b>Building sector</b>	<b>Location</b>	<b>Form of contract</b>	<b>Opened</b>
Public library	Crawley Library	Design and build	2008
<b>Floor area (GIA)</b>	<b>Storeys</b>	<b>EPC / DEC 2010</b>	<b>BREEAM rating</b>
4,468 m <sup>2</sup>	4	A (25) / D (90)	Very good

Phase 2 of the Technology Strategy Board (TSB) funded Building Performance Evaluation (BPE) project is designed to evaluate the in-use condition of Crawley Library.

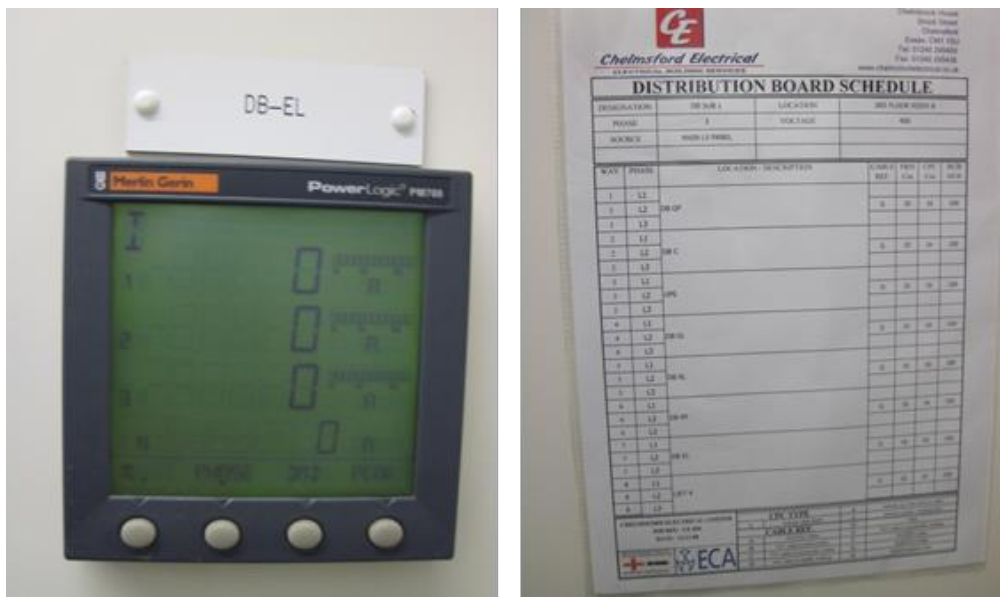
- DB-LL21, DB-LLG1, DB-LPG1, DB-LP11, DB-LP21, DB-3L1, DB-3P1, DB-FL are logging in reality but were not connected to the BMS where they appeared to have a zero indication (Figure 18).
- DB-LP11 is missing from the Logbook monitoring schedule but exists in the BMS and is located in DB/LIB1 meters (Figure 19).
- DB-SEC exists in the PVQ but not in Log Book and BMS and was not found during the walkthrough.
- DB-FL exists in BMS but not in the Log Book and PVQ. It was not found in the walkthrough.
- DB-EL exists in the Log Book but not in BMS and PVQ, it was found during the walkthrough. Potentially, the above are the same meter but with different names in each case. The Log Book and BID document do not give any information on what DB-EL was supposed to be monitoring. However, there is a sub-meter in the PVQ that was supposed to measure external

Figure 17 Left: DB-EL sub-meter probably out of function. Right: Distribution board schedule located in one of DB-SUB1.

Figure 18 Sub-meters are logging in reality but appear to have a zero indication in the BMS.

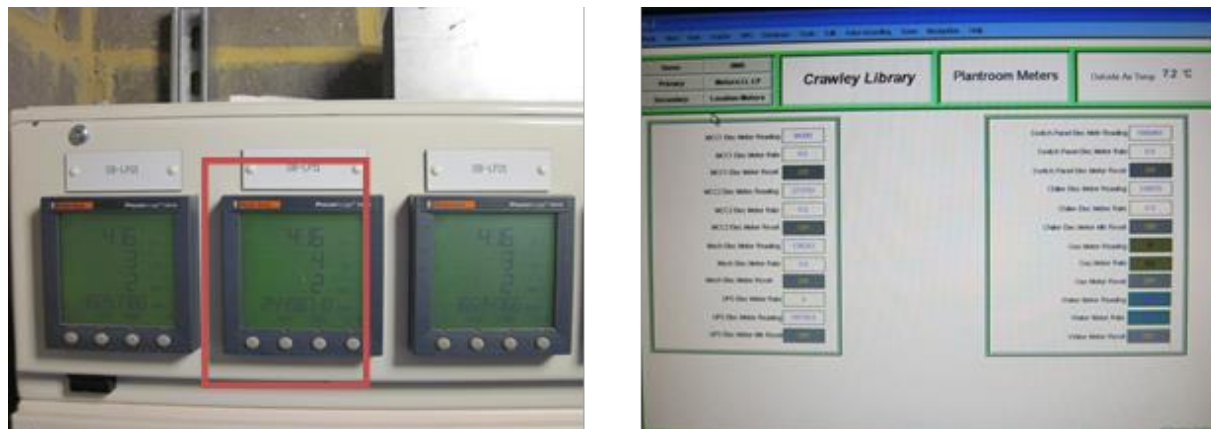
Figure 19 DB-LP11 sub-meter missing from the building's logbook metering schedule.

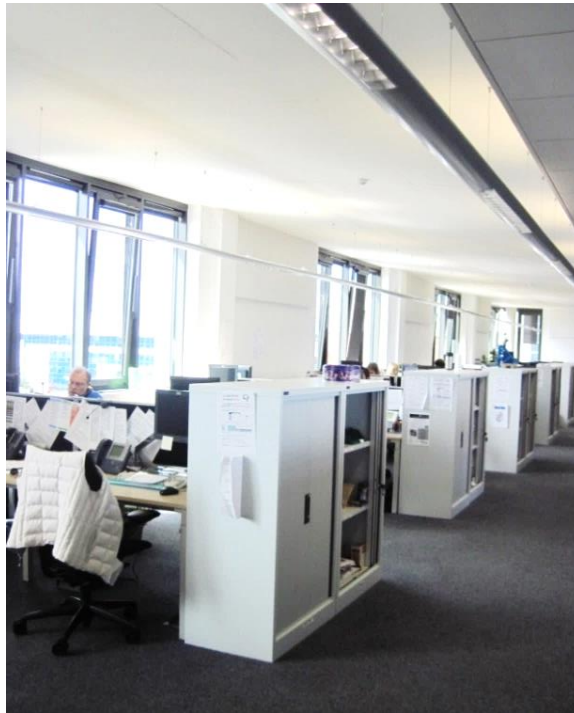
Figure 22 Usability of windows which only open only in rows and not individually was noted as a source of disputes and comfort issues in the open plan office area.

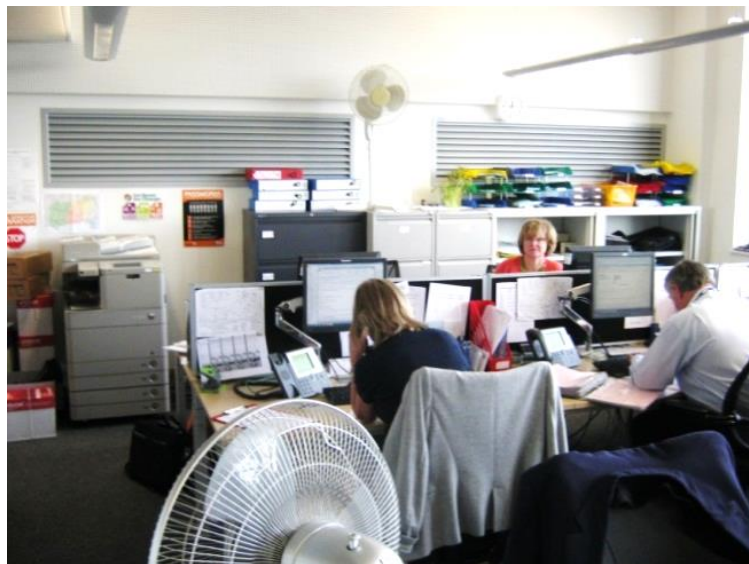
Staff members working on the third floor open plan office made several remarks on high noise levels, overheating during summer and the cold air flow during winter. There were complaints relating to the ventilation ducts on the wall that blow cold air directly on the staff during winter (Figure 23).

Figure 23 On the wall the ventilation ducts tend to blow cold air directly on the staff during winter. Fans are used during summer to increase comfort when the offices are overheated.

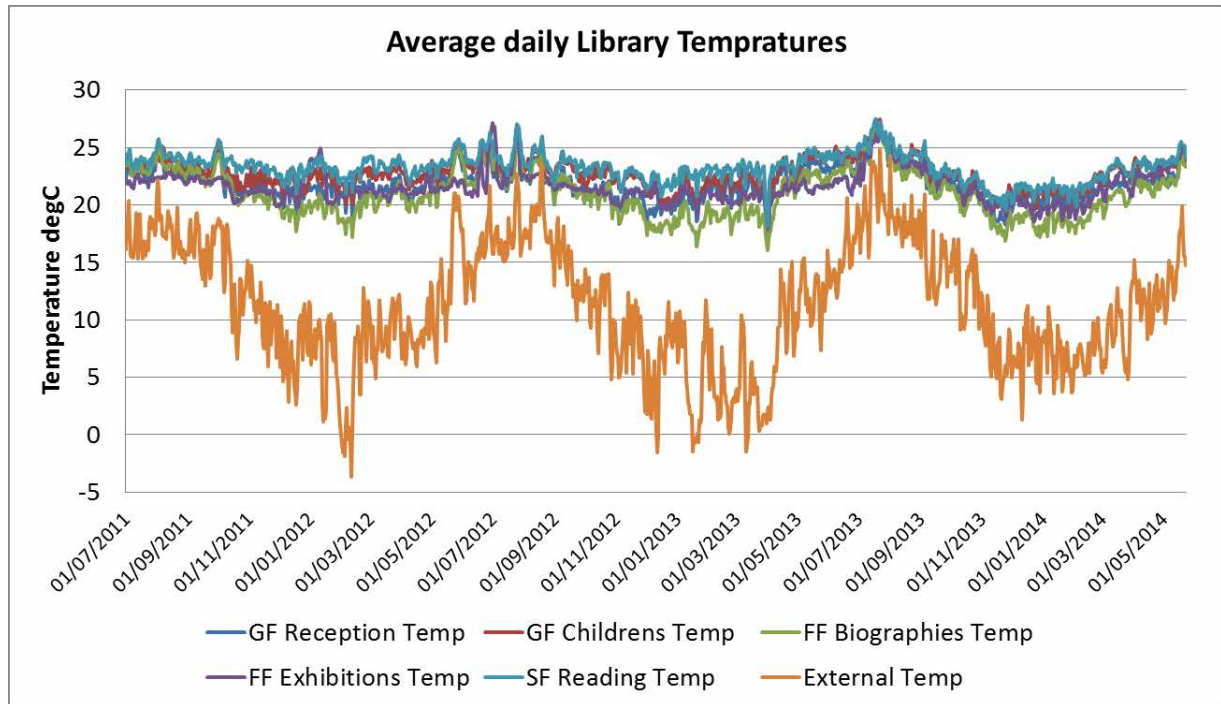
As shown in Figure 25, during the summer period the temperature slightly rises above the comfort zone in all areas of the library indicating that measures might need to be taken to prevent the building from overheating (shading, cooling).

Figure 25 Temperatures in the Library area during the monitoring period (July 2011-May 2014).

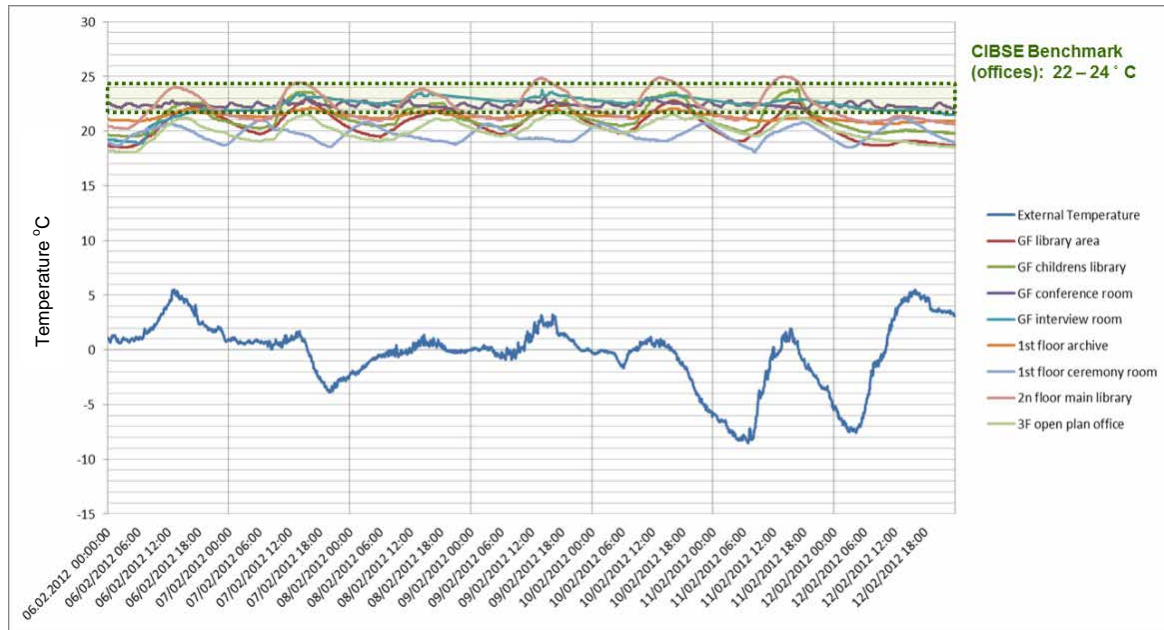
During the winter almost half of the respondents of the BUS questionnaire felt cold and found the air stuffy. Monitoring data and spot measurements taken during the winter show that temperatures in the building are mostly kept within the comfort zone. During a typical winter week (February 2012) it can be observed that internal temperatures ranges between 18 and 25°C whilst the external temperature is between -8.2 and 5.5°C (Figure 26).

Figure 26 Internal and external temperature levels during a typical winter week (06/02/2012-12/02/2012).

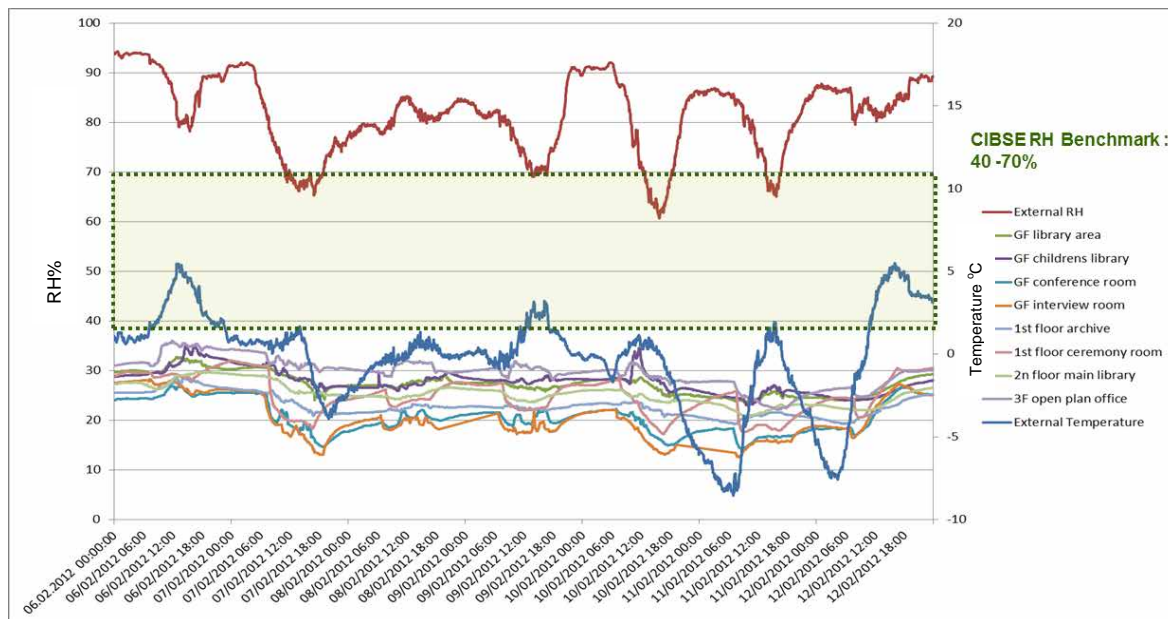
Low RH levels (Figure 27) and high CO<sub>2</sub> levels (Figure 28) recorded explain the feeling of stuffiness expressed by occupants. This can be explained by the windows being closed all the time during winter and lack of mechanical ventilation in most of the spaces.

Figure 27 Relative Humidity levels during a typical winter week (06/02/2012-12/02/2012).

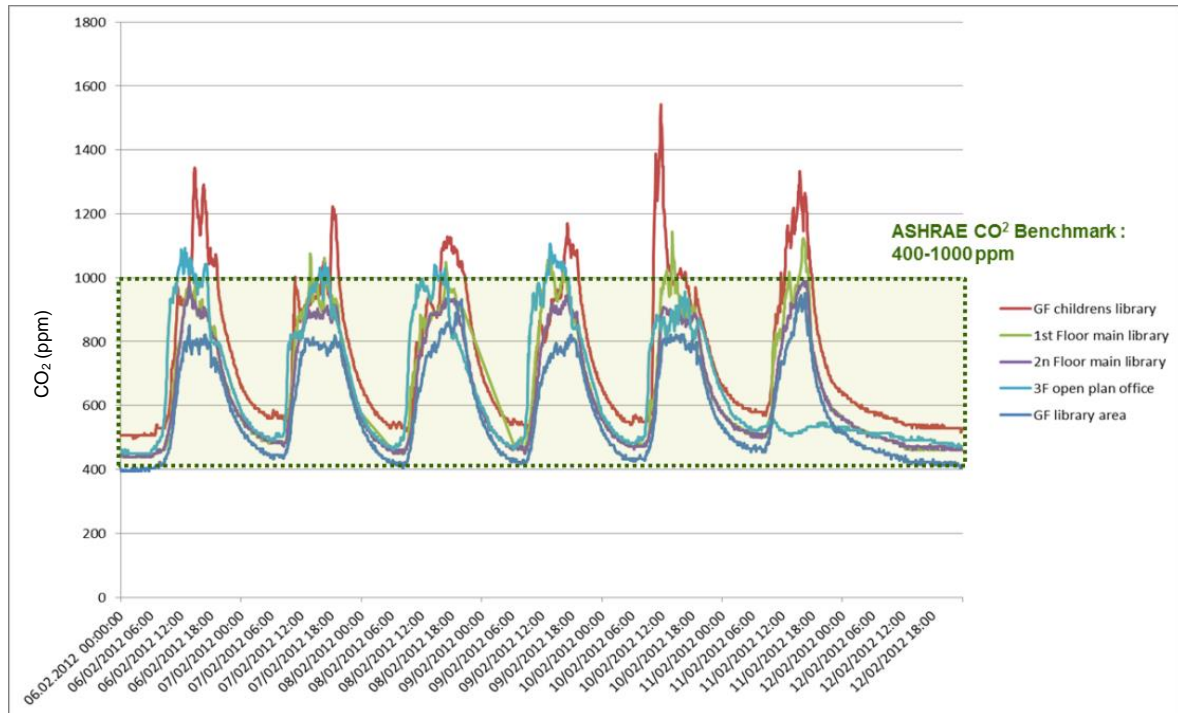
Figure 28 CO<sub>2</sub> levels during a typical winter week (06/02/2012-12/02/2012).

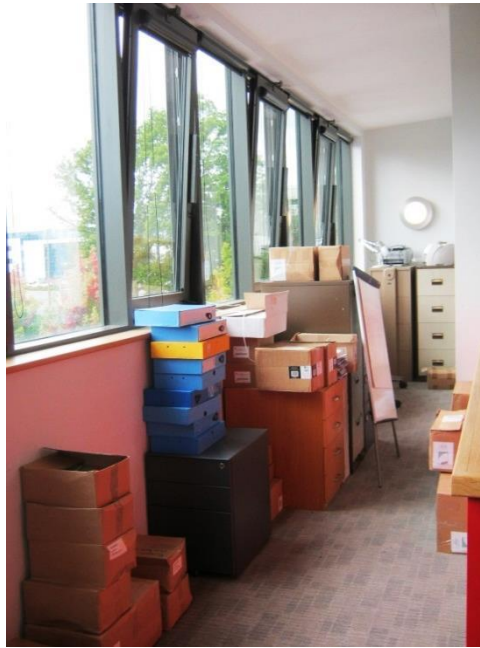
The facilities manager also pointed out that there are more people in the building than the building was designed for, therefore the available space and storage areas are limited and there is limited flexibility, which in turn has an impact on the comfort levels of staff who occupy the spaces

Figure 37 The space next to the staircase in the Register area used currently as storage space.

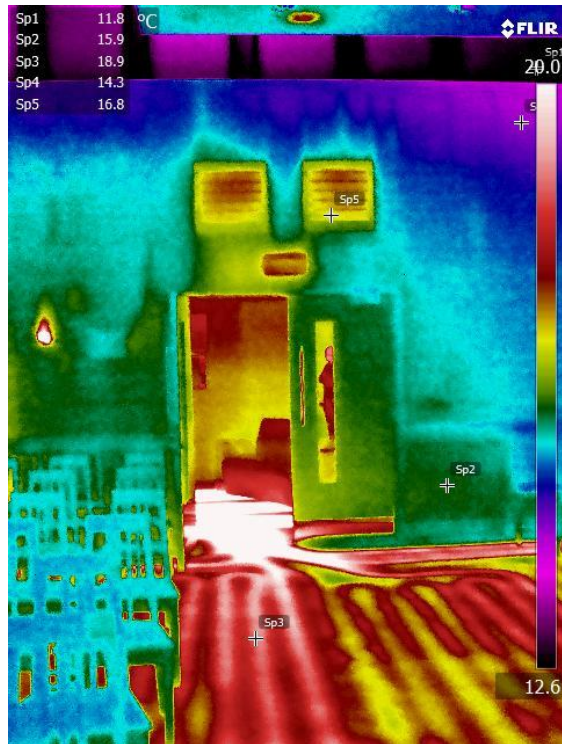
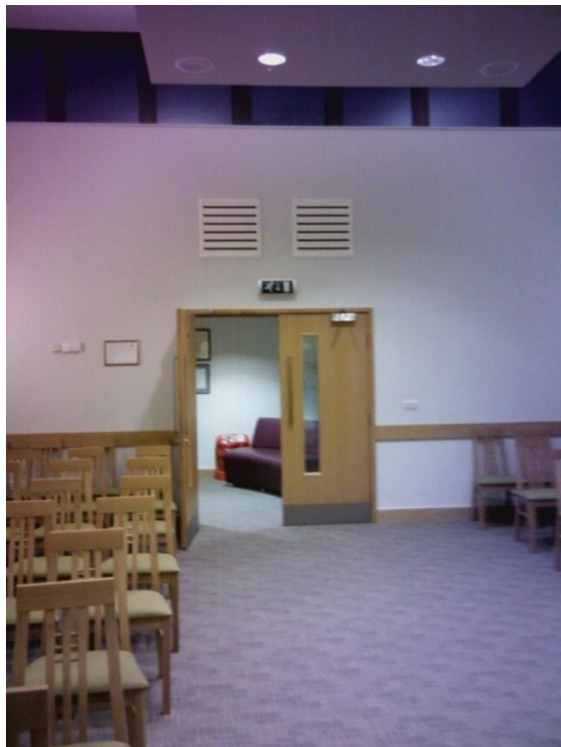
Measurements	°C
Sp1	11.8
Sp2	15.9
Sp3	18.9
Sp4	14.3
Sp5	16.8
Parameters	
Emissivity:	0.95
Refl. Apparent temp:	20 °C
Room temperature:	17 °C

Figure 43 Small ceremony room thermogram. Possibly the top left windows are leaky creating draughts since the temperature captured is very low (Sp1). A flow of cold air dropping from the windows can be noticed while the grilles over the door are also blowing cold air into the unoccupied room.

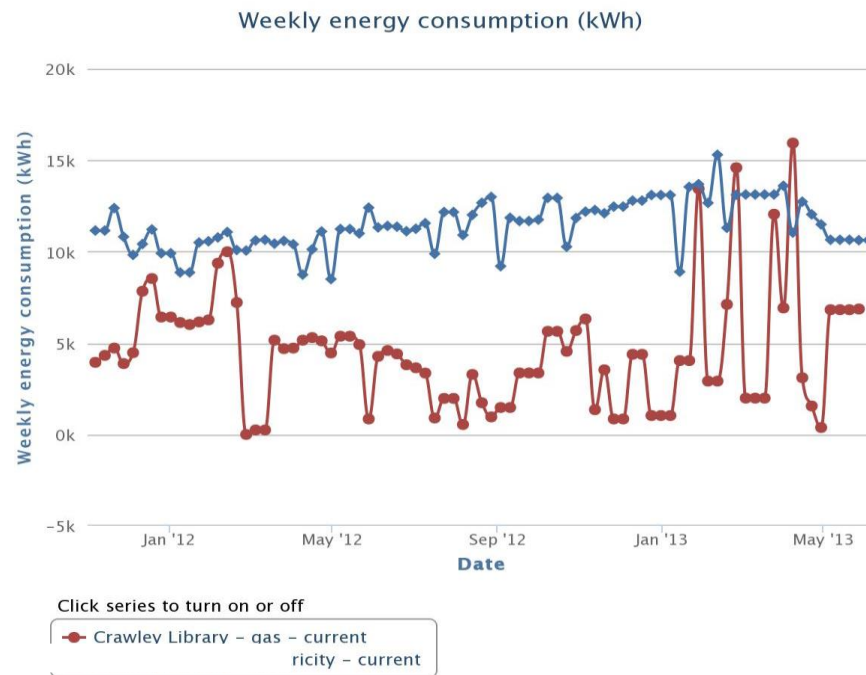
In addition, the correlation between weekly weather and weekly energy consumption for heating is poor ( $R=0.33$ ) (Figure 50). This indicates that the heating system and the controls do not follow closely the changes in external temperature and that the efficiency of the heating system is poor.

Figure 49 Weekly gas and electricity consumption (KWh) from November 2011 to May 2013

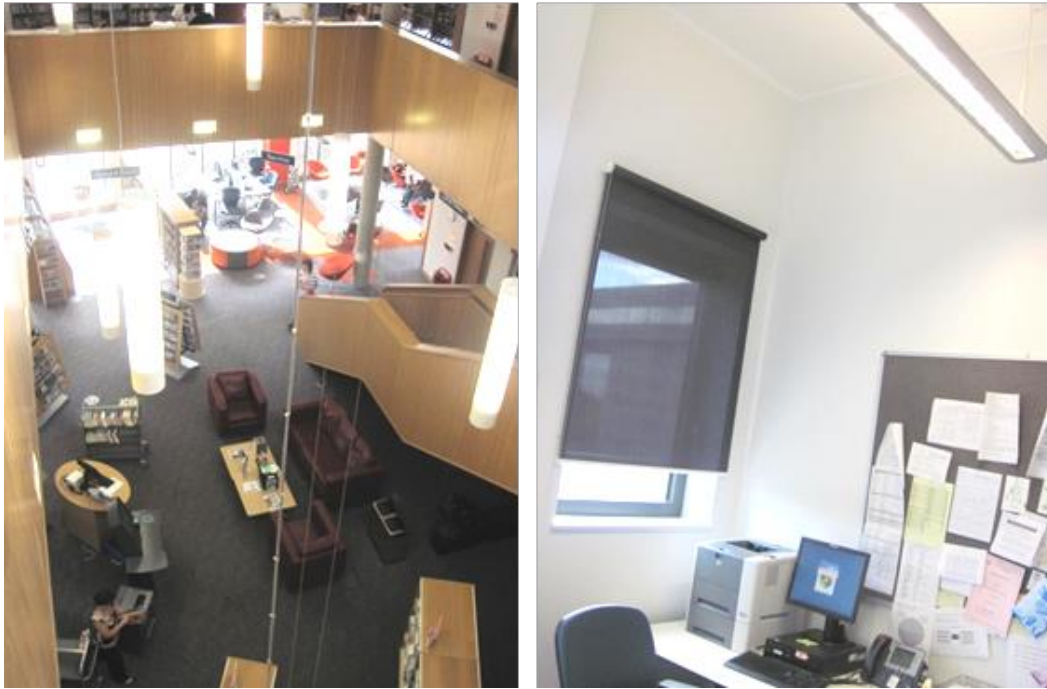
Figure 120 Left: Ground floor library view. Right: First floor office space. The office was found empty with the blinds down and the light is turned on.

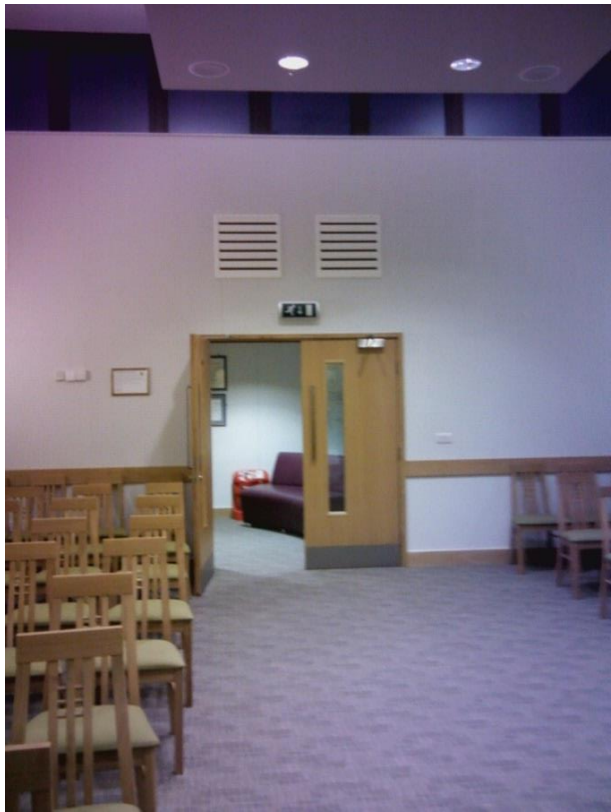
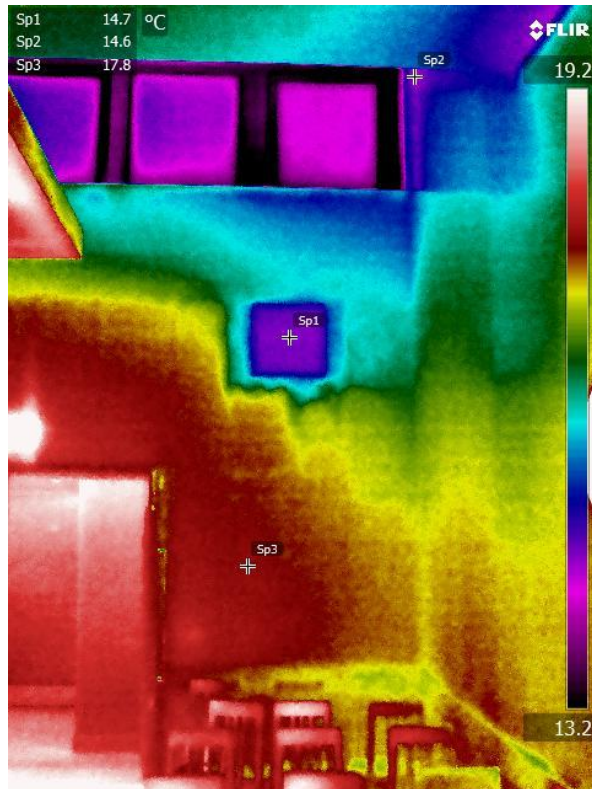
Figure 128 Small ceremony room thermogram. Possibly the top left windows are leaky creating draughts since the temperature captured is very low (Sp1). A flow of cold air dropping from the windows can be noticed..

Measurements	°C
Sp1	14.7
Sp2	14.6
Sp3	17.8
Parameters	
Emissivity:	0.95
Refl. Apparent temp:	20 °C
Room temperature:	17.5 °C

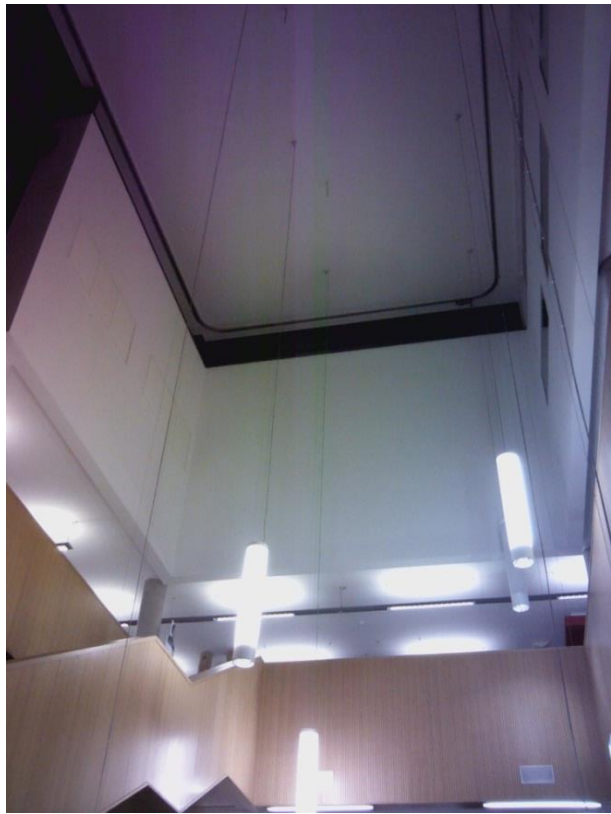
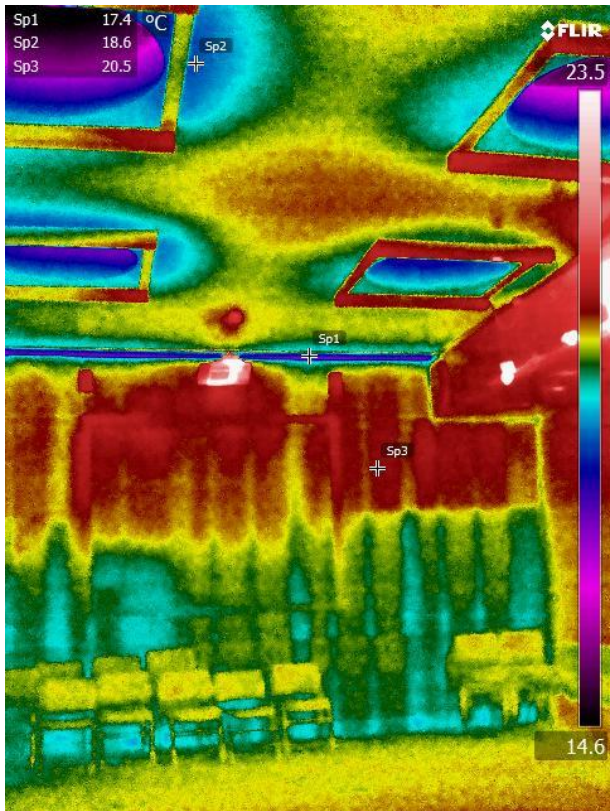
Figure 131 Library atrium thermogram. Cold air dropping from the corner windows indicate air leakage and draughts. The lower temperature of the roof compared to other parts also indicates that perhaps it is not insulated

Measurements	°C
Sp1	17.4
Sp2	18.6
Sp3	20.5
Parameters	
Emissivity:	0.86
Refl. Apparent temp:	20 °C
Room temperature:	20.7 °C

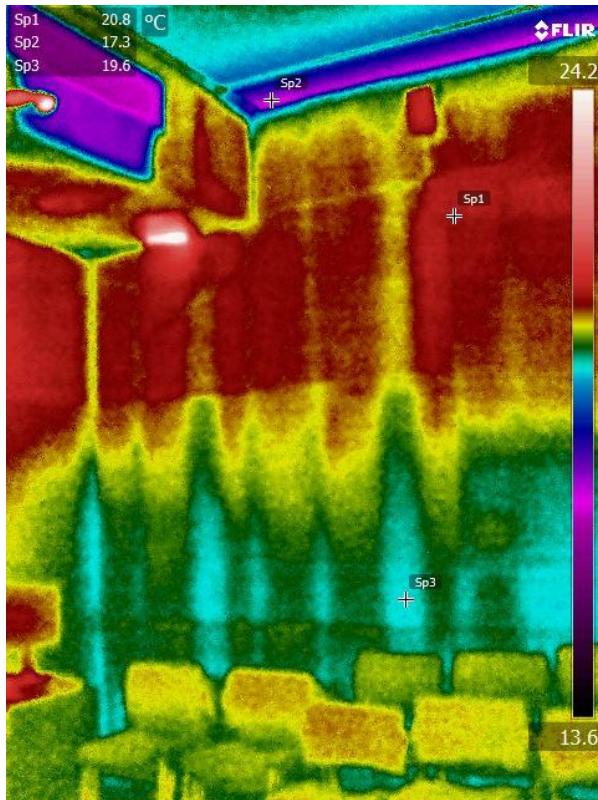
Figure 132 Exhibition space thermogram. Cold air draughts can be noticed around the skylights. A cold line in the connection between the ceiling and wall indicates missing insulation or a construction deficiency

Measurements	°C
Sp1	20.8
Sp2	17.3
Sp3	19.6
Parameters	
Emissivity:	0.86
Refl. Apparent temp:	20 °C
Room temperature:	20.7 °C
