# Cross Lane Development

<b>Innovate UK project number</b>	450021
<b>Project author</b>	Sheffield Hallam University
<b>Report date</b>	2012
<b>InnovateUK Evaluator</b>	Fionn Stevenson (Contact via <a href="http://www.bpe-specialists.org.uk">www.bpe-specialists.org.uk</a> )

<b>No of dwellings</b> 22 properties: 18 tenanted, 4 in shared ownership*	<b>Location</b> Royston, Barnsley	<b>Type</b> 2 detached, 20 semi-detached*	<b>Constructed</b> 2011
<b>Area</b> 82 - 120 m <sup>2</sup>	<b>Construction form</b> Timber frame	<b>Space heating target</b> N/A	<b>Certification level</b> CSH Level 4

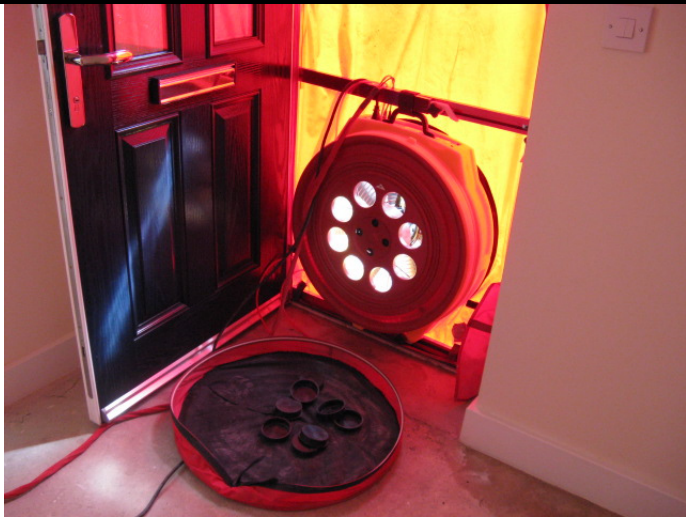
Image ref:	Figure 18	Floor:	Ground	Room:	Hall

Air pressure testing (front door blower)

It was observed during the air pressure test that the external wall electrical sockets and the access hole for opening/closing the valve for the external water tap (Figure 19) were primarily the permeable areas during the test. Other service outlets for waste pipes from the sinks and toilets were well sealed. The influence of the air tight nature of the building is further discussed in Section 6 (BUS survey).

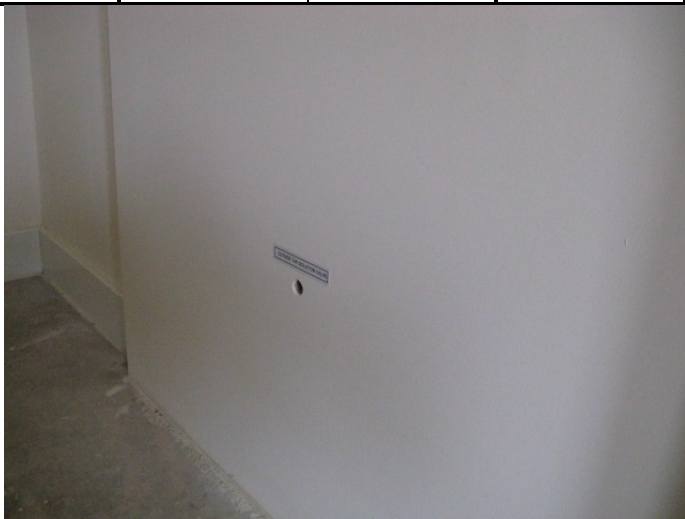
Image ref:	Figure 19	Floor:	Ground	Room:	Under stairs

Access hole for valve of external water tap

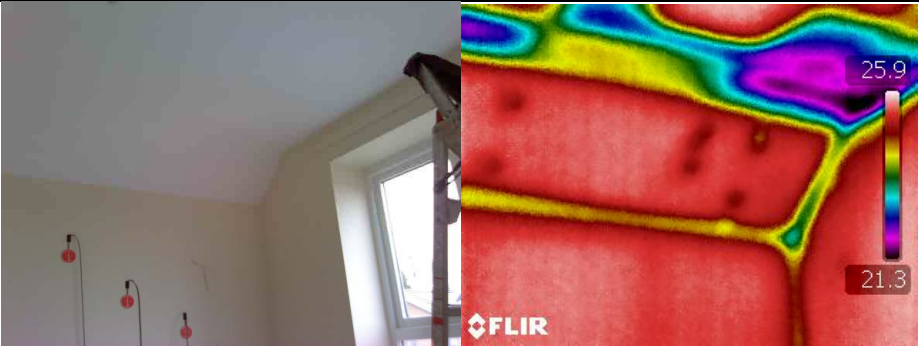
Image ref:	Figure 23	Floor:	First	Room:	1

Photo and thermal image of bedroom 1 party wall

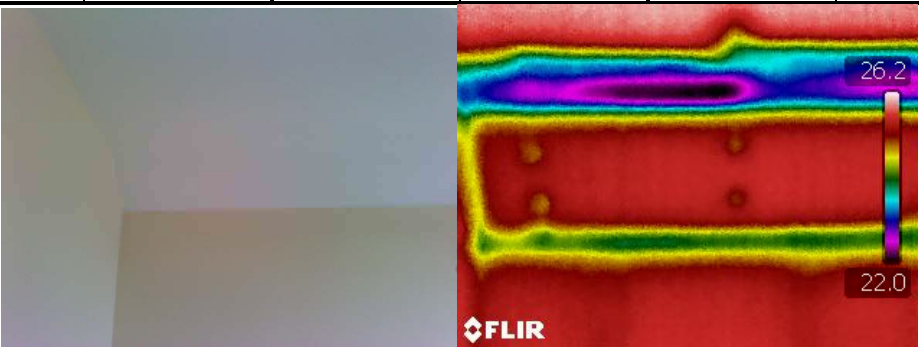
Image ref:	Figure 24	Floor:	First	Room:	1

Photo and thermal image of bedroom 1 party wall

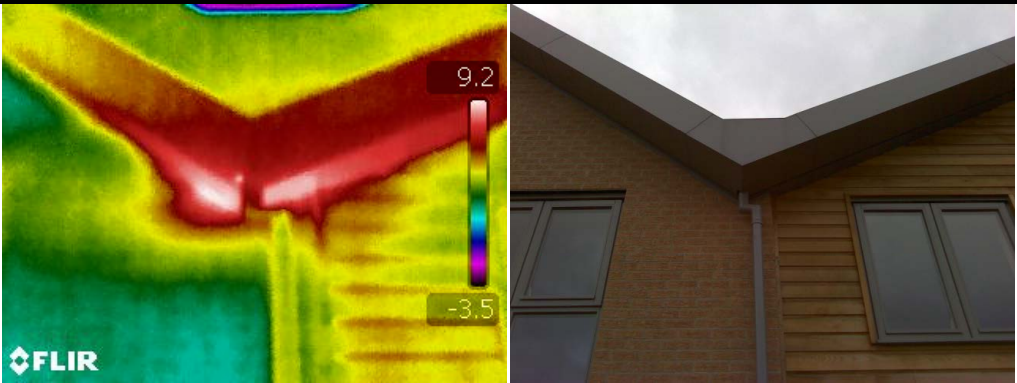
Image ref:	Figure 30	Floor:	-	Room:	-

<p>The image shows a side-by-side comparison. On the left is a thermal image from a FLIR camera, with a color scale ranging from -3.5 (blue) to 9.2 (red). The red area indicates a heat leak at the eaves junction. On the right is a corresponding photograph of the same area, showing a brick wall, a window, and the roofline.</p>					
Photo and thermal image of front eaves junction

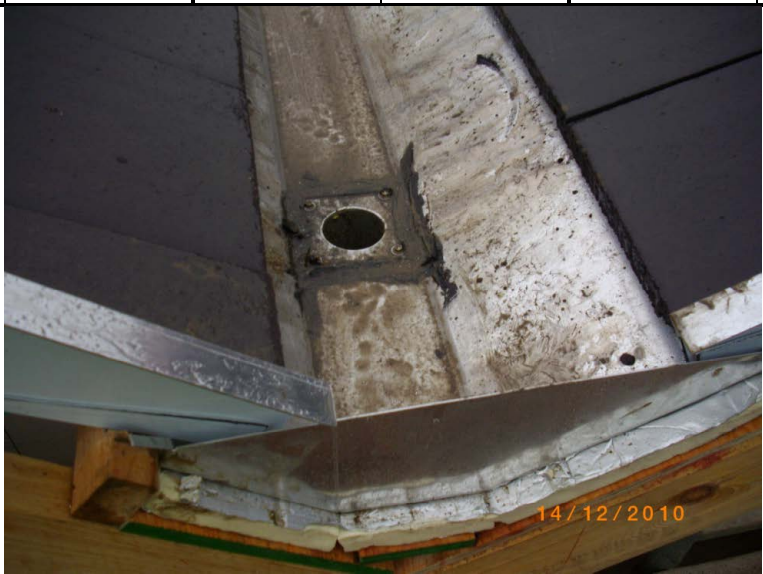
Image ref:	Figure 33	Floor:	-	Room:	-

<p>A photograph showing a close-up of a valley gutter. The gutter is made of metal and is installed over a wooden roof structure. A circular hole is visible in the metal gutter. The date '14/12/2010' is printed in orange at the bottom right of the image.</p>					
Valley gutter detail

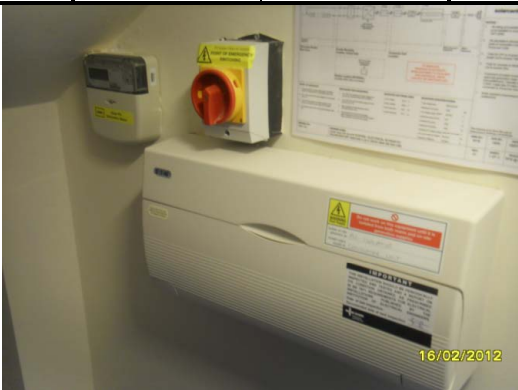
Image ref:	Figure 34	Floor:	Ground	Room:	Under stairs

- Previously in these types of designs, the consumer unit, PV isolator and switch gear were located in the hallway and were considered unsightly. They are now located under the stairs (Figure 34). The PV isolator switch is to be replaced by a less intrusive isolator switch in future designs.

Consumer unit, switch gear and pv isolator switch located under the stairs

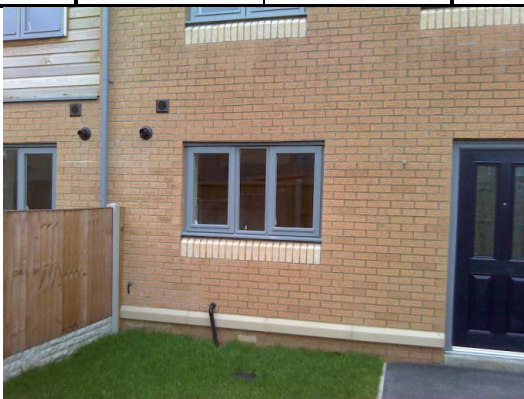
Image ref:	Figure 38	Floor:	Ground	Room:	Kitchen

- Double glazed timber windows were installed as these were considered easier to repair over time as opposed to PVC. However, it is not known which product offers better longevity (Figure 38).

Example of a timber window, ground floor kitchen

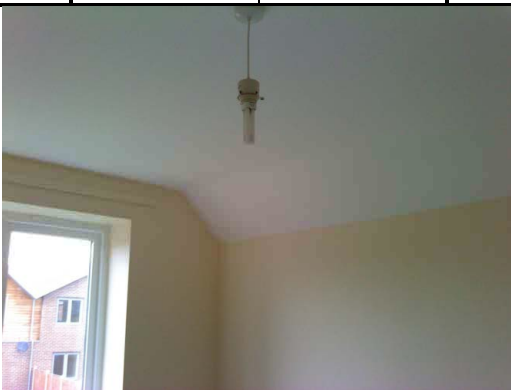
Image ref:	Figure 39	Floor:	First	Room:	Bedroom 2

Example of a chamfered ceiling due to shallow roof pitch

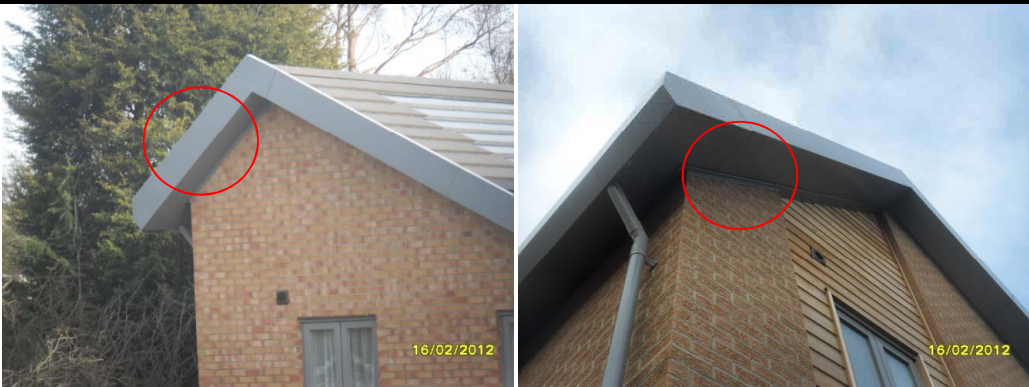
Image ref:	Figure 40	Floor:	-	Room:	-

Examples of compressible filler between roof and brickwork

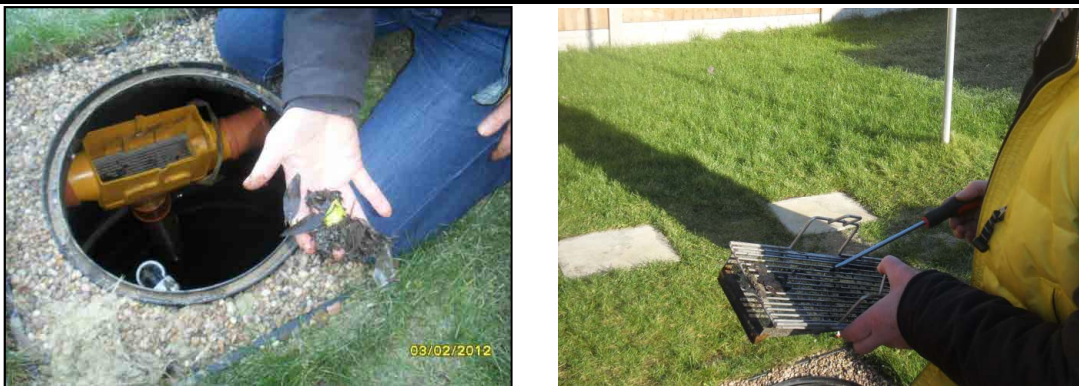
<b>Image ref:</b>	<b>Figure 49</b>	<b>Floor:</b>	-	<b>Room:</b>	-

Leaves and mud removed from a filter (left), cleaning mud and grit from the filter

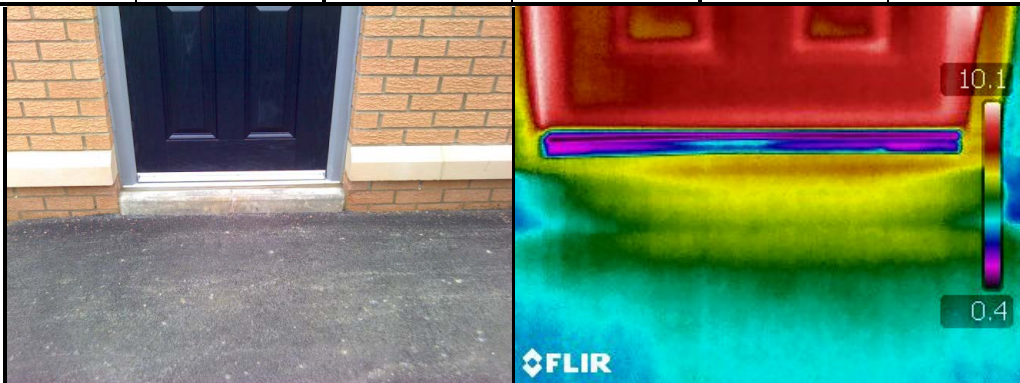
Image ref:	Figure 64	Floor:	Ground	Room:	Dining

Photo and thermal image of threshold of dining room (external back)door

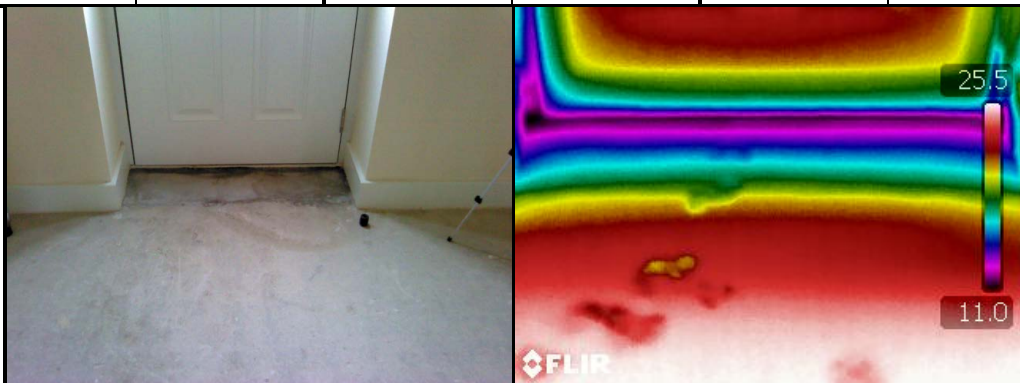
Image ref:	Figure 65	Floor:	Ground	Room:	Dining

Photo and thermal image of threshold of dining room (internal back) door

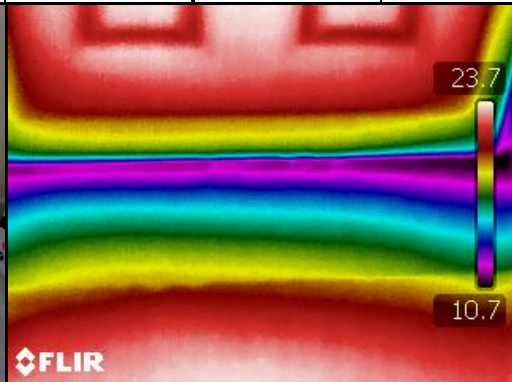
Image ref:	Figure 67	Floor:	Ground	Room:	Hall

Photo and thermal image of threshold of front door (internal)

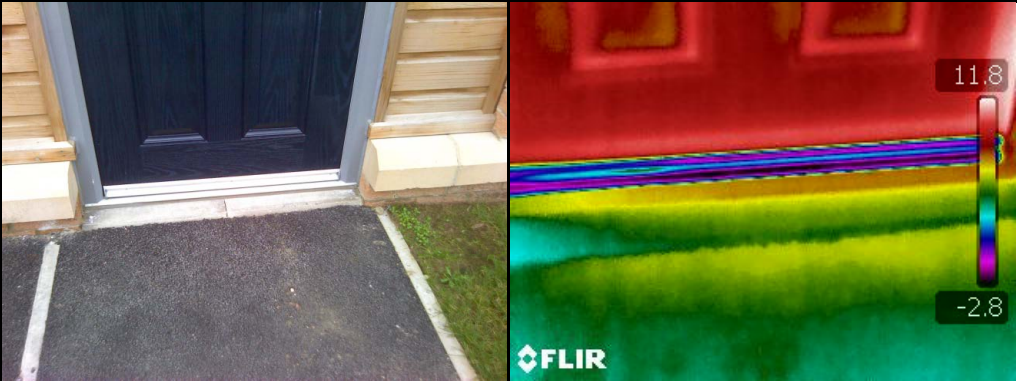
Image ref:	Figure 68	Floor:	Ground	Room:	-

Photo and thermal image of threshold of front door (external)
