This document contains a Building Performance Evaluation report from the £8 million Building Performance Evaluation research programme funded by the Department of Business Innovation and Skills between 2010 and 2015. The report was originally published by InnovateUK and made available for public use via the building data exchange website hosted by InnovateUK until 2019. This website is now hosting the BPE reports as a research archive. Although no support or further information on the reports is available from the host, further information may be available from the original InnovateUK project evaluator using the link below¹.

| InnovateUK project number | 450040 Related study: 450013 (Phase 1) ² |
| Project author | Leeds Beckett University for Joseph Rowntree Housing Trust |

This report outlines the findings obtained from an in-use performance and post occupancy evaluation study undertaken on a small mixed-tenure development of six dwellings. The development comprised two 4-bed detached bungalows for supported living, and four 4-bed terraced family dwellings for rent or shared ownership. Due to monitoring issues, data is incomplete in many areas, limiting the ability of the resea

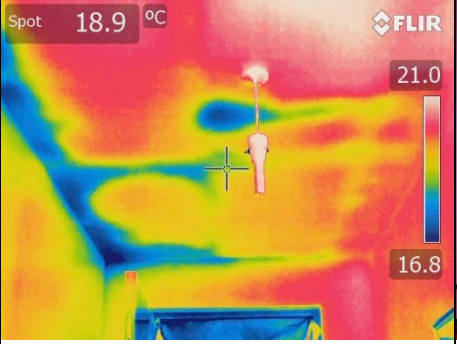
| | | <p>IR_1939 and DC_1940</p> <p>24th March 2014 10:36</p> <p>Internal Temp – 21.3 °C</p> <p>External Temp – 4.5 °C</p> <p>Internal RH – 44.5%</p> <p>External RH – 70.7%</p> |

| <p>Front door</p> <p>A number of cold spots can be clearly seen on the ceiling of the entrance hall, particularly at the junction with the partition wall. This suggests discontinuities in the insulation layer in the loft space.</p> | | |

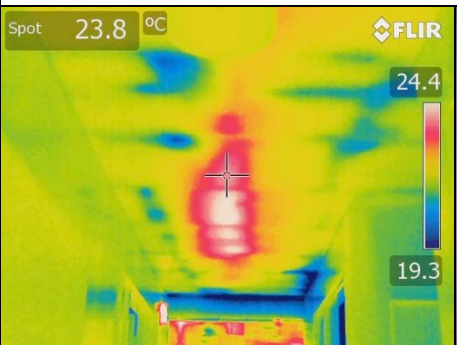
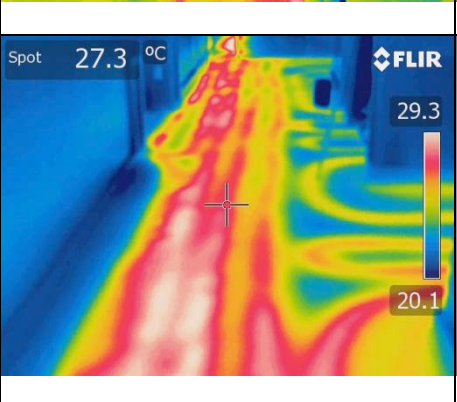
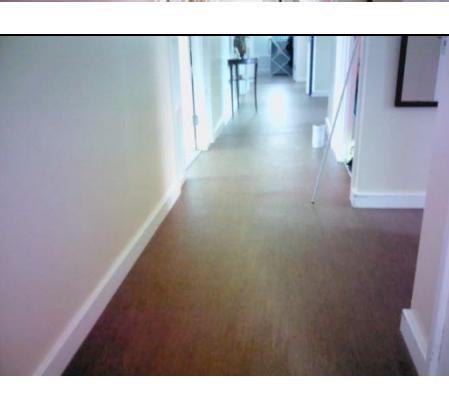
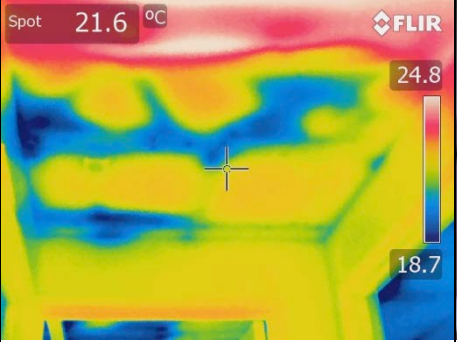
| <p>Main hallway</p> <p>Looking down the corridor from the consumer unit cupboard towards the laundry room, a number of cold spots on the ceiling are evident, illustrating various discontinuities in the loft insulation layer (IR_1993). An area of unregulated heat gain is also apparent in the middle of the ceiling, which is over 1 metre in length and is approximately 2°C warmer than the surrounding area. It is thought that this heat gain area is a result of heat loss from a poorly insulated or uninsulated domestic hot water supply pipe. Unfortunately, due to Health & Safety reasons (the lack of any form of artificial light or access platform in this section of the loft), it was not possible to investigate this source of unregulated heat gain.</p> <p>The underfloor heating system can be clearly seen in Image IR_1997.</p> <p>Discontinuities in the loft insulation layer can also be observed in the hallway ceiling just outside the doorway to the laundry room (IR_2025).</p> | | |

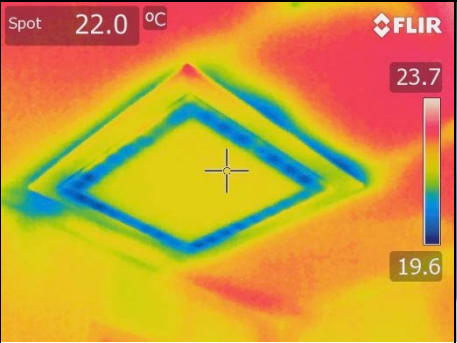
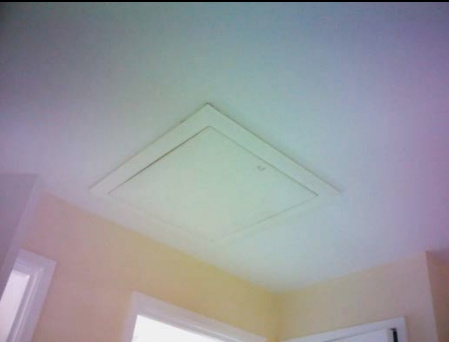
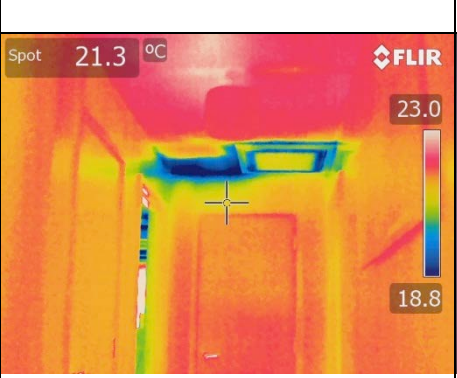
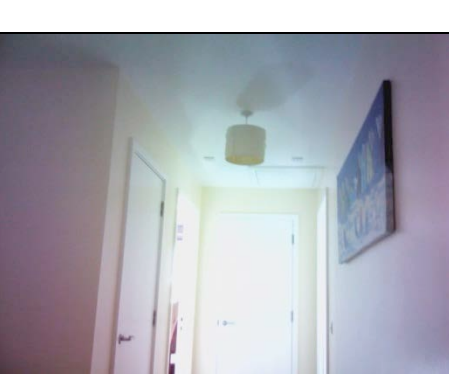
| <p>Loft hatch in main hallway outside consumer unit cupboard</p> <p>Colder areas are obvious around the opening portion of the loft hatch (IR_1953). There is also some insulation discontinuities or air leakage at the loft hatch/ceiling interface.</p> | | |

IR_1969 also highlights a lack of insulation under the loft access platform that is located to the left of the loft hatch.

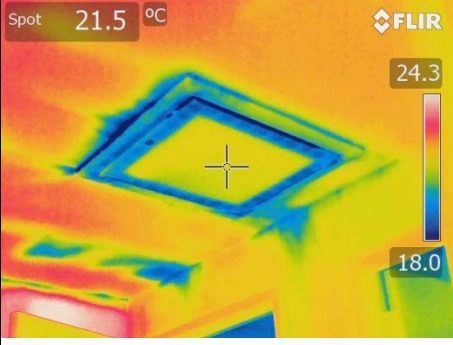
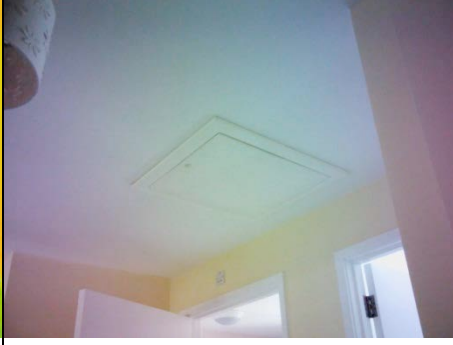
| | | <p>IR_2073 and DC_2074</p> <p>24th March 2014 11:01</p> <p>Internal Temp – 21.3 °C</p> <p>External Temp – 4.5 °C</p> <p>Internal RH – 44.5%</p> <p>External RH – 70.7%</p> |

| <p>Loft hatch in main hallway outside carer's room.</p> <p>Colder areas are obvious around the loft hatch (IR_2073). There are also some insulation discontinuities and/or air leakage at the loft hatch/ceiling interface. Some insulation discontinuities are also apparent above the doorway to bathroom 2.</p> | | |

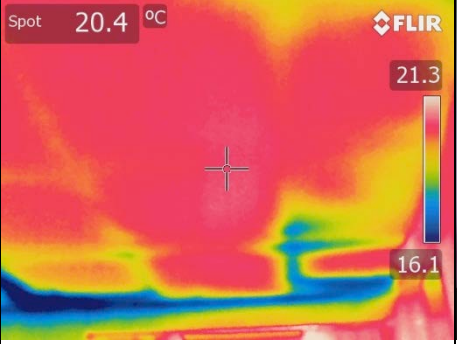
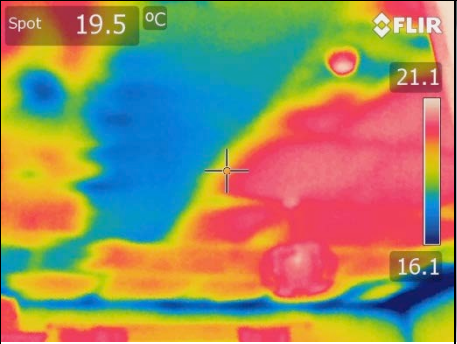
| <p>Bedroom 2</p> <p>Discontinuities in the loft insulation at the eaves are clearly apparent on both the gable wall (IR_1981 and IR_1983) and the front elevation (IR_1985). The lack of insulation below the loft access platform is also clearly illustrated in IR_1985.</p> | | |

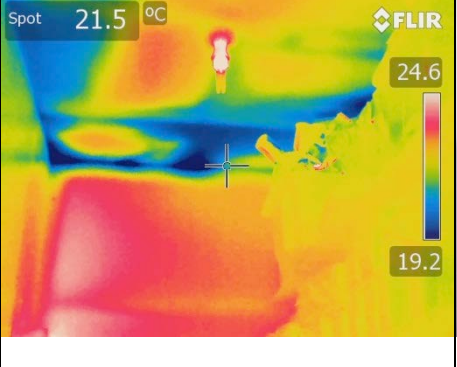
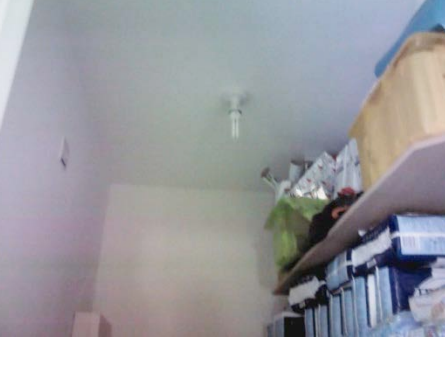
| | | <p>IR_1989 and DC_1990</p> <p>24th March 2014 10:43</p> <p>Internal Temp – 21.3 °C</p> <p>External Temp – 4.5 °C</p> <p>Internal RH – 44.5%</p> <p>External RH – 70.7%</p> |

| <p>Consumer unit storage cupboard</p> <p>A number of cold areas can be clearly seen on the ceiling, particularly at the junction with the partition wall and at the external wall/ceiling junction. This suggests discontinuities in the insulation layer in the loft space.</p> | | |

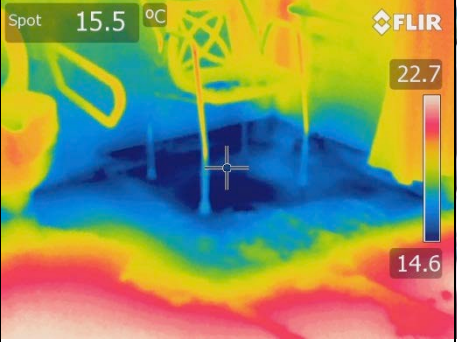
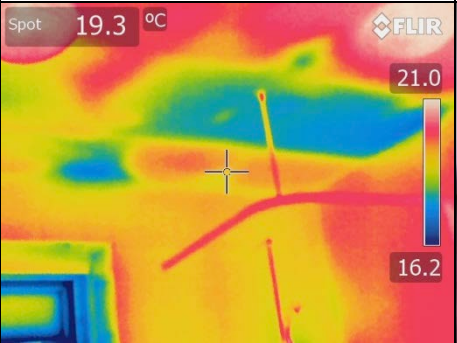
| <p>Bathroom 1</p> <p>No underfloor heating and the lack of insulation below the sunken shower tray is evident in IR_1999. Some discontinuities in the loft insulation at the eaves and the lack of insulation below the loft access platform are also apparent in IR_2001.</p> | | |

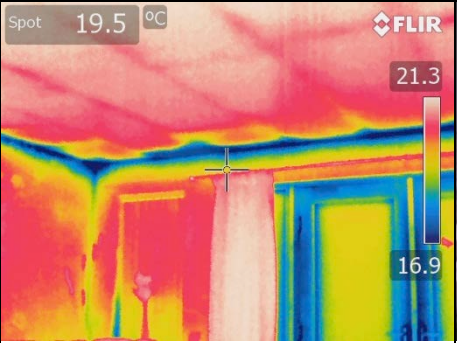
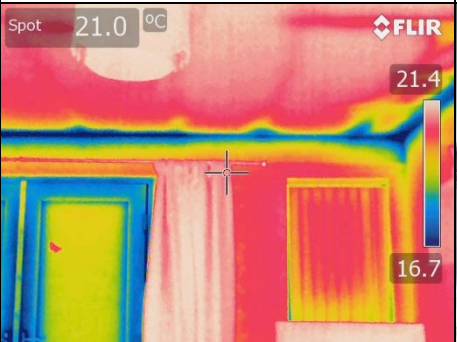
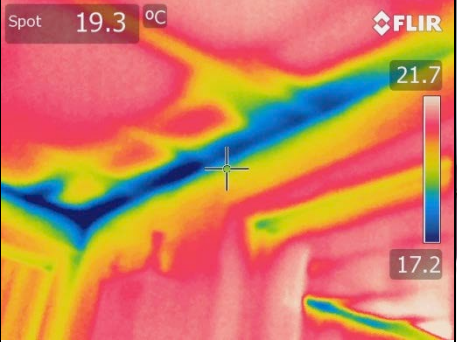
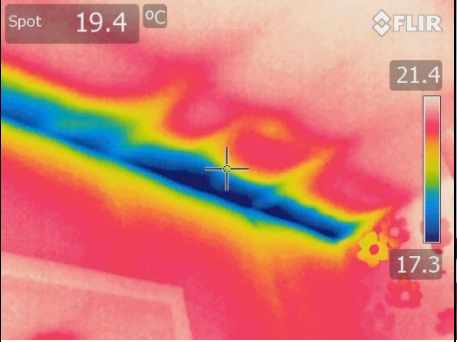
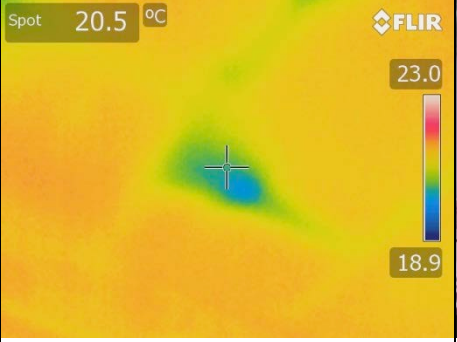
| <p>Living area</p> <p>Discontinuities in the loft insulation are apparent at the eaves (IR_2005 and IR_2007) and at the potential party wall/ceiling junction (IR_2011 and IR_2013). There is also a discontinuity on the loft insulation layer on the ceiling close to the entrance to the living area from the corridor (IR_2009).</p> | | |

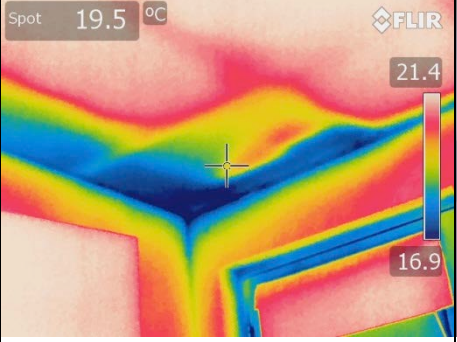
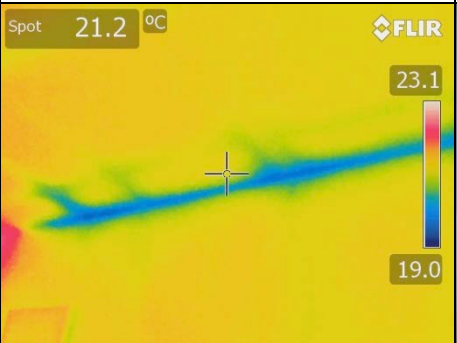
| <p>Kitchen area</p> <p>Discontinuities in the loft insulation are apparent at the eaves (IR_2019 and IR_2021) and to a lesser extent at the potential party wall/ceiling junction (IR_2015). There is also some unregulated heat gain from around the frame of the central heating manifold cupboard and through the partition wall at the top of the cupboard (IR_2023).</p> | | |

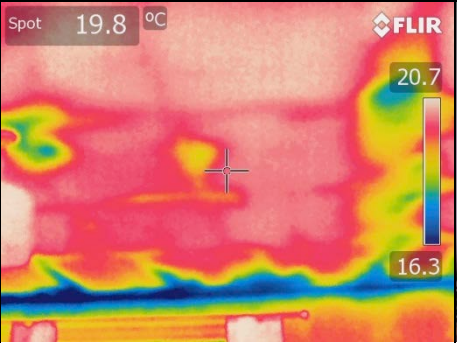
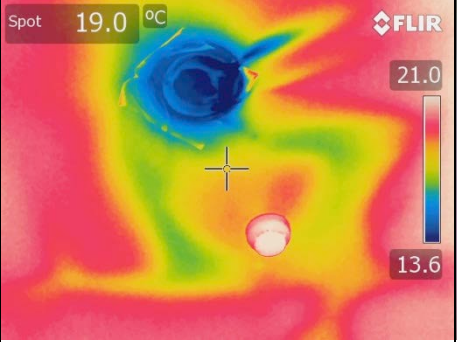
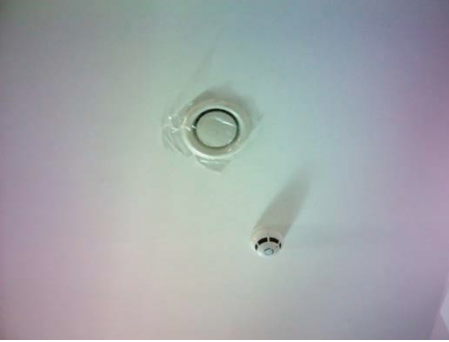
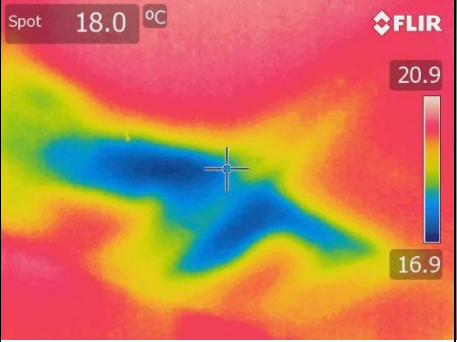
| <p>Bedroom 3</p> <p>Discontinuities in the loft insulation were observed at the eaves (IR_2034). In addition, discontinuities were also observed around the MVHR supply vent and smoke sensor (IR_2034) and at a section of the ceiling close to the gable wall (IR_2035).</p> | | |

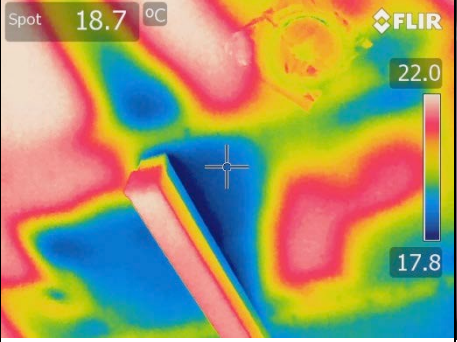
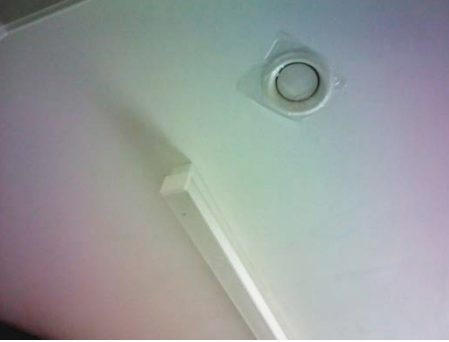
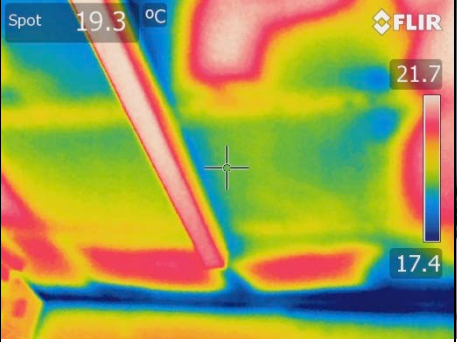
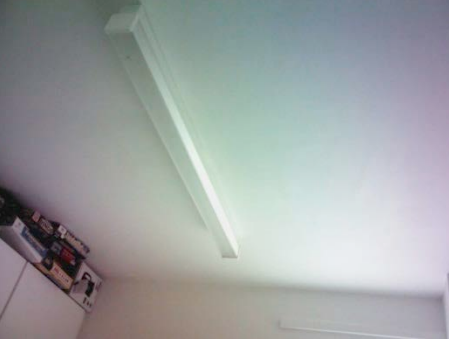
| <p>Laundry room</p> <p>Significant discontinuities were observed in the loft insulation layer in the laundry room. These discontinuities</p> | | |

occurred at the eaves (IR_2041) and beneath the MVHR unit loft platform (IR_2039 and IR_2041).

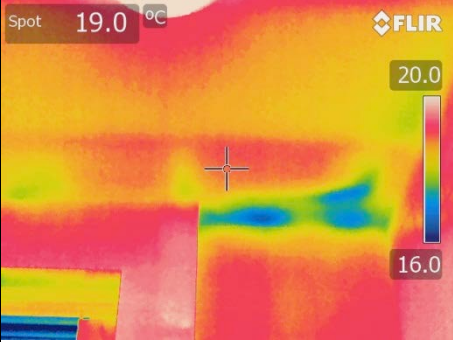
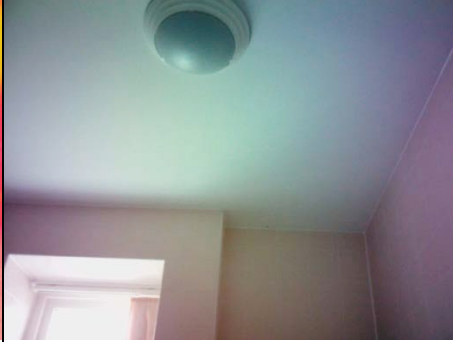
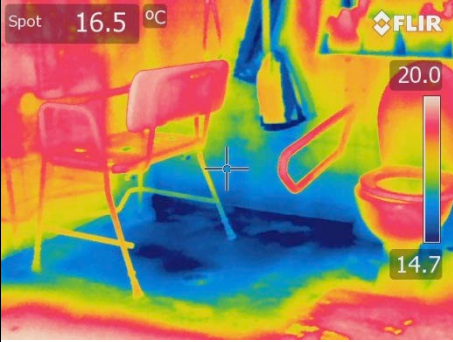
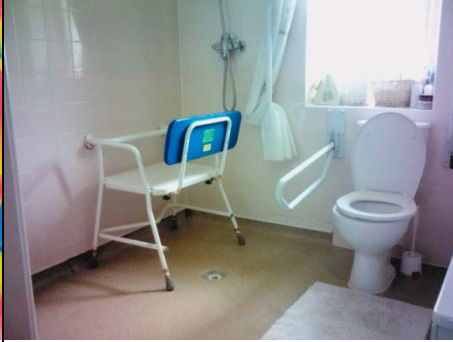
| <p>Bathroom 2</p> <p>Some discontinuities in the loft insulation are apparent at the eaves (IR_2051). However, these discontinuities are not as severe as those observed within other rooms in the dwelling. The lack of underfloor heating and insulation below the sunken shower tray is evident in IR_2049, which was also observed in bathroom 1 (see IR_1999).</p> | | |

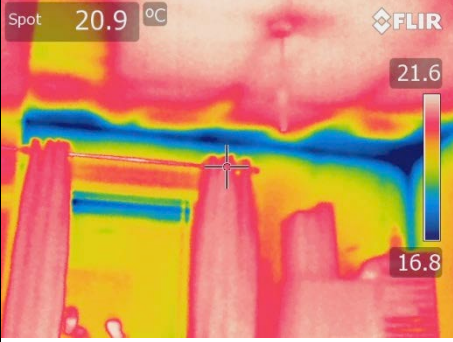
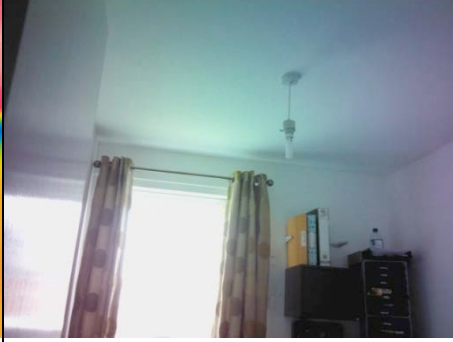
| | | <p>IR_2075 and DC_2076</p> <p>24th March 2014 11:02</p> <p>Internal Temp – 21.3 °C</p> <p>External Temp – 4.5 °C</p> <p>Internal RH – 44.5%</p> <p>External RH – 70.7%</p> |

| <p>Carer's room</p> <p>Discontinuities in the loft insulation were observed at the eaves.</p> | | |

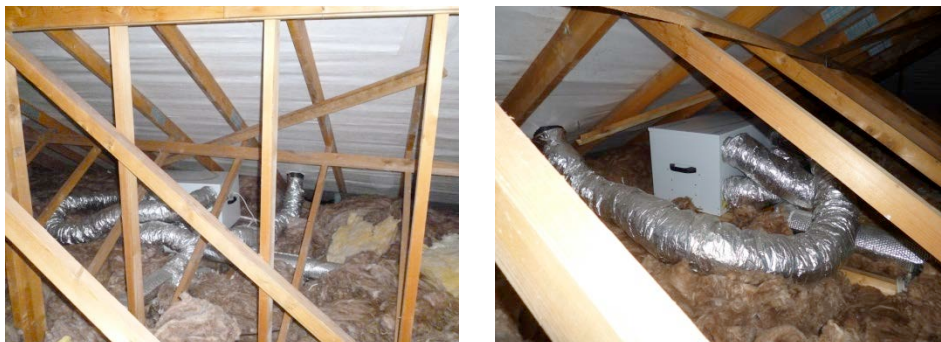
Figure 5 Location of the MVHR unit within the loft space.

- **MVHR unit platform** – A platform has been used to support the MVHR unit in the loft space immediately above the laundry room (see **Error! Reference source not found.** 5). The space beneath this platform is uninsulated, resulting in a significant thermal bridge. As the laundry room is a wet room, there will be an increased risk of surface condensation and mould growth on the ceiling of this room.

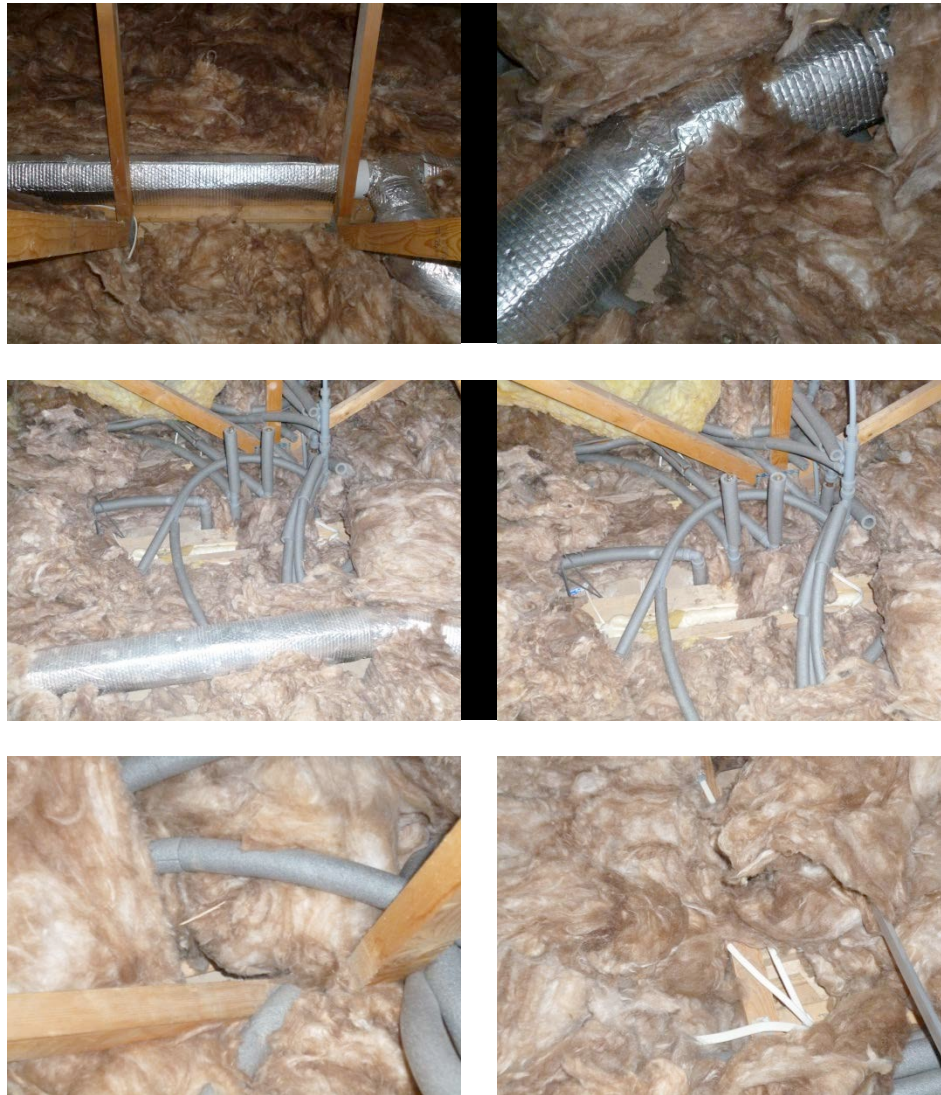
Figure 6 Discontinuities in the insulation layer in the loft space.

- **Services in the loft** – Electrical cables, pipework and the MVHR ductwork all run along the top of the plasterboard ceiling and up and over the ceiling joists. The loft insulation has then been applied around, but not always above, a number of these services. In addition, it appears that some of the insulation has been displaced to obtain access to some of these services. This has resulted in significant discontinuities in the insulation layer in the loft space which will result in thermal bridging and the potential for air movement (see **Error! Reference source not found.** 6).

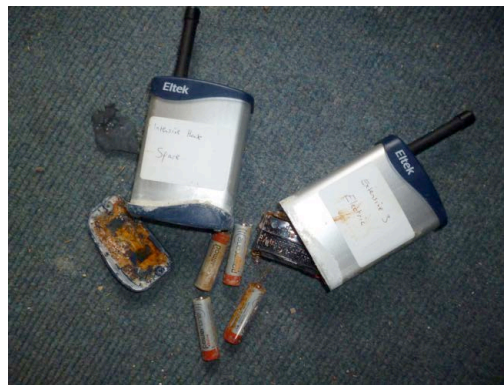
Figure 14 Water damage to pulse transmitters.

This issue was not foreseen by the research team as the external housing was thought to be weather proof. In future projects, the research team will use weatherproofing systems that are known to be sufficiently robust.

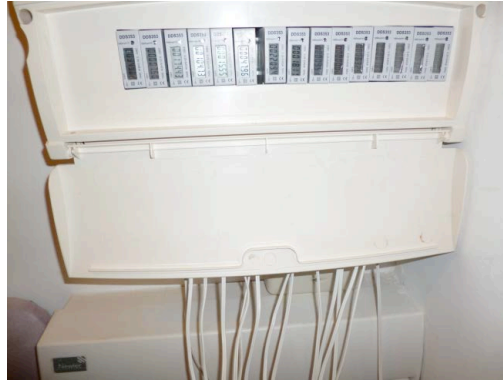
Figure 15 Unlabelled wiring

impossible to determine which trailing wire was attributable to each circuit (Figure 15). This required the JRHT electrician to return to the property to label each of the trailing wires and resulted in data loss.
