This document contains a Building Performance Evaluation report from the £8 million Building Performance Evaluation research programme funded by the Department of Business Innovation and Skills between 2010 and 2015. The report was originally published by InnovateUK and made available for public use via the building data exchange website hosted by InnovateUK until 2019. This website is now hosting the BPE reports as a research archive. Although no support or further information on the reports is available from the host, further information may be available from the original InnovateUK project evaluator using the link below¹.

| InnovateUK project number | 450097 |
| Project author | Glasgow School of Art, Mackintosh Environmental Architecture Research Unit (MEARU) for Dormont Estate |

| Four | Lockerbie | Semi-detached | 2011 |

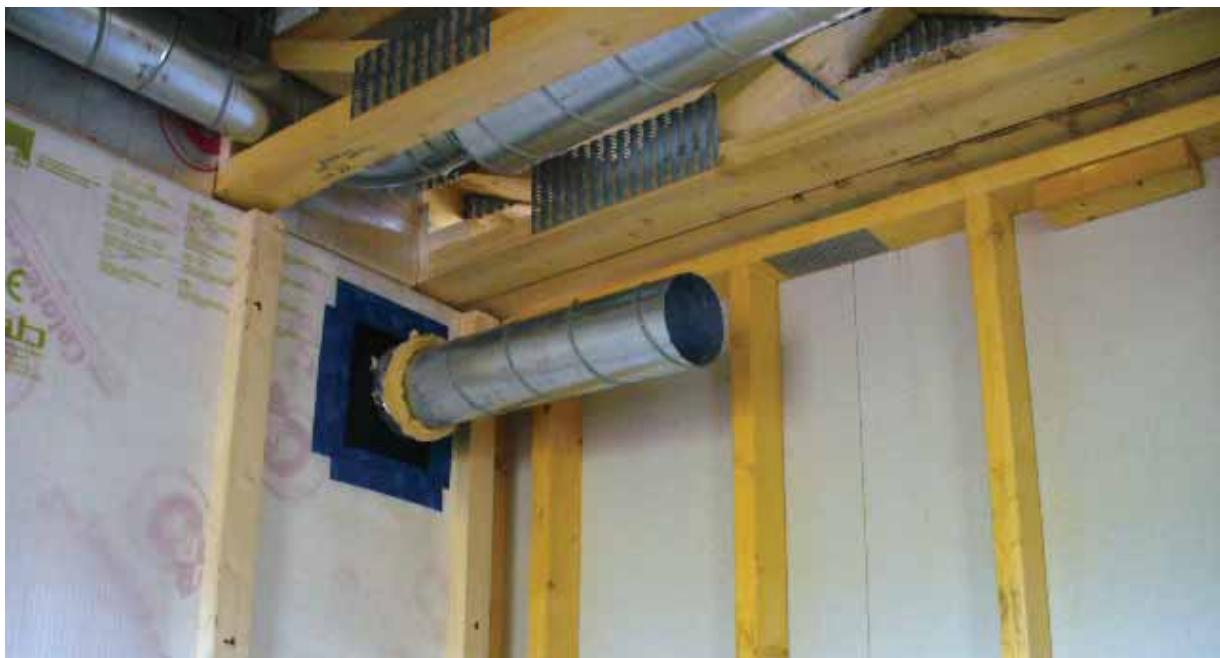
The only significant problem that arose during construction was the difficulty in achieving the requisite level of airtightness. This issue is discussed further in Section 3. Although not a problem on site as such, a subsequent problem was related to the difficulty occupants had in understanding and using the various active services, particularly the plumbing and the associated controls. It is worth noting therefore that the plumbing and electrics packages were left as Contractor-design elements and were not finalised until well into the build process. There are important lessons to be learnt from this in terms of either including the services as part of a detailed package of specification / details, or by ensuring that the Contractor has the relevant experience / expertise to design and install services to a Passivhaus standard. It is also important that the Installer is able to produce clear and accurate "as-built" drawings and is able to adequately explain the systems to the incoming occupants.

Figure 2.10: Achieving the required level of airtightness proved to be the most difficult part of the site works. Image shows a proprietary grommet and taping to seal one of the air ducts as it passes through the wall.

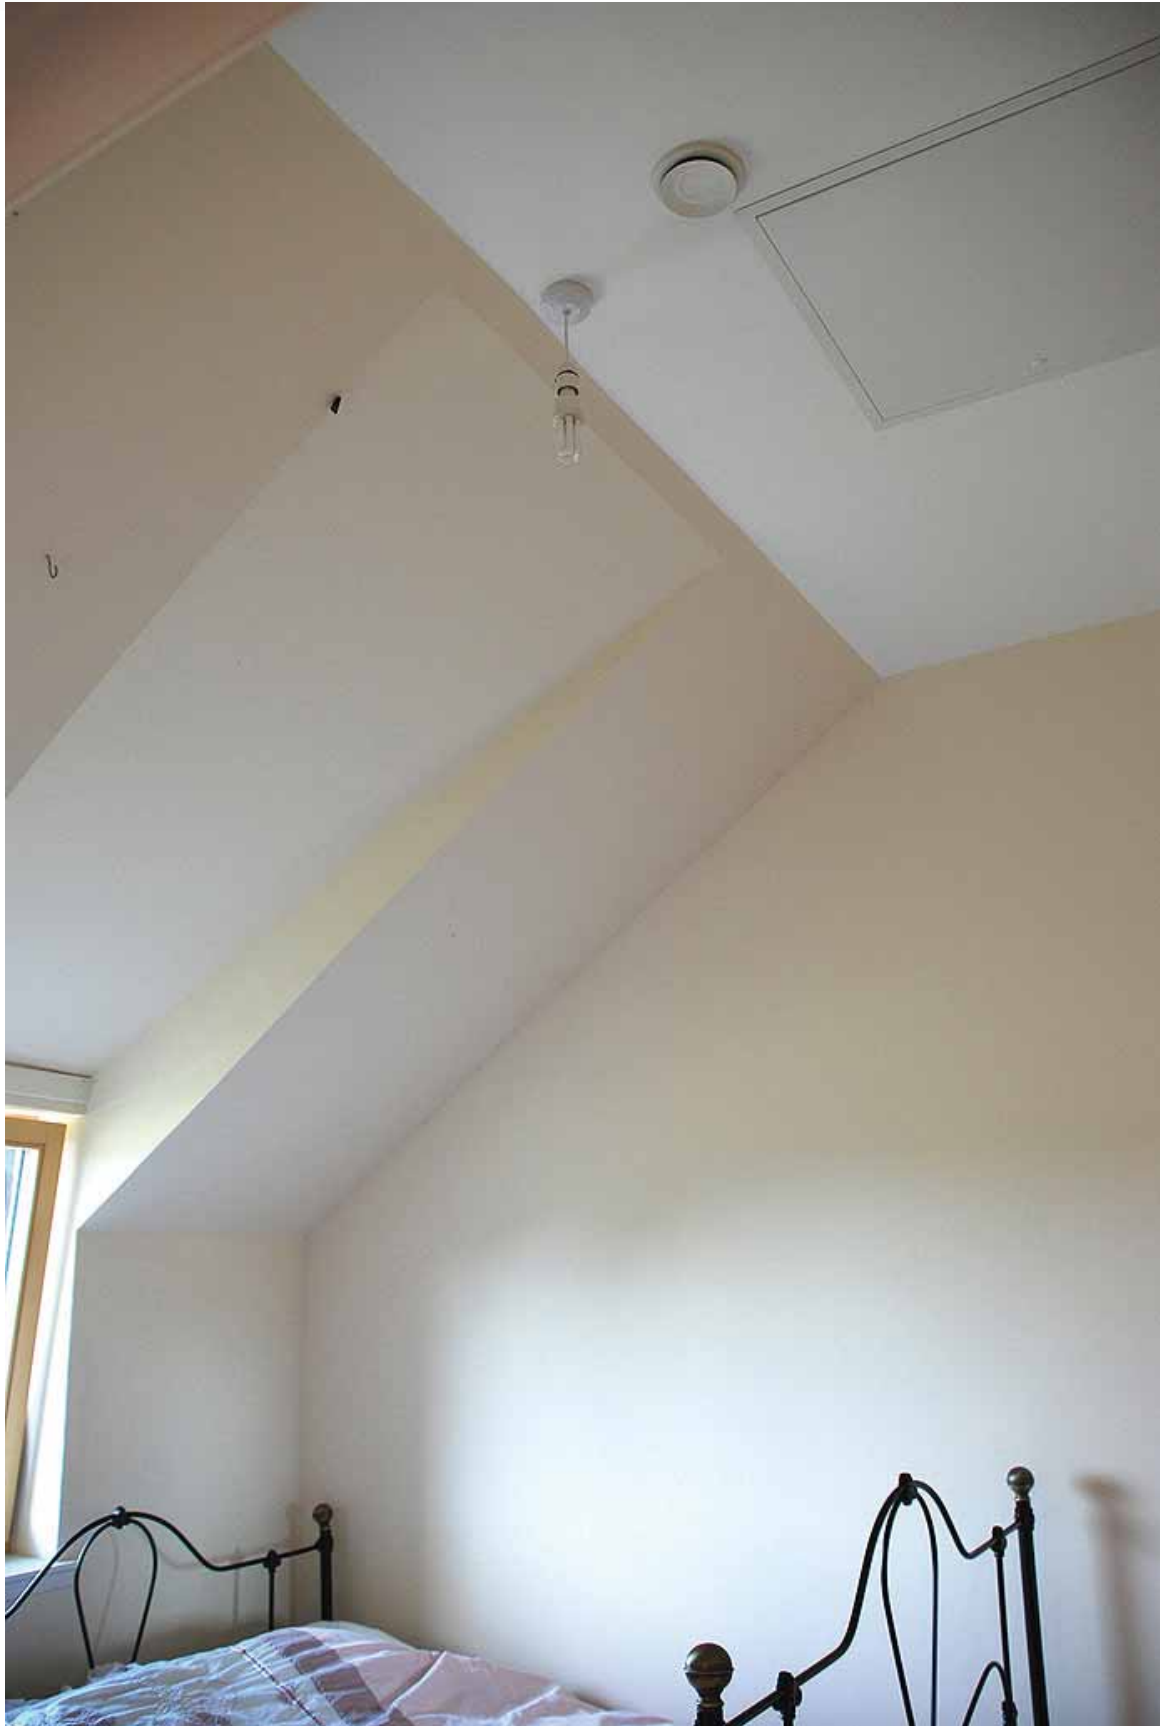
Figure 2.15: View of DA2 Rear bedroom with high sloping ceilings. Access to lights, air grilles and the attic hatch is difficult.

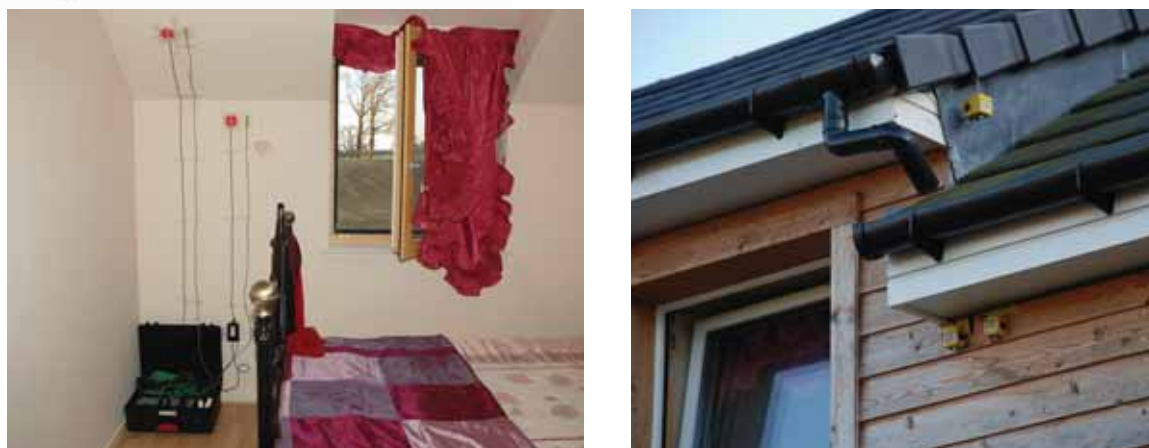
The results of this first test showed that whilst the roof appeared to be per the design intent, the result for the wall was well outwith the design intent. This may have been because the sensor was positioned too close to the top of the wall and was measuring the wall head construction (solid timber) rather than a more representative section of the wall.

Figure 3.1: Internal and External views of the insitu U value test kit installed for the first test.

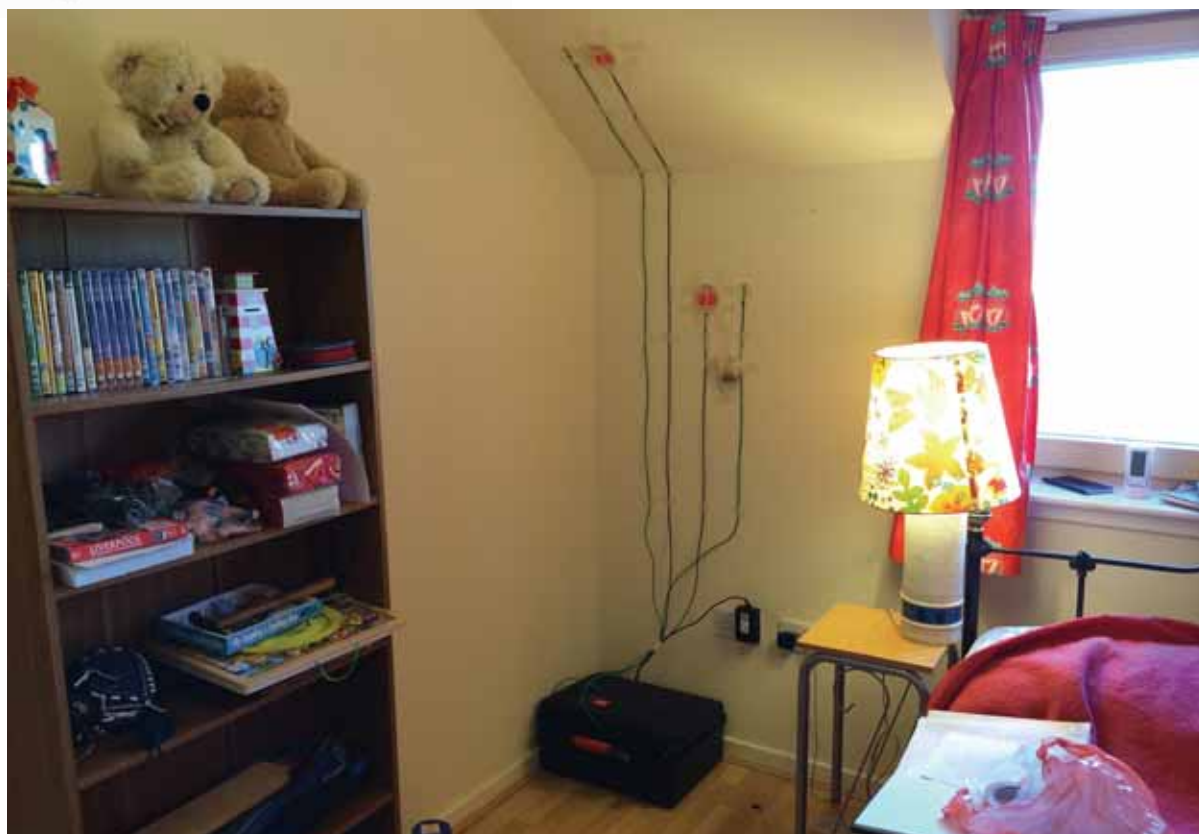
This discrepancy is noted within the Hukseflux analysis spreadsheet used to derive the above results where the deviation between modelled (predicted) and measured figures are shown to be 28.6% for the wall and 34.4% for the roof. The predicted figures for both wall and roof without thermal bridging ought to be around 0.08 W/m²K and in this context it is clear that the measured figures are not as good as first appears.

This drop in performance may be due to a number of factors such as local poor workmanship or misleading declared lambda values, but the discrepancy is still relatively small and performance overall is relatively good.

Figure 3.3: Internal view of the Hukseflux installation for the second test. Note the position of the wall plate, which is lower than in the first test.

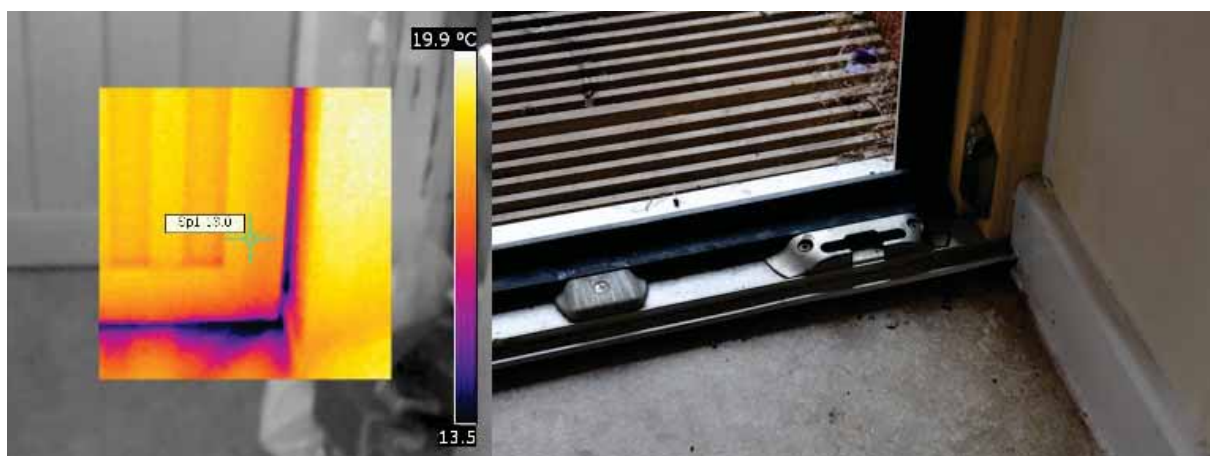
In the first exercise, the thermography was being used to help trace air leakage and in this capacity, the main leaks discovered were around the lower corner of the Utility Room doors and also from the wood stove flues.

Figure 3.4: Air leakage at the Rear doors in several of the cottages could be seen when de-pressurised.

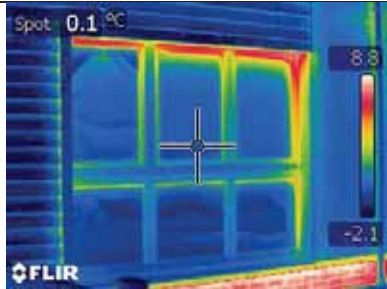
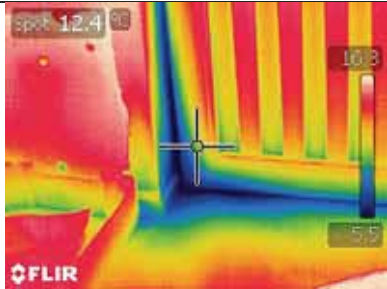
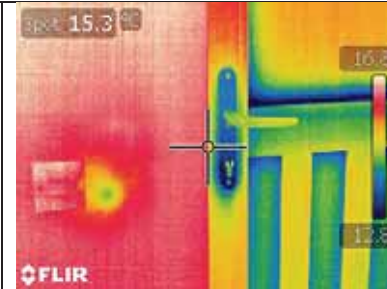
| External. DA1 Living Room Window. Increased heat loss around window heads, and apparent heat loss (but more likely retained warmth) along base brick course. | Internal. DA2 Utility Door. Excessive heat loss around leading edge of door at base. Apparently explained by incorrect hinges currently fitted | Internal. DA2 Entrance. Cold patch by light switch linked to wiring for door bell – there was a corresponding 'warm' patch externally. Presumably an air gap caused by creating the hole for the wiring |

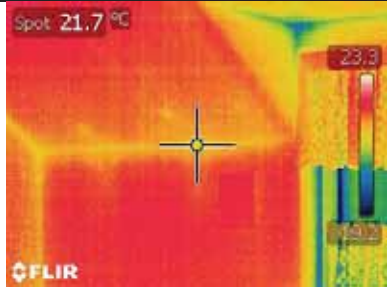
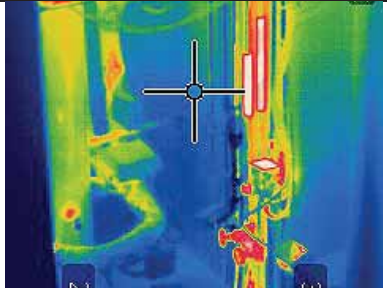
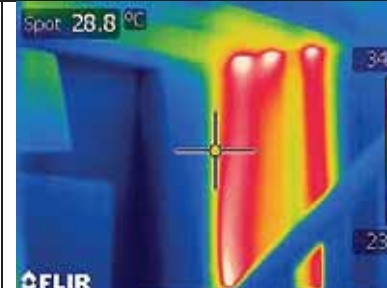
| Internal. DA2 Main Bedroom. Showing minimal heat loss at exposed gable wall / roof junction and also at dormer. | Internal. DA2 Cylinder Cupboard Showing exposed uninsulated water pipework | Internal. DB1 Stairwell Showing significant heat gain from uninsulated hot water pipes within bathroom / stairwell partition. |

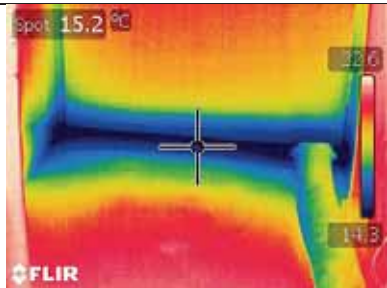
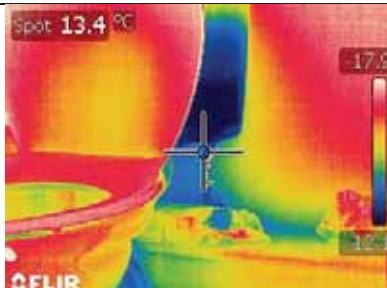
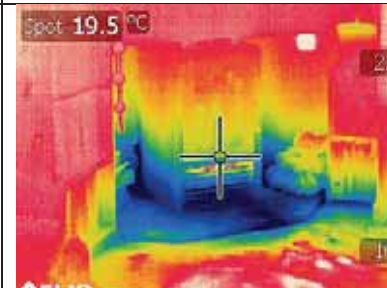
| Internal. DB2 Utility Door from Kitchen. Showing significant difference in temperature (8°C) between Kitchen and utility (which is within same thermal envelope) | Internal. DB2 GF Toilet Cistern. Drop in surface temperature to exposed cistern (condensation evident) after toilet flushing. Passivhaus best practice promotes use of concealed & insulated cisterns. | Internal. DB2 Wood Stove and Hearth. Taken at request of Occupant who suspected hearth area to be colder, shown to be correct, likely cause being the cooling effect of uninsulated air intake duct |

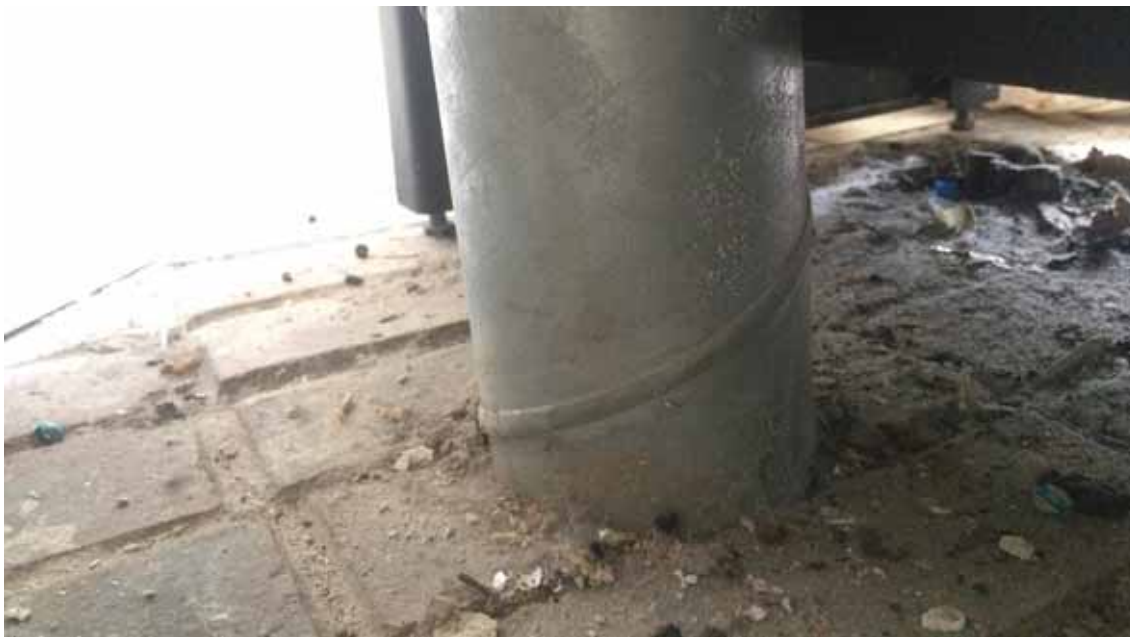
The second test report highlighted the contribution to leaks from the combustion air supply pipes into the rear of the wood stoves, along with doors and service penetrations.

Figure 3.7: View of the combustion air supply pipe located behind the wood stoves. Air leakage was found at the junction between the pipe and the adjacent brickwork.

The two sets of tests undertaken on behalf of MEARU identified a limited range of air leakage points; the doors, service penetrations and the stove flue and combustion air supply pipe associated with the wood stove, pictured above. Whilst it is possible that the stove flue has opened up slightly since being installed, and there is some evidence that the rear doors to the properties have become less tight in the intervening period, none of these areas have evidently failed to such an extent that it explains the discrepancy in figures.

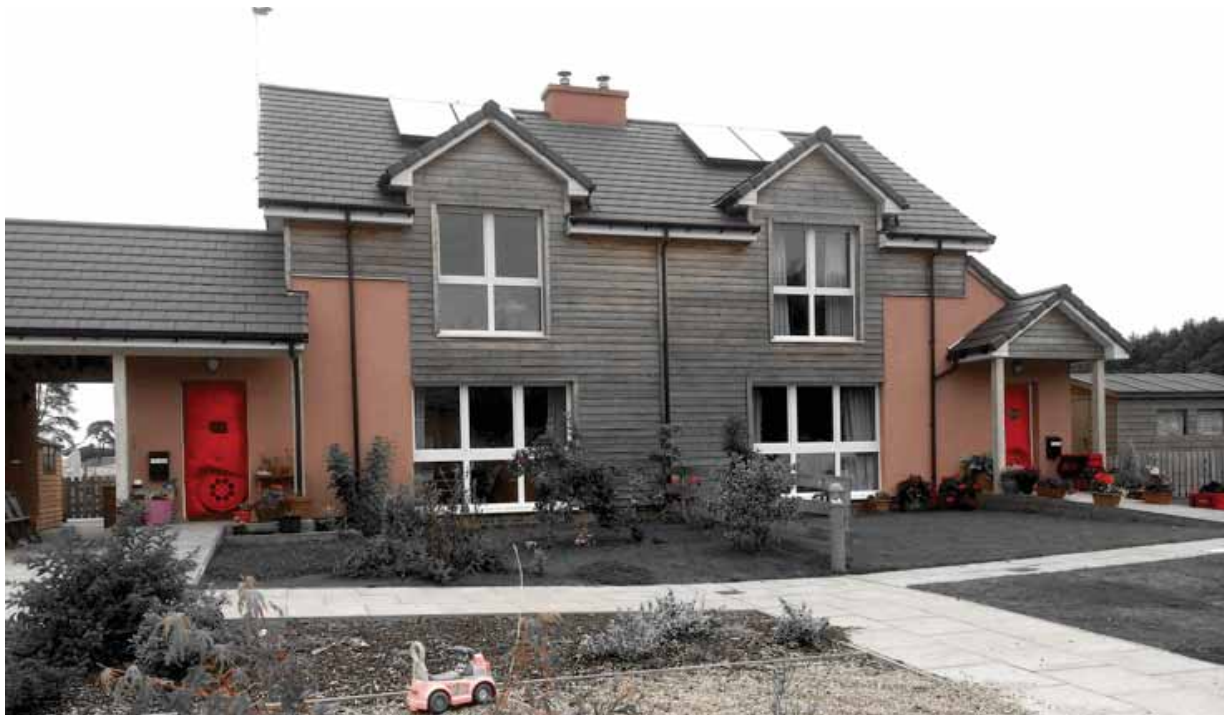
The first is the fact that the compliant tests made at completion used 'co-pressurisation' to achieve the results, whereby adjacent properties are simultaneously pressurised (or de-pressurised). This tactic effectively removes anomalies caused by air leakage in party walls and is used in some cases.

MEARU's first tests were undertaken without co-pressurisation so this could have been a potential reason for the differences. For this reason, the second tests undertaken in August 2014 used both methods and co-pressurisation gave on average 6.3% lower ('more airtight') results than standard testing.

Figure 3.8: View of cottage DA2 (to left) and its neighbour under co-pressurisation, whereby both adjoining properties are pressurised, or de-pressurised.

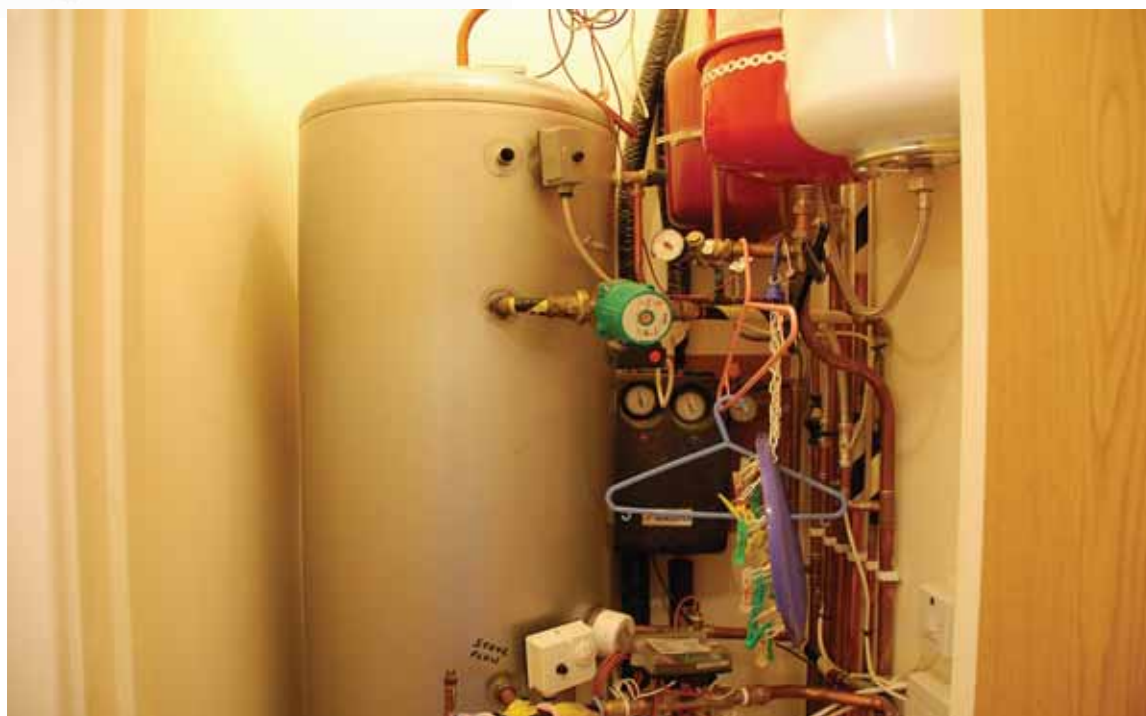
Figure 6.2: Thermal Store in Cottage DA2, showing uninsulated pipework, the expansion tanks and (surrounded by black polystyrene) the solar thermal panel controller, linked to an information display in the Kitchen.

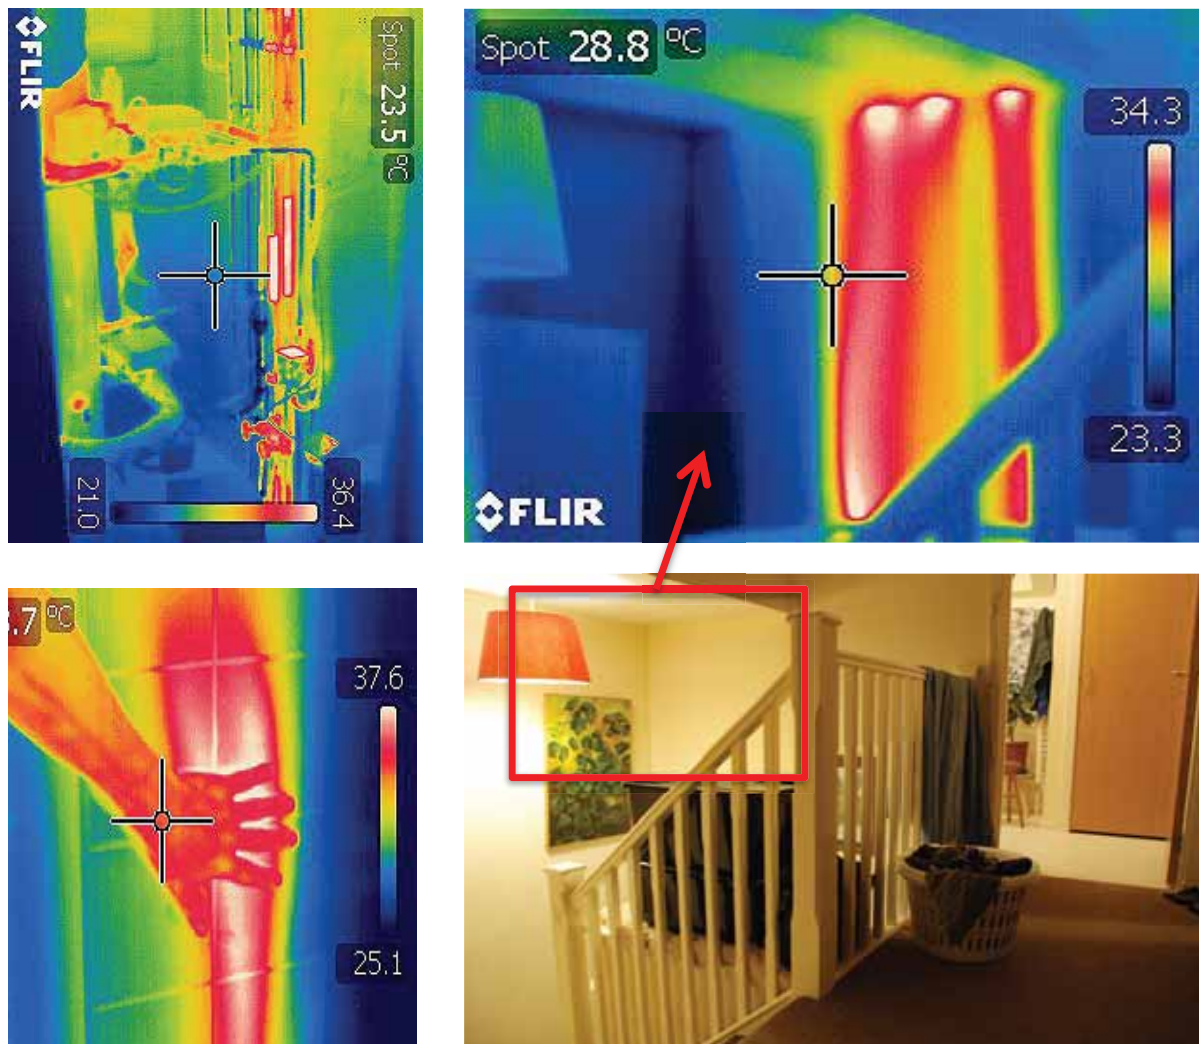
Figure 6.8: Top left: thermographic image of the uninsulated pipework in one of the landing cupboards. Top right: thermographic image of a section of wall to the stairwell with uninsulated hot water pipes running within and, bottom right: the same area of wall in context. Bottom left: thermographic image of the other side of the same area of wall, behind tiling to the bath with the Occupant's arm to indicate the high surface temperature created.

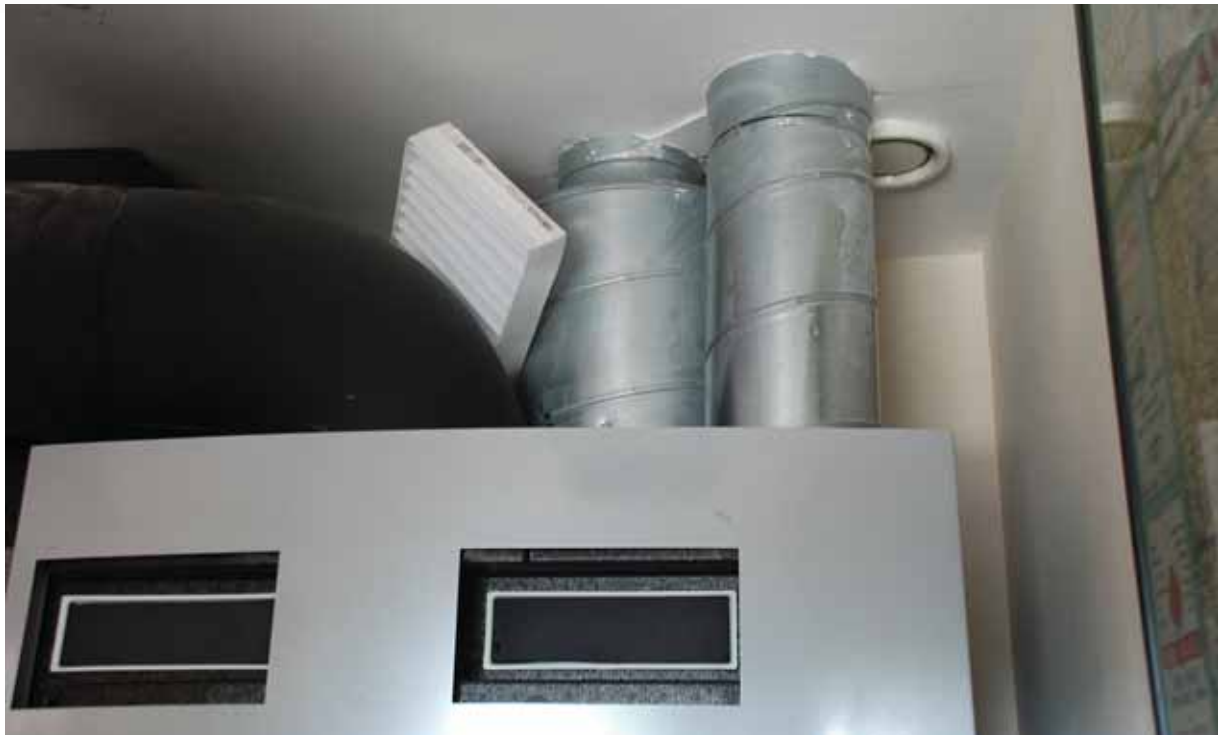
Figure 6.18: MVHR Unit in Cottage DB2 with Intake and Exhaust ductwork and extract grille behind, inaccessible for commissioning.
