Eli Lilly Research Office Building

Innovate UK project number	450058
Project lead and author	AECOM
Report date	2013
InnovateUK Evaluator	Unknown (Contact via www.bpe-specialists.org.uk)

Building sector	Location	Form of contract	Opened
Offices	Windlesham.	Traditional	2012
Floor area	Storeys	EPC / DEC	BREEAM rating
Main building: 2150 m ²	2	B (46) / N/A	Excellent

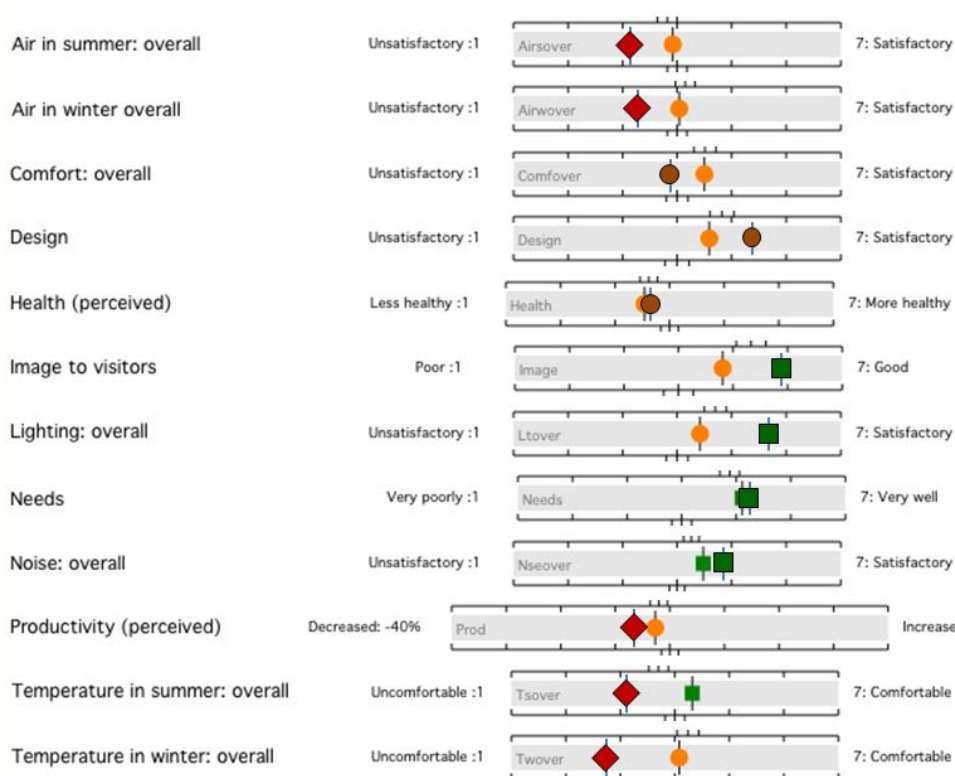
Figure 8: The overall summary from the BUS carried out for the ROB

In general, the survey responses reflected dissatisfaction with aspects in the ROB consistent with the technical issues identified elsewhere in this report. These issues relate to the provision of ventilation and space conditioning, which at the early stages of post-handover have caused a significant amount of disruption to the occupants. In the many site visits during the study, the dissatisfaction of the occupants has already been made known to the building manager as well as the BPE project team. Figure 8 summarises the BUS output for the ROB showing the following perception by the occupants surveyed tabulated in Table 2. Please refer to the report in A19 for more details.

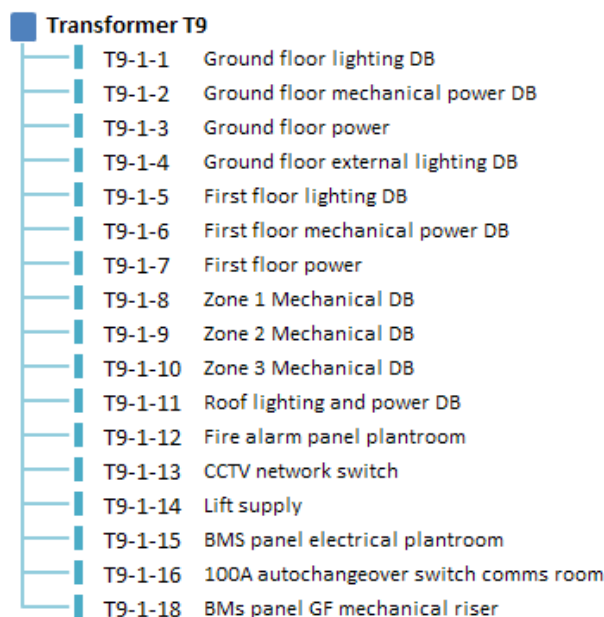
Figure 9 The extent of sub-metering available in the ROB. Please note that some meters are not being recorded on the M&T system and some minor energy uses are not metered.

However, during the course of this study, it has been established that further breakdown of energy use will be beneficial in order to determine specifically energy use associated with the VRF condenser units. Along with other relevant information, this would enable the energy use for space conditioning (heating and cooling) and for hot water generation to be more accurately determined. Understandably, this may have cost implications where the typical process of value engineering would have reviewed this aspect and cut the metering strategy based on cost to the client.

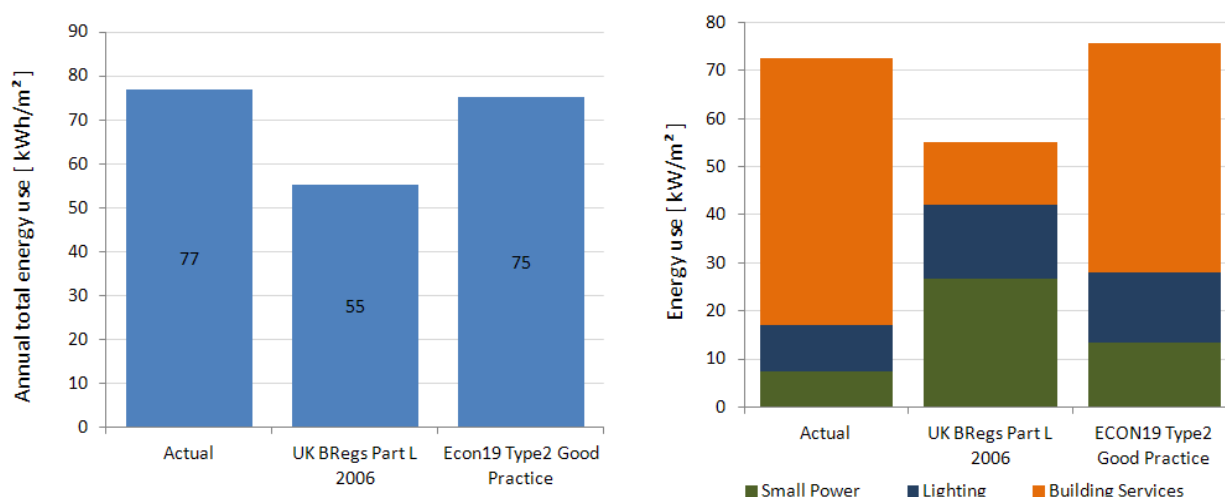
Figure 11 comparison of the ROB actual in-use energy against relevant benchmarks

The energy use for mechanical services in the ROB is shown to be excessive in comparison to the benchmarks. This could be due to the control issues suffered throughout the period of the study since building handover, leading to the system switching between heating and cooling. This could also be affected by the low occupancy in the building, leading to low casual (passive) heating, which then requires additional active heating by the system. Regardless of the cause, this has led to the need for further investigation to the cause of such high energy use. It must be noted that no adjustment for low occupancy was carried out to the benchmarks for a fairer comparison as no corresponding occupancy data was available.

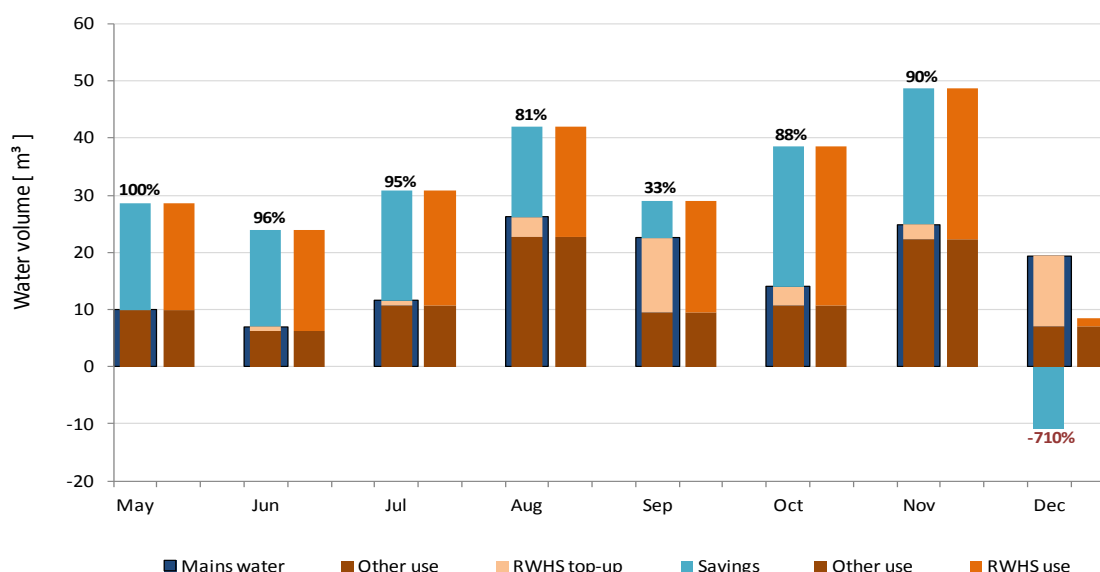
Figure 14: The ROB in-use water consumption. Note “RWHS use” meter defect in December

Water use data downloaded from the M&T system has been plotted in the chart shown in Figure 14. The chart shows the amount of mains water saved each month as a result of rain water offset. However, an anomaly was discovered for December, which was later established to be a meter defect.

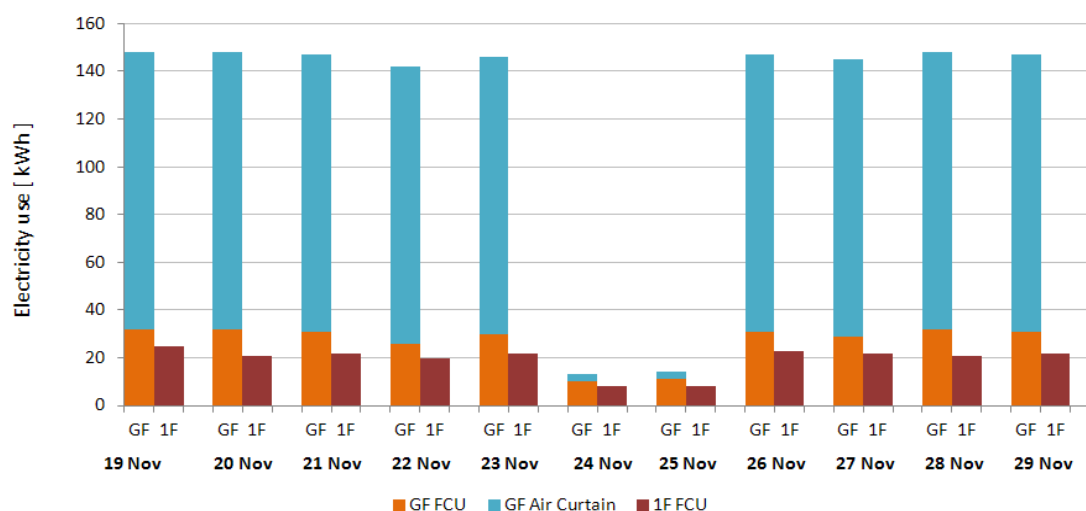
Figure 15: Energy use by the entrance door air curtain compared to fan energy by FCU on both ground and first floor

It has been highlighted that whilst controlled on a time-clock basis and to operate when the external temperature is less than 16°C and internal space temperature is less than 21°C, the main entrance door air curtain appeared to be running continuously. Its estimated typical energy use is approximately 80% of other use for the floor terminal mechanical services as illustrated by Figure 15. The remainder of the energy use is due to FCUs fan energy. The client has since switched off the air curtain and is awaiting a modification to its operation regime to be derived and implemented.

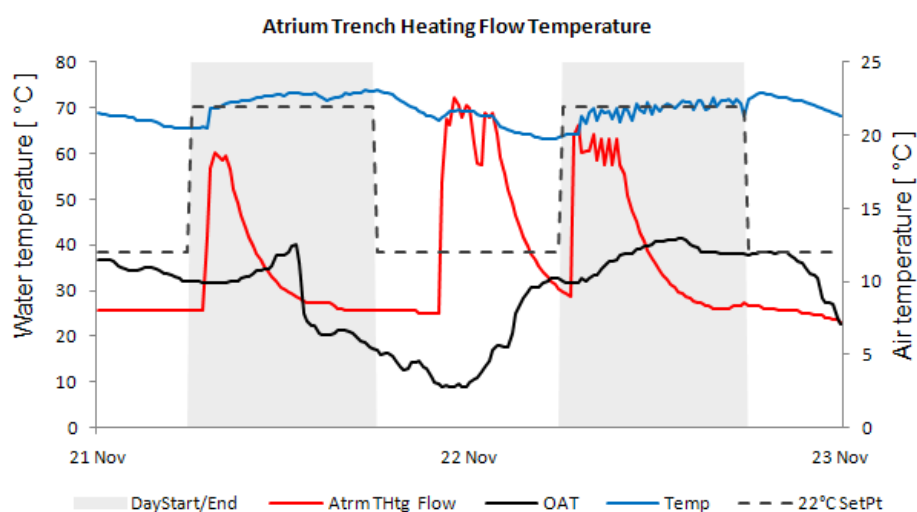
Figure 16: The atrium trench heating operation based on zonal time-clock and external temperature

Whilst it appeared to be operating according to design intent, closer inspection of the trench heating suggested that its operation could be optimised for energy saving. The trench heater has been programmed to run based on a time-clock for each zone and when the outside temperature drops below 5°C to mitigate any potential down-draught and risk of condensation on the atrium double-height glazing, as shown in Figure 16. This may not be necessary when the internal space temperature is relatively high. Further investigation into this potential energy saving measure is required beyond the timeframe of this study.
