# Graham Construction Head Office

<b>Innovate UK project number</b>	450087
<b>Project lead and author</b>	GRAHAM Construction
<b>Report date</b>	2014
<b>InnovateUK Evaluator</b>	Unknown (Contact via <a href="http://www.bpe-specialists.org.uk">www.bpe-specialists.org.uk</a> )

<b>Building sector</b>	<b>Location</b>	<b>Form of contract</b>	<b>Opened</b>
Offices	Hillsborough, NI	Design and build	2009
<b>Floor area (TFA)</b>	<b>Storeys</b>	<b>EPC / DEC</b>	<b>BREEAM rating</b>
3106.5 m <sup>2</sup>	3	A / C (unofficial)	Excellent

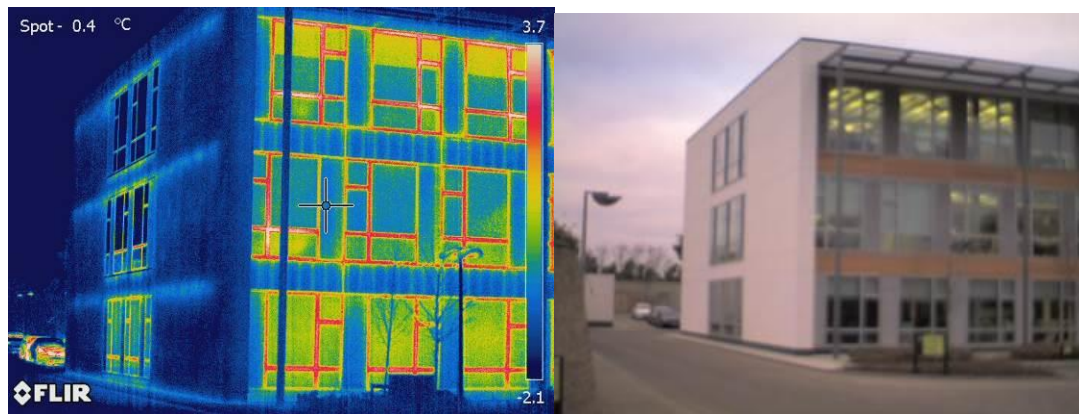
Figure 4.3 Thermal image of external left side gable end elevation and location photograph

Thermal Imaging highlighted potential areas of heat loss from entrance doors, curtain walling, building service grilles, 3<sup>rd</sup> floor north facing office and some areas of solid wall on the north facade between the narrow windows on the 1<sup>st</sup> and 2<sup>nd</sup> floors. Some examples are shown below.

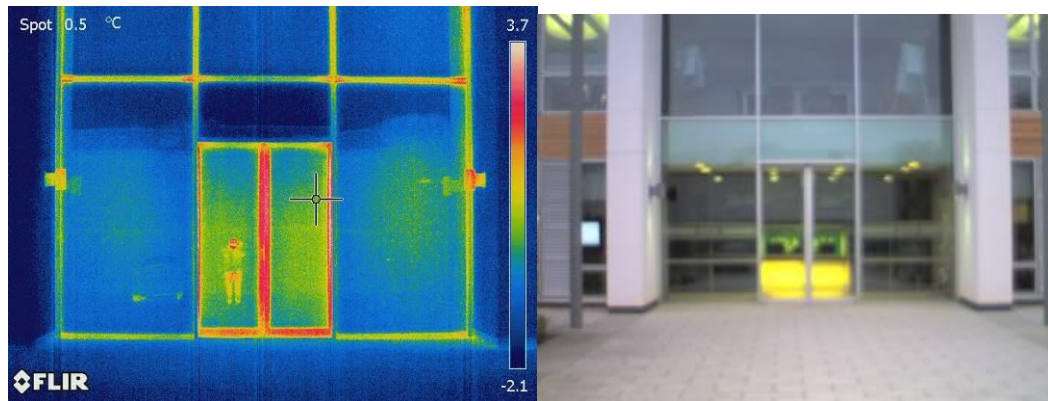
Figure 4.4 Thermal image of external front door (with reflection) and location photograph

Figure 4.4, (others in main report) illustrates the heat loss for the front door area of the building and the central front façade. The automatic doors in the centre of the image exhibit a higher degree of heat loss than the surrounding glazed area due in part to the intermittent opening and closing of the doors to facilitate entry to the lobby space. Note the hot spots which represent the down/up lighters mounted on the wall. The surface temperature pattern for the door region is generally consistent with what would be expected with no anomalies in heat loss detected.

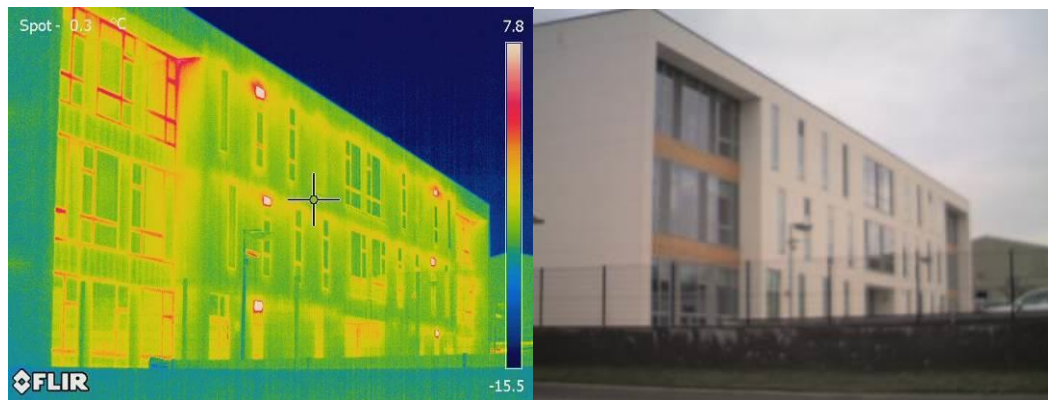
Figure 4.5 Thermal Image of rear elevation and location photograph

The thermograph in Figure 4.5 illustrates a number of anomalies. The elevated surface temperature pattern represented in red which is apparent in the top left of the thermal image where the curtain walling meets the junction with the roof slab and the standard masonry walling, (as shown in the location photo), would indicate increased heat loss in this region.

This may be a result of missing/voids in insulation, damp ingress or air leakage or a combination of all three. It could also be due in part to localised internal temperature variations as a result of the location of the inlet grills for the buildings' heating system. The inlet grills are spaced around the periphery of the building and the warm air may be travelling up the internal face of the curtain walling system causing an increased temperature in the region. The six hot spots at the top of the windows are as a result of extractor flues or fans for the toilets. The extractors are linked to the lights in the toilets so when someone enters the toilet the lights come on which activates the extractor fans. The fans are on over-run timers which automatically switch off after a predetermined time has elapsed.

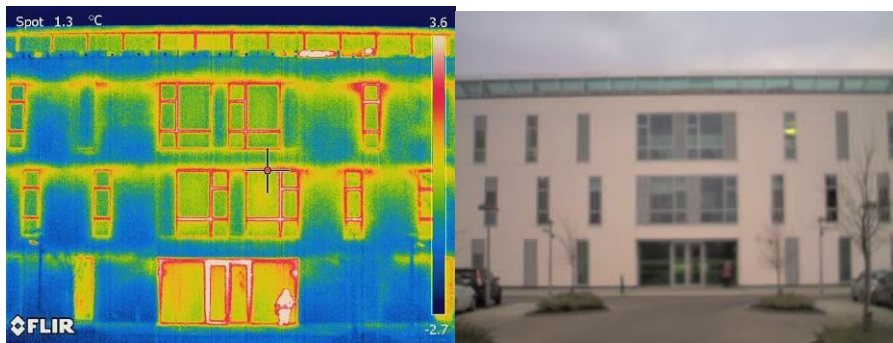
Figure 4.7 Thermal Image of external central rear façade (showing person) and location photograph

Figure 4.7 shows some evidence of increased heat loss between the narrow windows particularly on the first and second floors. This is most evident at the top of the windows which may be a result of thermal bridging due to the window lintels, heat escaping from the top of the window or due to an elevated internal temperature as the warm air rises to the top of each floor. There is also evidence of some increased heat loss around the door however continual opening may be the primary cause for this.

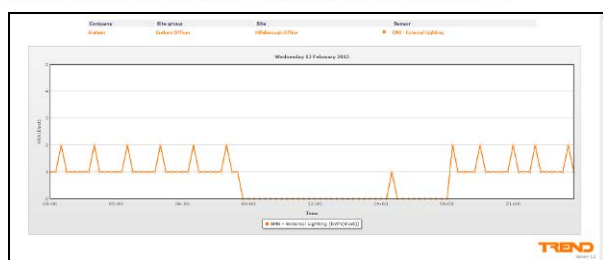
External Lighting consumption has reduced by 48% from Year 1 to Year 2. The higher consumption in Year 1 was due to a fault with the timer in February 2013. This was repaired in March 2013 and consumption has continued to stay low since then. External lighting load profiles can be viewed on the TEM system and show optimum operating hours in use and seasonal variances.

Figure 7.13 February 2013 –Lights on all night –fault in timer

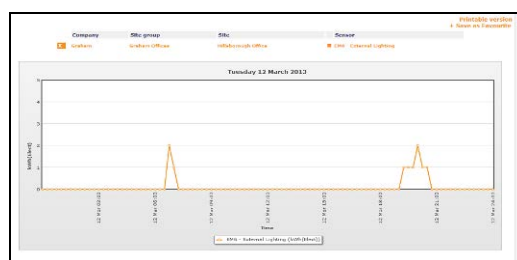
Figure 7.14 March 2013 – timer repaired

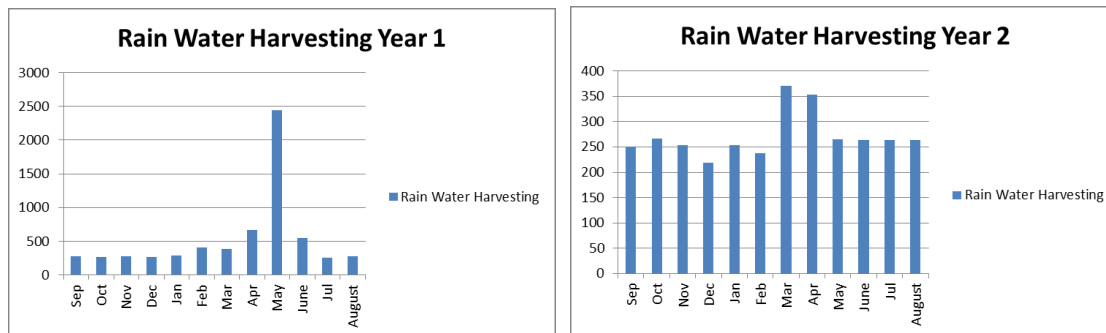
Figure 7.26 Annual Consumption Rainwater Harvesting Year 1 and Year 2

The annual energy consumption graphs below for the Rainwater Harvesting pumps show that there was a fault in the pump in May 2013. This fault was causing the pump to run continuously. Facilities management arranged for this to be repaired and normal operation resumed in June 2013. This fault caused consumption to be almost 8 times greater in May 2013 than it would be in a normal month. This can account for some of the increased energy consumption in Year 1. The graph below shows the fault beginning in April 2013 with no change to the amount of rainwater collected.

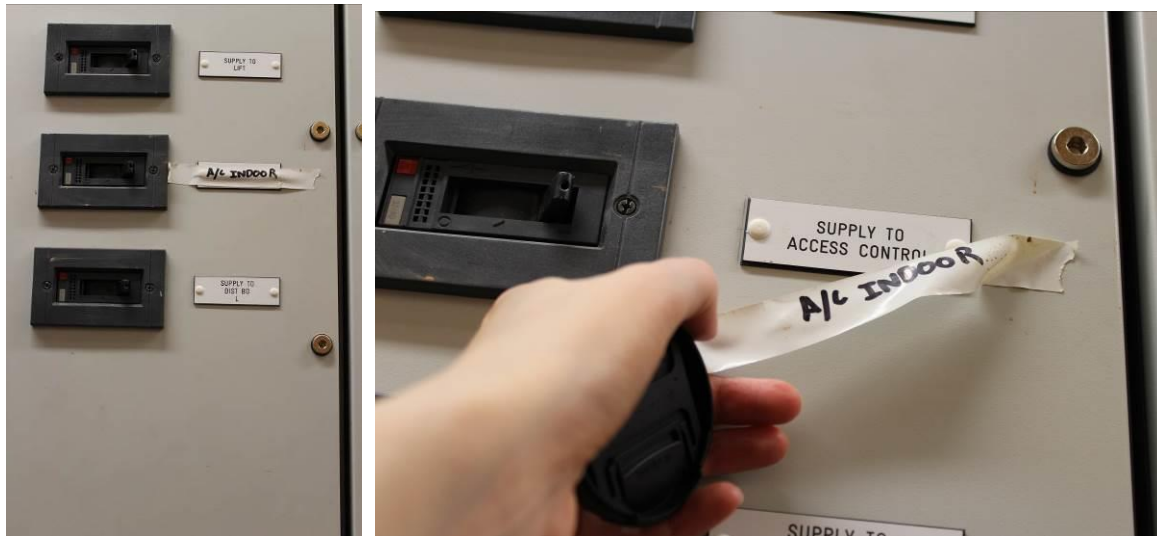
From the graph above the green line shows the load profile of the Access Control Panel sub-meter and the blue and yellow lines show the Air Conditioning sub-meters. The load profiles are so similar that air conditioning was suspected to be the additional load on the Access Control Panel sub-meter. Following on from this and after further inspections in the plant room a piece of duct tape had been used to cover over the access control panel switch.

Figure 7.30 Images of A/C indoor duct tape notice over Access Control Label.

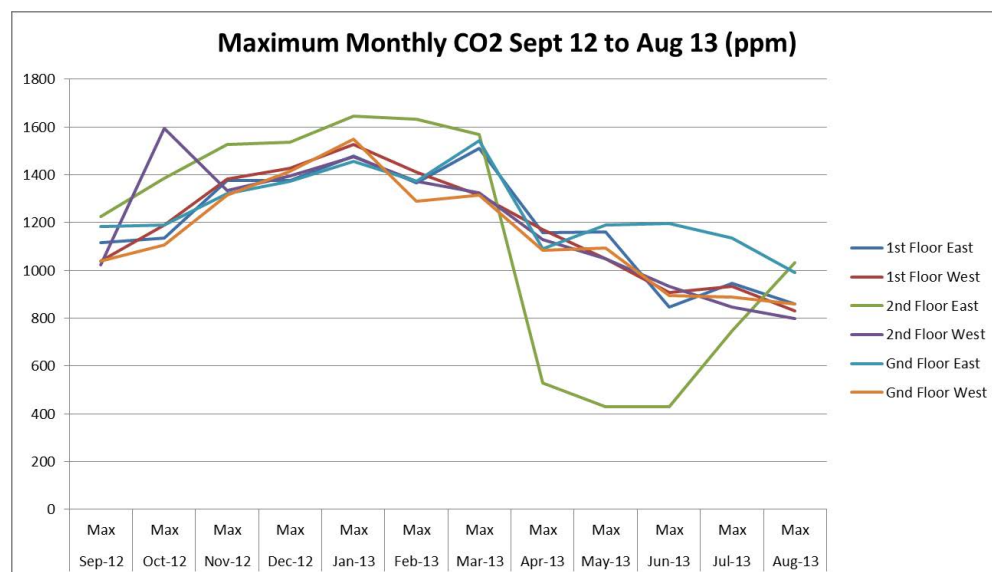
From the above results it can be deduced that there is a fault with the sensor on the 2<sup>nd</sup> Floor East. This was recognised by FM and the sensor has since been replaced. Apart from this sensor other readings indicate that the maximum CO<sub>2</sub> ppm detected in the building is somewhere around 1500 – 1600 ppm. To ascertain if this is a once constant occurrence or a one off daily profiles need to be investigated. See below for TEM graphs showing air quality results.
