<b>InnovateUK project number</b>	450070 Related study: 450014 (Phase 1)
<b>Project author</b>	Leeds Beckett University for the Gentoo Group
<b>Report date</b>	2015
<b><sup>1</sup>InnovateUK Evaluator</b>	N/A

<b>No of dwellings</b>	<b>Location</b>	<b>Type</b>	<b>Constructed</b>
Six	Houghton-le-Spring	Terraced bungalows	2011
<b>Area</b>	<b>Construction form</b>	<b>Space heating target</b>	<b>Certification level</b>
66 m <sup>2</sup>	Pre-fabricated timber-frame	N/A	Level 4 Code for Sustainable Homes

The BPE report outlines the findings obtained from an in-use performance and post-occupancy evaluation study undertaken on six 66 m<sup>2</sup> 2-bedroomed terraced bungalows. All have solar thermal systems installed on their South-facing roof slopes. Dwelling 7 was chosen to be intensively monitored. As it is of the same size, shape and of very similar form to Dwelling 1 studied in Study 450014, the post-construction test results relating to that dwelling were considered likely comparable.

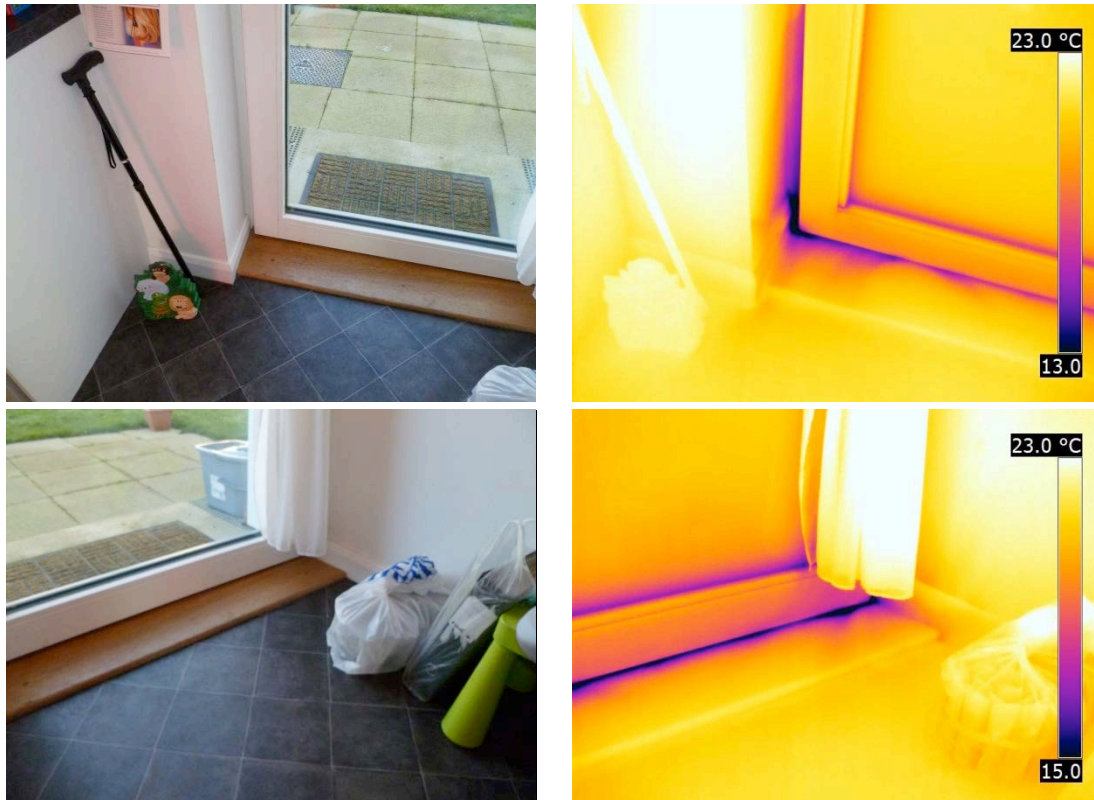
- At the threshold corners of the external rear door (see Figure 6).
- At the top corner of the rear door (see Figure 7).
- At the threshold corner of the front door (see Figure 8).
- At the top of the window in the master bedroom (see Figure 9).
- At the window frame joints in the master bedroom (see Figure 10).

**Figure 6 Leakage around the bottom corners of the rear external door.**

All of the leakage points identified within Figure 6 to Figure 10 are consistent with those that were identified in the earlier post-construction and initial occupation study. Analysis of the leakage points suggests that the increase in air permeability measured over the in-use monitoring period is attributable to wear-and-tear on the front, rear and patio door seals. The results indicate that the performance of these seals has degraded over the last 6 months or so of the in-use monitoring period.

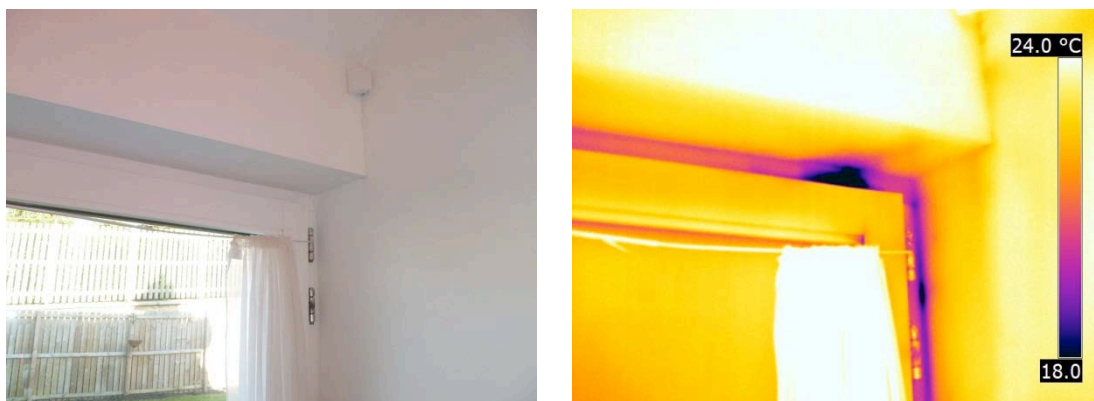
**Figure 7 Leakage at the top right hand corner of the rear door.**

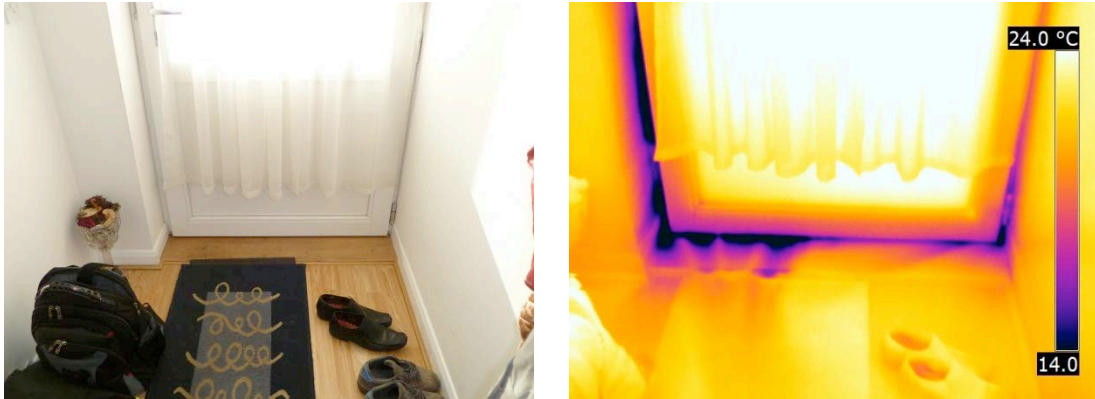
**Figure 8 Leakage at the bottom corner of the front door.**

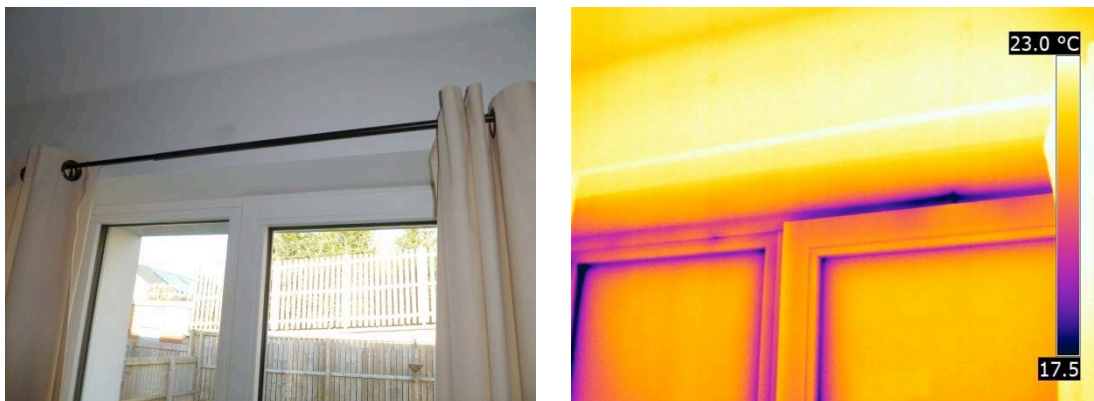
**Figure 9 Leakage at the top of the window in the master bedroom.**

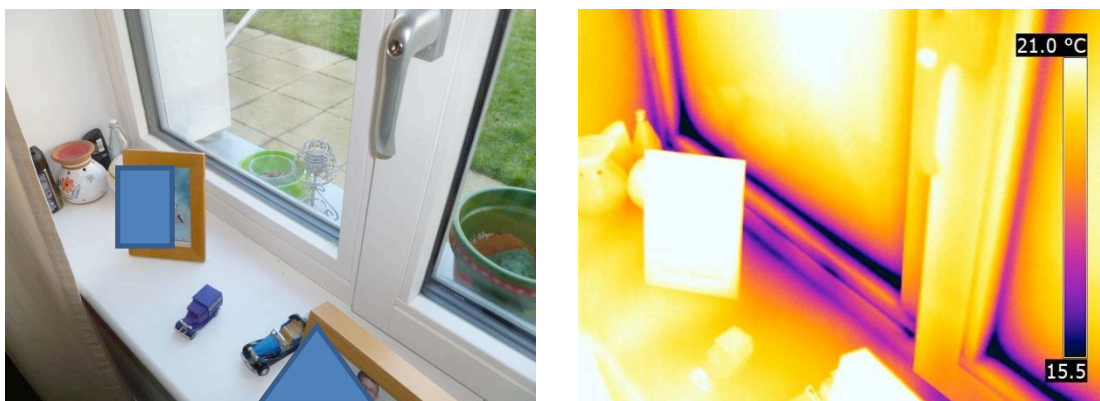
**Figure 10 Leakage between the joints in the frame of the window in the master bedroom.**

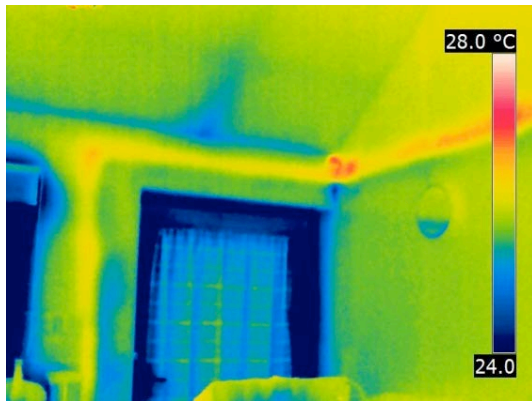
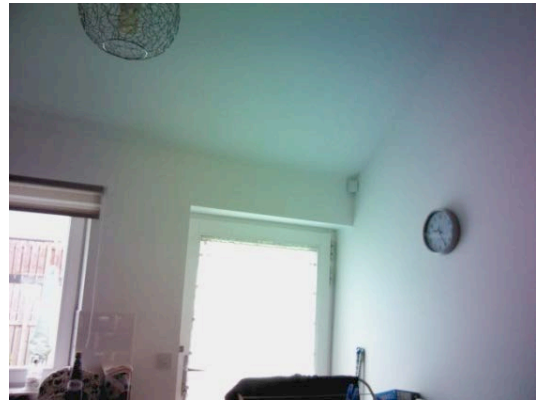
- A strip running across the partition wall between the master bedroom and kitchen in both dwellings. In dwelling 2, this strip crosses across the top of the back door and then runs down the North facing external wall to the light switch. It is thought that this may be being caused by the electrical cable that feeds the light switch, which appears not to be installed within a cable duct (see Figure 11).

**Figure 11 Strip running across the partition wall and above the back door in dwelling 2.**

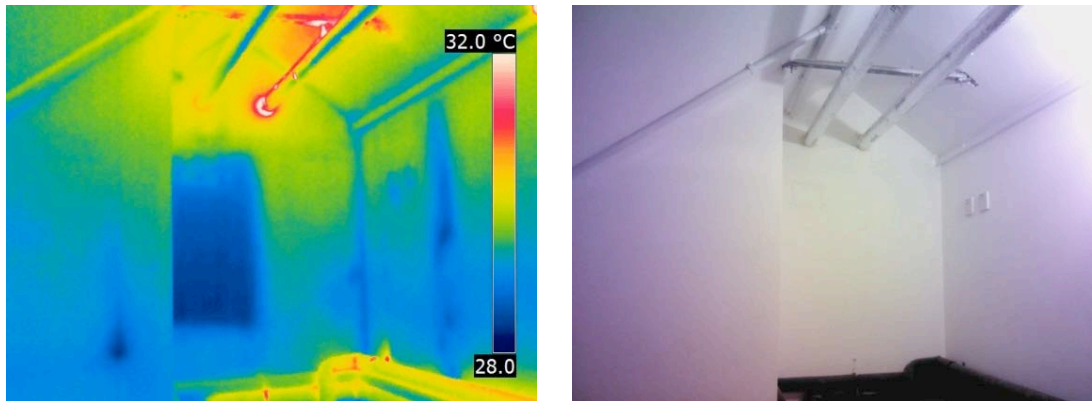
- A small hot spot around the communal main from the boiler (the flow) as it penetrates through the partition between the mezzanine plant room and the void above the living/kitchen area in both dwellings (see Figure 14). This may be caused by a break in the pipework insulation at the point where it penetrates through the partition wall.

- In dwelling 2, a visible rectangular section of wall (approximately 1.5m<sup>2</sup> in size) on the partition between the mezzanine plant room and the void above the living/kitchen area that is very slightly cooler (~1°C) than the surrounding wall (see Figure 14). It looks as though this may be caused by missing insulation in the studwork partition. As this partition wall is within the dwellings thermal envelope, it does not constitute a heat loss area.

**Figure 14 hot spot around the communal main from the boiler and cooler rectangular section observed on the partition wall.**

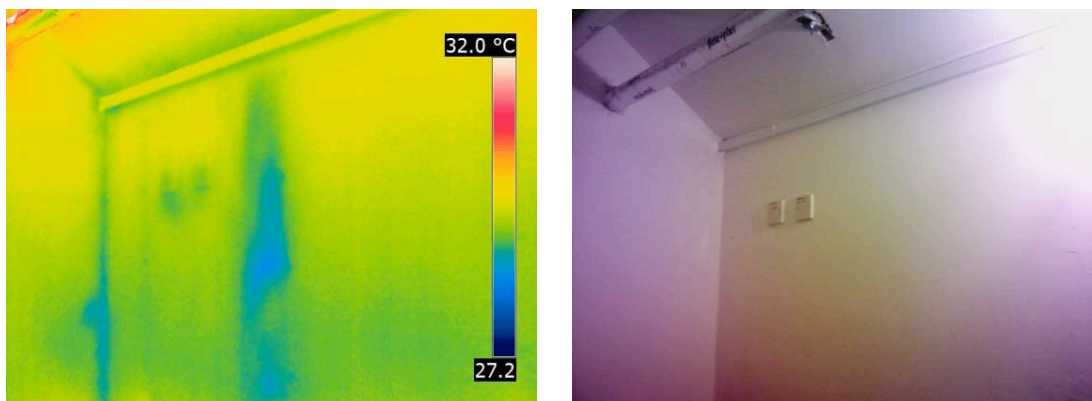
- In dwelling 2, a very slightly cooler area (~1°C cooler) is also visible on the North facing knee wall (see Figure 15). It is not known what is causing this cooler area. It is not known what is causing this spot on the external wall using the non-destructive test methods available to the research team alone.

**Figure 15 Cooler section observed on the North facing knee wall.**

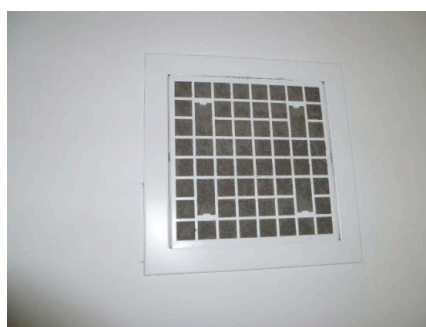
grilles revealed that one possible reason for the imbalance may be related to the condition of the kitchen extract grille and filter (see Figure ). A closer inspection of the kitchen area revealed that even though an integrated recirculation cooker hood with carbon filter had been installed in the kitchen above the cooker, it looked as though the previous occupants of the dwelling never used this hood. Instead, all of the grease from cooking was being extracted through the high level MVHR extract grille in the kitchen, rather than through the integrated cooker hood. The reason why the recirculating cooker hood was not used was thought to be due to the fact that it had been integrated into the kitchen cupboards, and the previous occupants were simply not aware that it was even there. The hood was of the same design as the cupboards, above the cooker, and was activated automatically when pulled out. As this was quite stiff to pull out and located high up, residents may have assumed it was simply a blank door and purely aesthetical. This has implications in terms of the occupant handover process, and stresses the importance of ensuring that not only are the occupants made aware of all of the services that provided within the dwelling, but that they are also shown and understand how to use them.

**Figure 31 Kitchen extract grille prior to cleaning**
