Mayville Community Centre (aka Mildmay Centre)

Innovate UK project number	450041
Project lead and author	Bere Architects
Report date	2015
InnovateUK Evaluator	Tom Kordel (Contact via www.bpe-specialists.org.uk)

Building sector	Location	Form of contract	Opened
Community Centre	London	JCT SBC/Q05	2011

Purpose of evaluation

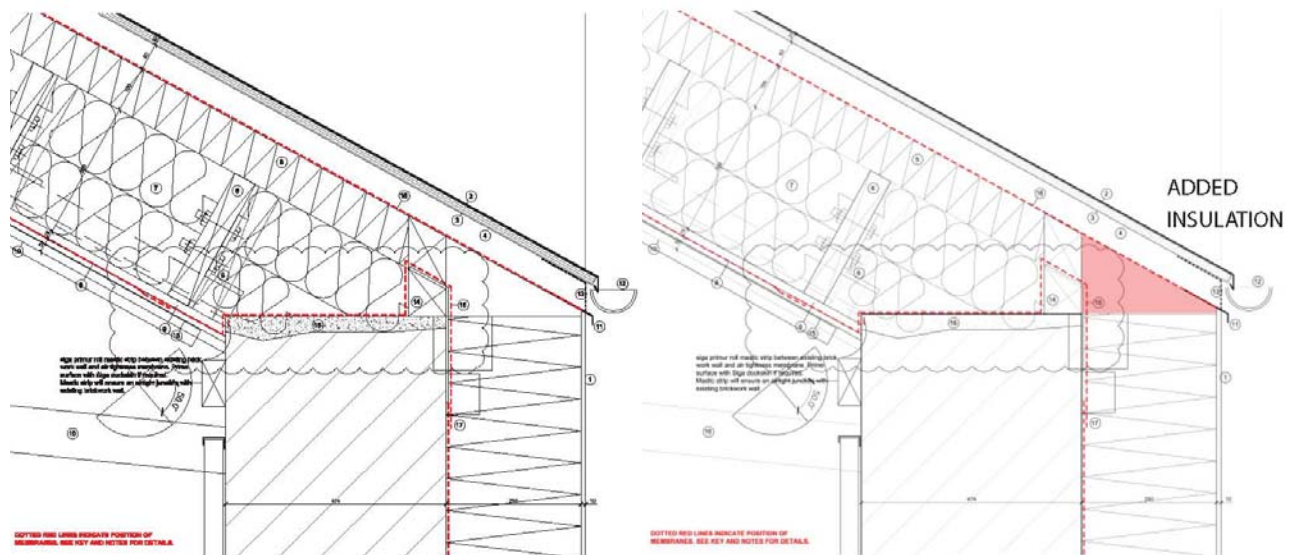
After completion of the roof construction it was noticed that thermal bridging might occur in one of the eaves of the existing building roof (detail below) where the junction between the wall and the roof insulation was left uninsulated due to an error in a drawing. This problem was rectified by using sprayed expanding foam to fill the gap in the north elevation eaves line, in the void found between the top of the EPS insulation boards and the plywood substrate to the zinc roof.

Figure 2-9 Heat 2 analysis of roof eaves

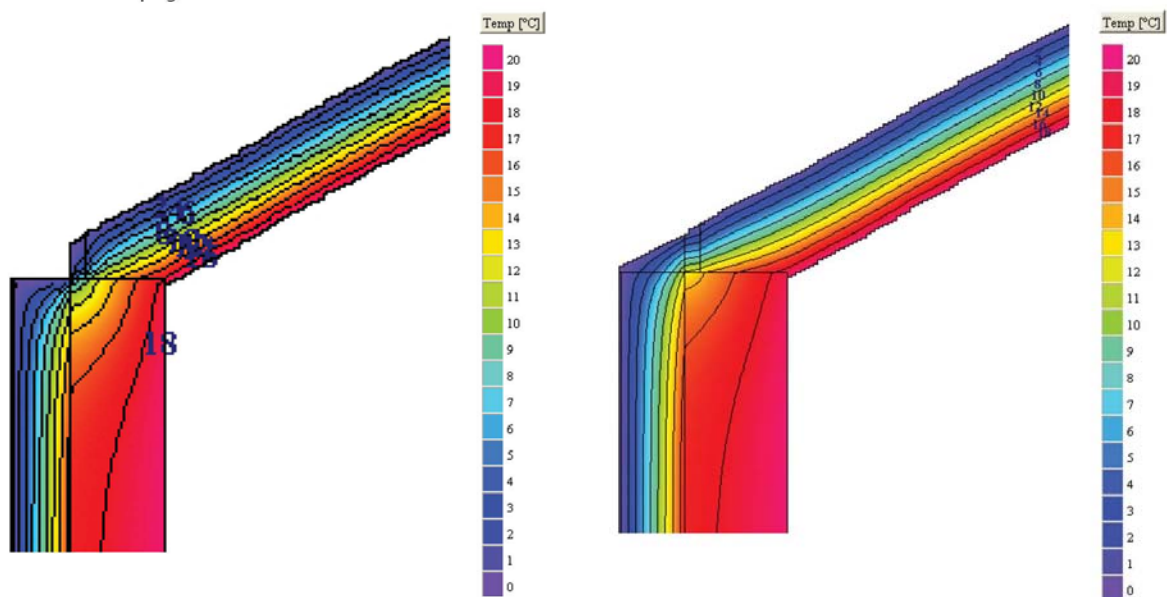
The heat 2 analysis of the 'before' and 'after' solutions show the heat flow through that detail without insulation, and then with added insulation creating a continuous thermal envelope (the 'tea-cosy effect') which is one of the key features of Passive House design.

Figure 2-10 Heat 2 comparison of heat flows through insulated and insulated edge detail of roof eaves

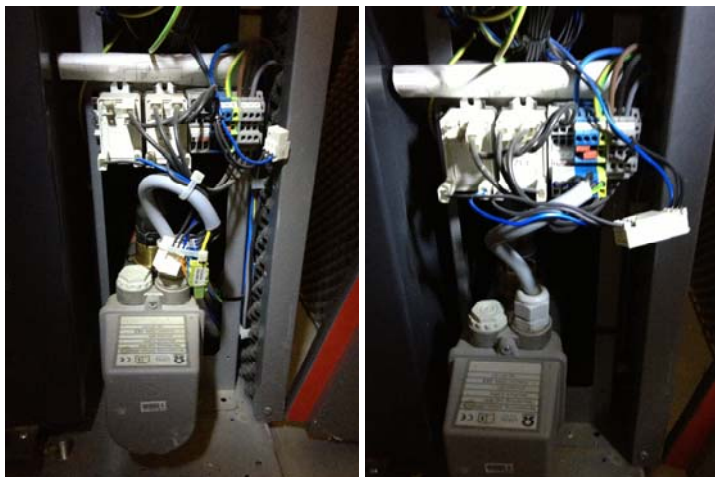
Since the direct electric heater had not been connected to power inside the GSHP, the space heating and DHW had been, until May 2013, provided solely by the compressor of the GSHP without any contribution from the immersion heater.

Figure 3-12 The GSHP direct heater as found in May 2013 (left), and after it was connected (right)

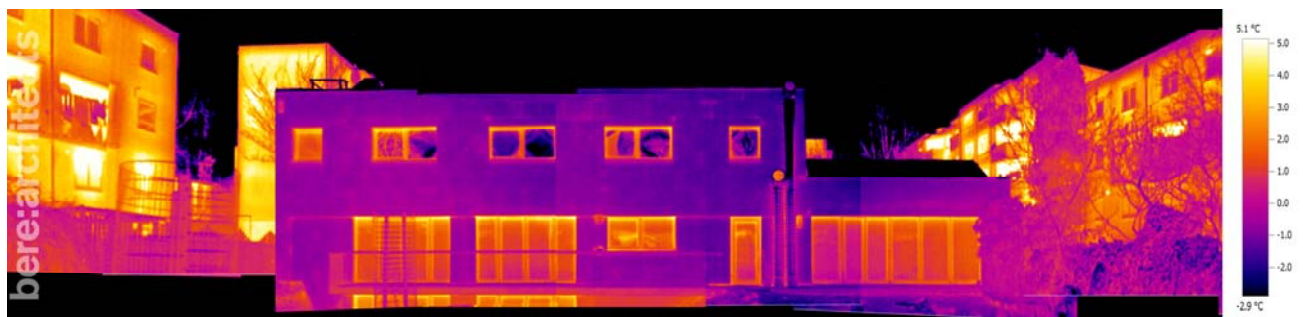
The report showed that the building fabric overall performs well, with minimal heat losses through the building. The thermal image of the South elevation below is even more striking due to the contrast between the well-insulated Centre, and the near-by estate leaking heat through uninsulated thin walls and poor PVC frame double glazing. (The research team have carried out a short analysis comparing the indoor conditions in the centre and in some of the near-by flats, described later in chapter 6 Energy use and environmental conditions).

Figure 5-1 Mildmay Centre – thermographic image of the south elevation and near-by estate with high heat losses (note: windows reflecting heat from uninsulated building behind camera)

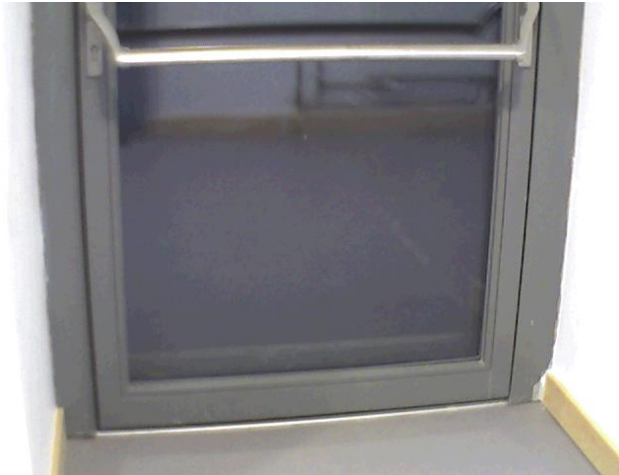
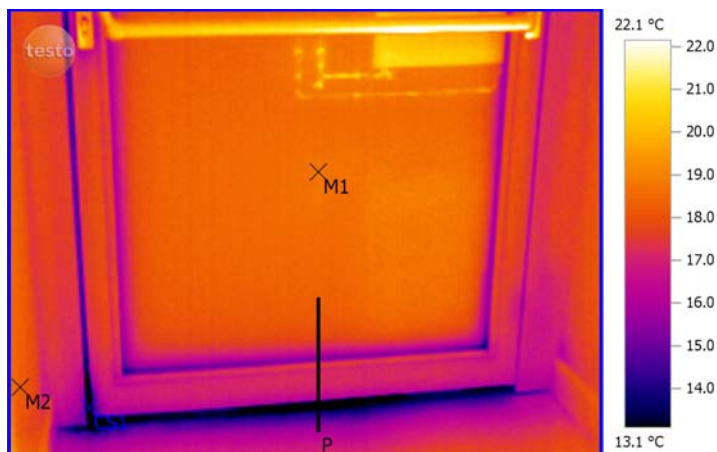
The report highlighted some installation flaws of the external doors, which were leaking heat. This was due to poor handling, forcing, or poorly adjusted hinges.

Figure 5-2 Fire escape door –thermographic image

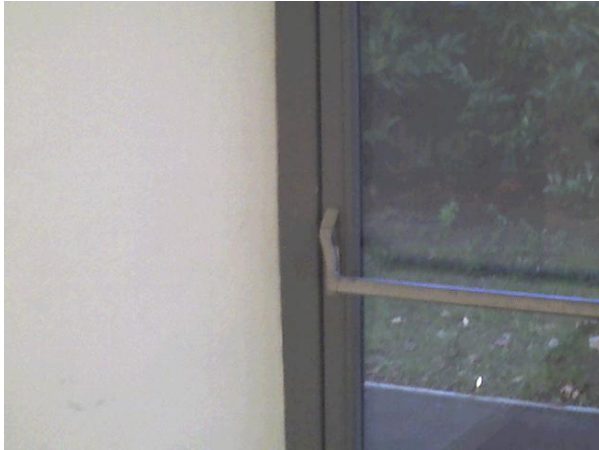
The installation of the fire escape door located in the main hall still needs to be repaired (as shown in the images below). The frame was distorted by the site carpenters who installed the windows.

Figure 5-3 Fire escape door- thermographic image

Section P shows that the temperature on the frame and the wall drops below the dew point temperature (usually around 10-12°C, it varies according to internal conditions), and therefore can pose risks of condensation where the heat from inside meets the cold surfaces.

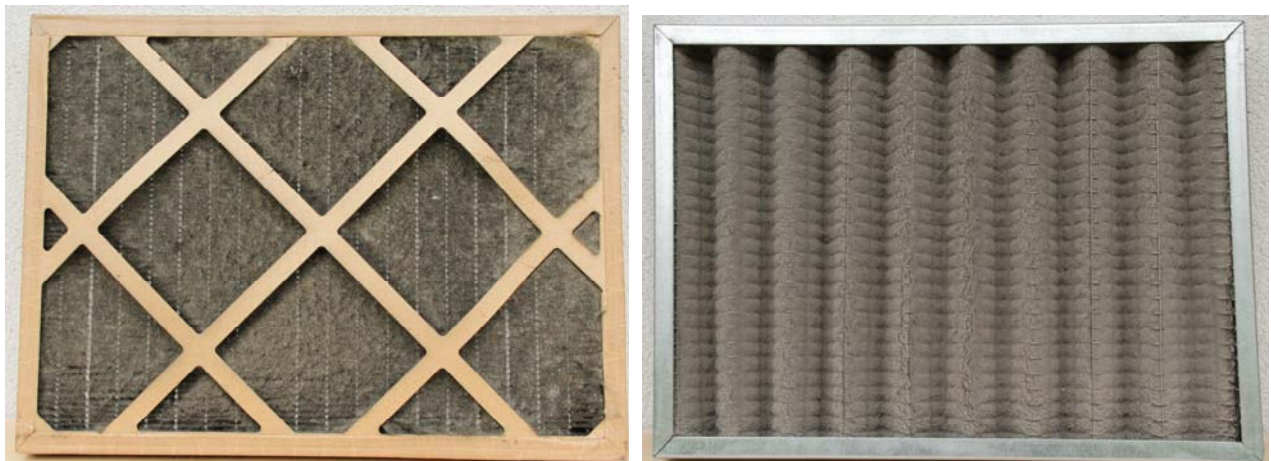
The second filter change was done by the Centre manager in April 2014. As the manufacturers and suppliers of constant pressure ventilation units point out, extremely dirty filters increase the energy used by the fans in order to deliver the same air flow (and maintain the air quality), however if this persists for a long time this can cause damage to the fans and the unit itself. Since for the public this is still quite new technology, as part of their soft landings approach the design team regularly reminds the clients, tenants and managers of all their low energy buildings of the need to change the filters in the ventilation unit. The team noted that after 2 years of monitoring the occupants seem to become familiar with the need to change filters periodically.

Figure 5-8 Dirty filters

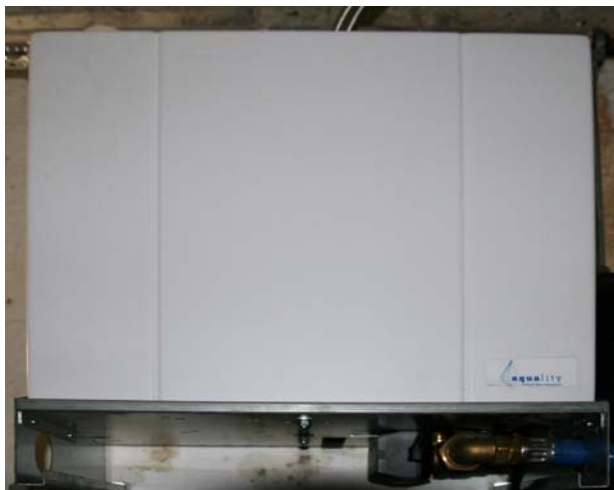
The system does not help an un-trained user to easily establish whether the pump is supplying rainwater or mains water to the toilets. A pump failure resulted in the system being switched to mains and the system as designed relies on maintenance checks to ensure it is operating correctly. A simple alarm on the system, or a red flashing light, would be a good refinement of the design of this reclaimed water system. More information about the operation and maintenance of the system is given in Chapter 3; Details of aftercare, operation, maintenance & management.

Figure 5-9 Aqualite rainwater harvesting pump
