Murray Place

This document contains a Building Performance Evaluation report from the £8 million Building Performance Evaluation research programme funded by the Department of Business Innovation and Skills between 2010 and 2015. The report was originally published by InnovateUK and made available for public use via the building data exchange website hosted by InnovateUK until 2019. This website is now hosting the BPE reports as a research archive. Although no support or further information on the reports is available from the host, further information may be available from the original InnovateUK project evaluator using the link below¹.

InnovateUK project number	450104
Project author	Hanover Housing Association
Report date	2014
¹InnovateUK Evaluator	N/A

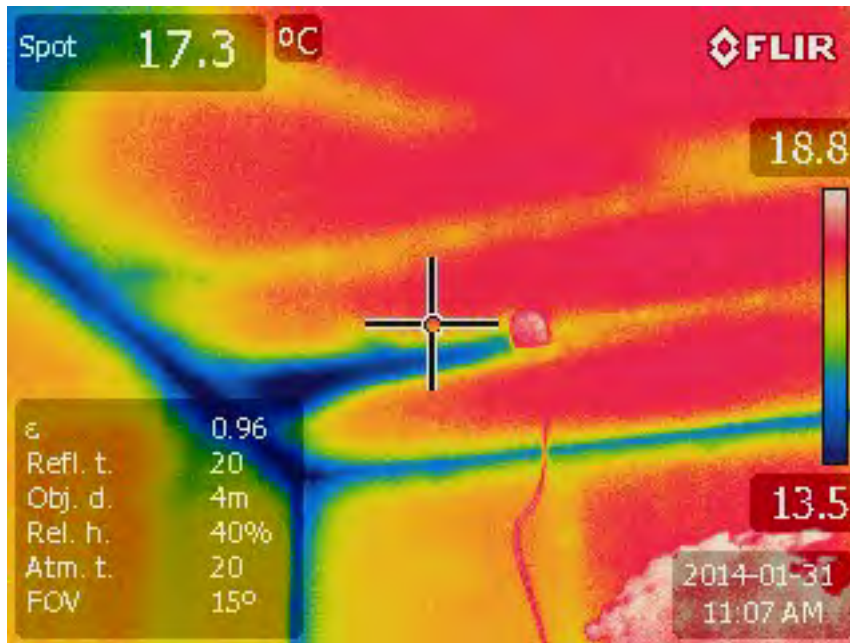
With respect to the roof construction the performance is obviously poor in relative terms. The quality of data derived from the tests and the validity of the analysis process suggest that the result is correct within the range of accepted errors. This level of variation therefore identifies a construction issue, which demanded further investigation.

Figure 24: The image shows the flux plate and temperature sensor located at a cold element of the roof construction

Examination of the thermographic survey images identified a significant cold spot in the ceiling construction terminating at the flux plate location. It is presumed that this issue is caused by missing or ill-fitting perimeter insulation and it is clear that this will have impacted on the data recorded for the roof construction. The U-value derived is, therefore, not representative of the majority of the roof construction (the warmer areas to the right of the image and generally away from the perimeter) but it is very useful in quantifying the effect and impact on performance of the construction issues identified by the thermographic survey. What this identifies is that whilst the straightforward construction (for example as seen in the details) may be performing to a reasonable level, there are many areas where junctions and other construction elements – in this case the trusses - are resulting in some thermal bridging.

There is clearly a case for undertaking U-value testing prior to full occupancy. This would ensure that there were no restrictions on the placement of sensors, internal conditions can be controlled, and effects on decoration and finishes are reduced. It would also allow any defects identified, in this case the insulation, to be addressed prior to occupancy.

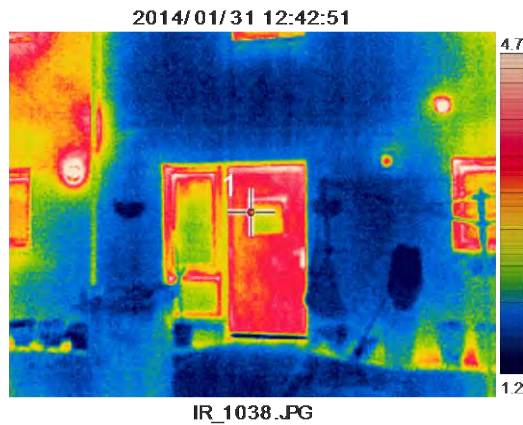
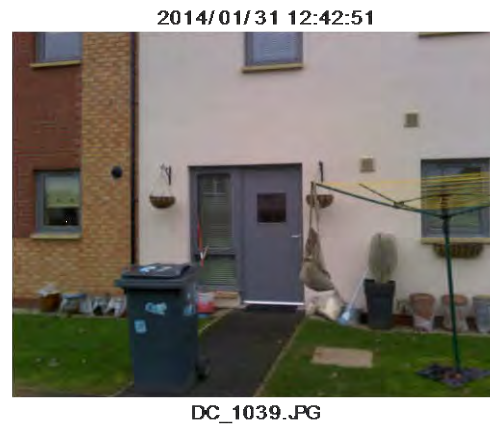
Outwith the confines of the courtyard development a significant wind was prevalent at the time of testing which may have created limitations in identifying instances of external heat loss. The general fabric construction generally appears to be of good quality with few obvious defects affecting thermal integrity. There was no evidence of slumping of the cellulose insulation, which had been a concern; however further testing over time is required to verify this. It is clear that openings are a clear source of thermal weakness, and thermal weakness at door and window frames were noted in all of the properties.

MEASUREMENTS		°C
Spot 1		3.0

Figure 25: Rear elevation of BA1.

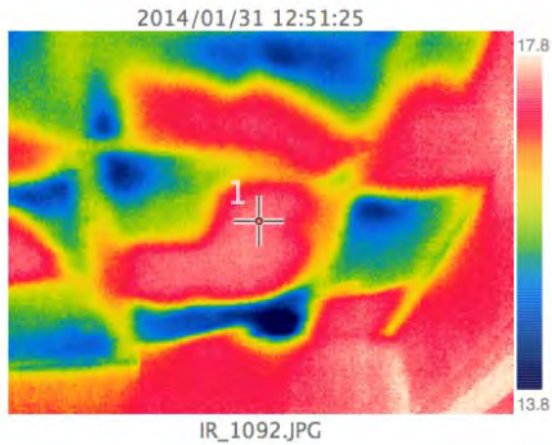
MEASUREMENTS		°C
Spot 1		17.5

Figure 27: Missing insulation at ceiling.

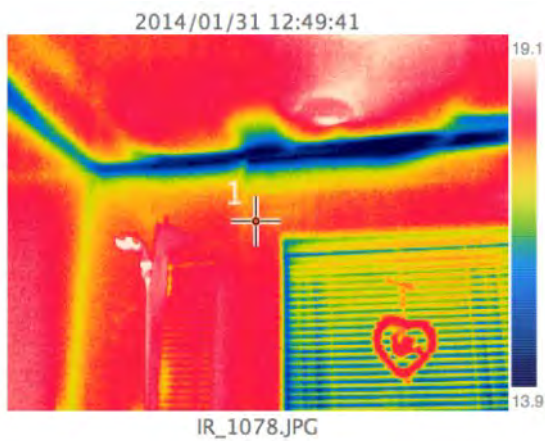
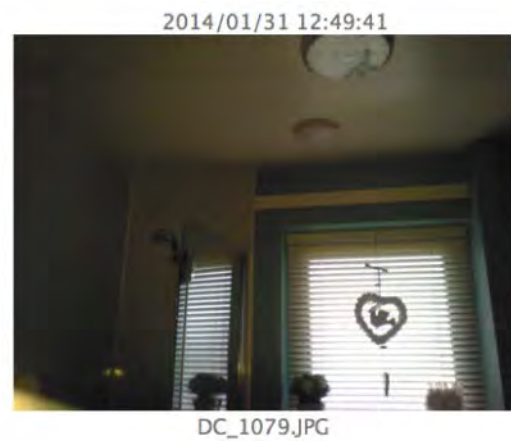
MEASUREMENTS		°C
Spot 1		17.8

Figure 28: Missing insulation at eaves.

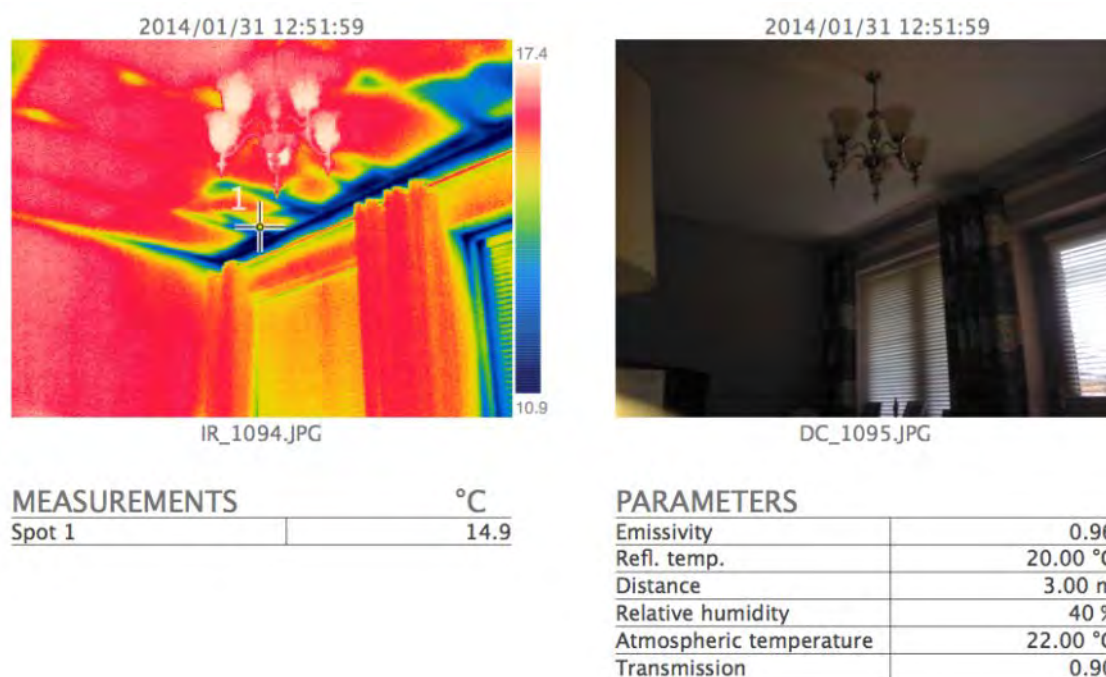
Insulation at wall head/ eaves conditions and around perimeters generally was found to be problematic due to the practical difficulty of installing insulation over the wallplate. This was found to be an issue in all three test houses and prompted a review of an industry wide 'standard' detail.

Figure 29: Missing insulation at eaves.

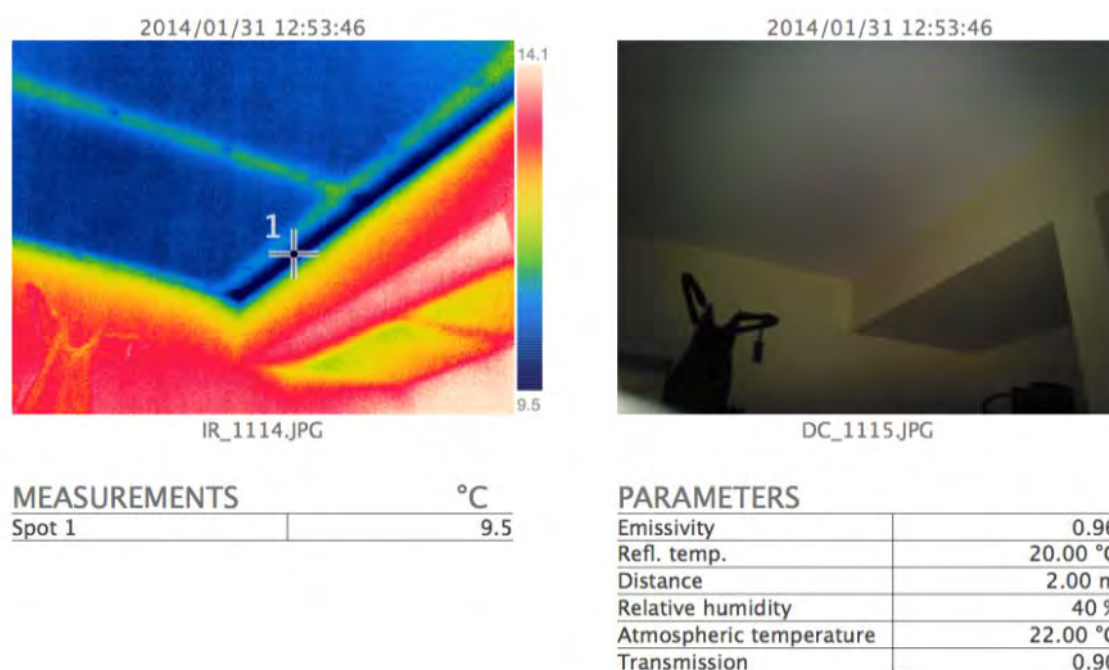
A specific issue was observed in the ceiling of the dressing room at BA1. In this case it would appear that insulation had been omitted. The very shallow pitch of the roof here is such that insulation cannot easily be installed from within the roofspace and would need to be placed during construction prior to the installation of linings.

Figure 30: Missing insulation in BA1 dressing room.

The ceilings in all the dressing rooms were inspected by the contractor and their report found that insulation had been omitted in BB1, this was the only one that was defective. As a result

of this survey, remedial work was undertaken to fit insulation in the ceiling of the affected room.

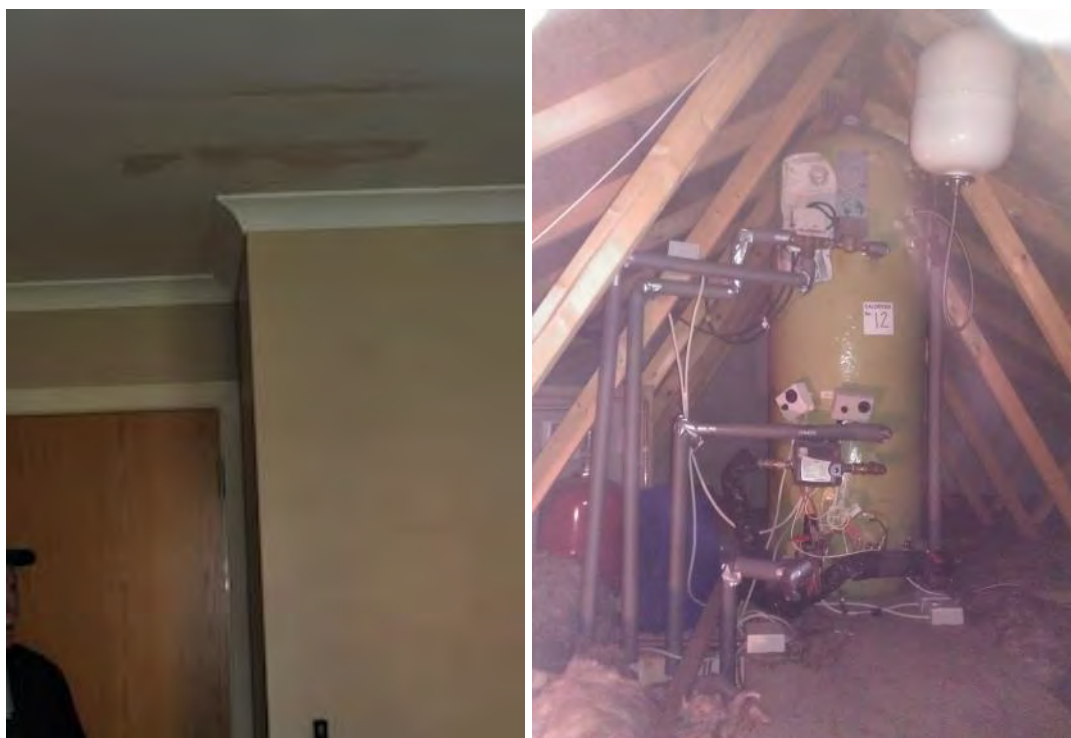
During the course of the works, it became apparent that there was uncertainty as to the exact responsibilities of the Mark Group and the contractor’s electrician in relation to the interface between the electrical installation and the solar water system. These were resolved but a legacy of this included finding during the monitoring that the cylinder thermostat in BC1 had not been properly connected, resulting in the solar water system not functioning. This was resolved early in the project and the resident was delighted to find that they were subsequently receiving “free” hot water rather than, as previously, using the system boiler. However there was a subsequent leak from this cylinder and the positioning of it meant that this resulted in damage to the ceiling. It was found during the repair of this that a container cannot be placed under the unit, which hampered drain down and led to further damage. Problems were also identified in BA1 at the start of the BPE project where polystyrene debris was blocking the pump.

Figure 50: Left: Water damage due to a leak from the Solar Thermal system. Right: Cylinder located in the loft
