This document contains a Building Performance Evaluation report from the £8 million Building Performance Evaluation research programme funded by the Department of Business Innovation and Skills between 2010 and 2015. The report was originally published by InnovateUK and made available for public use via the building data exchange website hosted by InnovateUK until 2019. This website is now hosting the BPE reports as a research archive. Although no support or further information on the reports is available from the host, further information may be available from the original InnovateUK project evaluator using the link below¹.

InnovateUK project number	450088
Project author	ECD Architects for Fife HARCA
Report date	2014
¹InnovateUK Evaluator	N/A

Building sector	Location	Type	Constructed
Commercial	Lochgelly, Fife	Tenanted offices	2011
Floor area	Storeys	EPC / DEC	BREEAM rating
1450 m ² (GIA)	Four	N/A	N/A

The Ore Valley Business Centre Lochgelly Business Centre (also known as Lochgelly Business Centre) was designed as an energy efficient building which would be economical to run, as the commercial rent to tenants was to include all energy costs. The environmental design used the Te

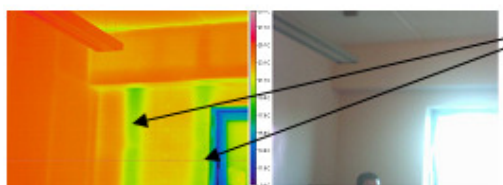
Relative temperatures and thermal pattern of external wall may highlight that cool air is able to cool the plasterboard lining of the external wall from inside the wall. This may be resulting in a thermal bypass negating to some extent the benefits of the wall insulation.

Cooler regions may be caused by thermal bridging of wall structure

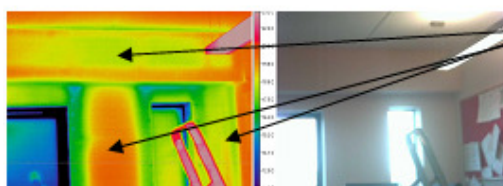
Cooler regions may be caused by thermal bridging of wall structure, accentuated by cool air flow on the warm side of the insulation

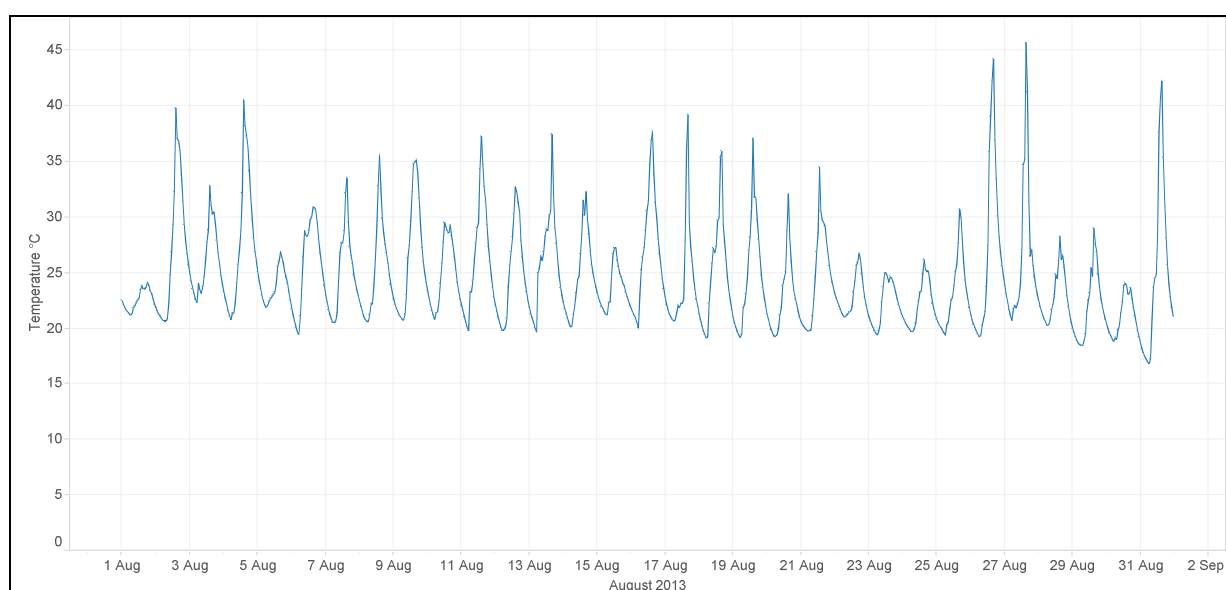
radiation throughout the day. A white shield was placed around the temperature sensor; however due to the extensive glazed areas there was difficulty in placing the sensor in a shaded position in the room, even with a shield. Air flow measurements by MEARU, using an automatic volume flow meter, revealed the extract fans are not providing their combined design extraction rate of 210 litres per second (maximum) which will have an effect on comfort temperatures. There were complaints by the owner regarding summer overheating in the room in 2013. The eastern glazing has some degree of internal shading by way of a projector screen, which is not effective as the heat gains have already entered the room. The conference room and the overheating issues are discussed in more detail in Chapter 9 of this report. Figures 6.2.3 and 6.2.4 detail conference room temperature profiles for August and December 2013. During August the conference room temperature rarely fell below 20°C through the month and daily peaks reached up to 45°C. As the recordings were clearly affected by solar radiation, December 2013 has been graphed to provide a comparison of summer and winter temperatures in the room. While there are distinguishable daily peaks during the weekdays when the heating is operational, there were also temperature peaks as a result of solar radiation towards the end of the month, at a time when the building was unoccupied and heating system was switched off.

Figure 6.2.3: Recorded Temperature in Conference Room August 2013

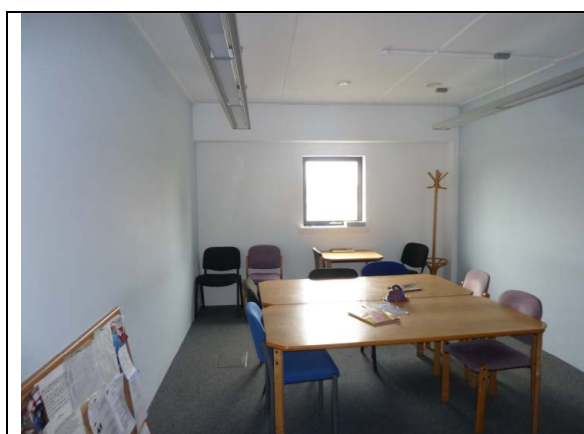
Mean values for CO₂ concentrations (Table 6.2.2) indicate all rooms are of acceptable air quality. However values greater than 1000ppm have been recorded in all rooms at some stage during the monitoring period. The two most frequent rooms with high CO₂ concentrations are the conference room and room 3 on the ground floor. The conference room exceeds 1000ppm for 18% of the monitoring period which correlates with the function of the room (more densely occupied) and the poor performance of the extract fans in the room. In room 3, the frequency of CO₂ concentrations over 1000ppm was 5% of the monitoring period. This correlates to the nature of the tenants business; the tenant does not use the incubator unit as a conventional office, where there are frequently a large number of occupants in the room seated around a large table (**Figure 6.2.5**). The ventilation system provides a fixed air supply to the rooms, based on an assumed occupancy. This unanticipated use of the room (with high occupant numbers) has an impact on the ability for pollutants to be diluted by the ventilation system. Random air flow measurements were taken at three supply diffusers in room 21, the design air flow rate from each diffuser was 21 litres per second (l/s). The three measurements taken were 13.1 l/s, 10.8 l/s and 13.2 l/s, suggesting the ventilation system may not have initially been commissioned properly. Thus, the air flow delivered into room 3 may not be the design flow rate.

Figure 6.2.5: Internal view of room 3.

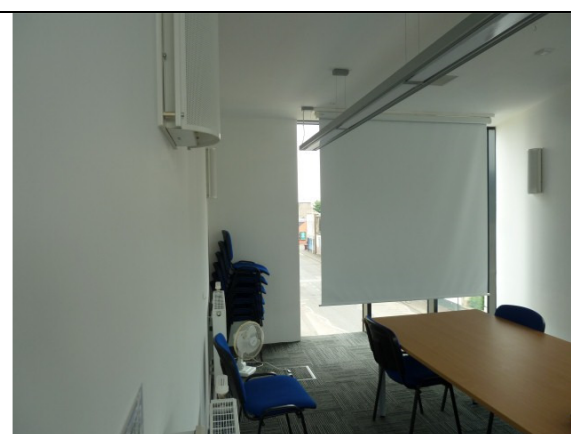
Figure 6.2.6: Internal view of conference room, showing pull down projector screen often used for solar shading.

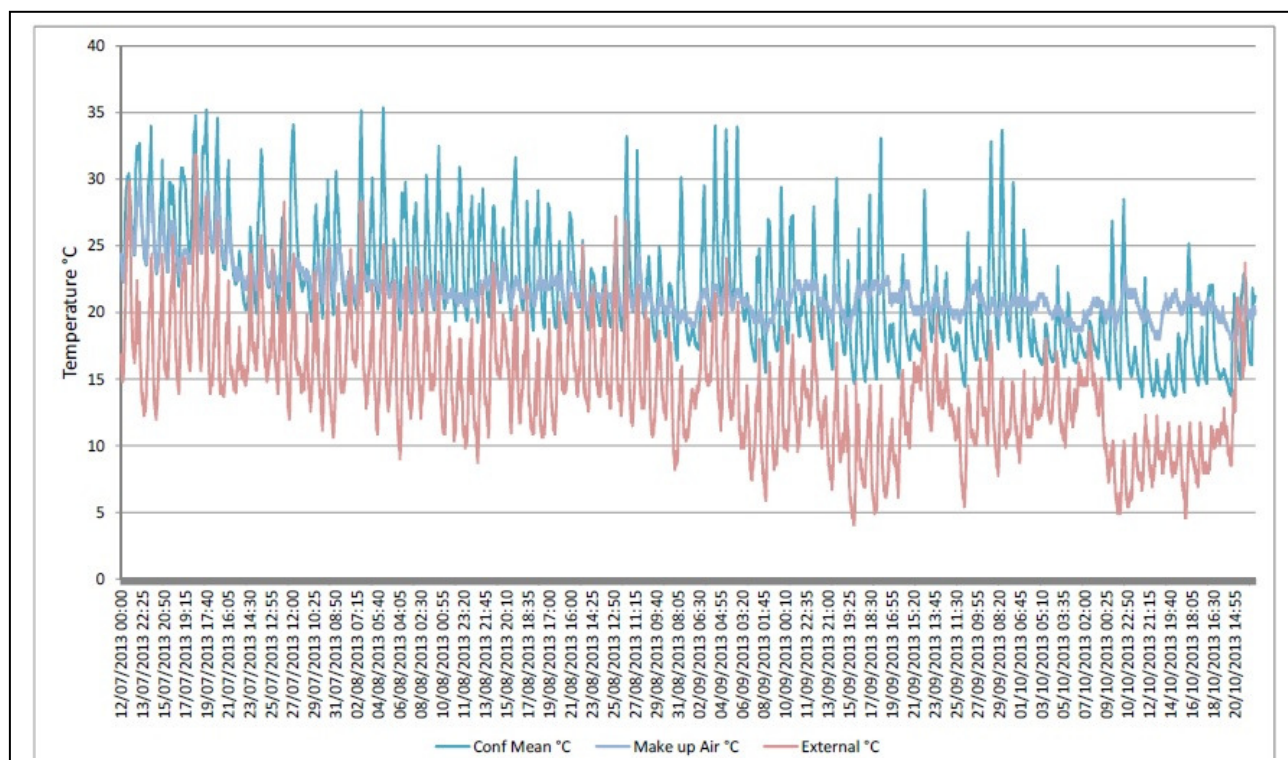
Figure 9: Graph indicating conference room temperature against adjacent hall and external temperatures.

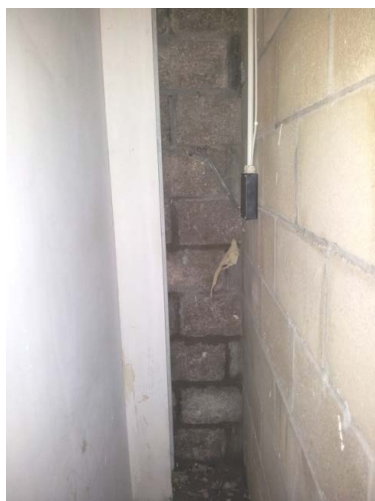
Photo 1 services void behind staircase enclosure and lift

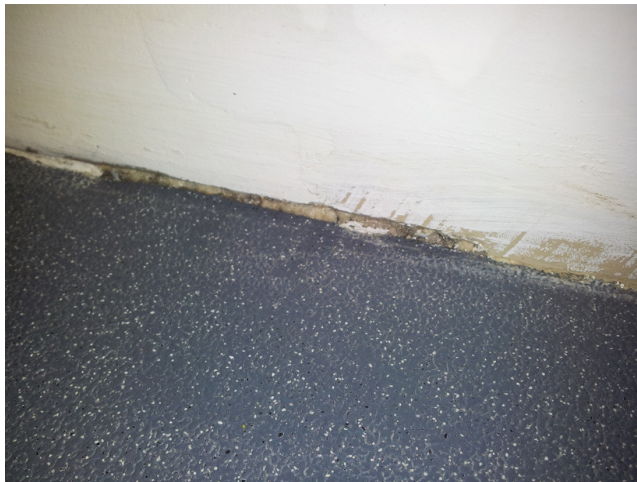
Photograph 3 Staircase and rear corridor wall junction

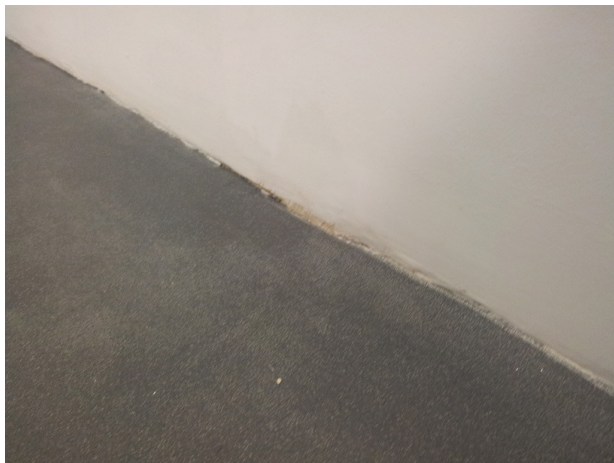
Photograph 4 rear entrance corridor. Image indicates area of floor where ponding occurred.
