Plummerswood House

This document contains a Building Performance Evaluation report from the £8 million Building Performance Evaluation research programme funded by the Department of Business Innovation and Skills between 2010 and 2015. The report was originally published by InnovateUK and made available for public use via the building data exchange website hosted by InnovateUK until 2019. This website is now hosting the BPE reports as a research archive. Although no support or further information on the reports is available from the host, further information may be available from the original InnovateUK project evaluator using the link below¹.

| Project author | Gaia Research |
| Report date | 2015 |

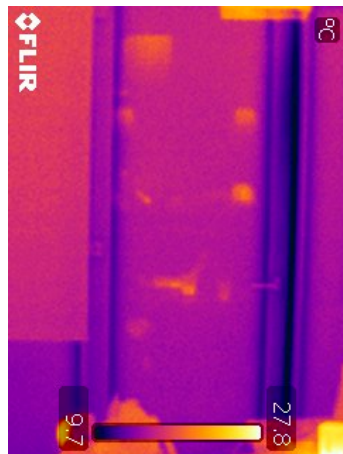
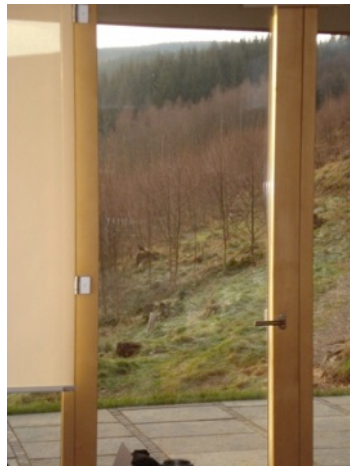
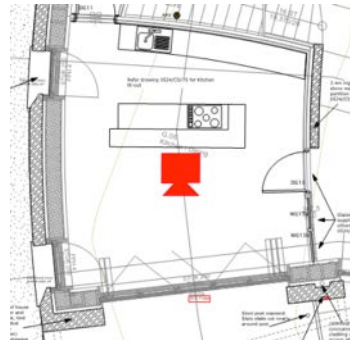
Air Leakage: No evidence
Thermal Bridge: Minor at window frame as expected
Missing Insulation: No evidence

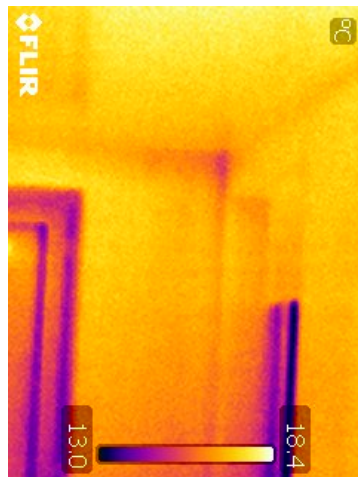
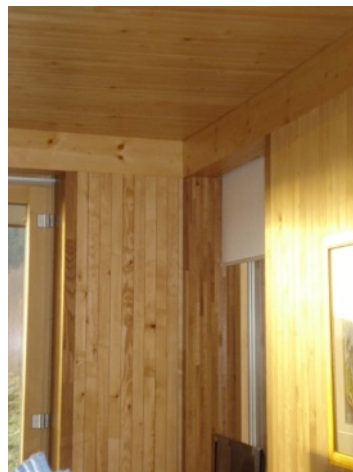
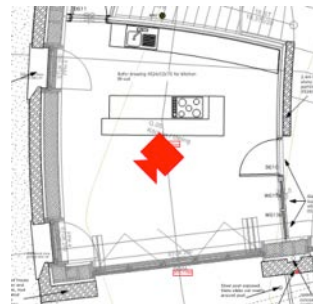
Dining Room South West Corner

Air Leakage: No evidence
Thermal Bridge: Minor at window frame as expected
Missing Insulation: No evidence

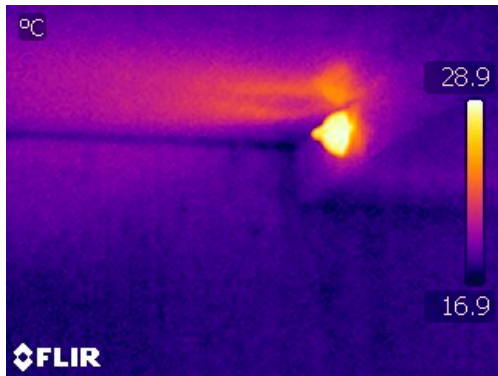
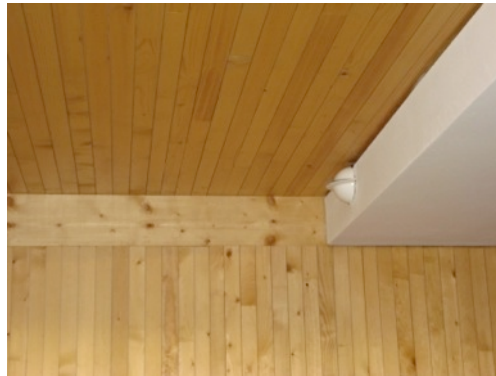
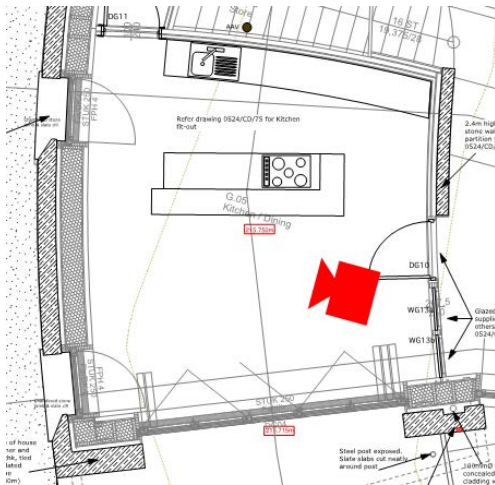
Kitchen Bulkhead

Heat from supply air diffuser as a part of MVHR and air plume on ceiling identifiable.

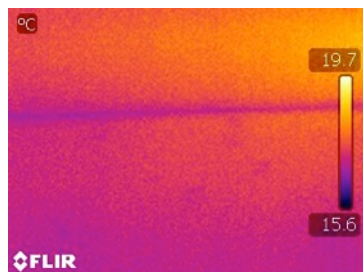
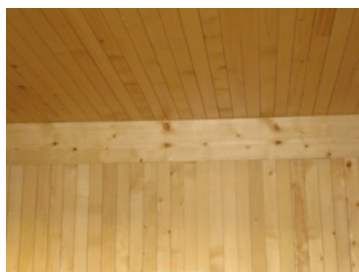
Kitchen Wall/Ceiling Junction

Air plume on ceiling identifiable from supply air diffuser as a part of MVHR.

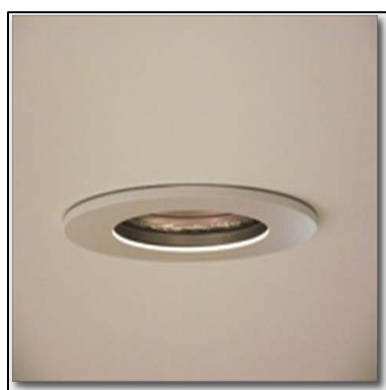
Picture 24: Leakage between spotlight fittings and adjacent plasterboard ceiling

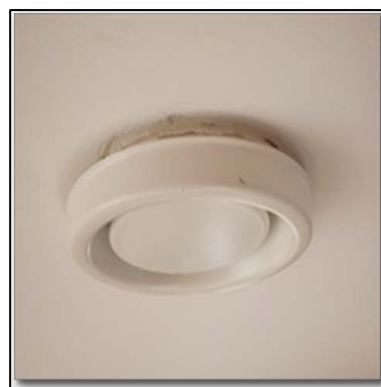
Picture 25: Leakage between ventilation terminals & adjacent plaster board ceilings and walls

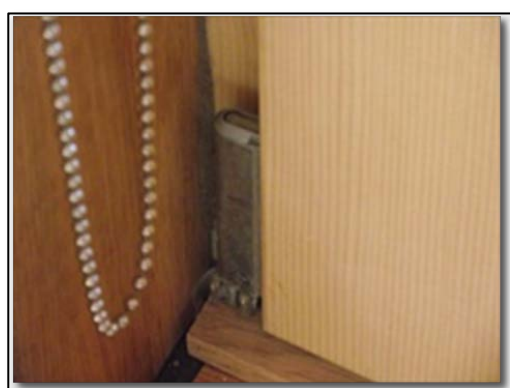
Picture 26: Leakage at side of window cill in upstairs bedroom

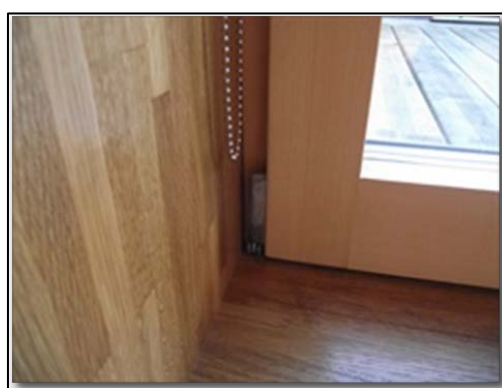
Picture 27: Substantial low level leakage at hinge side of balcony doors in two bedrooms, Doors DF.02 & DF.03

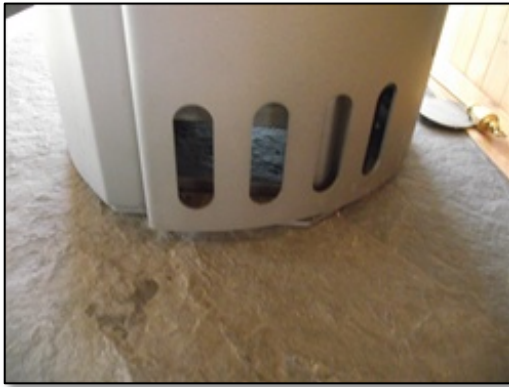
Picture 28: Substantial leakage through base of wood-burning stove in living room

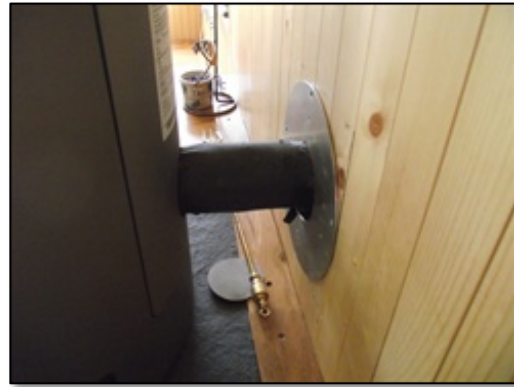
Picture 29: Leakage around external air supply to rear of wood-burning stove in living room

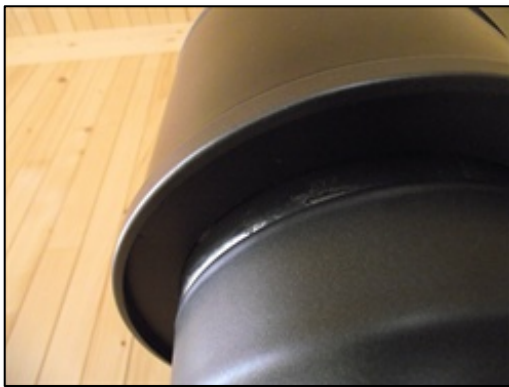
Picture 30: Leakage fire cement ineffective at junction between wood-burning stove & chimney

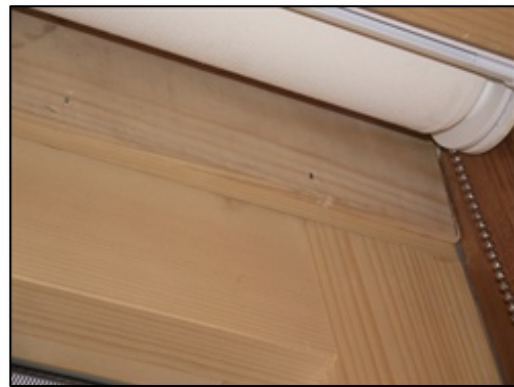
Picture 31: Leakage at window head along wall to jamb interface

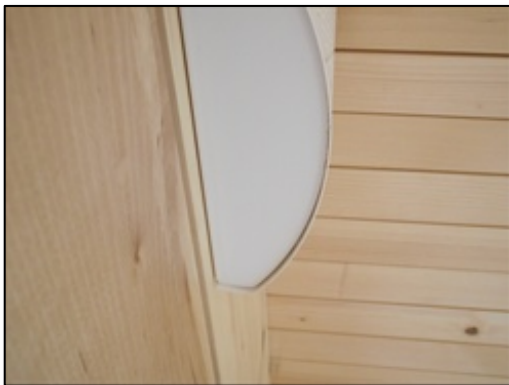
Picture 32: Leakage along back edge of ventilation terminal

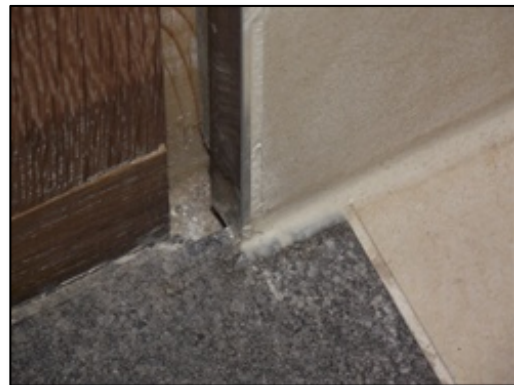
Picture 33: Leakage at edge of tiling in downstairs bathroom. Some leakage at side of the window

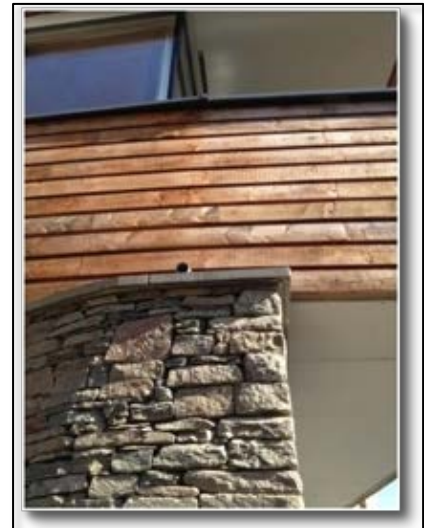
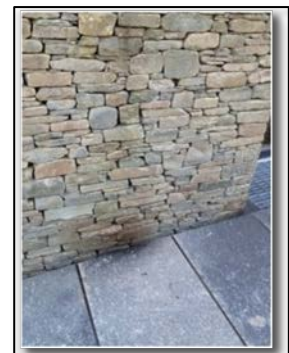
Balcony Fall to Drain

There was evidence of staining resulting from the overflow from the balcony discharging down the stone wall, onto the paving below. The occupants also had good reason to be disappointed with the appearance of the overflow, which was a late addition to deal with water pooling on one of the balconies. Remedial work was undertaken to provide a more attractive finish combining a rain chain and slate sculpture.
