Innovate UK project number	450043 A
Project lead and author	AHR (formerly Aedas Architects)
Report date	2013
InnovateUK Evaluator	Roderic Bunn (Contact via www.bpe-specialists.org.uk)

Building sector	Location	Form of contract	Opened
Offices	Pool, Cornwall	Design and build	2010
Floor area (GIA)	Storeys	EPC / DEC	BREEAM rating
3747 m ² (3785 m ² on DEC)	3	A (23) / N/A	Excellent

Pool Innovation Centre is a three-storey building in Cornwall, configured as two wings around a central atrium. The rentable floor space provides flexible workspace and business support for start-up and innovation businesses. The performance evaluation covered the building's fabric performance, energy consumption, and occupant satisfaction.

Tremough Innovation Centre

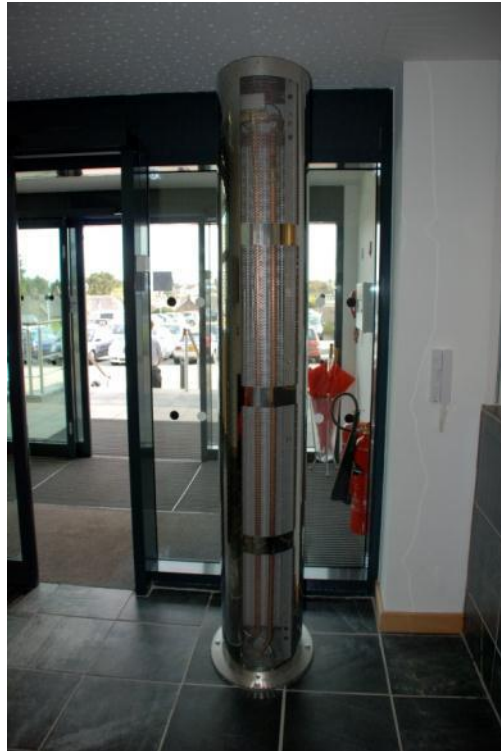
The atrium has two horizontal air curtains, one alongside the internal sliding door of each air lobby. However these are not in use, since they are very noisy in operation and are immediately adjacent to the reception desk.

Figure 10 Unused air curtain

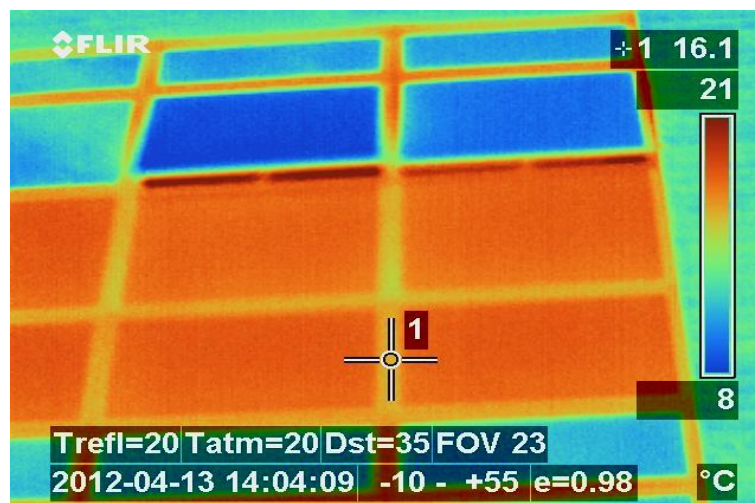
The results of the thermal imaging tests showed that there were no major discontinuities in the building fabric. The openings were where most of the heat loss occurred in wintertime.

Figure 11 Thermal image from PIC showing heat loss via open windows

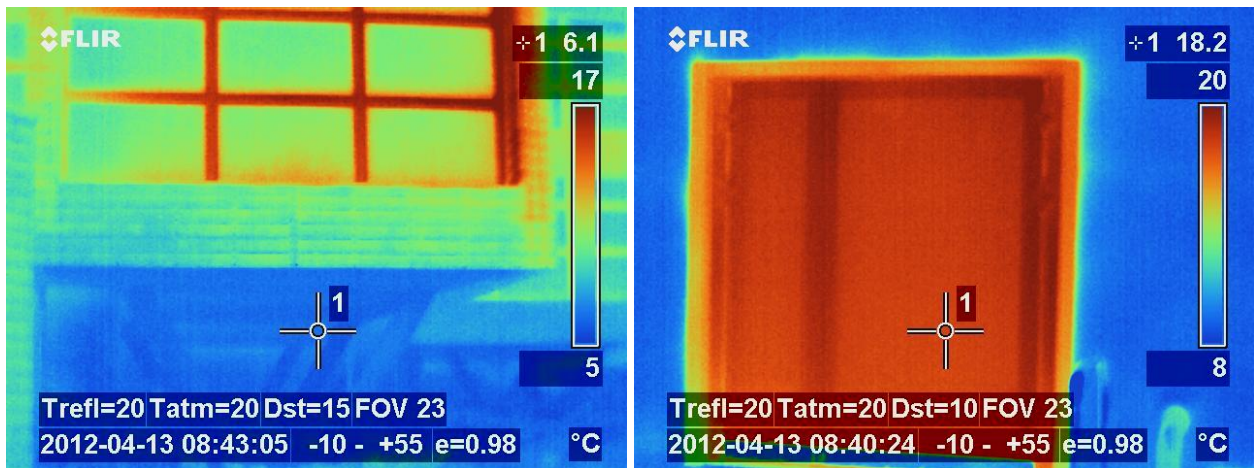
The results of the thermal imaging tests showed that there were no major discontinuities in the building fabric. The openings were where most of the heat loss occurred – in particular at Pool the windows were perceived open during the winter period.

Figure 17 Thermal images of TIC

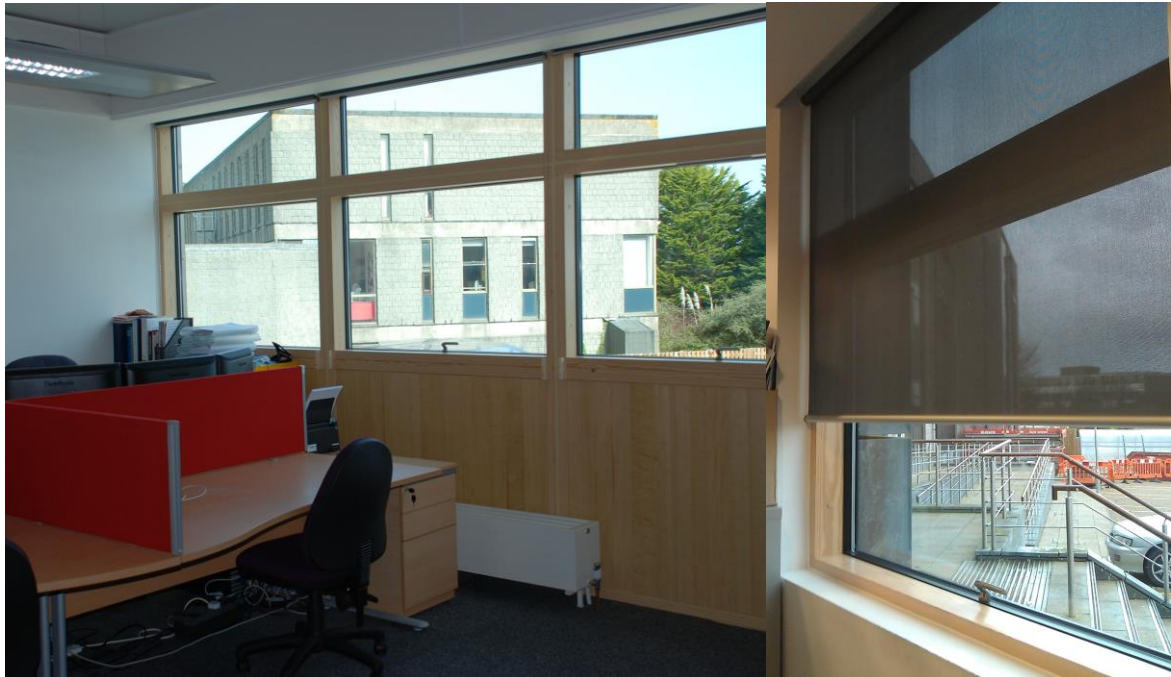
office has an exposed ceiling for thermal mass. Tenants are able to override the Windowmaster settings via local switches. The Windowmaster system has its own BMS, installed on a different computer from the rest of the building's BMS. Windowmaster have remote access to this.

Figure 21 window controls at IC and brise soleil

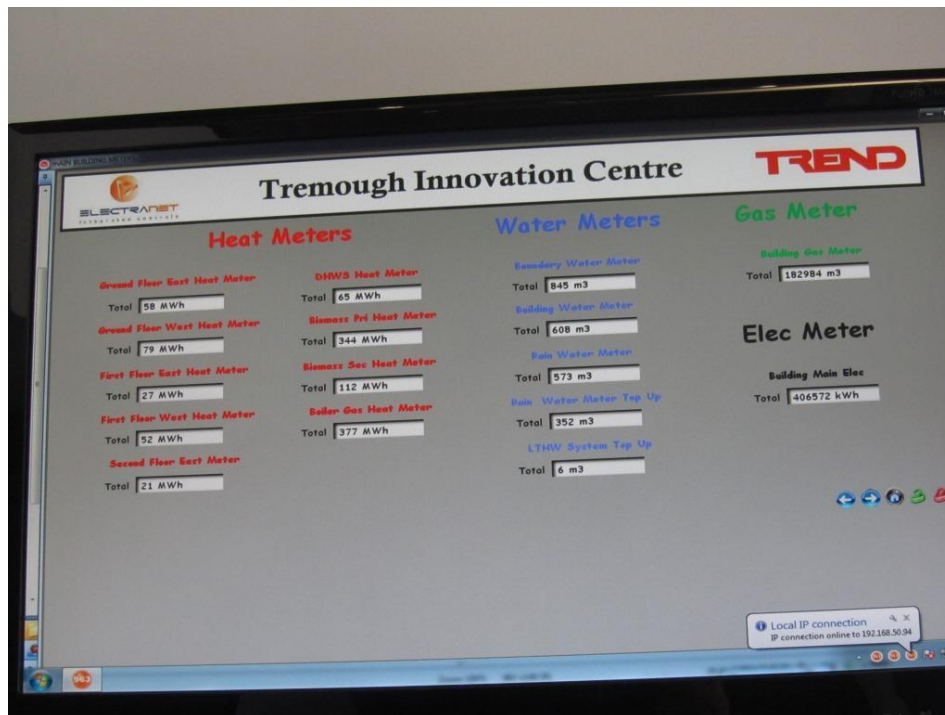
Another problem observed in both buildings was that the contribution of **biomass boilers to heating was much lower than design intent.** There was also a significant mismatch between the heat meters installed for the primary and secondary low temperature hot water loops at TIC that points to waste of energy in plant room. The problem of lower than expected contribution of Low or Zero Carbon technologies where conventional back-up technologies have been installed is endemic in the industry and the research team have come across it in other buildings as well. The new CIBSE publication AM15, Biomass Heating, points to the shortcomings of the existing control strategies used in the industry that can lead to significant underperformance of biomass boilers. This publication also provides a set of 'preferred' hydronic arrangements in contrast to the 'typical' arrangements used in the industry that could be deployed to achieve the expected performance from biomass boilers and more widely other LZC technologies that interact with back-up systems.¹ This shows that the underlying **root causes of performance gap can go well beyond the remit of individual projects and project teams,** and a review of the existing industry guidelines that have not been updated to accommodate the modern complex building services arrangements is required.

Figure 6.6: Snapshot of primary and secondary heat meter readings from the BMS

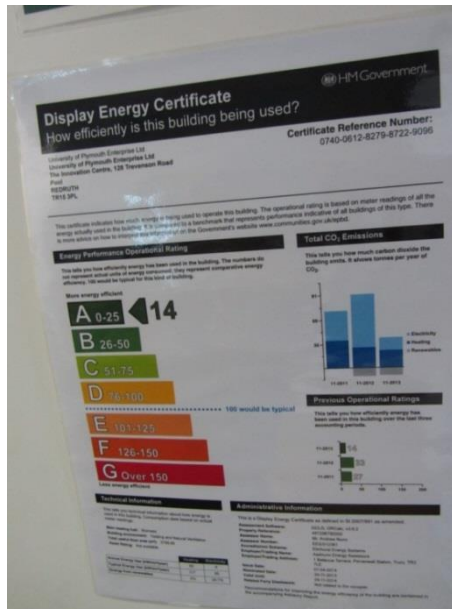
Figure 6.7: The DEC lodged for PIC is A rated; this is based on 8 kWh/m² per year electricity use billed by the electricity supplier using their meter. Actual electricity supplied, measured by the BPE team, using a clip-on meter and its readings reconciled with bottom-up TM22 analysis was 67.5 kWh/m² per year,.

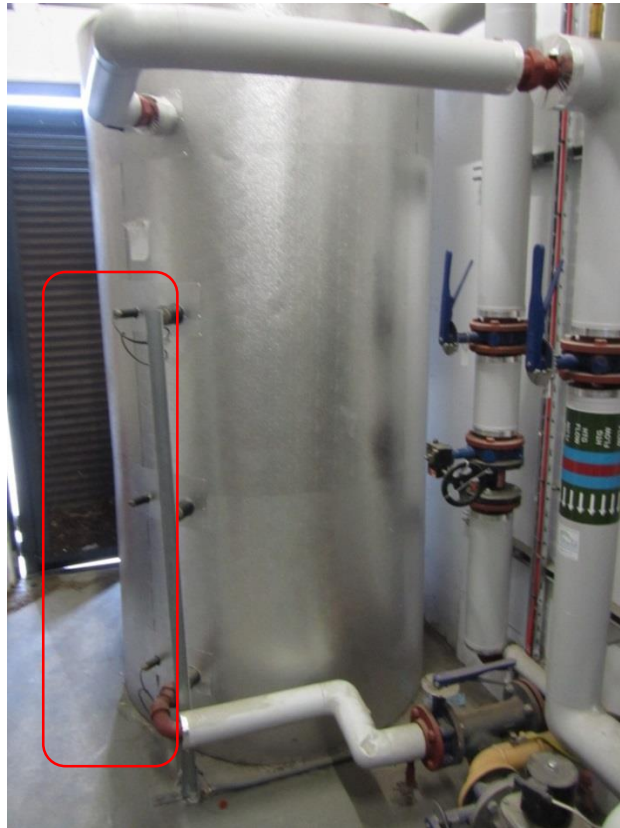
Figure 6.16: Shortcomings in biomass buffer vessel insulation can lead to high standing loss
