This document contains a Building Performance Evaluation report from the £8 million Building Performance Evaluation research programme funded by the Department of Business Innovation and Skills between 2010 and 2015. The report was originally published by InnovateUK and made available for public use via the building data exchange website hosted by InnovateUK until 2019. This website is now hosting the BPE reports as a research archive. Although no support or further information on the reports is available from the host, further information may be available from the original InnovateUK project evaluator using the link below¹.

| InnovateUK project number | 450073 |
| Project author | Glasgow School of Art, Mackintosh Environmental Architecture for Research Unit (MEARU) Architecture + Design Scotland |

| Eight | Milton of Leys, Inverness | Various (see p.13) | 2010 |

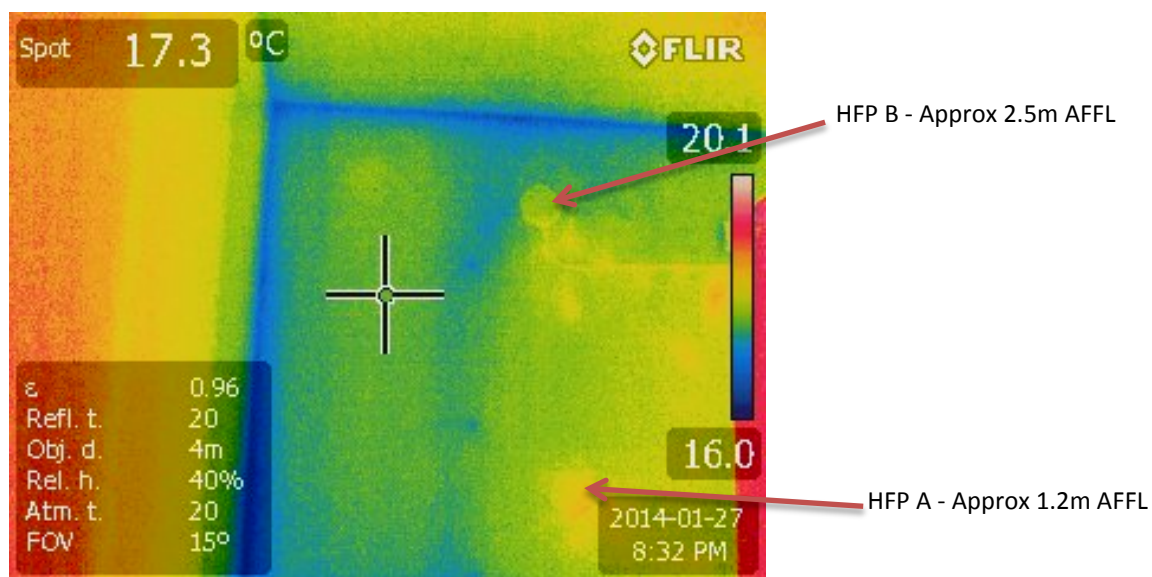
The thermography (Figure 3:6) indicated an area of wall at high level with a thermal bridge, which potentially identifies missing or ill-fitting insulation within the wall, HFP B was set up in the vicinity of the thermal bridge. HFP A was located in an area representative of the wall construction. The results indicate HFP A to have achieved a U-value 6% better than the design U-value and 53% better than the backstop value of $0.30\text{W/m}^2\text{K}$. In contrast, the test at the thermal bridge revealed a U-value 62% poorer than the design intent and 33% poorer than the Building Regulation backstop U-value. This highlights the effect missing or ill-fitting insulation can have on heat loss from a wall element.

Figure 3:6: Thermal image of wall under test, highlighting location of HFPs mounted at 1.2m and 2.5m above finished floor level (AFFL).

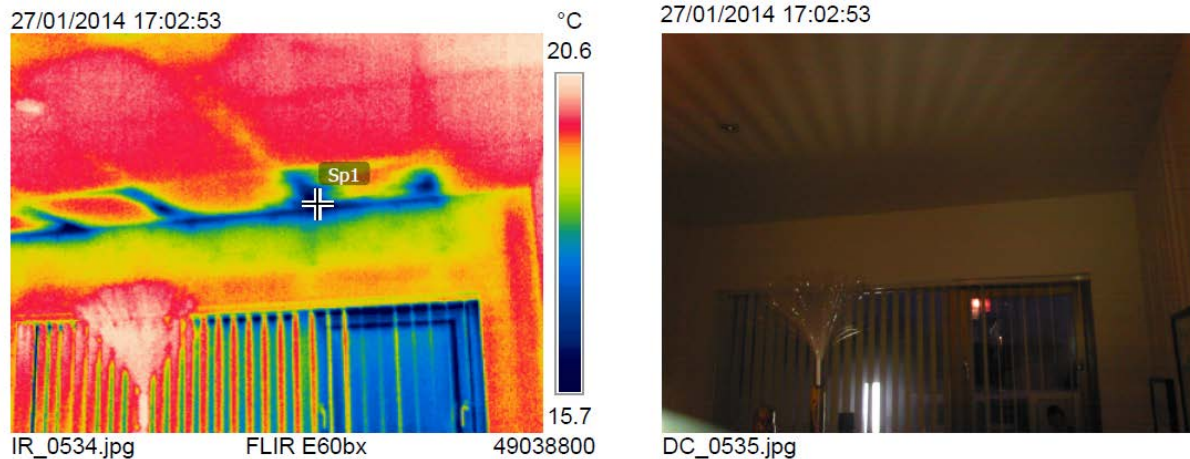
The survey of House Type A revealed several repeating thermal bridges due to poor sealing of joists ends (Figure 3:7). There were non-repeating thermal bridges at window frames, unsealed skirting boards, door seals and thresholds and penetrations in the building fabric for pipes and ducts. However, the most significant non-repeating thermal bridge was, in the first floor ceiling, where there were areas of ill-fitting or missing insulation, (Figure 3:8). Many of these thermal bridges could have been avoided with good on site workmanship.

Figure 3:7: Thermal image of wall under test, highlighting location of repeating thermal bridge in living room ceiling.

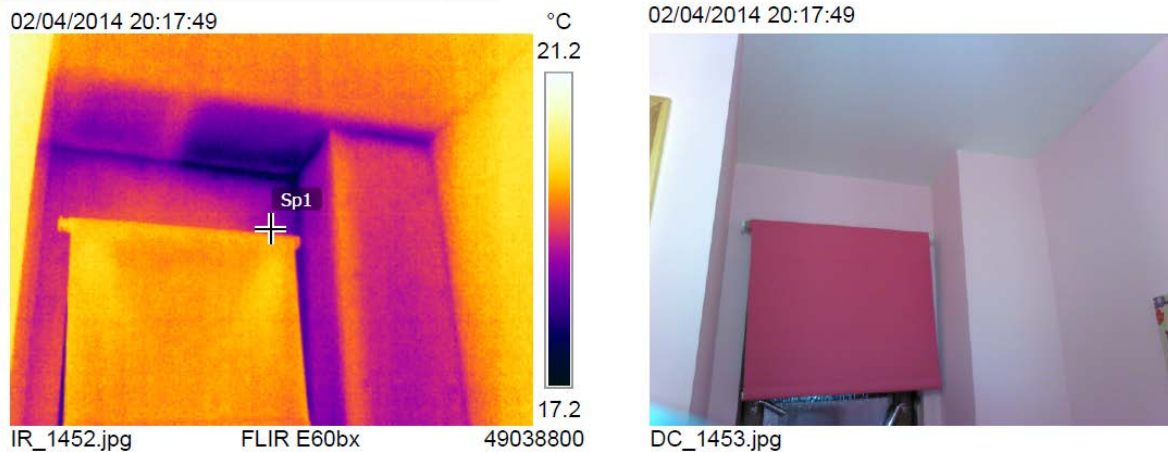
In House Type B there appeared to be ceiling insulation missing in the ground floor WC (Figure 3:9) and around all roof lights in the dwelling. Whilst it is common building practice to increase timber stud thickness to form structural openings, this practice causes thermal bridging and puts the building fabric at risk. There was evidence of increased heat loss around the front door seals and extensive thermal bridging at timber wall and roof studs. The architects' external wall drawings detail an external layer of insulation over the outside of studs in an effort to reduce repeating thermal bridging, however the specification on the same drawing makes no reference to this layer of insulation and notes a 10mm OSB layer instead. In the roof an attempt to limit thermal bridging has been made by specification of timber 'I joists', however the architects specification (and drawing) excludes an additional insulated layer over these joists to reduce thermal bridges (Figure 3:10) as noted for the walls.

Figure 3:9: Thermal image of wall under test, highlighting location of non-repeating thermal bridge in ground floor WC ceiling, missing insulation is suspected.

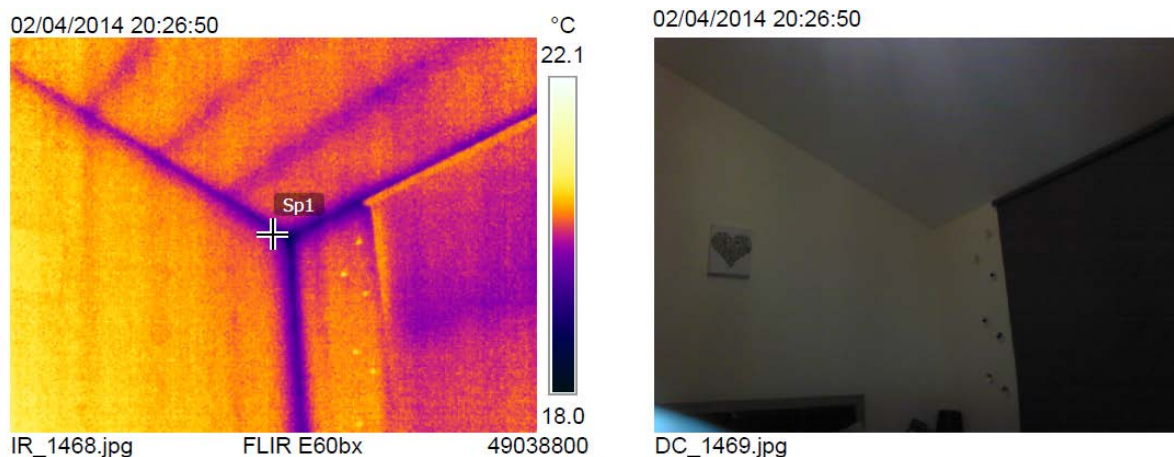
Figure 3:10: Thermal image of wall under test, highlighting location of repeating thermal bridge roof and to some extent walls. An additional layer of insulation over the studs and joists would have reduced this.

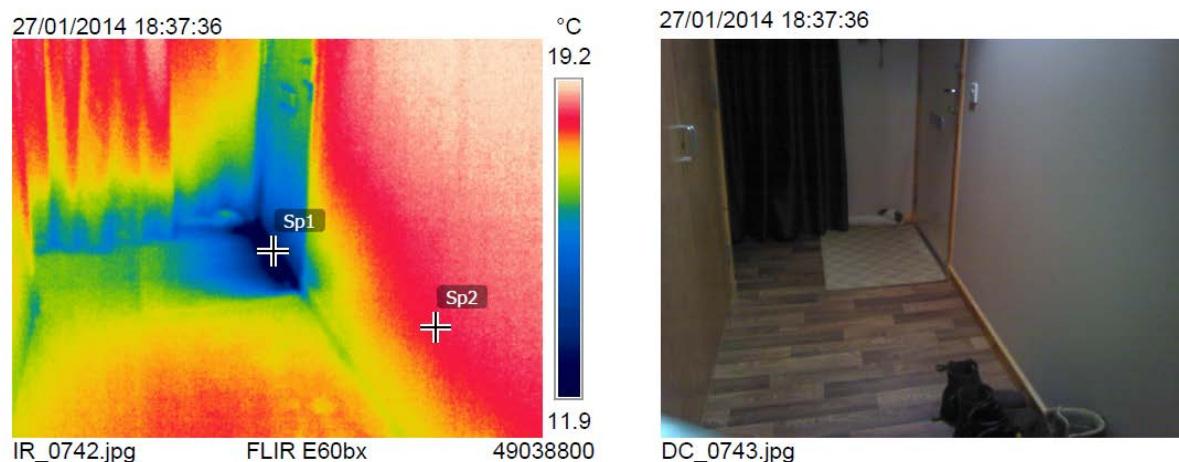
Figure 3:11: Thermal image of draught detected at main entrance door to the property.

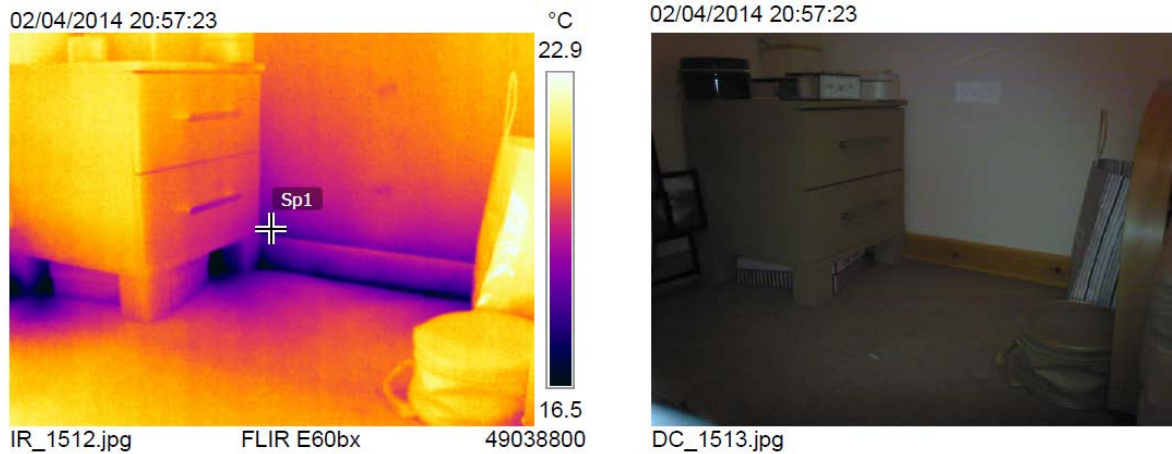
Figure 3:13: Thermal image of wall/floor junction. An area of non-repeating thermal bridge is detected above and below the skirting.

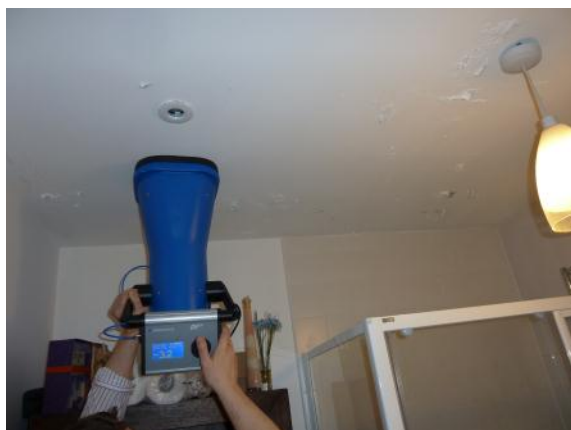
Figure 6:1: Volume flow measuring equipment (without extension hood attachment) in ground floor bathroom in A2. Note extent of peeling decorative paint.

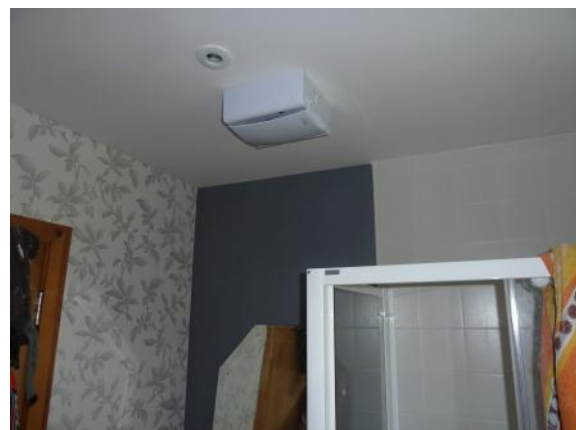
Figure 6:2: Replacement extract fan in ground floor shower room in dwelling A1.

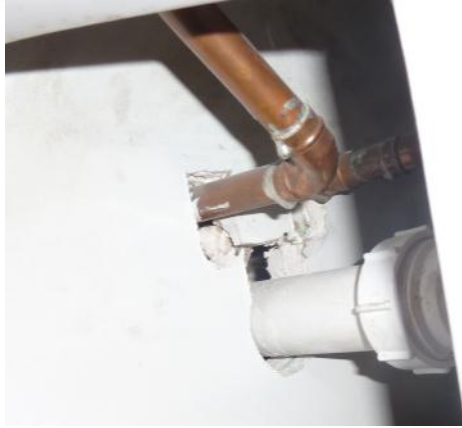
Figure 6:5: Uninsulated pipework serving bathroom wash basin. Note inadequate sealing around pipe penetrations and also excess solder flux on pipe elbows, indicating poor workmanship.

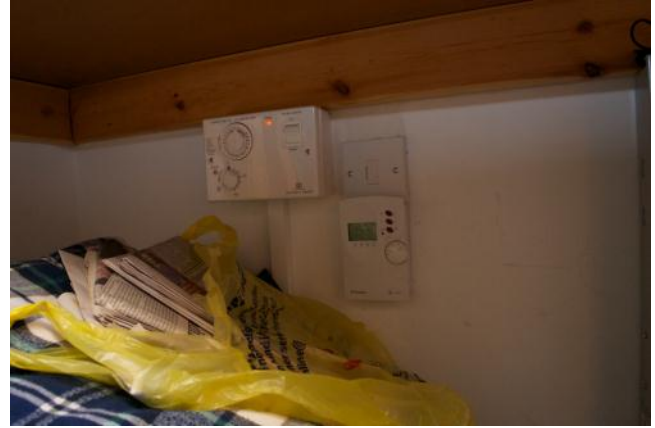
Figure 6:6: Heating programmer at rear of cupboard housing domestic hot water tank out of view (dwelling C1), note items stored on top of the domestic hot water tank restricting access to the control panel.

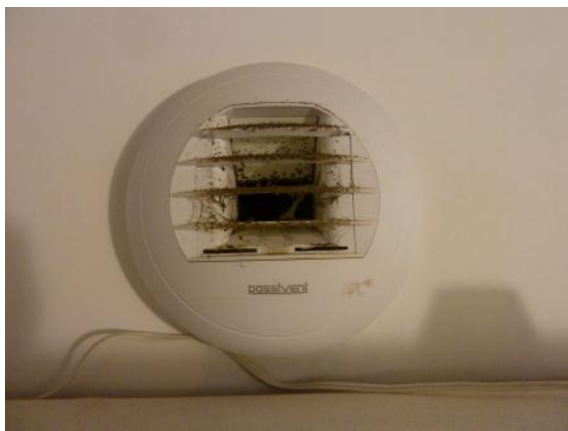
Figure 6:7: Soiled extract inlet grille in kitchen, dwelling C1.

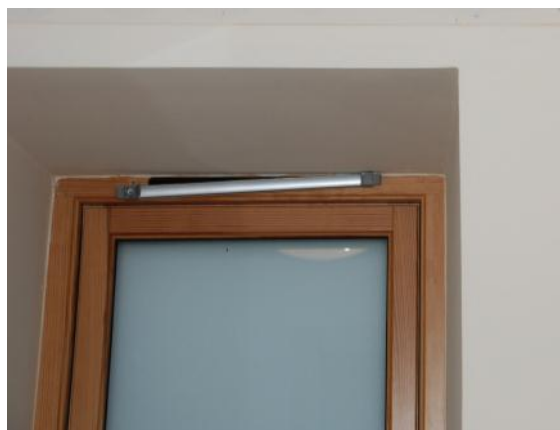
Figure 6:10: Broken trickle vent in bathroom, dwelling D2.

The occupants advised of their intention to read their owners handbook to establish if the run-on of the fan could be increased and to fit a replacement screw in the trickle vent.

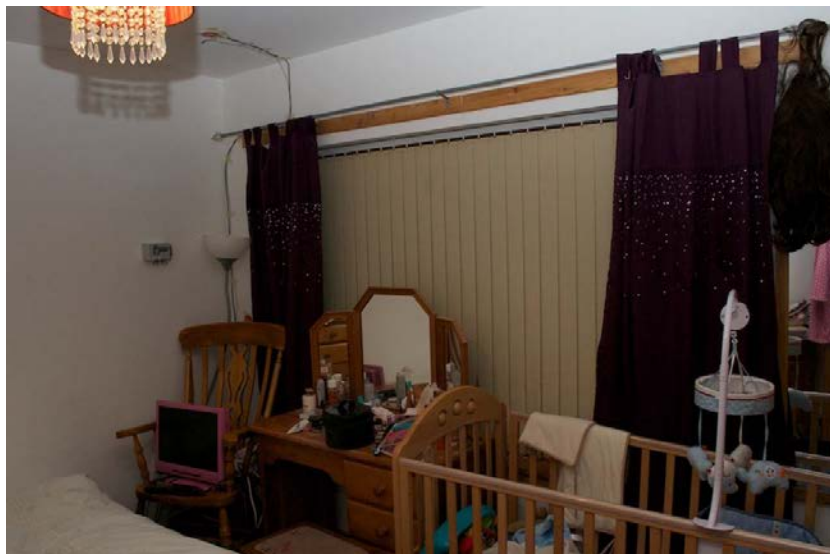
Figure 7:45: Dwelling A2 West Bedroom detailing obstacles to window opening. The operable section of the window is located on the right hand side, behind the cot.
