Seager Distillery Housing

Innovate UK project number	450102
Project author	AECOM for Galliard Homes
Report date	2014
¹InnovateUK Evaluator	N/A

No of dwellings 20 (3 detailed, 9 in less detail)	Location Deptford, London	Type Apartments	Constructed 2011
Apartment area Various: 35 - 74 m ²	Construction form Reinforced concrete	Space heating targets Various (see SAP analyses)	Certification level Building Regulations, 2006

Background to evaluation

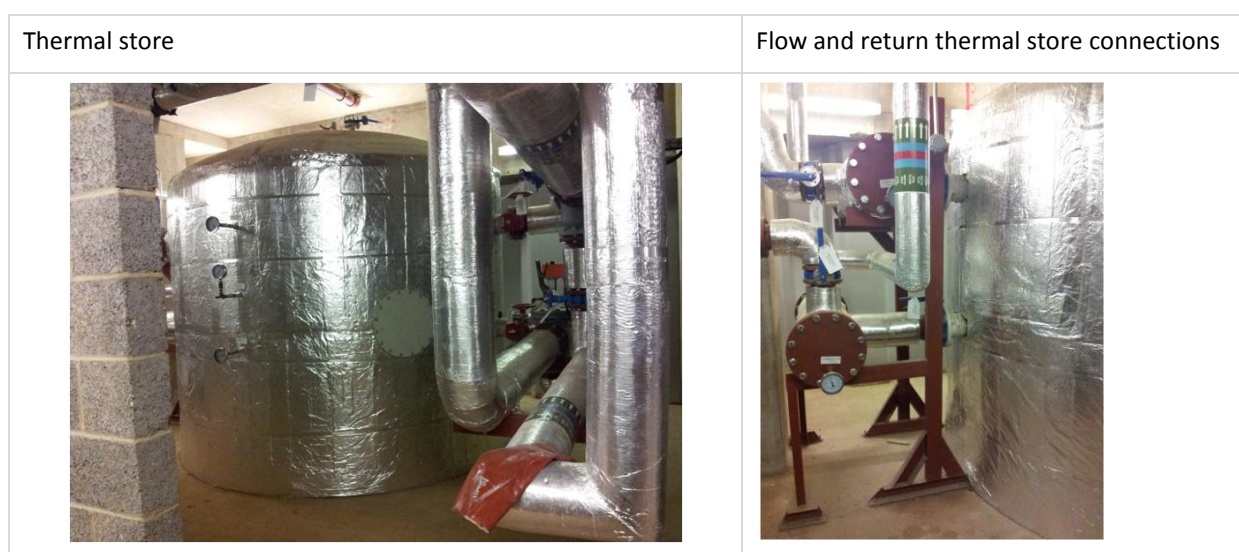
- As a rule of thumb, thermal stores should be tall and narrow (e.g. height is 3 times diameter) to promote stratification. Furthermore, flow and return should be at top and bottom of thermal store respectively. Based on AECOM's walk-around, it was noted that the thermal store appears to have a similar diameter to its height and the return pipe is located halfway up the height of the store resulting in half the thermal store capacity not being used. See Figure 2.1.

Figure 2.1: Photos of energy centre

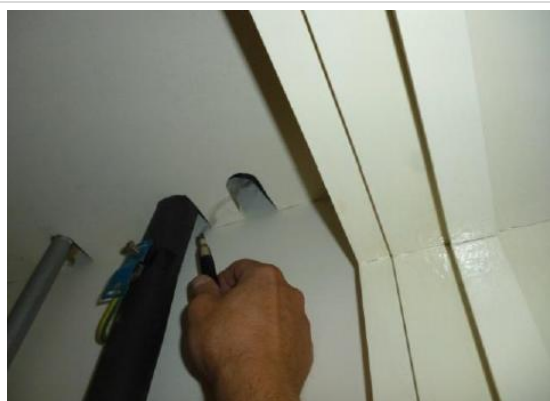
a) Penetration at water pipework in airing cupboard

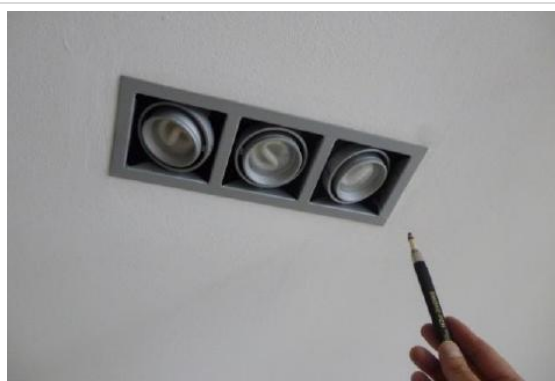
c) Air leakage around light fitting in Flat 2 living room

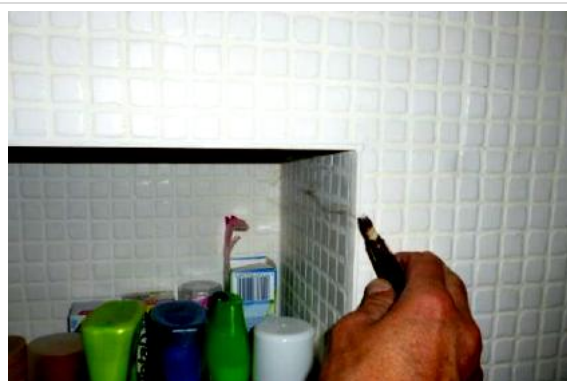
d) Penetration at sink cut out in bathroom

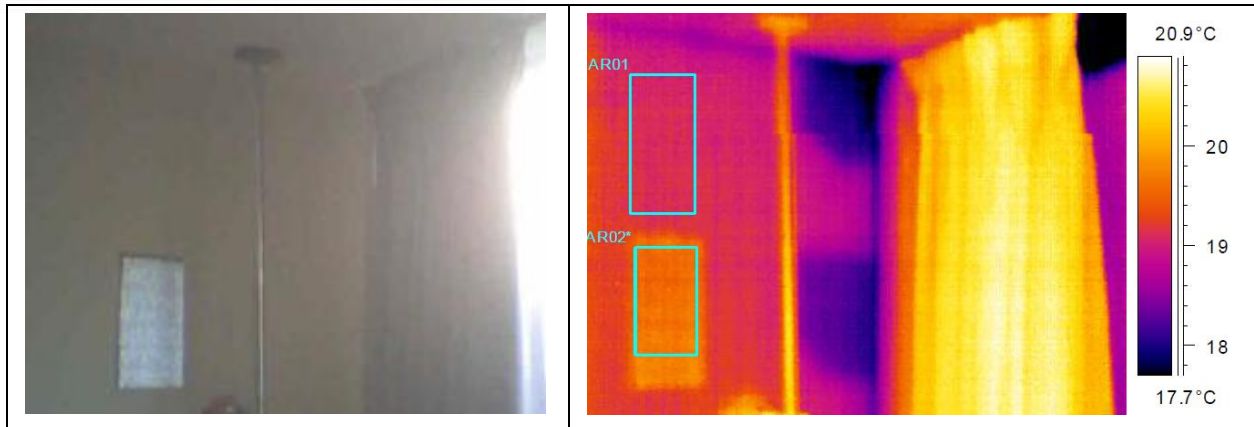
Figure 3.3: Thermography image of Flat 3 external wall indicating cold patches

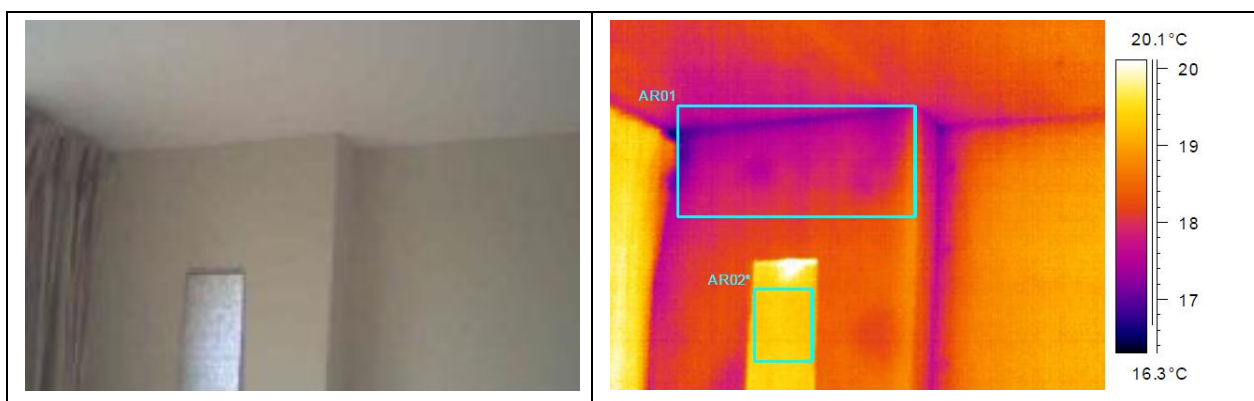
Figure 3.4: Thermography image of Flat 2 external wall indicating slight cold patch near wall roof interface

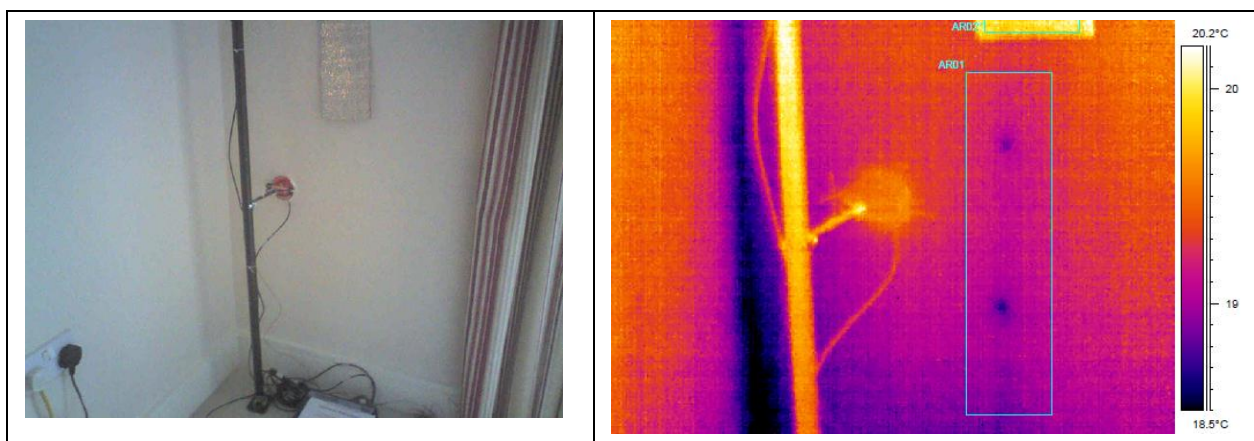
Figure 3.5: Thermography image of Flat showing potential cold bridging due to stud-wall fixings

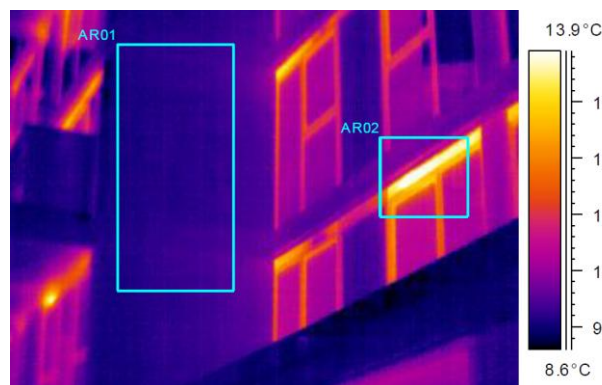
However, salient features remain evident in the survey in the form of higher recorded temperatures related to MVHR outlet vents above windows and some “open” windows as demonstrated in Figure 3.6.

Figure 3.6: Thermography image showing heat loss (AR02) on the external façade of Norfolk House associated with the inlet/exhaust vents of the MVHR system

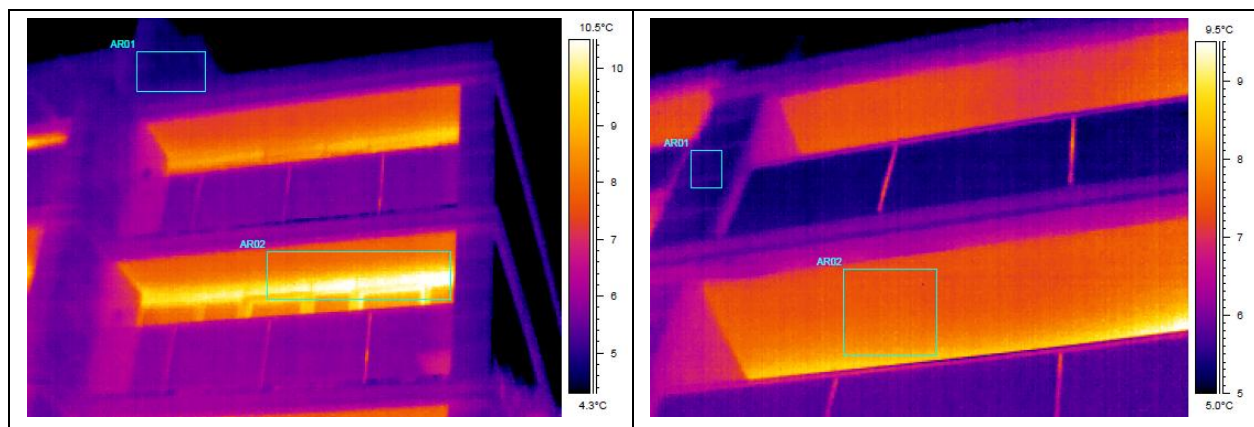
Figure 3.7 shows the thermography images of the underside of the Norfolk House flat balcony floor slabs. It can be seen that the surface temperature is higher at the interface with the external wall, indicating potential thermal bridging caused by the penetration of steel structure.

Figure 3.7: Thermography image showing heat loss (AR02) on the underside of the flat balcony floor slab of Norfolk House potentially by thermal bridging due to structural steel penetration at the façade.

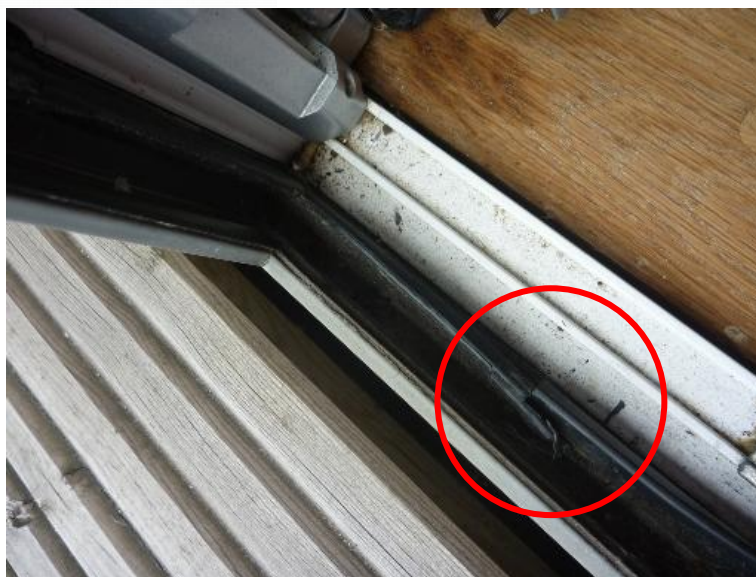
Figure 4.1: Balcony door seal, where the joints have started to fail, which would compromise the air-tightness of the property

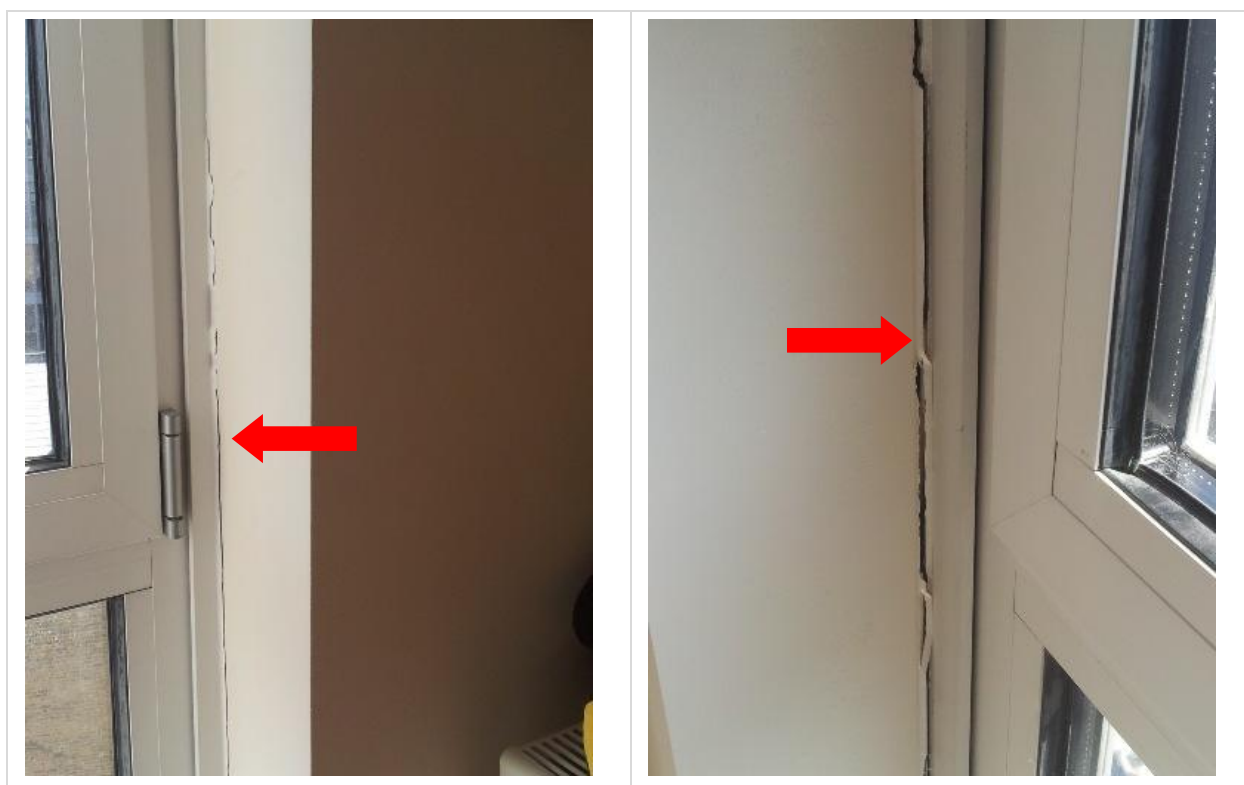
Figure 4.2: Cracks found in Flat 3 at the wall interface with the windows

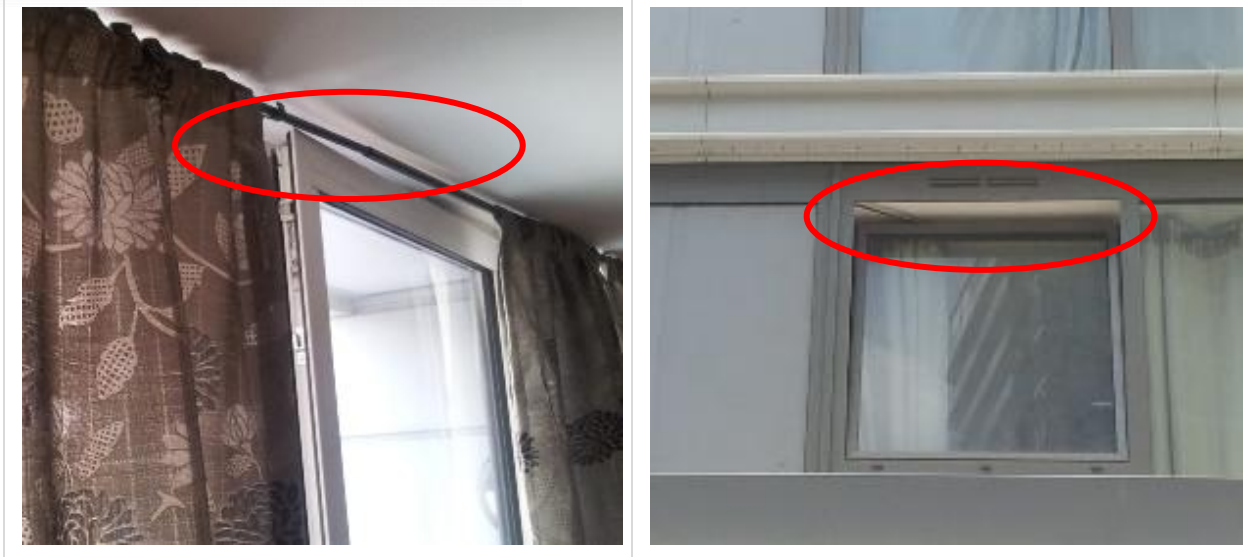
Figure 4.3: The narrow gap available between the windows/doors and the false ceiling, making the opening of fenestrations difficult and restricting ventilation

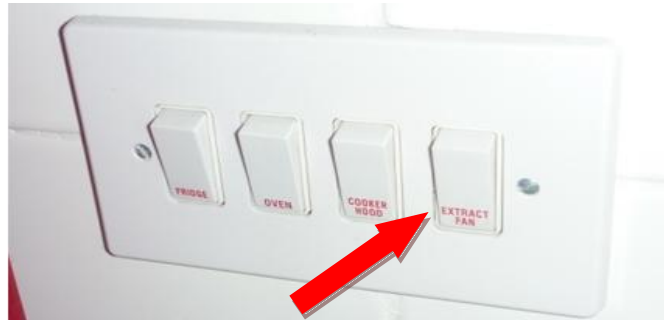
- The boost capability in Flat 2 has only been operating via the kitchen extract fan switch and not the bathroom switch. This is despite an engineer visiting to repair the MVHR, during which the filters were also changed. This may have contributed to the occupant's complaints of condensation (e.g. not using boost during bathing).

Figure 6.3: The switch gang in the kitchen where the switch for MVHR boost is located, labelled as 'extract fan'

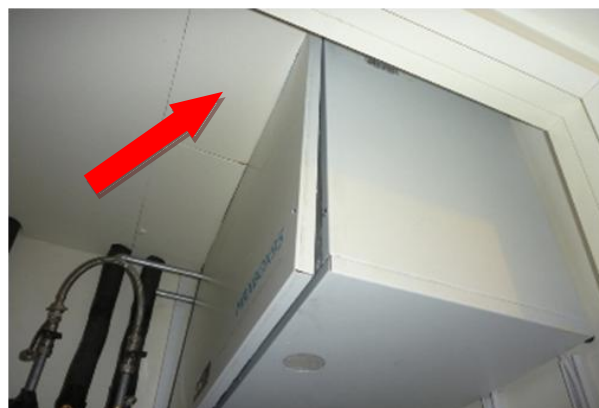
Figure 6.4: The constraints with opening the MVHR front panel due to placement of the unit part way into the false ceiling

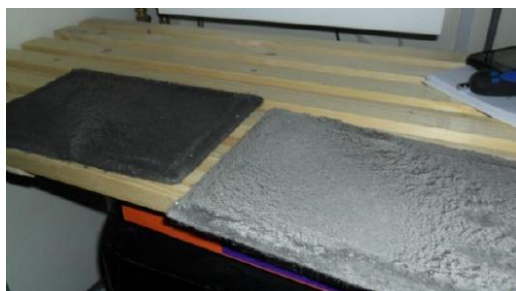
This test took place on 22nd July 2013. Figure 6.7 shows the “as-found” condition of the two filters. The filter on the right filters the extract air from the flat, where it was heavily clogged up with dust. The cleaner filter on the left filters the intake air from outside. Figure 6.8 shows the impact of partially cleaning the extract filter using a vacuum cleaner on-site. The extract filter was fully cleaned with the vacuum cleaner for the “clean” test. To carry out a simulated blocked filter, tape was wrapped around half of each of the filters to achieve a “50% blocked filter” test (see Figure 6.9).

Figure 6.7: The filters for the supply and extract side of the MVHR unit in Flat 1
