<b>Innovate UK project number</b>	450030 B
<b>Project lead and author</b>	Feilden Clegg Bradley Studios
<b>Report date</b>	2014
<b>InnovateUK Evaluator</b>	Peter Tse, BSRIA

<b>Building sector</b>	<b>Location</b>	<b>Form of contract</b>	<b>Opened</b>
Schools (Secondary)	Brighton	Design and build	2011

The study at Brighton Aldridge Community Academy (BACA) examined the handover and initial occupation of the building. Energy and occupant surveys were conducted. Both schools took a similar route to servicing the buildings, using mixed-mode ventilation with biomass heating. In both schools the BMS has been largely overlooked due to issues with the systems. **Note that the energy assessment in the report was based on an NIA of 8,883 m<sup>2</sup>. The energy consumption data have therefore been modified below to account for the revised floor area. The figures below override the data reported in Section 6.2.**

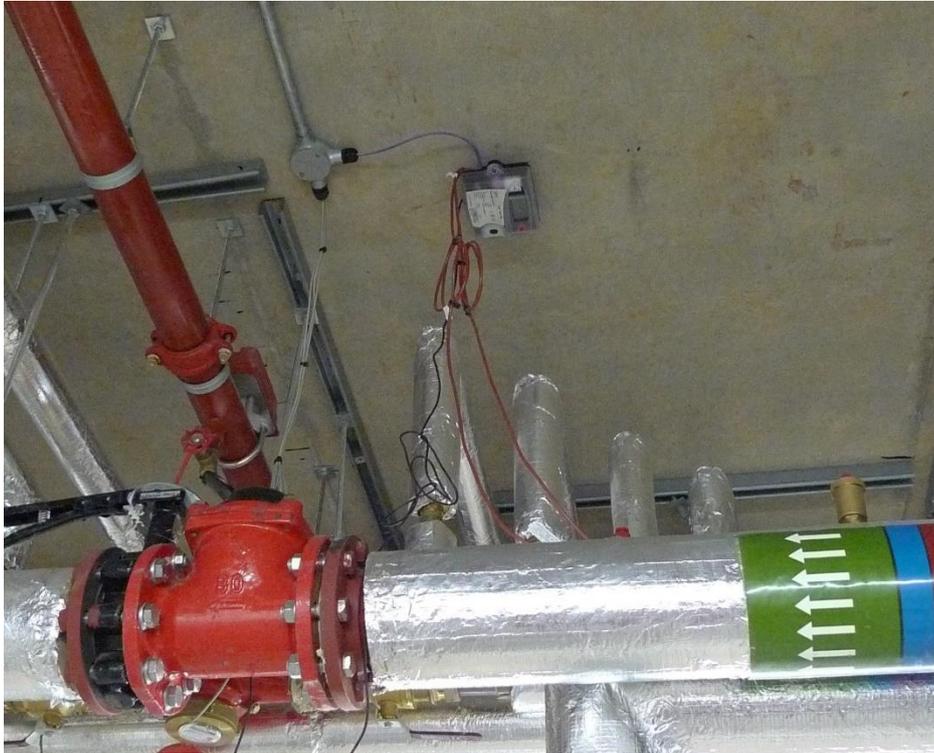
**Figure 3.3 – Image showing the location of the heat meter controller on the underside of the soffit in the plant room.**

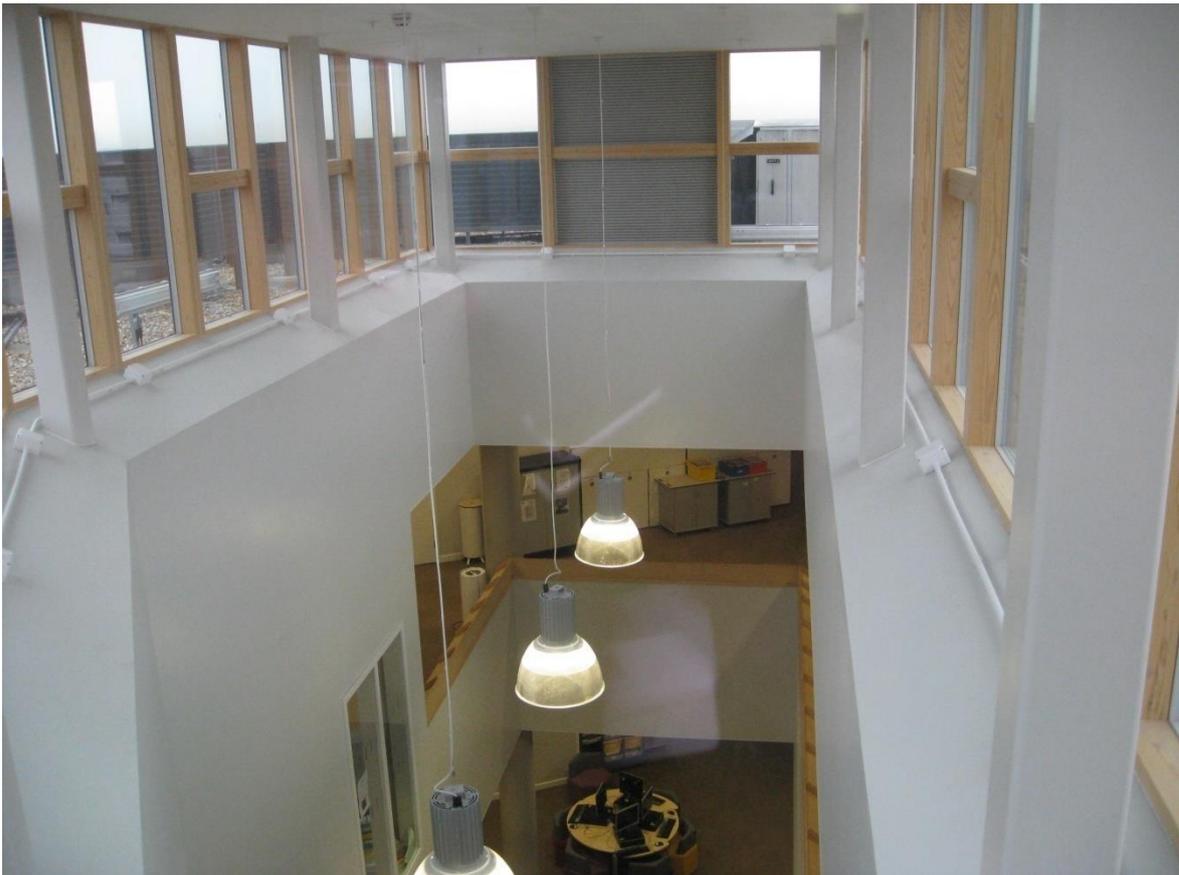
In the areas with no manual switching, such as the communal area, the lighting is only activated when the daylight sensor and the PIR deem it necessary. This works well for the corridor areas, but many of the lights were on when it was not necessary, particularly those over the atria, which provide little beneficial light to the surrounding corridors (see Figure 3.7). The sensors controlling these lights need to be set up correctly, ensuring that they only operate when absolutely necessary.

**Figure 3.7 – Image showing the atria lighting working during daylight hours.**

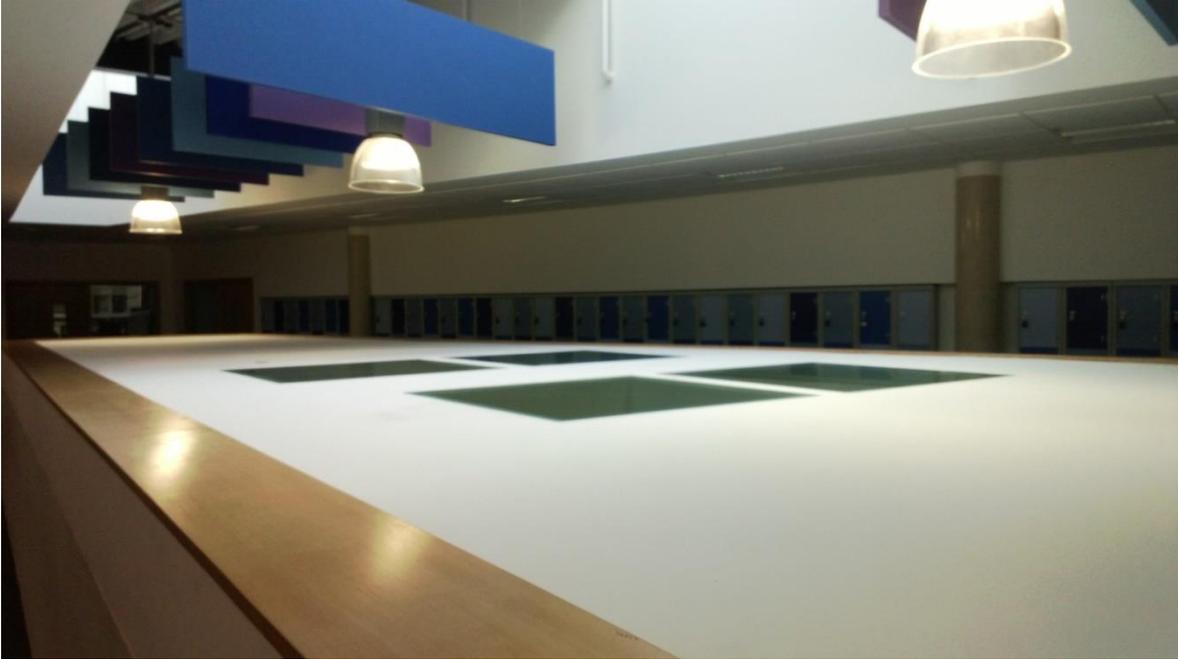
**Figure 3.11 – Image showing the atria lighting, controlled by the sensors on the ground floor, illuminating the cover over the atria to the free school below.**

(see Figure 3.11). It has been suggested that these be disconnected, or manually controlled, to prevent unnecessary usage.

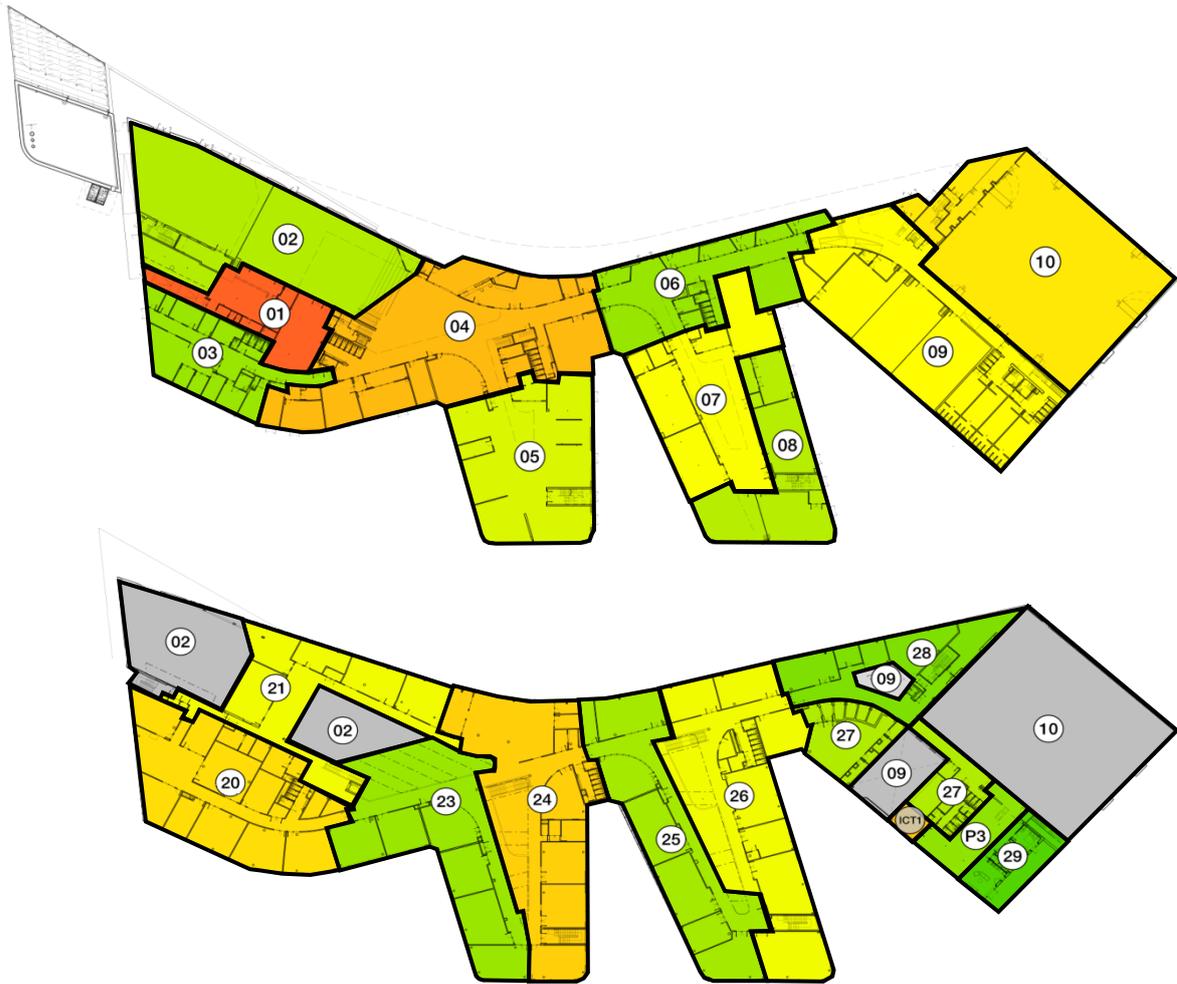
The services at BACA are not being controlled appropriately, with no modulation of inverters on fans or pumps through the BMS. This is of key concern for the fresh air supply to the kitchen, main halls and the first floor offices above the entrance, where there are two extract units connected to the one supply. In order to operate the supply to the hall and the offices, the kitchen extract has to be operated even when not needed. This is a design issue, with no automated dampers or speed control on the supply fan to ensure that the supply and extract are balanced. This is further compounded as the AHUs for these areas were commissioned to run at duties less than designed (as the motors were at the full-load current).

Figure 6.5 – Layout plan showing the areas using the most energy at BACA, top: ground floor and bottom: first floor

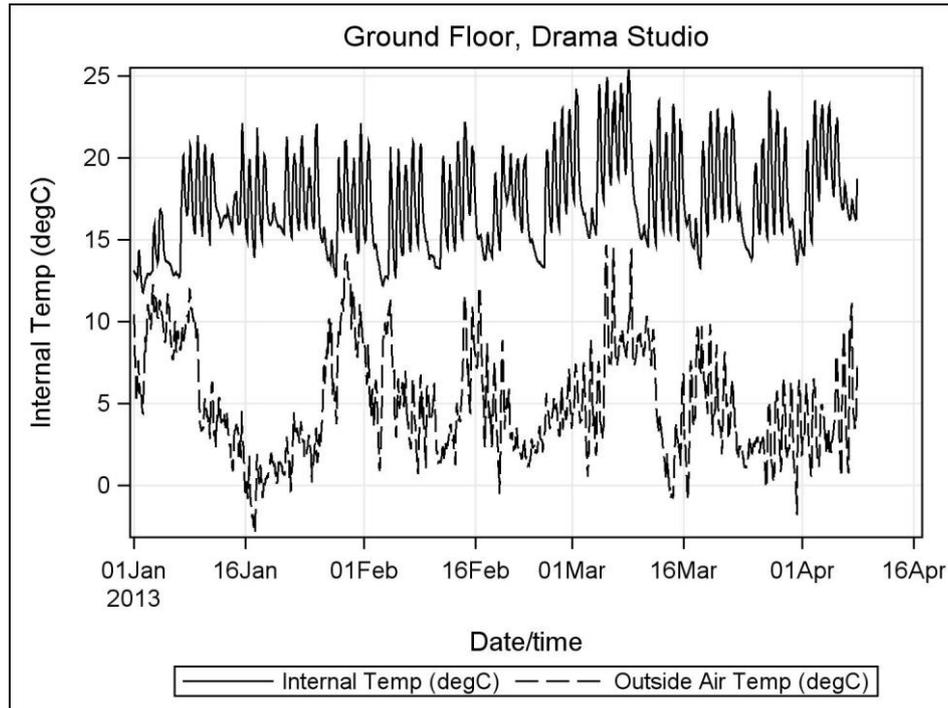
The time taken to rectify some of the defects has had a direct impact on the school environment, with the cold drama space a prime example. While each building issue takes time to understand and find its root cause, this has been a particularly complex issue, with a number of solutions attempted. While it is important that the solutions implemented are appropriate and address the underlying issues, it is just as important to speedily rectify problems that directly affect the school. Without the direct control of the building, the school can feel particularly powerless when dealing with issues that relate to the

**Figure 7.1 – Graph showing internal and external temperatures in the drama studio at Thamesview**

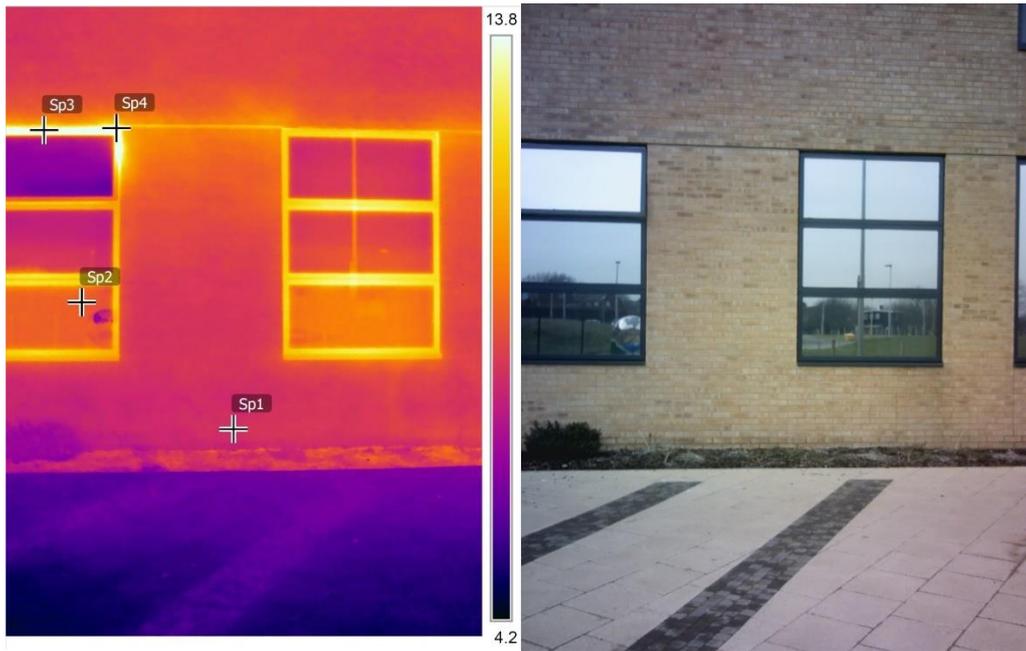
**Figure 7.2 – Infrared image of offices at Thamesview School, showing the bond between the window frames and the building fabric. Note the top windows on the left are open, despite the cool external temperatures.**

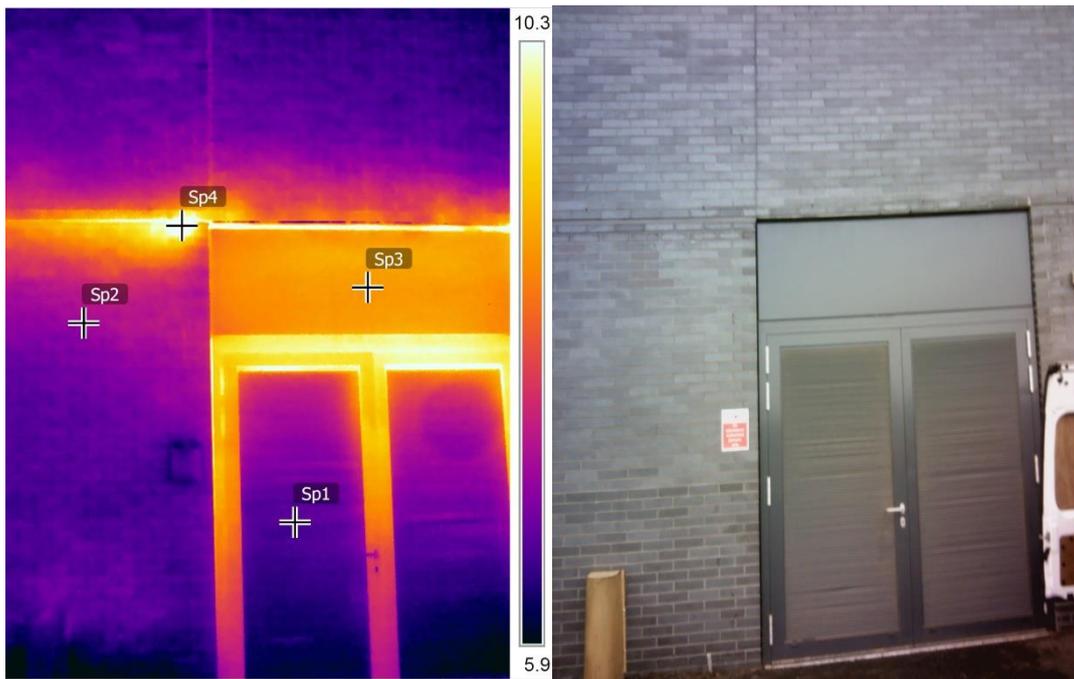
**Figure 7.3 – Infrared image of plant room door at Thamesview School, showing the heat escaping from the movement joints to the top left of the door.**

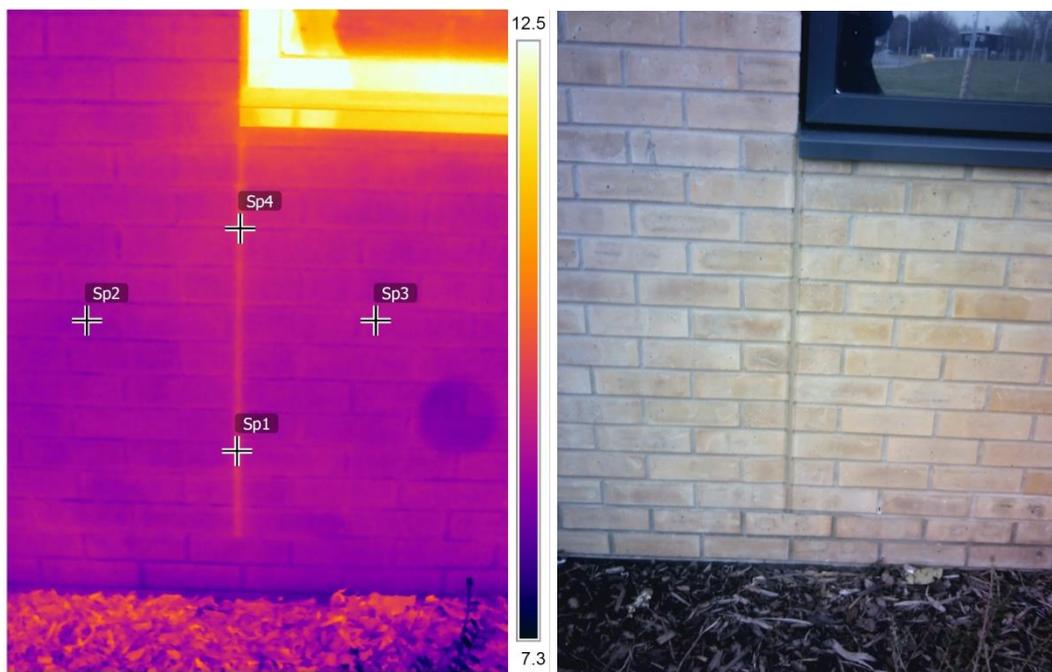
**Figure 7.4 – Infrared image at Thamesview School showing the movement joint beneath the windows, with little heat escaping.**

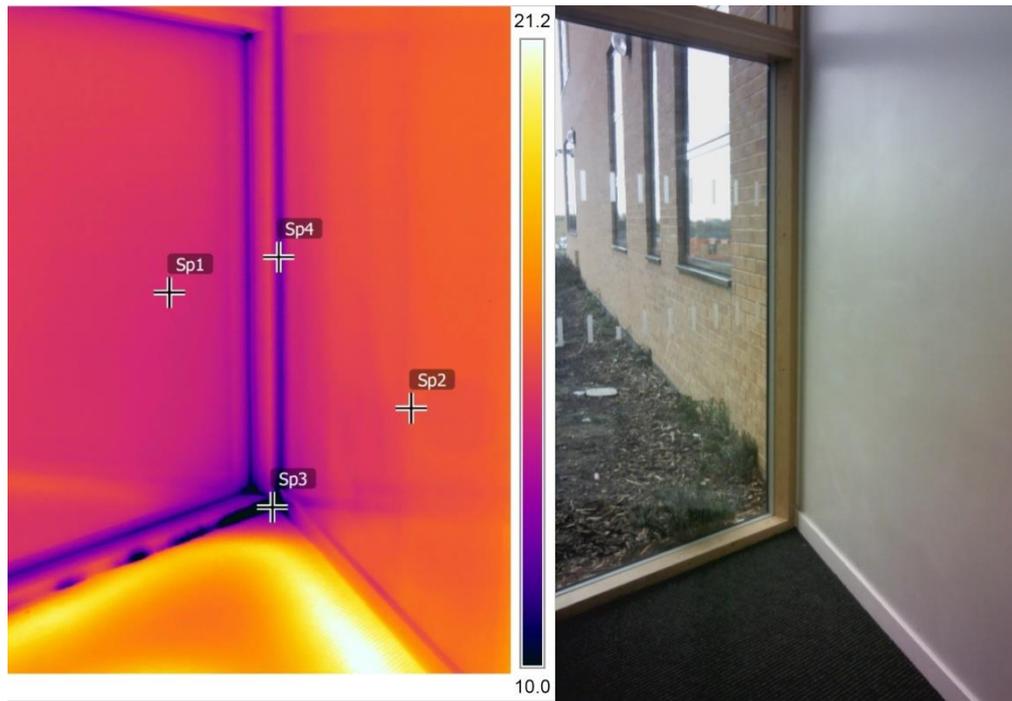
**Figure 7.5 – Infrared image at Thamesview School showing the thermal bridging between the window frame, wall and the floor**

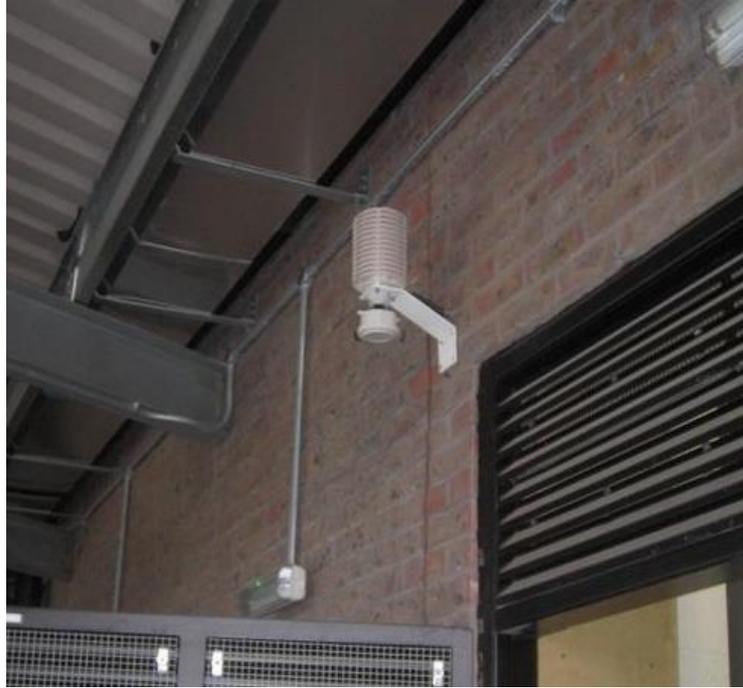
**Figure 7.6 – Outside air temperature sensor located above the plant room doors at BACA**

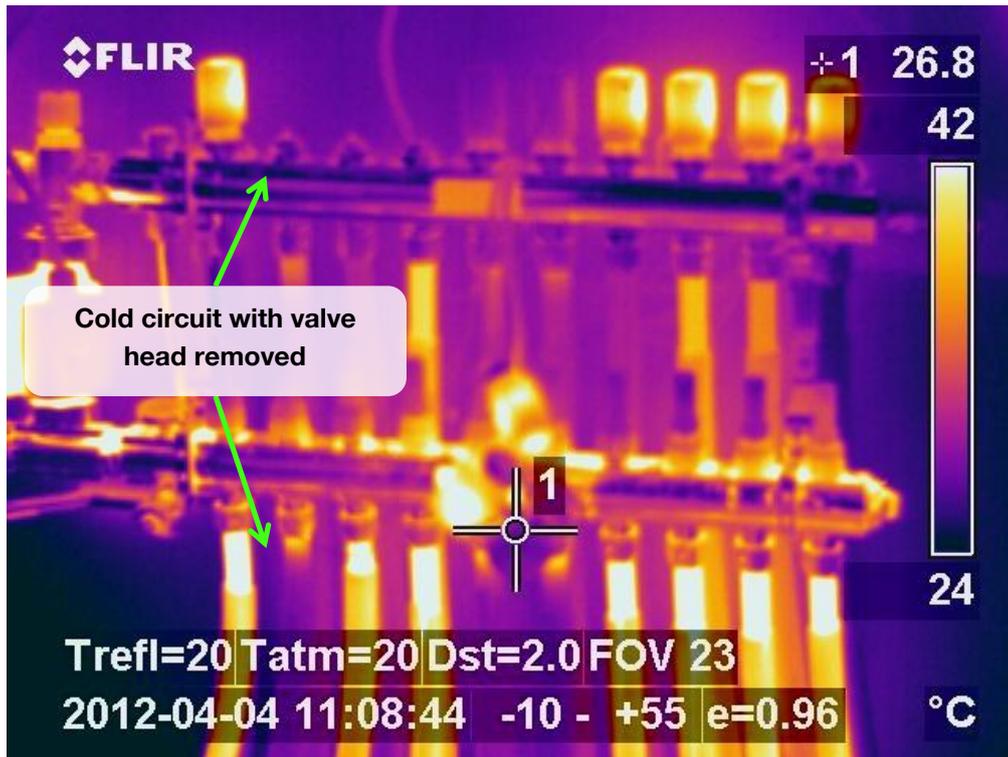
**Figure 7.7 - Underfloor heating manifold to principal's office with cold pipework at BACA**
