Woodland Trust HQ

Innovate UK project number	450028
Project lead and author	Bill Bordass Associates for Max Fordham and Feilden Clegg Bradley Studios
Report date	2014
InnovateUK Evaluator	Jason Palmer (Contact via www.bpe-specialists.org.uk)

Building sector	Location	Form of contract	Opened
Offices	Grantham	Traditional	2010

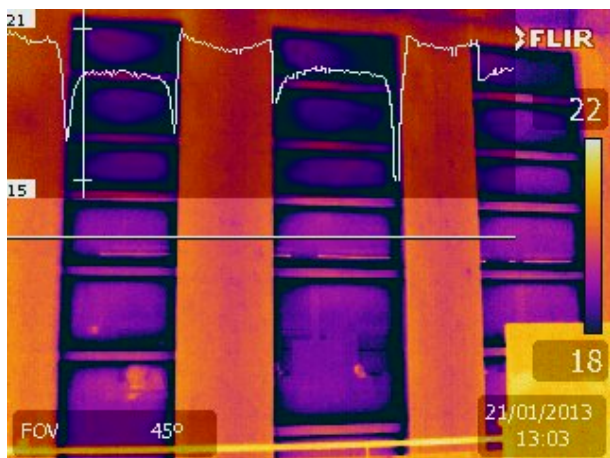
The construction using cross-laminated timber (CLT) structural panels for walls, floors and roof, performed well thermally. Infra-red photos taken internally showed minimal cold bridges, as there were no structural members or panel frames to create weak spots, Figure 2-9. External IR photos were not informative owing to the highly-insulated rainscreen construction.

Figure 2-9 Infra-red photograph inside the north facade on a frosty January day. Note the uniform temperatures across the CLT panels, as there is no thermal bridging by structural elements. The windows have timber frames which largely cover up the aluminium opening elements, which form localised cold bridges.

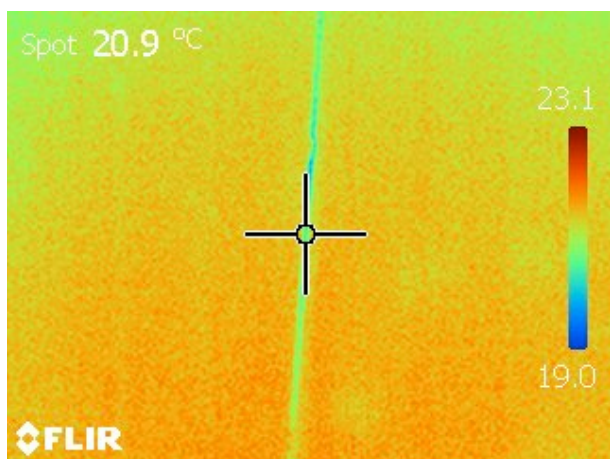
The CLT panels shrank during the first year, exposing some cracks some 5 mm wide, some of which have opened further over time. The mastic will be replaced when re-decorating. However, infra-red photographs and smoke pencil tests indicated that these were not causing significant leakage of heat and air, see Figure 2-10. A selection of IR photos is included in Appendix 10.3.

Figure 2-10 Infra-red photograph of the junction between two CLT panels. The joint between the panels is a little colder, but that can largely be attributed to the absence of the insulating properties of the timber in the gap. Joints between all CLT panels were sealed externally with laps and tape.

This is natural for a timber structure, and was not found to cause significant additional heat loss, as the joints between panels were sealed externally with laps and air tight tape. The cracked mastic pointing on the inside will be replaced when the interior is redecorated to maintain the fire-retardant coating.

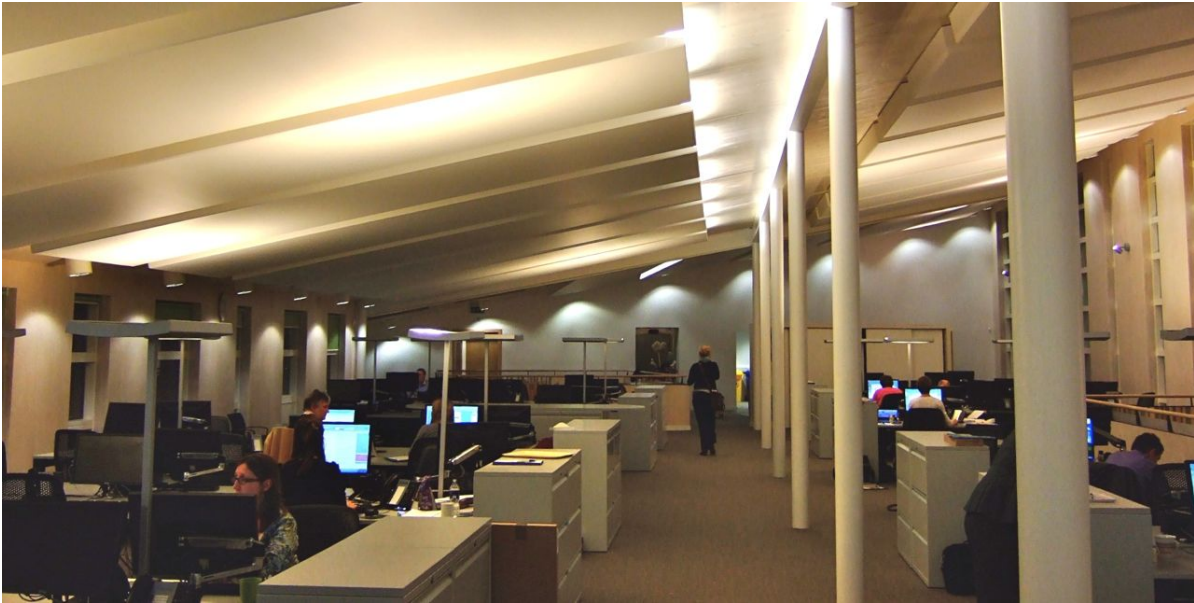
Figure 3-1 Second floor offices on a dark January evening, showing wall-washing, ambient lighting and the limited use of task lighting, with only five of the fourteen units visible in operation, as revealed by the bright patches on the ceilings.

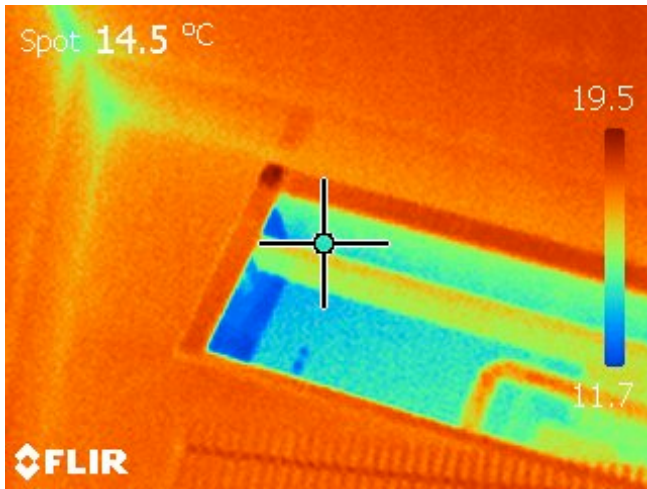
Figure 7-1 .Corner room, ground floor offices NE

Meeting and quiet rooms sometimes struggled to warm up. Smoke tests and infra-red photographs showed that cold air could enter the floor void through the open ends of the perimeter trench heater casing. Although the airtightness of the building was good, under some wind conditions, any infiltration into the floor void could be concentrated in a small room, where the short length of trench heater also had a proportionally much larger area of open end in relation to its output. The ends of the trench heaters in troublesome rooms were closed. The problem was exacerbated in the south wing for a period, when the server room floor void barrier was also cut away to accommodate emergency cooling pipes.

Note the cold housing of the trench heater unit (covering grille removed), and the yet colder concrete sub-floor beneath the open end of the trench heater. With south and west winds, air from the cold floor void could blow in through here.

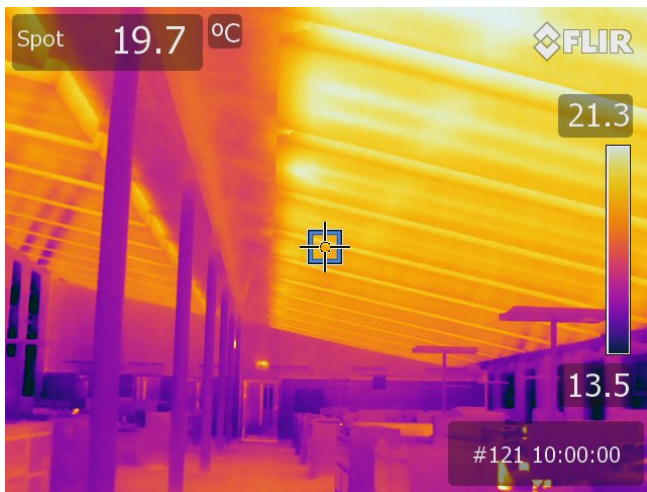
The most important finding from the monitoring was obvious in hindsight. Owing to their high thermal capacity, the concrete radiators are the slowest things to cool overnight. As a result, the air, furniture and timber in the building could be cold in the early morning, even though the concrete radiators were still relatively warm, see Figure 7-2. If night ventilation was terminated two hours in advance of occupancy, surface and air temperatures could come closer to equilibrium, as residual heat in the concrete radiators warmed up the air and the colder surfaces, see Figure 7-3.

Figure 7-2 Infra-red photograph of the interior of the second floor office, looking east, after ten hours of night cooling

Note the cold furniture, columns, and wall at the far end. The patterns on the concrete radiators indicate where the central ribs are. The ribs at the edges cool more than those in the centre, owing to the additional surface area.

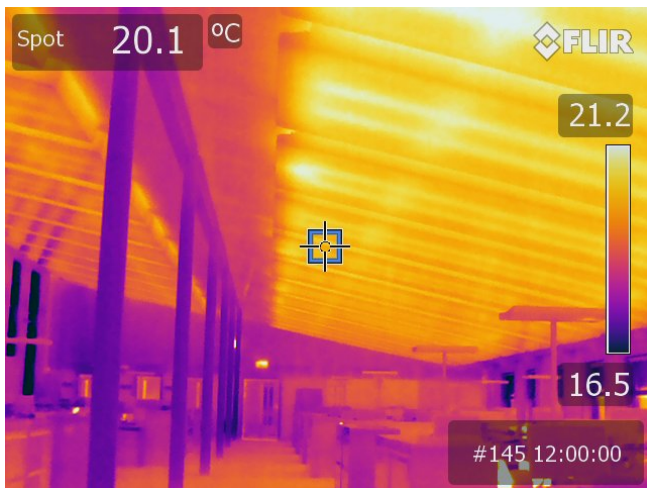
Figure 7-3 Two hours later

The windows were closed immediately after the photo in Figure 7-2 was taken. Two hours later, when the office is ready for occupation, the interior temperatures have become more uniform.

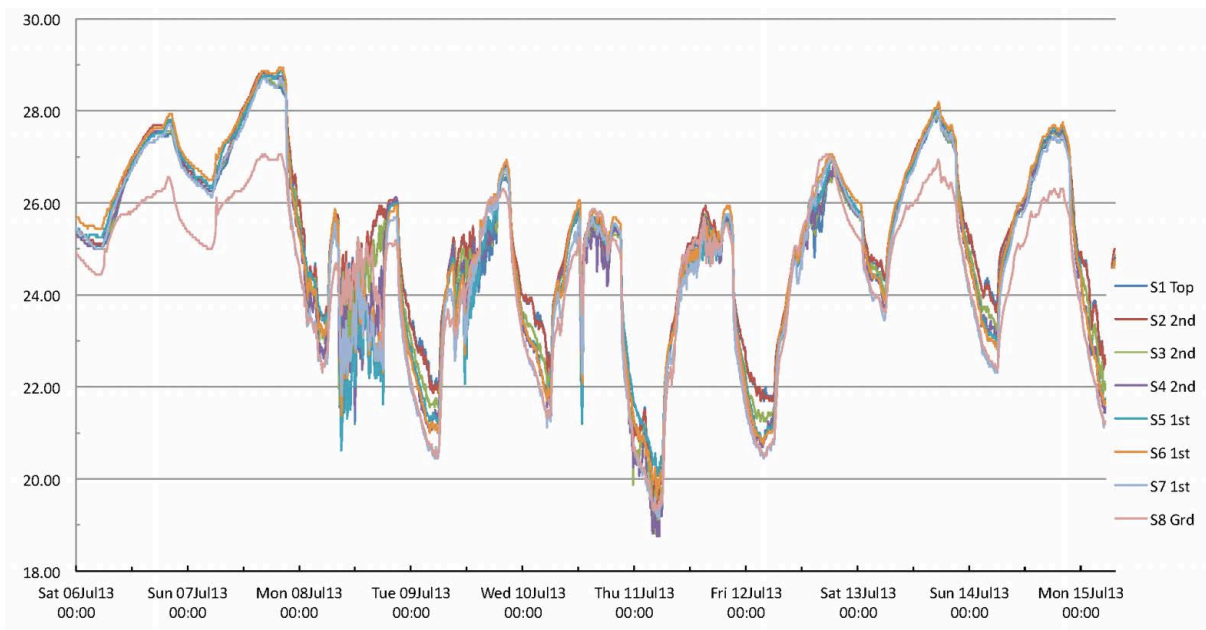
Figure 7-4 Stratification in warm weather

This shows the temperature recorded by a vertical array of temperature sensors, suspended on a cable from the roof in the SW corner of the 3-storey atrium on the North side of the building. This was at a time when full night ventilation had not been activated, and the motorised windows opened on Sunday to Thursday nights only. To the left and right are sunny weekends with the windows shut, the temperature of air on the ground floor is up to 2°C cooler than on the floors. Stratification is less on weekdays, when the offices are occupied and windows may be opened both manually and automatically. At the time, automated window control during the day was coarse, so its operation can be identified by ragged traces when it happened, here particularly on 8 and 9 July.

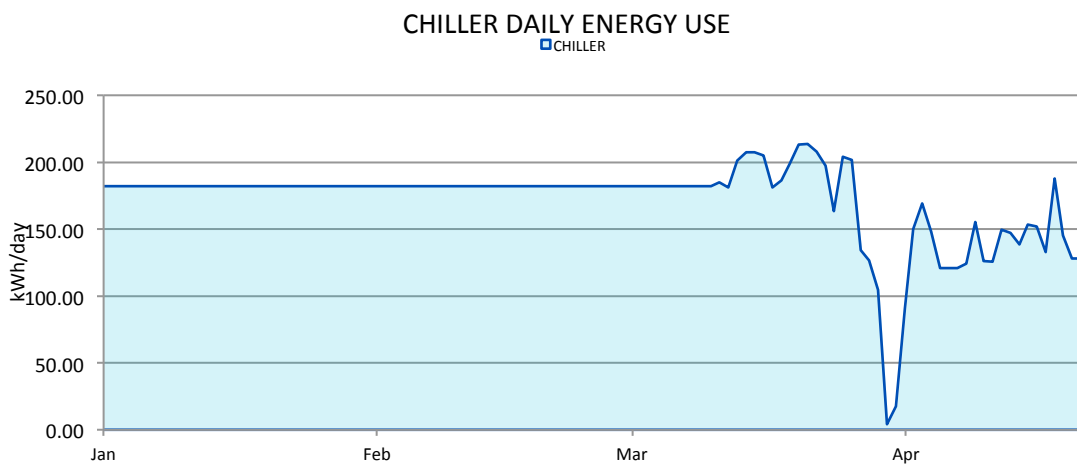
For a period after the waterside free cooling system was brought back into service in March 2012, the chiller worked less efficiently than using the compressor alone, see Figure 7-4 below. After another breakdown, the controls were adjusted for more efficient free cooling

Figure 7-4 Daily chiller electricity use for the first four months in 2012

Until the middle of March, the free cooling circuit was not in use and daily electricity consumption was flat, suggesting the compressor was its minimum setting and capacity controlled by condenser fans at very low speed. In mid-March, free cooling was activated, but on average increasing electricity use, with the extra cooling fan energy exceeding the compressor savings. The chiller then failed and the manufacturer reset the controls. After this, operation became more efficient on most days.

operation, as visible to the right of Figure 7-4. However, the chiller controls continued to fail when there was a power interruptions, until battery backup was eventually installed.
