Innovate UK project number	450033
Project lead and author	East Midlands Sustainable Construction iNet
Report date	2014
InnovateUK Evaluator	Unknown (Contact via www.bpe-specialists.org.uk)

Building sector	Location	Form of contract	Opened
Office	Daventry	Design and build	2011
Floor area (GIA)	Storeys	EPC / DEC 2013	BREEAM rating
4024 m ²	Single	B (26) / C (60)	Excellent

Intended as a practical demonstration of how to achieve high levels of energy and environmental performance in a cost-effective construction technique and procurement route.

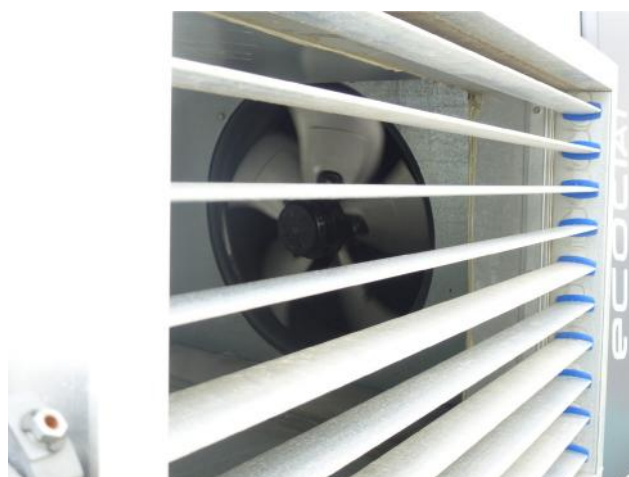
The increase to heating system flow temperature in December 2011 was believed to render the EAHP unable to contribute to the building's heating. Under the increased temperature settings the target heating flow temperature would exceed 55°C when ambient temperatures were below about 16°C. This compromised the ability of the EAHP to contribute to the building's heating system, which was designed to operate at lower temperatures than a traditional gas boiler system; the heat pump is unable to operate at heating water temperatures above 55°C. At the beginning of February 2012 the flow temperature was reduced back to its design value however the exhaust air heat pump remained offline due to a fault condition. This was eventually cleared and the heat pump was operational by the end of March. The EAHP operated until the end of November 2012. There was no indication of why the unit then ceased operating. At the time maintenance work was being carried out in relation to a heating system failure. In spring 2013 the problem with the exhaust air heat pump was traced to a control wiring modification. The control wiring was altered allowing the heat pump to operate however the adjustment affected the operation of a motorised pressure relief damper, resulting in air flow though the heat pump apparently exceeding its maximum duty. A simple solution was recommended by the heat pump manufacturer. This involved replacing the motorised damper with a spring loaded damper to allow excess air exhaust without needing additional controls. This work was carried out shortly before the end of the evaluation project.

Motorised damper prior to replacement

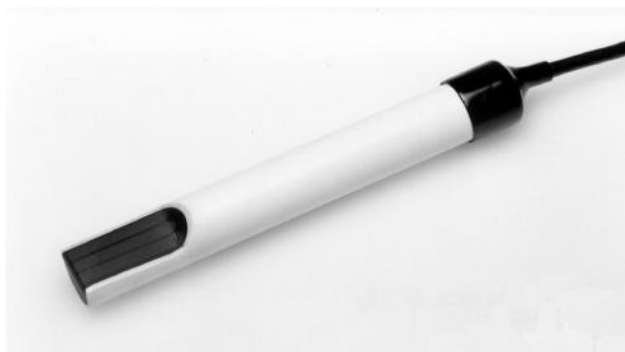
Overheating was reported in some of the incubator units and the street during the first summer of the building's operation in 2011. Some of this was due to a lack of ventilation caused by actuator failures. The faulty actuators were identified and replaced. Further problems occurred during warm but rainy weather. These were traced to the rain sensor, which is intended to close the vents to prevent rain ingress. The sensor was remaining damp after a rain shower had passed, preventing the vents from reopening. The problem was addressed by replacing the rain sensor with one that incorporated a heating element. The heated rain sensor is less likely to be triggered by dew or condensation and will dry more quickly when rain stops. The location of the sensor, at the side of the ventilation stacks, actually means that in certain wind directions it is sheltered from rain, reducing its sensitivity. Raising the sensor above the roof-line of the stacks would improve its sensitivity.

BMS rain sensor

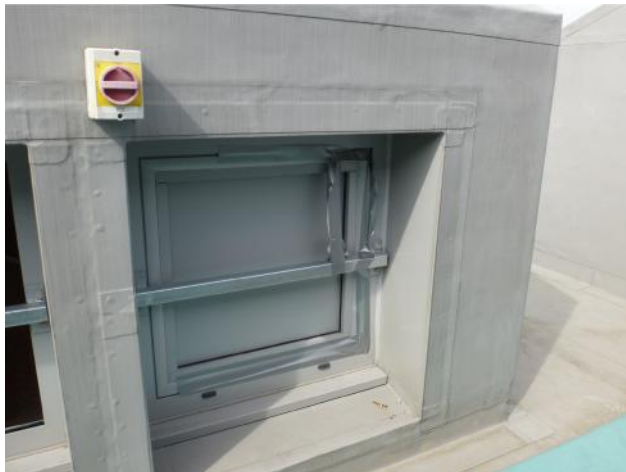
Summer 2012 was relatively cool, so it was difficult to ascertain whether the lack of overheating in the incubator units was due to weather conditions or the use of longer scheduled operating periods to permit night-time ventilation. The vent actuators have continued to cause problems; incubator unit vents have been found to be open despite the internal temperature being below the vent opening set-point and the BMS reporting the vents to be closed. The manual override switch was unable to close the vents, which suggested that the actuators themselves were faulty, unless the BMS was failing to register that the vents are open. An inspection of the roof in spring 2013 revealed several incubator unit vent doors were taped or tied closed and a number of other vent doors failed to open. During the summer the faulty actuators on the rooftop ventilation doors were replaced. The work was signed-off after each actuator has been demonstrated to work correctly.

Incubator unit vent taped-up

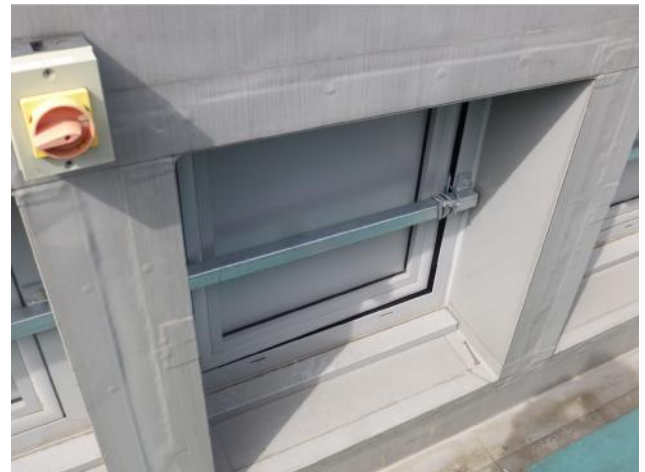
Incubator unit vent tied closed

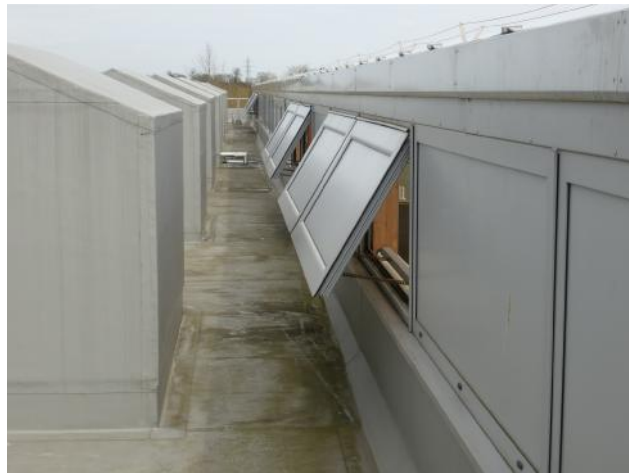
The street experiences high temperatures during hot weather, and has been the source of some complaints. The street is not considered to be a permanently occupied space and therefore was not required to satisfy any overheating criteria at design stage. The design stage compliance report actually indicates that the street would experience significant overheating however no action was taken. Even with a working ventilation system the street is likely to become very warm on the upper levels in sunny weather. This has been exacerbated by failed vent actuators. The building contractor has been asked to provide a report from the actuator manufacturer concerning the street vents, which rely on two actuators operating in tandem to open and close. It has been suggested that the actuators on the street vents are installed incorrectly and should be controlled with contactors rather than relays. The reason for this is not clear as the relays have a current rating more than adequate for the load. At time of writing a number of street vents are remaining open despite the rain signal, however they open outward so rain ingress is unlikely, others appear to remain closed. Failed actuators are scheduled to be replaced in 2014. The installation of louvres in the curtain walls at either end of the street remains a possibility. This was proposed to provide a path for air movement vertically through the street as there are currently no openings at low level to allow air circulation.

Only four of six vents on one side of the street were opening properly

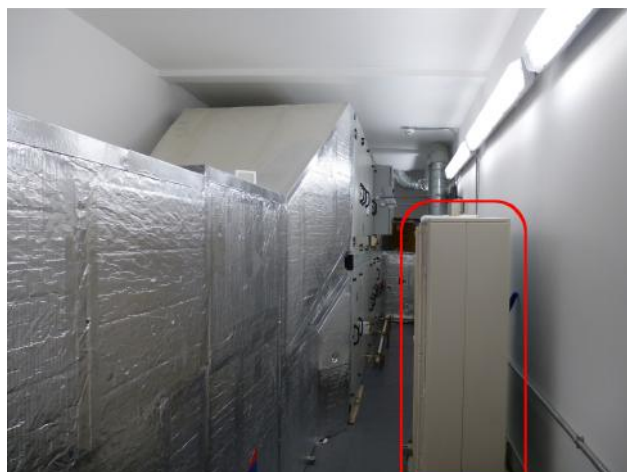
The building log book describes the condensers as being situated within an external plant space on the roof however the condenser unit serving the meeting rooms is actually located within the second floor plant room. The plant room may have originally been intended to be an external plant space however with no ventilation in warm weather the temperature within the plant room could adversely affect the efficiency of the unit. As the meeting rooms are infrequently used the potential savings due to increased efficiency may not justify the cost of relocating the unit.

Condenser unit located in unventilated plant room
