Delivery and performance of a low-energy ventilation and cooling strategy

C. Alan Short^{1,2}, Malcolm Cook³ and Kevin J. Lomas³

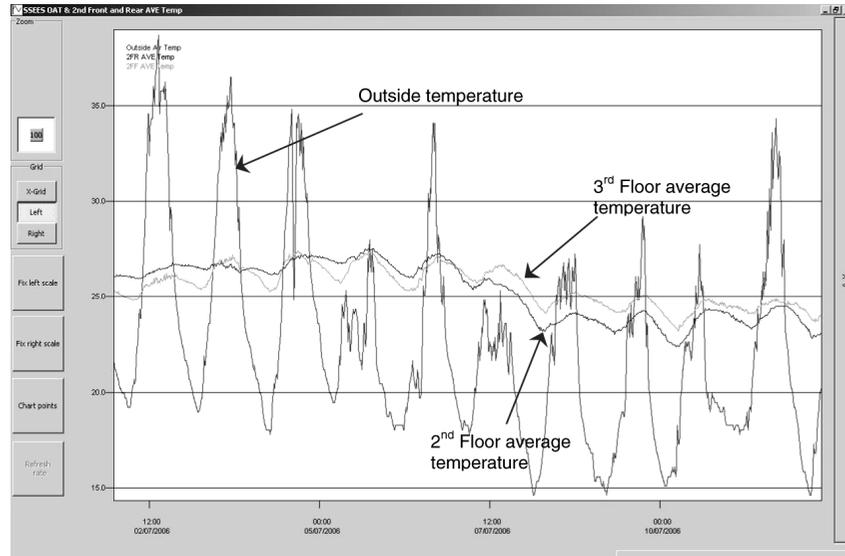
The trace shows a period in which internal temperatures rose to 27°C or greater as peak external temperatures exceeded 38°C, unprecedented to that date (Figure 10). Controls were malfunctioning fundamentally through this very hot period, as Table 1 indicates. On 3 July very restricted window movement was identified, and on 7 July ten actuators were observed to have failed, revealing that the first floor had been sealed shut through late May/June. Night venting was recorded by the BMS as being in operation, but temperatures varied so little over 24 hours that it was very probable that this space was still, in effect, sealed shut at supply or exhaust or both, and not receiving the benefit of (albeit 50% reduced) downdraught cooling in the lightwell (Table 1). In effect, the graph depicts the performance of a heavyweight building without night ventilation or mechanical cooling assistance during an exceptionally hot summer period, behaving much as the DSY date suggested it would (CIBSE, 2002) by the CFD model run without PDC in peak conditions.

Figure 10 First floor front: measured performance, 2–10 July 2006

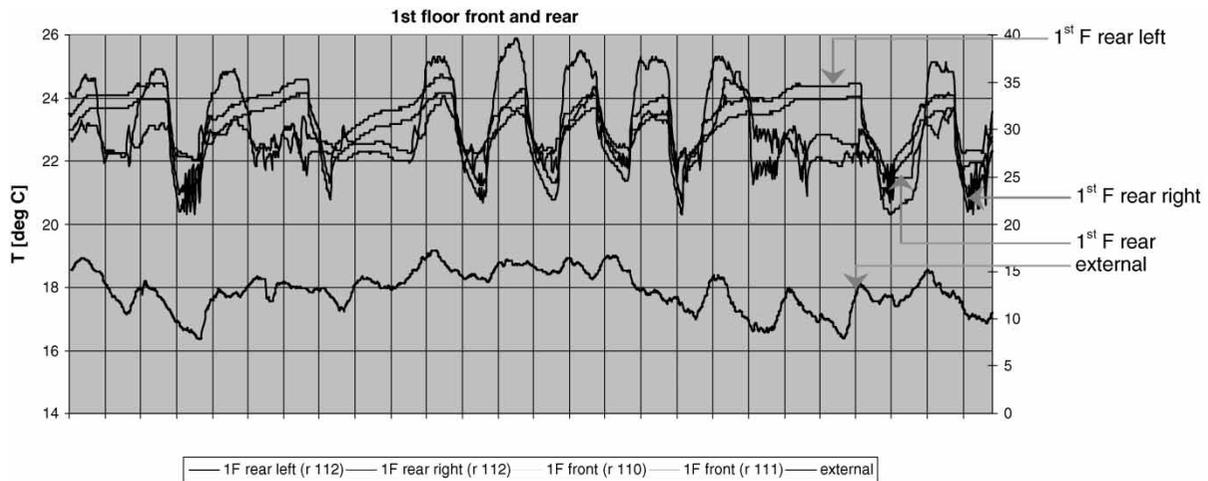
Data for November 2006 (Figure 11) indicated that conditions were in line with the design intent, after a commissioning exercise in the early stages after which airflow rates were temporarily increased to counter occupant complaints of 'heavy' air and high temperatures. Increasing the supply failed to improve perceived conditions and, counter-intuitively, a reduced flow restored design temperatures by re-establishing the stable stratification of the intended displacement system. Inlet and exhaust air paths were balanced and equalized. The mid-period shown above indicates improving conditions. The commissioning history

Figure 11 Library, first and second floors: recorded temperatures, 8–21 November 2006, mid-commissioning

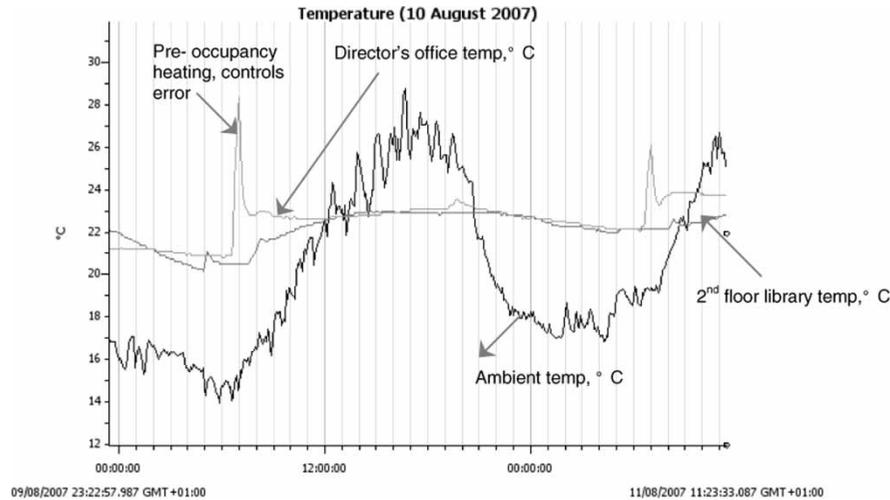
The spike in the record for the Director’s Office reveals that heating was triggered briefly by the controls. It was noted that a number of the windows at the lower end of the lightwell lantern wheel had failed closed, inhibiting natural cross-ventilation of the lantern to remove heat generated by solar gain. One lightwell lantern external window was observed to have failed open, despite the BMS reporting a ‘closed’ signal. At least two window mechanisms around the lightwell

Figure 12 Temperatures in the second-floor library and in the fourth-floor director's office both maintained below a maximum of 23.5°C by passive draught cooling (PDC) as afternoon ambient external temperatures exceeded 28°C

wheel were malfunctioning. In one case the chain had sheared, in another the actuator motor was inoperable.

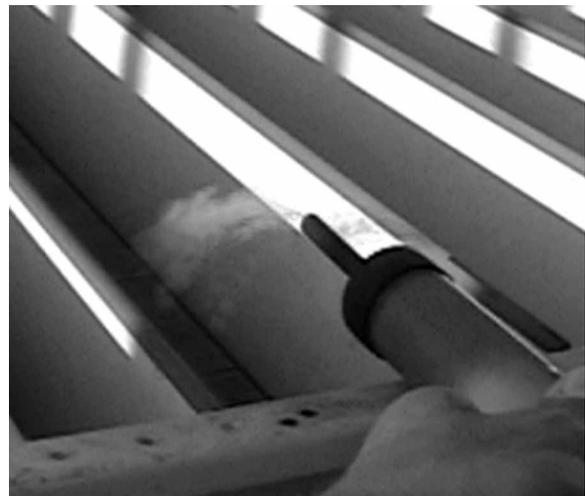
Vigorous cross-venting of the lightwell lantern wheel, which it was feared might starve the cooling batteries, was not observed. Use of the smoke pencil above the coils showed a clear but intermittent flow of air downwards and across the coils (Figures 13 and 14). The downward air movement was periodically disrupted by gusts of wind.

Figure 13 Lightwell wheel: smoke tracer following airflow down through open dampers and cooling coils

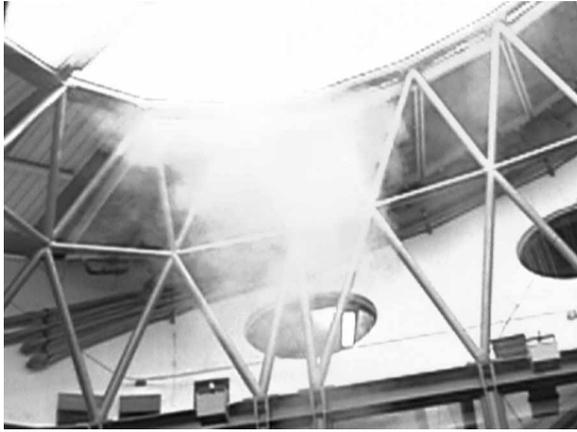
Figure 14 Beneath the cooling coils

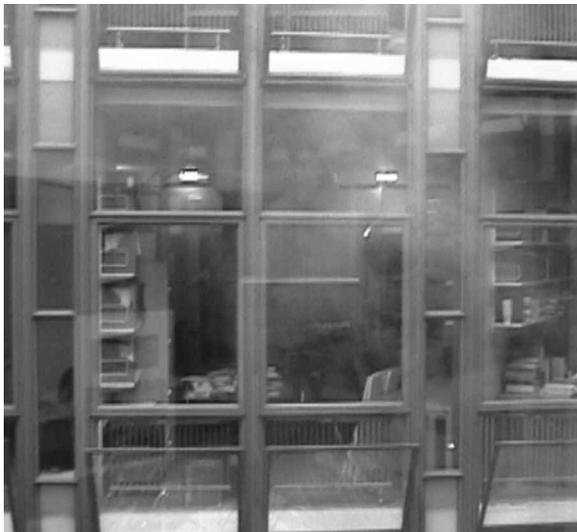
Figure 15 Lightwell at the fifth floor: smoke injected at a high level descends with cooled air

Smoke was injected at the top of the lightwell beneath the coils from the walkway accessible from the fifth-floor office (Figure 15) and was clearly observed descending from beneath the coils, over the walkway and downwards into the lightwell.

This smoke was observed to descend quickly to the glass lens at the base of the lightwell. The smoke was estimated to take about 30 seconds to fall from the cooling coils to the base of the lightwell. This equates to a ventilation flow rate of approximately 18 m³/s, which significantly exceeded the design flow rate of 12.76 m³/s.

Some smoke was seen to re-circulate at the top of the lightwell flowing along the ETFE layer. This was particularly noticeable in regions away from the cooling coils, for example, beneath the inner ETFE layer and beneath the lower end of the doughnut wheel (where there are no cooling coils and where all dampers were closed). Such behaviour was also observed in the computer simulations and was not unexpected (Figures 6 and 7). In one case, smoke moved upwards. This seemed to coincide with an increase in wind speed. It may be possible that having windows open on only one side of the lightwell wheel (as a result of controls and mechanical failures) caused a net suction effect rather than neutralizing the wind effect. This effect requires further study.

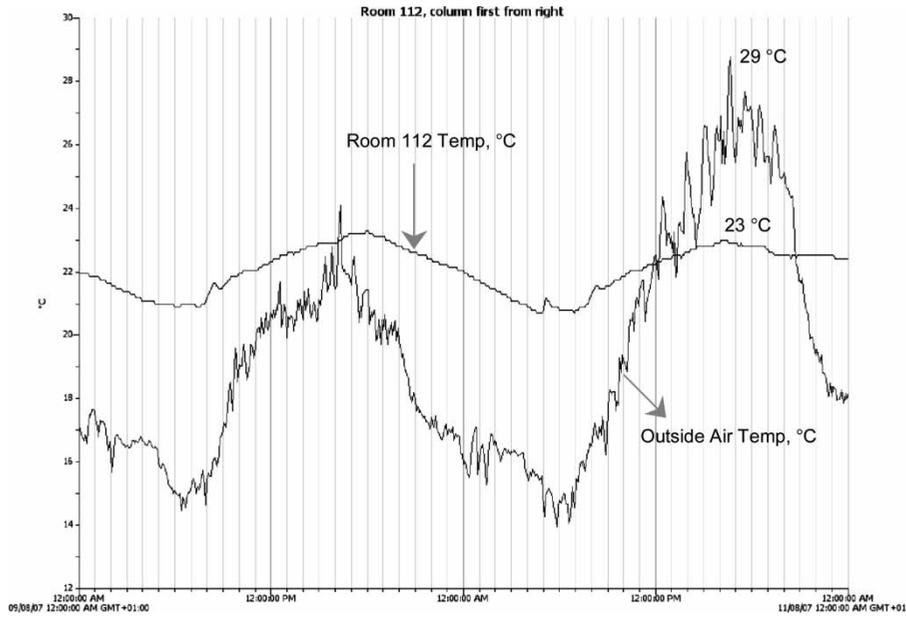
Figure 16 First-floor library (12:00 am 9 August–12:00 am 11 August): stabilization of room air temperature on 10 August while outside air temperature (OAT) rose to over 28°C

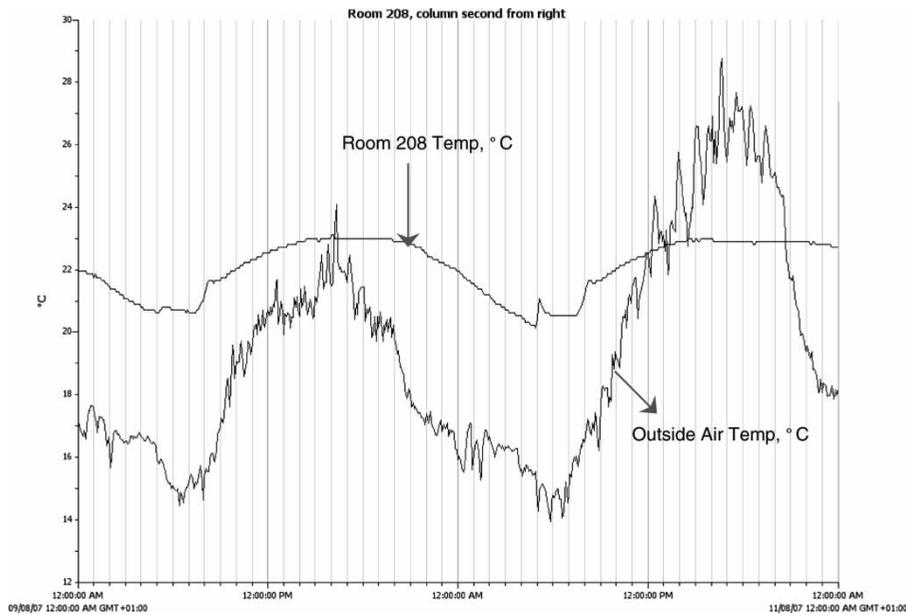
Figure 17 Second-floor library: first period of operation of cooling on 9 August between 15.30 and 20.00 hours; the internal temperature on 10 August was stabilized during a warm afternoon and evening

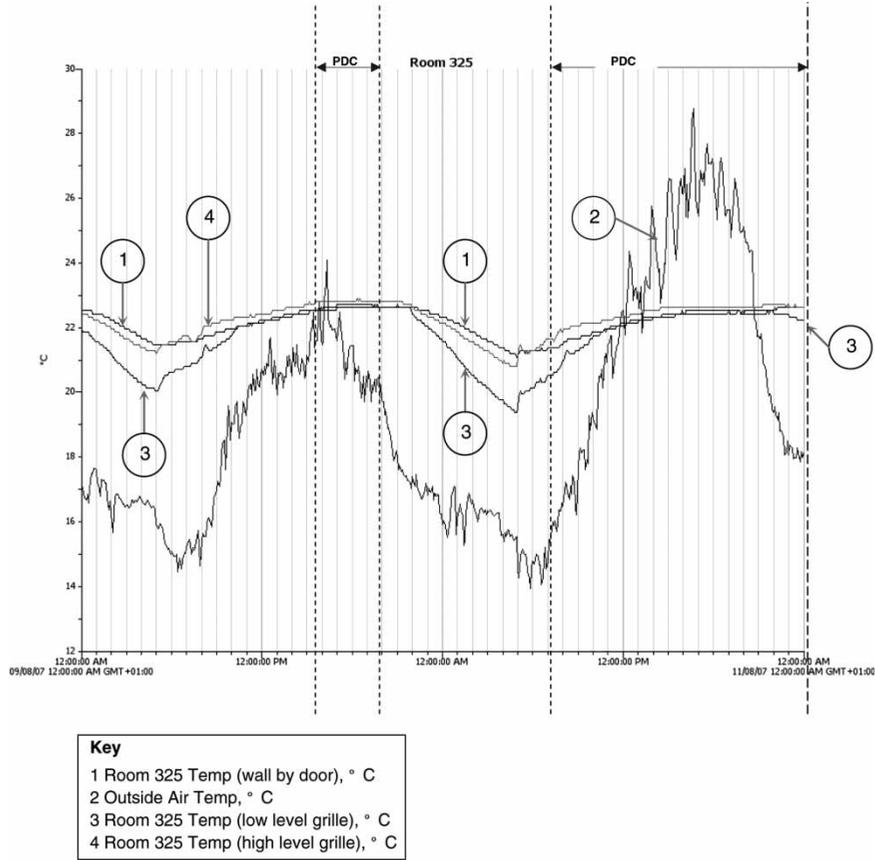
Figure 18 Rear academic room on the third floor: temperature rise arrested by passive downdraught cooling (PDC) as outside air temperature (OAT) peaked above 28°C

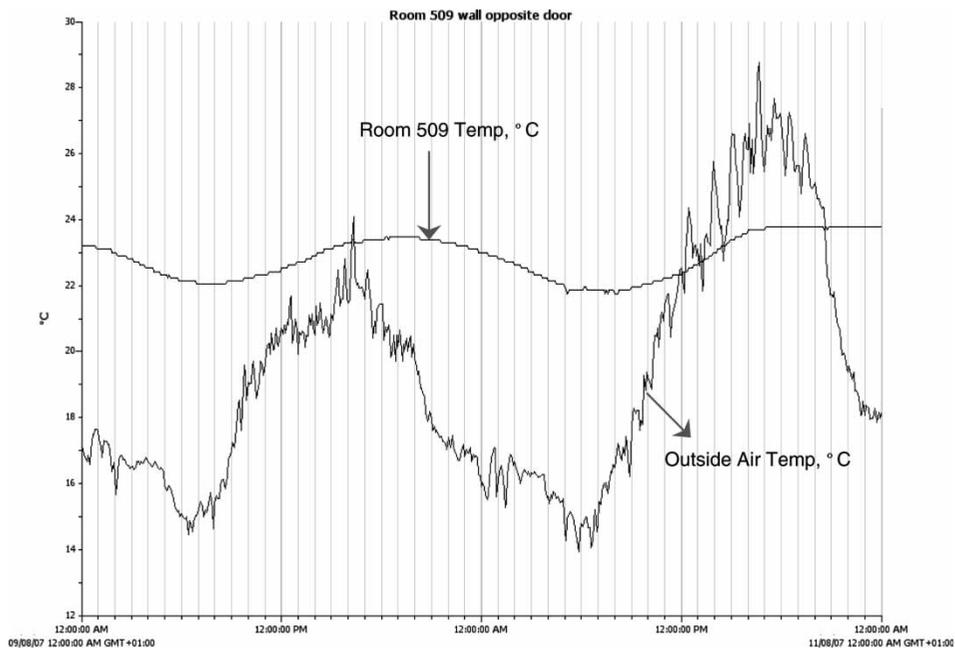
Figure 19 Rear academic room on the fifth floor. Similarly to rooms in lower floors, the internal temperature was 'capped' by passive downdraught cooling (PDC)

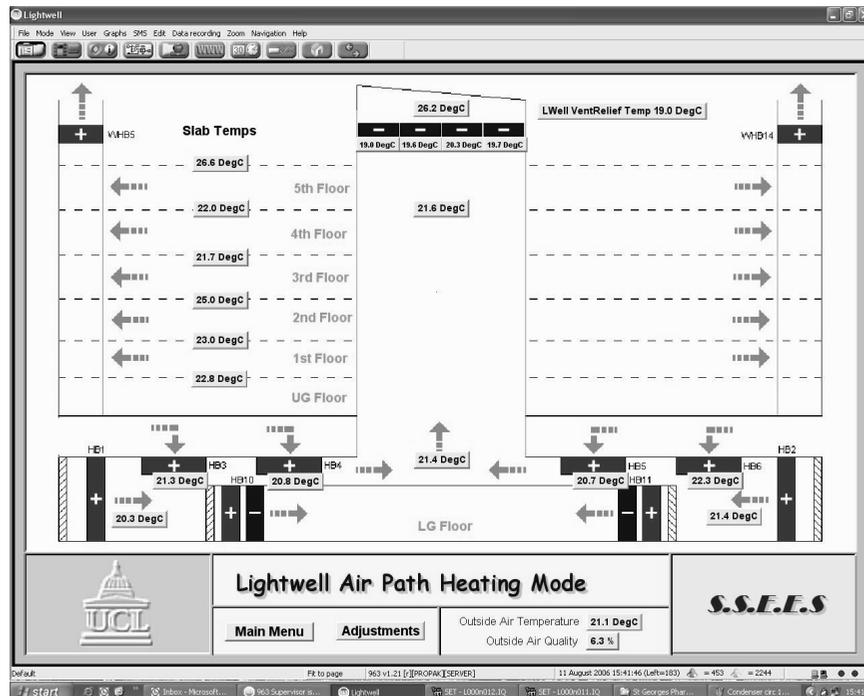
A sensor is embedded in each slab. The failure of the controls and the consequent non-implementation of the intended night cooling strategy allowed core structural temperatures to rise. Snapshots on 11 August 2006 (Figure 20) indicated temperatures between 21.7°C within the fourth-floor slab and 25°C within the third-floor slab. The commissioning history (Table 1) reveals that the night vent mode was either non-functional or heavily compromised during this period, delivering a significant 1–4°C disbenefit. The

Figure 20 Recorded structural slab temperatures on 11 August 2006 indicate a range of temperatures between 21.7°C within the fourth-floor slab and 25°C within the third-floor slab
