ENGLISH HERITAGE RESEARCH TRANSACTIONS

Volume 1

April 1998

The underside corrosion of lead roofs and its prevention

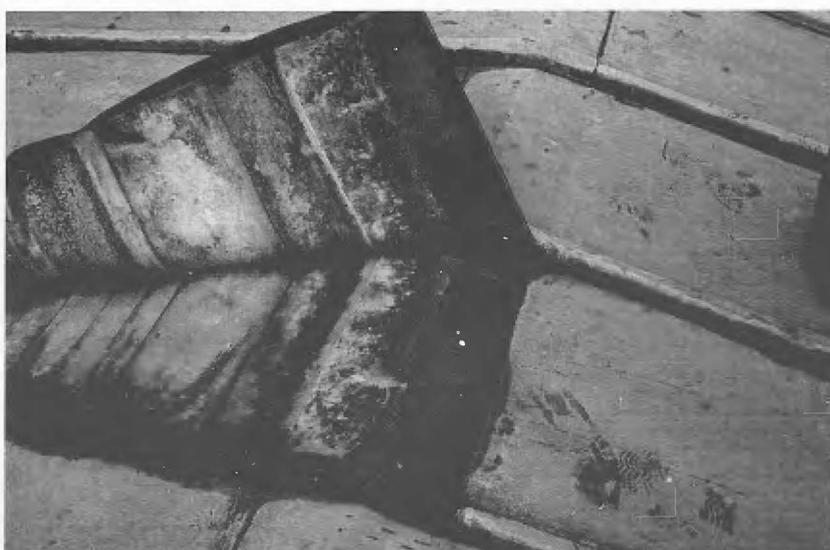
Figure 6. Corrosion above softwood boarding. White and yellowish (States 1 and 2) corrosion product on the nave roof of a Buckinghamshire church, with dark passivation above the gaps between the boards. The photograph was taken after a cold, clear night, and the roof was particularly damp at the time. Note also the passivation over the rolls (with the odd spot of corrosion). The ridge is passivated on the far (right) side, probably by rainwater, which also seems to flow over the ridge from time to time (the lap is mean). Not surprisingly, there are signs of corrosion here, probably the result of a combination of condensation and refluxing of rainwater. In spite of this, and of the church being particularly damp (RTL 1993, Report 6, Appendix D), the corrosion is not yet serious. See also Colour Plate 2.

The church in Buckinghamshire also has an example of the high variability of corrosion patterns. White corrosion products are generally visible between the boards from inside the church below, while in the higher nave roof (above a clerestory) they are not (see Figure 6).²⁴ Figure 8

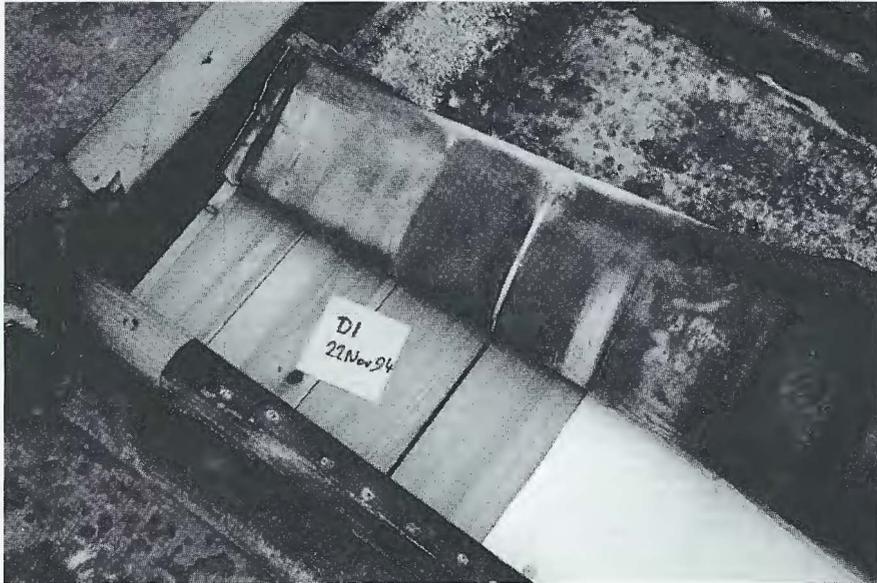
Figure 7. Lead after a two-month autumn test at Donnington Castle showing a wide range of surface states from passivation to corrosion. The two (untreated) boards on the left have kept the lead dry and its underside is only slightly dulled. The two to their right were preservative-treated and probably initially damper. This has assisted passivation over much of the boards, but corrosion around the perimeter. See also Colour Plate 3.

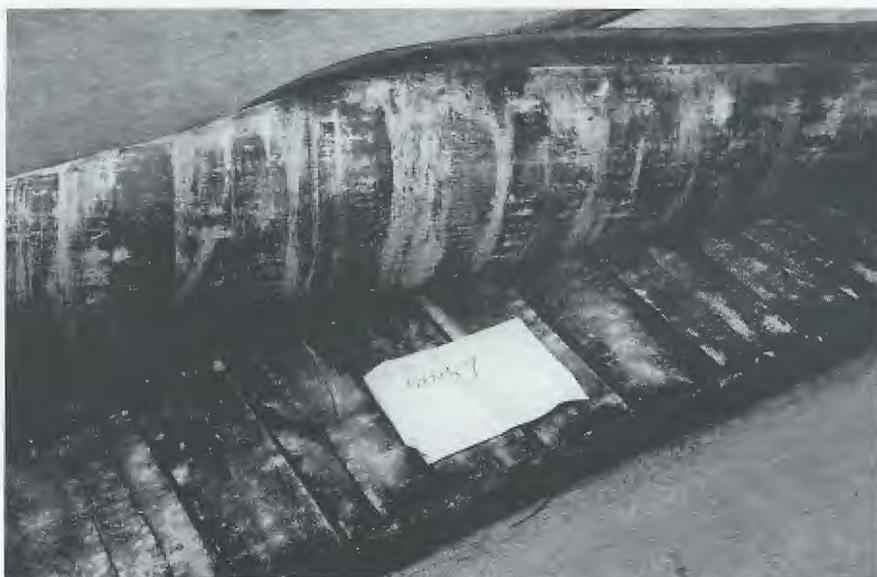
Figure 8. A church in Buckinghamshire: corrosion patterns on a slipped panel on the south aisle. See also Colour Plate 4.

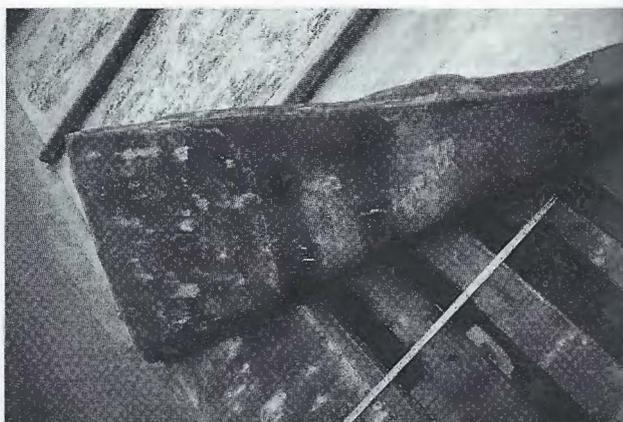
Figure 9. Lead over gap-boards at the Church of St Cross, Winchester. This lead, which dates from the 1880s, is generally passivated above the gaps and very slightly corroded over the boards. As in Figure 8, there has also been some slippage. To get some corrosion in the lap is not uncommon.

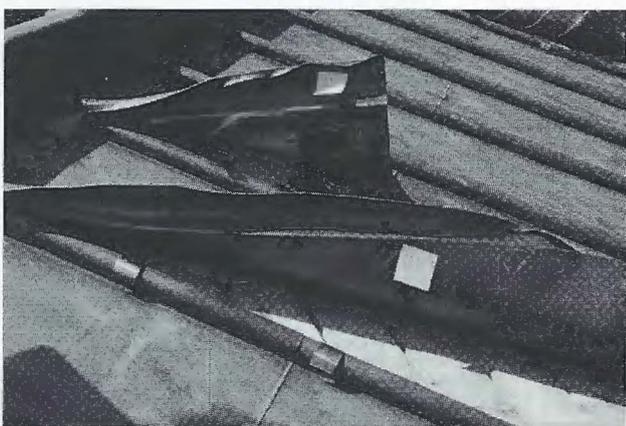
Figure 10. Variations in corrosion performance over the gaps in a ventilated warm roof. Small amounts of leakage of water vapour and moist air can make large differences to corrosion in a roof which has limited buffering capacity. For comparison with later illustrations, note also the good condition of the rolls, which here do not have splashlaps.

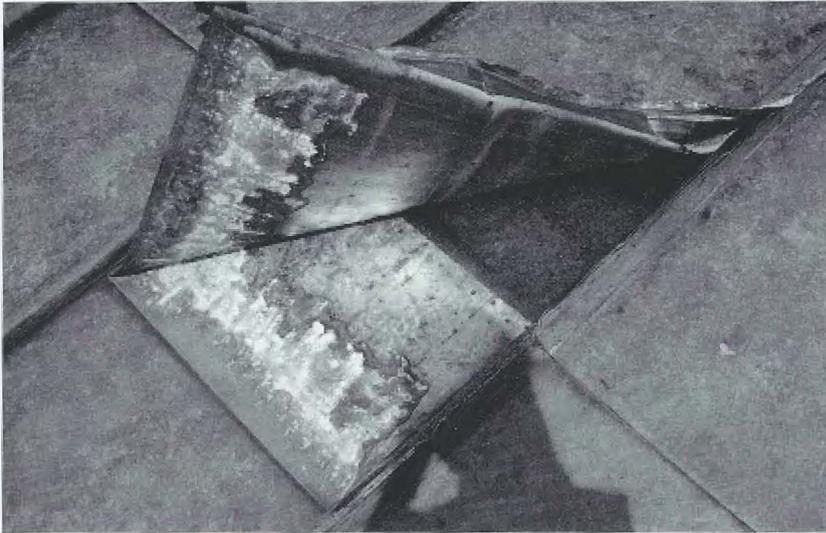
Figure 11. Lead over building paper on softwood on a relatively dry building. The lead is bright or only slightly dulled, though with a white haze between the boards. The pattern in the lap is not unusual: at the bottom a weathered area indicating capillary rise of rainwater, some corrosion (with a fringe of dark passivation) above that (where the rainwater distils) and the lead above that unaffected. The hollow rolls are free from corrosion. See also Colour Plate 5.

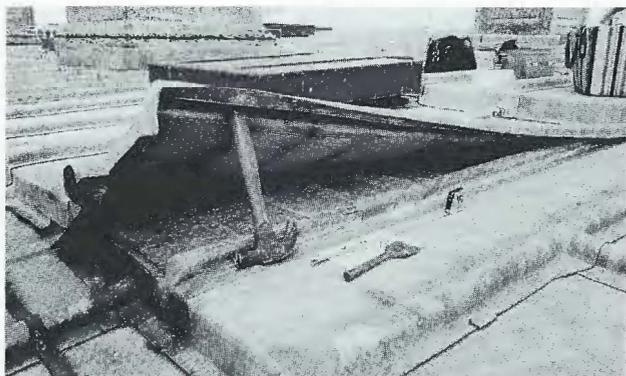
Figure 12. Underside of lead over Erskine's felt at a mansion in Dorset. The lead over the underlying boards above the public rooms is lightly and fairly uniformly corroded. Above the gaps there is a tendency to passivation. This corrosion is no longer active. Note also the corrosion in the roll above the splashlap caused by distillation of trapped rainwater: this recurs on a freshly wire-brushed surface. See also Colour Plate 6.

Figure 12 shows some uniformly-corroded milled lead (laid in 1985) over Erskine's felt at a mansion in Dorset.

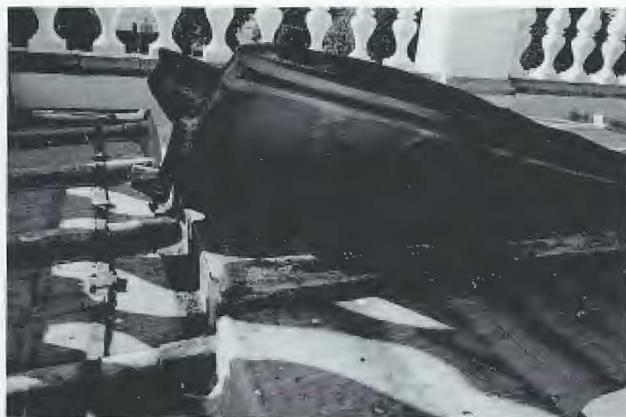
Figure 13. Underside of lead over Erskine's felt in a damper location at the Dorset mansion. The lead above the gaps is somewhat corroded, particularly towards the rolls in which there is also some corrosion. Note also the corrosion in the rolls above the splashlaps, as in Figure 12. The splashlap corrosion pattern varies with the distance apart of the sheets. Water is also trapped in the splashlap here by a slight backfall below the nosing. See also Colour Plate 7.

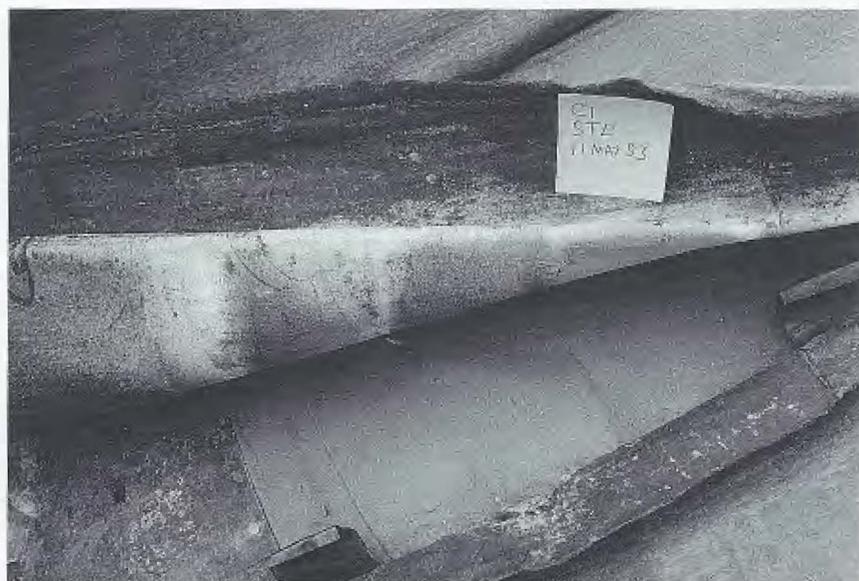
Figure 14. Corrosion over geotextile in a ventilated warm roof. While not serious, the underside lead corrosion is considerably greater than where the lead is placed directly on low-acidity softwood boards in ventilated warm roofs which are properly vapour-scaled from the building below.

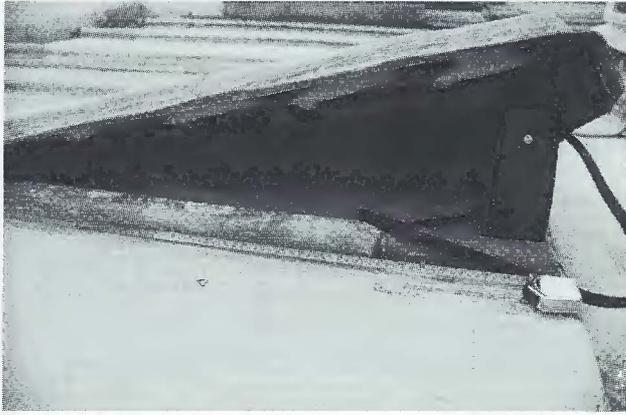
Figure 15. Rapid initial corrosion at a mansion in Buckinghamshire. Four weeks after this sheet was replaced in the autumn, fish-tails were already very evident.

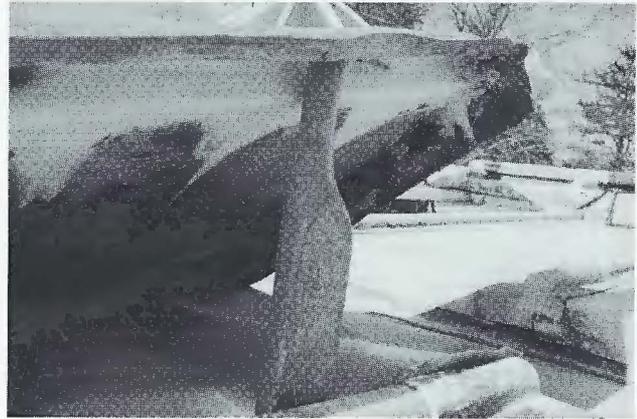
Figure 16. A year later in the same position the corrosion has now spread more widely.

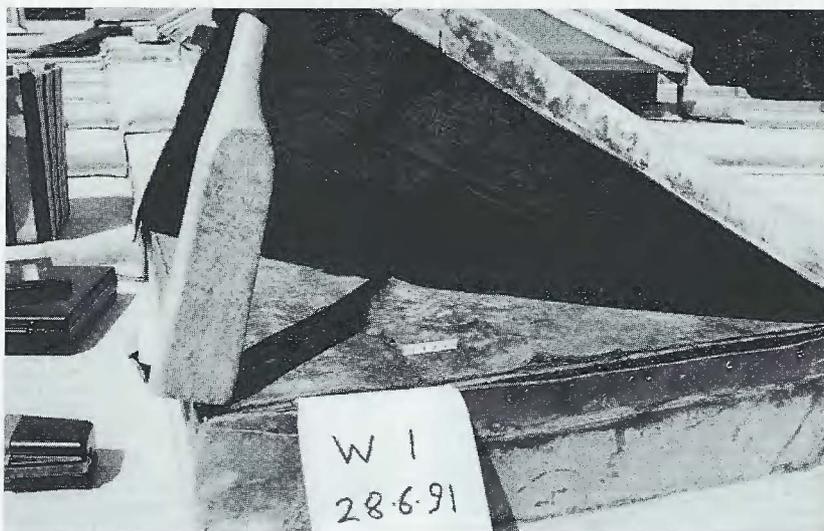
Figure 17. The original roof at the mansion in Buckinghamshire. Most of the roof was laid over Erskine's felt and was passivated between and corroded above the boards (the opposite of the current pattern). A few sheets, which did not have the felt, showed a similar pattern but with worse corrosion over the boards, probably because any moisture accumulating within this region would be trapped for longer than over the more permeable felt, and possibly there might have been some acidity. The longitudinal stripe was made by wire-brushing for tests and is not part of the original pattern. See also Colour Plate 8.

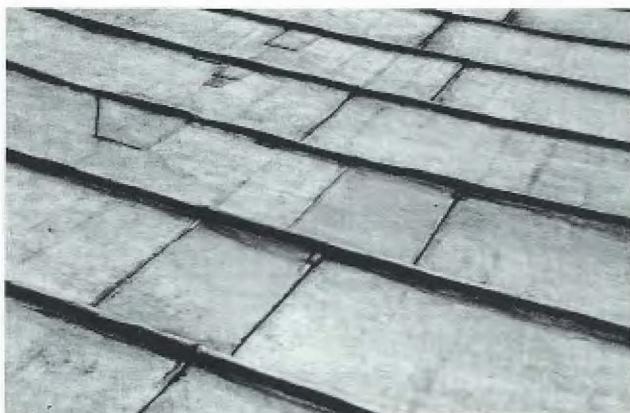
Figure 18. Norwich Cathedral cloisters, showing lead distress and repairs. The pattern here is characteristic of acid attack, with not only weakening along the gaps between the boards, but also failure at the perimeter, at rolls and laps. See also Colour Plate 9.

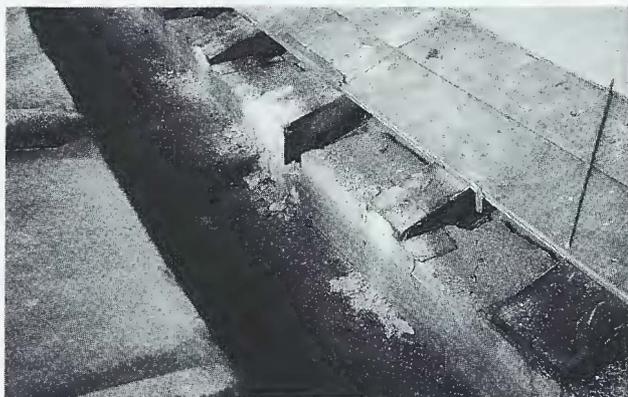
Figure 21. Valley gutter at the church near Sheffield. The lead from the gutter and roof has been removed in preparation for replacement by a ventilated warm roof. Products of corrosion at the oak rafter ends are very evident.

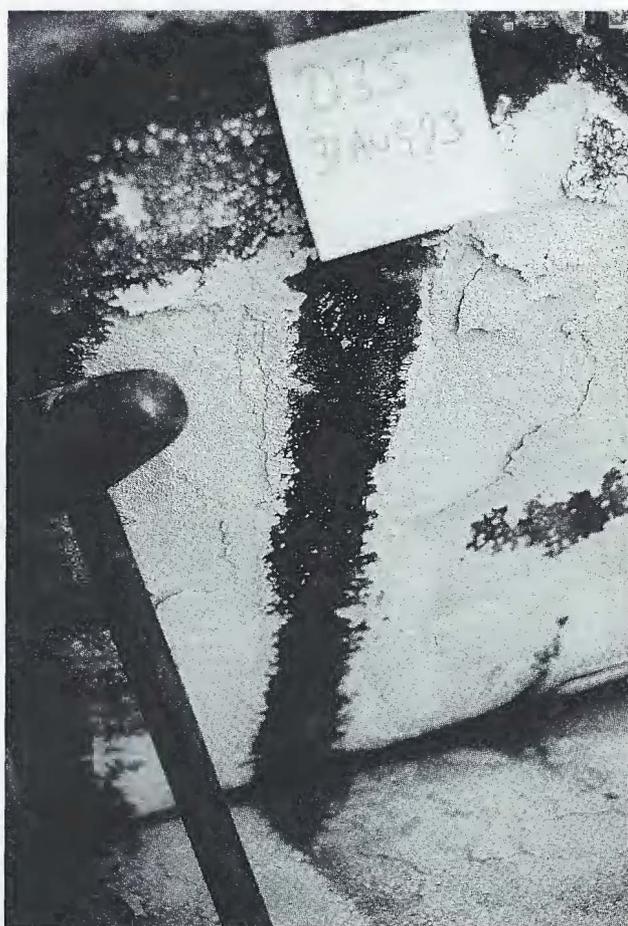
1994). Over the softwood strip, the hardboard's acetate content was only marginally smaller at 587 ppm, suggesting that the difference in corrosivity was likely to be primarily related to the physical (hygroscopic) properties of the softwood, and probably its higher absorbency. The

Figure 23. Passivated stripe at Donnington Castle. 3 mm hardboard separates the lead from the oak boarding underneath. The lead is badly corroded except for this dark passivated stripe, beneath which a softwood fillet was found under the hardboard. Since the acid content of the hardboard was found to be high (600 ppm) and similar throughout, the contrast is likely to be the consequence of different hygroscopic properties of the two woods.

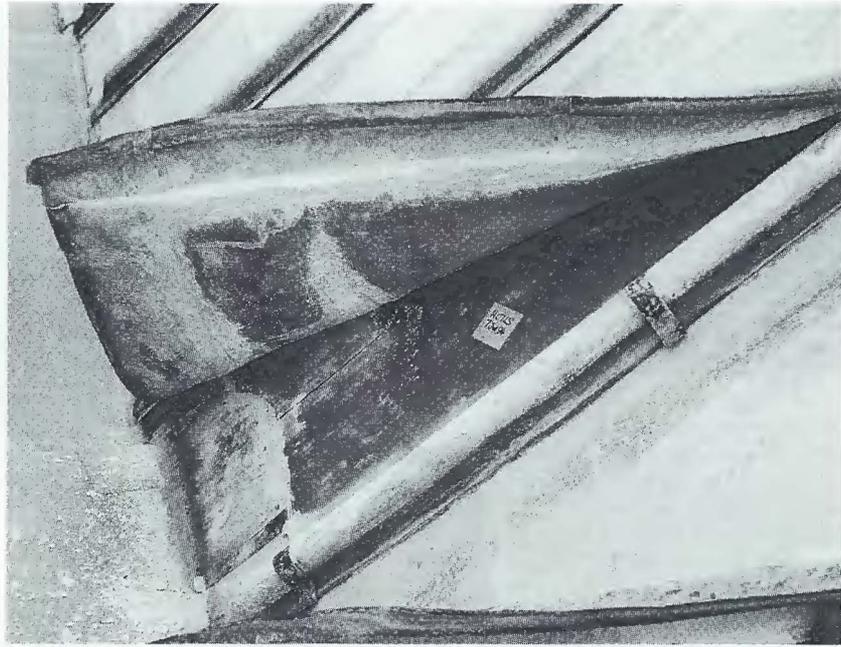
Figure 24. The south-facing roof of the Great Hall at Hampton Court. Corrosion is greatest around the perimeter and in places where the lead has bulged away from the substrate. The corrosion in the rolls varies from place to place and from sheet to sheet, presumably depending upon the precise geometry and its propensity to trap moisture.

The lead at the Great Hall of Hampton Court was relaid over hardboard in the 1950s, at much the same time as Donnington. On this much more steeply pitched roof, the hardboard has bitumen-cored building paper underneath. It too is heavily corroded, but the corrosion is more localized than at Donnington. Acetate in the

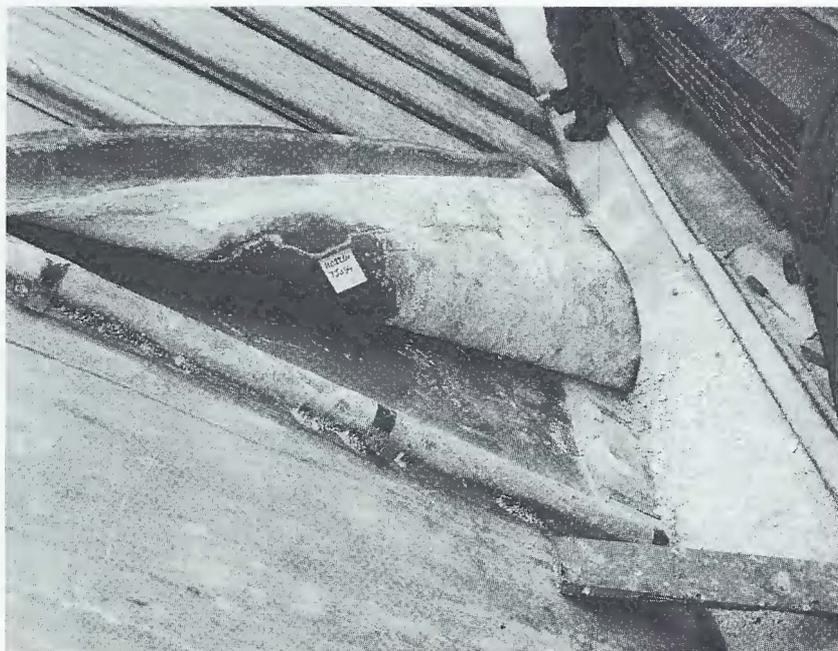
Figure 25. The north-facing roof of the Great Hall at Hampton Court. While this sheet generally exhibited more corrosion, it has a highly passivated area in the middle. Contrasts like this also occur on the south side.

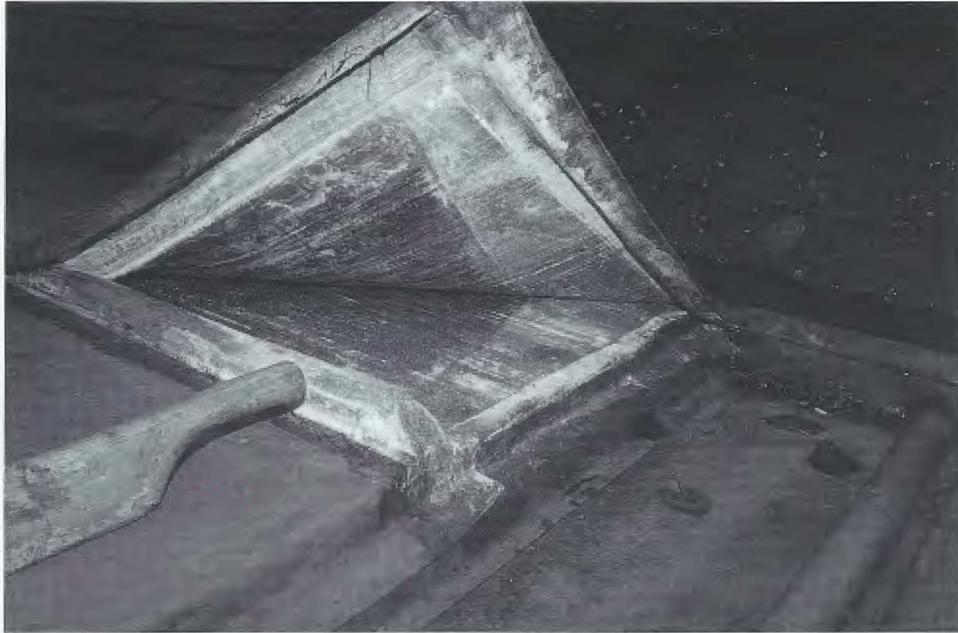
Figure 27. Lead over plywood at a converted stables.

Figure 27 shows one bay where the building paper was partly omitted. The pattern of light streaks and spots of corrosion is continuous across the edge of the building paper and so the lead may well have already been stained like this at the time of laying, or before. However, the background lead is darker in colour (and similar to fresh lead) above the building paper, while over the plywood there is a whiter haze. Corrosion on the outside of the roll may well be related to rainwater distillation from the splashlap, but the light corrosion at the inside of the roll

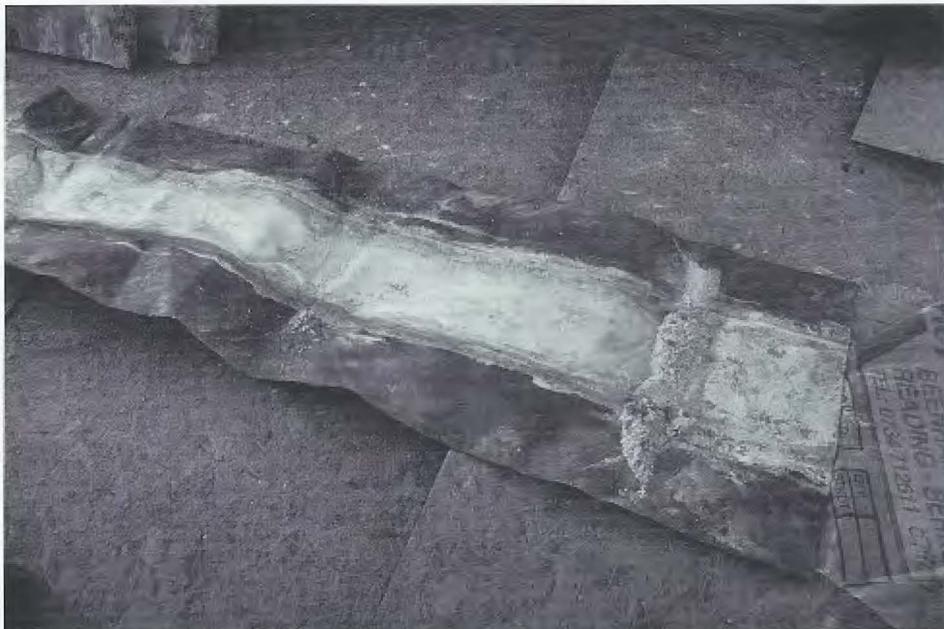
Figure 28. Lead over plywood in a gutter, with woodwool slabs to each side.

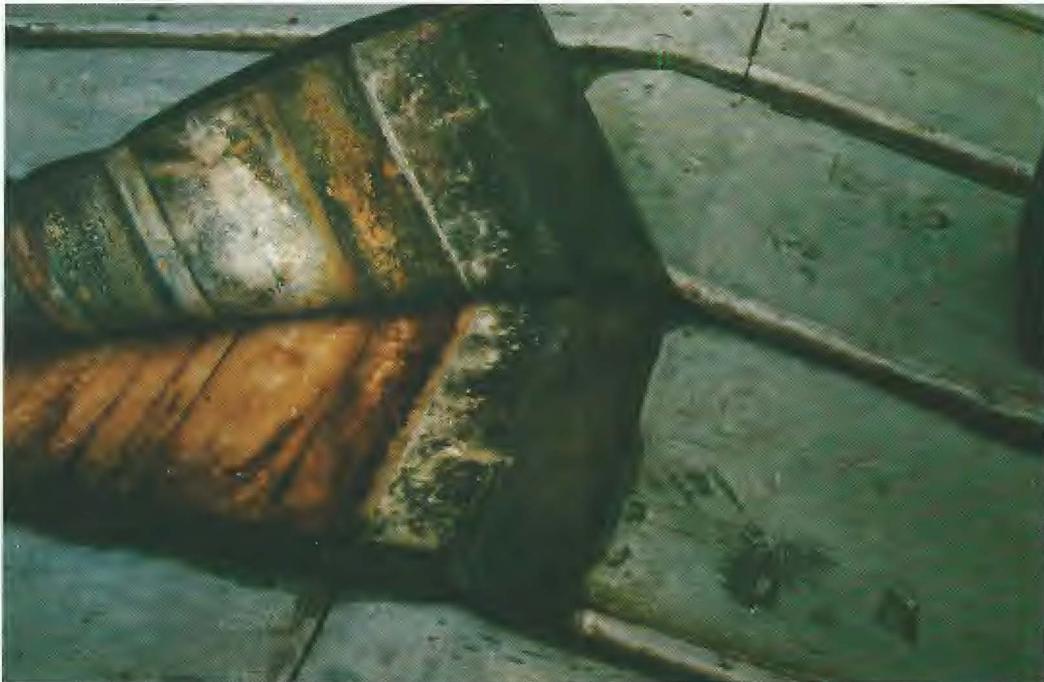
Plate 2. Corrosion above softwood boarding. White and yellowish (States 1 and 2) corrosion product on the nave roof of a Buckinghamshire church, with dark passivation above the gaps between the boards. The photograph was taken after a cold, clear night, and the roof was particularly damp at the time. Note also the passivation over the rolls (with the odd spot of corrosion). The ridge is passivated on the far (right) side, probably by rainwater, which also seems to flow over the ridge from time to time (the lap is mean). Not surprisingly, there are signs of corrosion here, probably the result of a combination of condensation and refluxing of rainwater. In spite of this, and of the church being particularly damp (RTL 1993, Report 6, Appendix D), the corrosion is not yet serious. See also Figure 6, p 38.

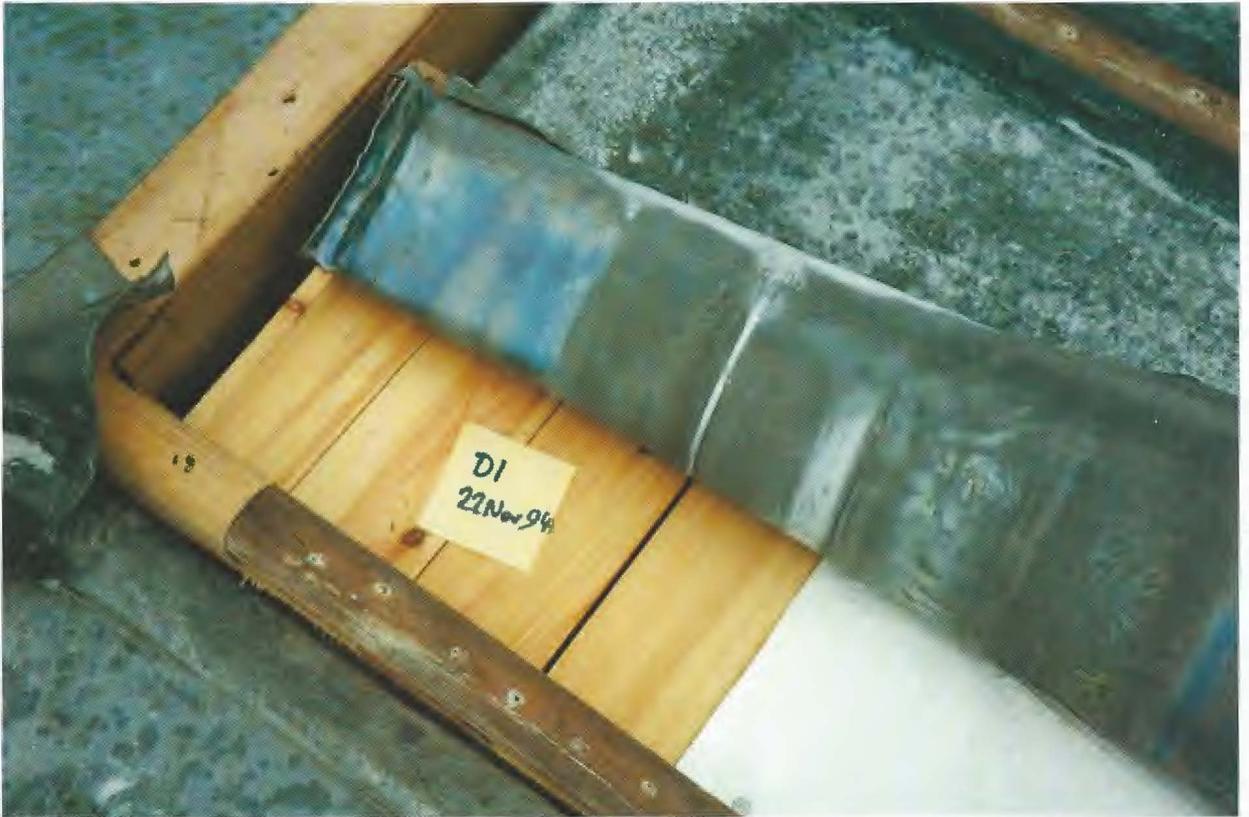
Plate 3. Lead after a two-month autumn test at Donnington Castle showing a wide range of surface states from passivation to corrosion. The two (untreated) boards on the left have kept the lead dry and its underside is only slightly dulled. The two to their right were preservative-treated and probably initially damper. This has assisted passivation over much of the boards, but corrosion around the perimeter. See also Figure 7, p 39.

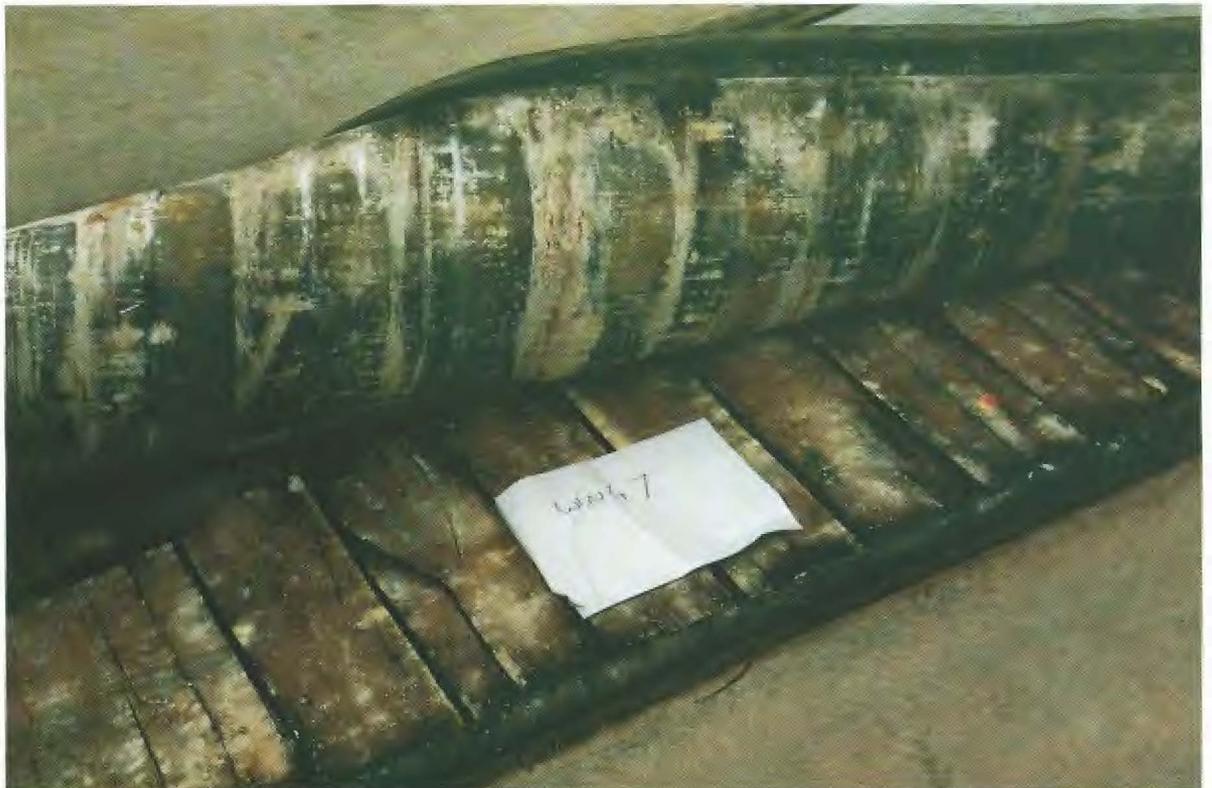
Plate 4. A church in Buckinghamshire: corrosion patterns on a slipped panel on the south aisle. See also Figure 8, p 39.

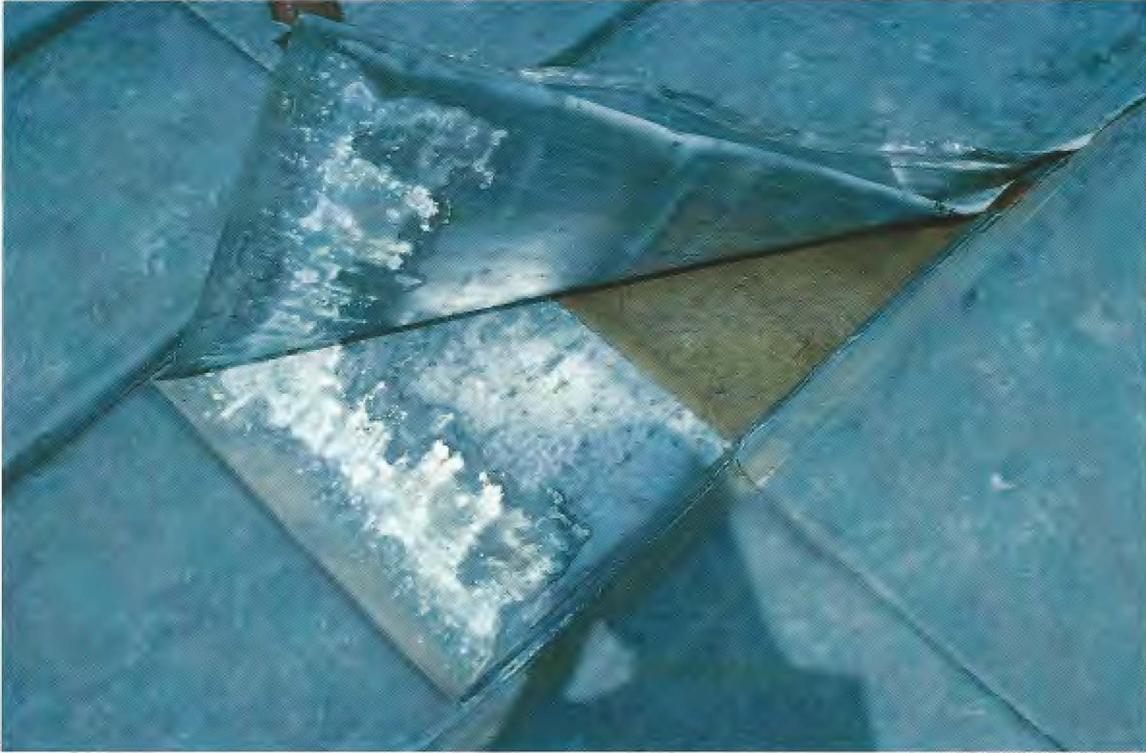
Plate 5. Lead over building paper on softwood on a relatively dry building. The lead is bright or only slightly dulled, though with a white haze between the boards. The pattern in the lap is not unusual: at the bottom a weathered area indicating capillary rise of rainwater, some corrosion (with a fringe of dark passivation) above that (where the rainwater distils) and the lead above that unaffected. The hollow rolls are free from corrosion. See also Figure 11, p 41.

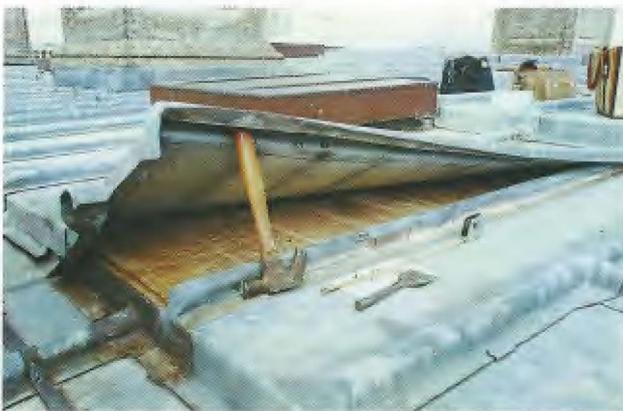
Plate 6. Underside of lead over Erskine's felt at a mansion in Dorset. The lead over the underlying boards above the public rooms is lightly and fairly uniformly corroded. Above the gaps there is a tendency to passivation. This corrosion is no longer active. Note also the corrosion in the roll above the splashlap caused by distillation of trapped rainwater: this recurs on a freshly wire-brushed surface. See also Figure 12, p 42.

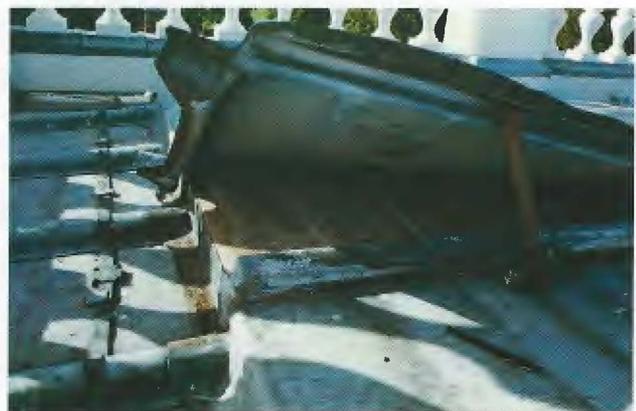
Plate 7. Underside of lead over Erskine's felt in a damper location at the Dorset mansion. The lead above the gaps is somewhat corroded, particularly towards the rolls in which there is also some corrosion. Note also the corrosion in the rolls above the splashlaps, as in Figure 12. The splashlap corrosion pattern varies with the distance apart of the sheets. Water is also trapped in the splashlap here by a slight backfall below the nosing. See also Figure 13, p 42.

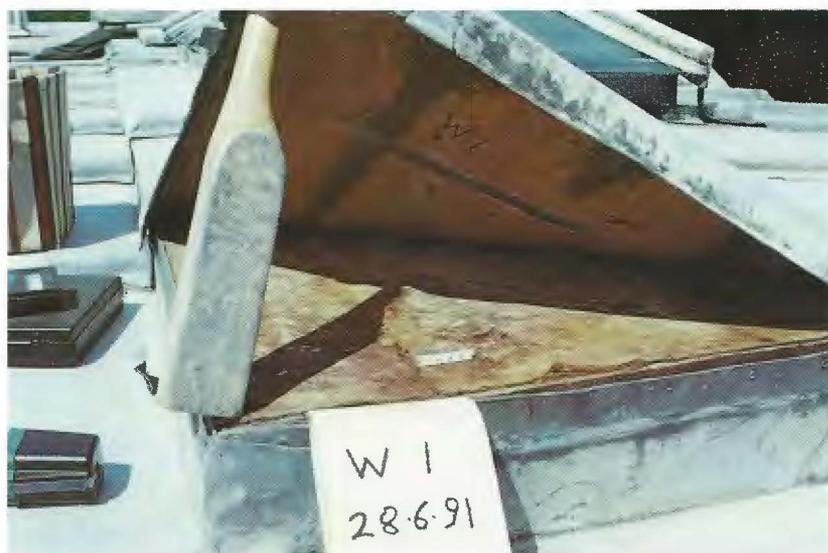
Plate 8. The original roof at the mansion in Buckinghamshire. Most of the roof was laid over Erskine's felt and was passivated between and corroded above the boards (the opposite of the current pattern). A few sheets, which did not have the felt, showed a similar pattern but with worse corrosion over the boards, probably because any moisture accumulating within this region would be trapped for longer than over the more permeable felt, and possibly there might have been some acidity. The longitudinal stripe was made by wire-brushing for tests and is not part of the original pattern. See also Figure 17, p 43.

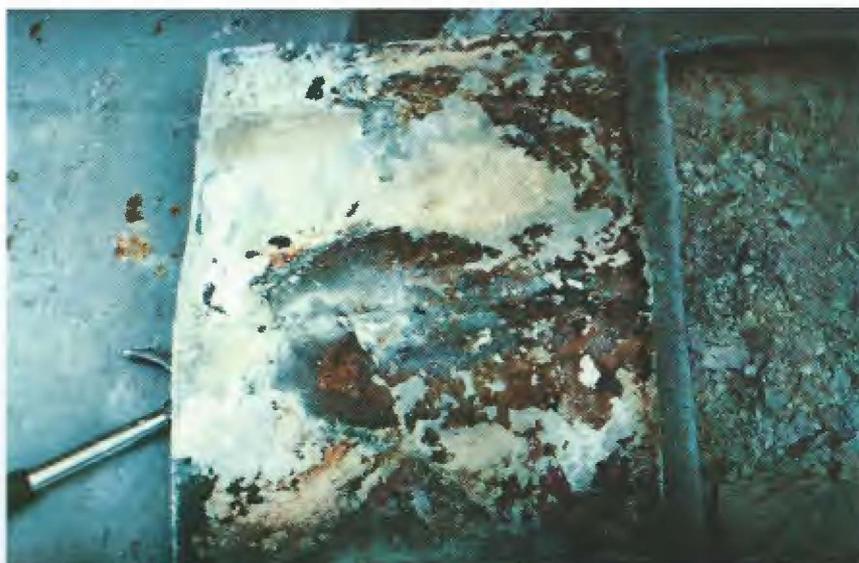
Plate 10. Underside corrosion over oak at Norwich Cathedral cloisters. The patch removed, on the left, failed at the perforation in the middle. The characteristic red/brown oxide can be seen near the interface with the metal, with the thick, flaky and granular corrosion product remaining underneath (on the right). See also Figure 19, p 44.
