Orchard Learning Resources Centre

The Orchard Learning Resources Centre at the University of Birmingham attempted to develop the genre for low energy, naturally ventilated academic buildings. How did the design and construction team get on?

BY THE PROBE TEAM

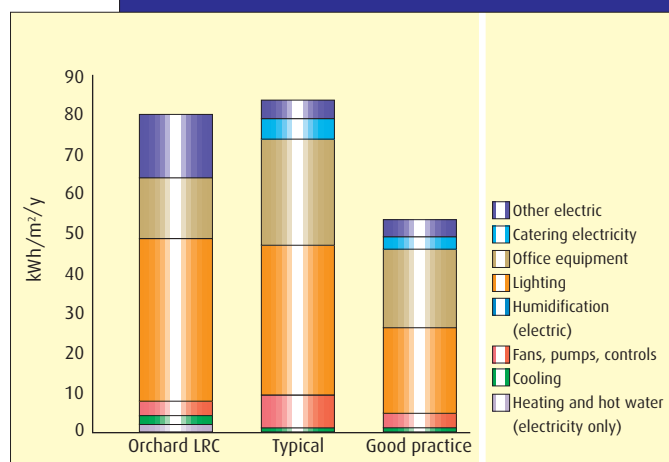
FIGURE 1: End-use electricity breakdown at the Orchard Learning Resources Centre.

The Office Assessment Method analysis considers performance against benchmarks. It excludes the floor areas and energy consumptions of the Mingana manuscript room and the book stack rooms to recognise that the type 2 benchmark building does not allow for such loads. The result of this analysis puts the adjusted electricity consumption at 69 kWh/m² tfa, which is about 28% above Type 2 good practice and 18% below typical (figure 1).

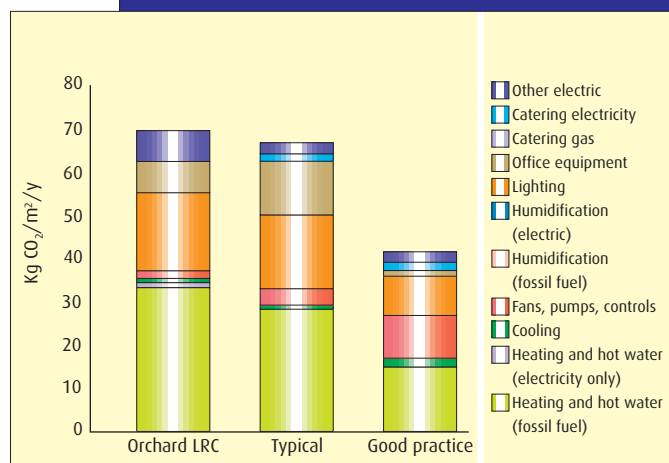
FIGURE 2: Carbon emissions at the Orchard Learning Resources Centre by end use. The conversion factors are 0.46 kg CO₂/kWh for electricity and 0.19 kg CO₂/kWh for natural gas (Econ 19, January 2000).

Total annual CO₂ emissions (after adjustment for weather) are 71 kg CO₂/m²/y, 4% above the typical level (figure 2). In comparison with the Anglia Polytechnic University learning resources centre, examined by the PROBE team in 1996¹, the Orchard Learning Resources Centre uses twice the amount of gas, 50% more electricity and emits 82% more CO₂.

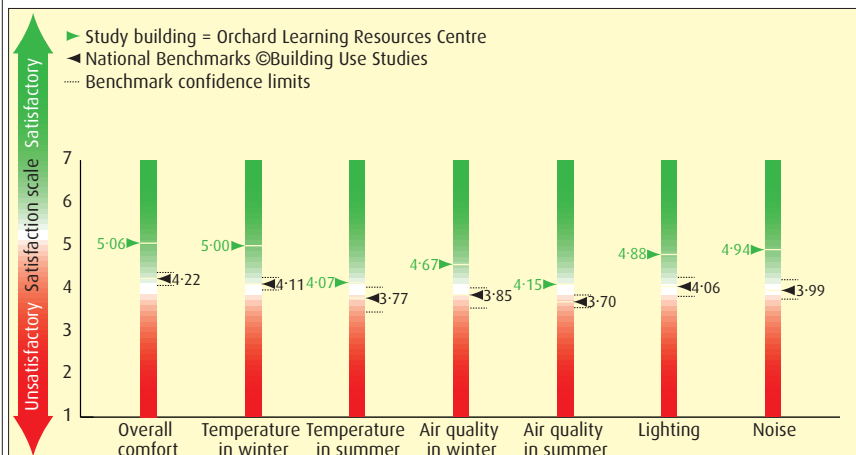
FIGURE 3: Overall satisfaction with comfort conditions at the Orchard Learning Resources Centre. A green arrow signifies a performance at or better than benchmark, a red arrow below benchmark. These scores are relative to the benchmark dataset of 50 buildings. They are therefore not absolute.

On temperature and air quality, the building is perceived to be neither too hot nor too cold, although there were localised complaints. In winter it is considered stable, still, dry, fresh and odourless. Winter air quality is also perceived to be satisfactory. For summer, the building is comfortable overall, but too hot, stable, still, dry and stuffy. Again, air quality is satisfactory (figure 3).

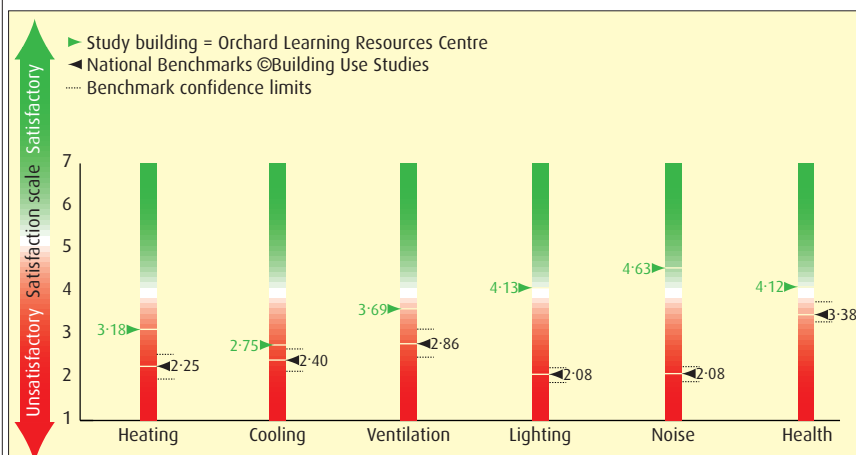
FIGURE 4: Occupants' perceived control over their environment, plus scores for their perception of the building as a healthy place to be.

Every one of the scores for perceived control and quickness of response is significantly better than the dataset benchmarks. The score for occupants' view of the building as a healthy environment are also high (figure 4).

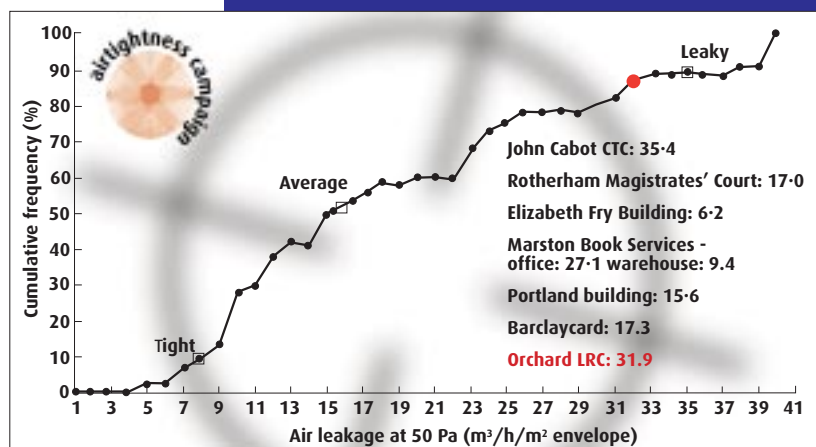
FIGURE 5: The air leakage data for the Orchard Learning Resources Centre, plotted on the BRE/BSRIA database. The cumulative distribution represents a sample of three building types: those designed to be airtight, buildings designed without airtightness as a design criteria, and some older buildings.

The resulting air leakage (at a reference pressure of 50 Pa) was calculated to be 31.9 m³/h per m² of envelope area. As a tight non-domestic building would have an air leakage index of less than 7.5 m³/h per m² of envelope area, and a leaky one 34 m³/h per m² of envelope area, then the Orchard Learning Resources Centre can be considered to be close to the leaky benchmark on the BRE/BSRIA database.

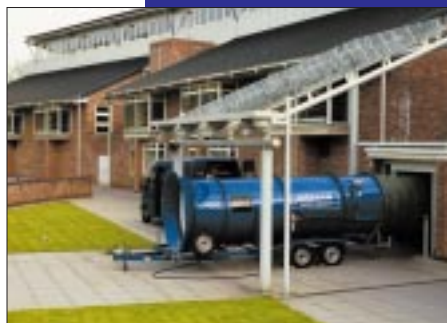
A brief air leakage audit using hand-held smoke tubes identified the leakage paths in the envelope. Significant air leakage occurred at the coffered ceiling/external wall junction. The top and bottom of the columns also leaked.

The BREFAN Large Fan Pressurisation System during the BRE pressure test at the Orchard Learning Resources Centre.
