PROBE 6

Mark Standeven, Robert Cohen and Adrian Leaman report on how Woodhouse Medical Centre, one of the first truly green buildings in the UK, has performed since completion. To understand the building's detailed design, readers should refer to the original article "Introducing the thick building", which appeared in the January 1990 edition of *Building Services Journal*.

Woodhouse Medical Centre is located in the village of the same name on the outskirts of Sheffield. Commissioned by two local medical and one dental practice, the building was constructed under strict financial and spatial constraints exercised by the Sheffield Health Commission.

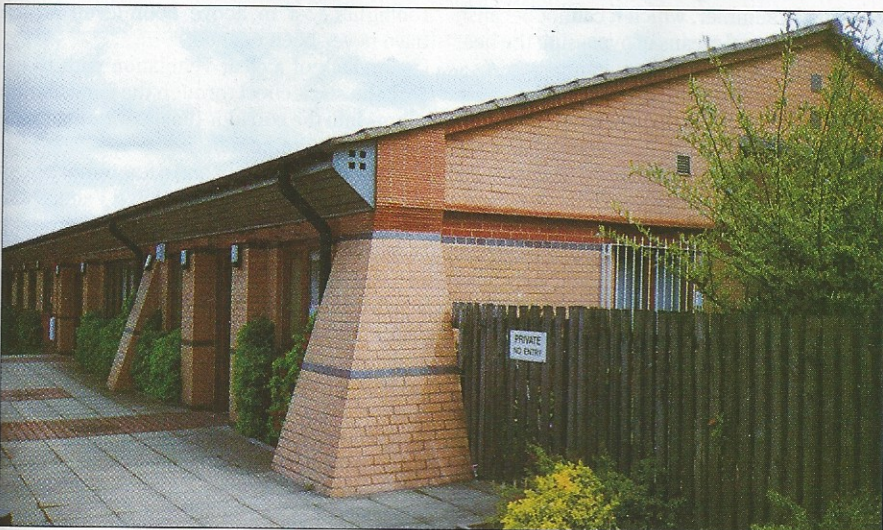
Highly insulated, the Woodhouse Medical Centre scores well on winter comfort.

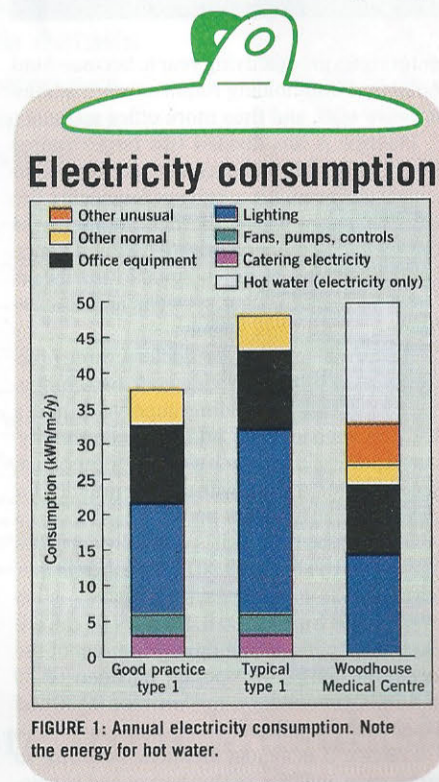
FIGURE 1: Annual electricity consumption. Note the energy for hot water.

A breakdown of the annual electrical consumption of 50 kWh/m² is shown in figure 1. At 17 kWh/m², hot water represents the largest single use of electricity and reflects the considerable number of hand washes per staff member per day, together with cleaning and washing up. Standing losses from the 27 point-of-use water heaters amount to 8 kWh/m², which is nearly half the total.

At 14 kWh/m², lighting energy consumption is lower than for a good practice office which reflects the low average installed load of 8 W/m². However, in the rooms with the halogen uplighters in unit B the installed load is 17 W/m². Office equipment accounts for 10 kWh/m², which is similar to the figures for equipment use in a typical office.

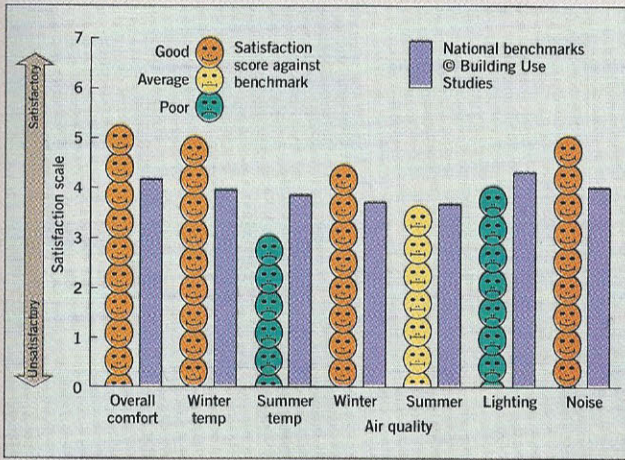
FIGURE 2: Overall satisfaction scores compared with national benchmarks.

Overall comfort, winter air temperatures, winter air quality and noise are all significantly better than the Building Use Studies (BUS) benchmarks. Overall comfort is the best yet recorded by BUS (a total of 55 buildings) and winter temperatures second best (figure 2).

There is no significant difference between the benchmarks and Woodhouse Medical Centre for overall summer air quality and lighting, but perceived summer air temperatures are much worse and the centre falls into the lowest 10% of buildings surveyed.

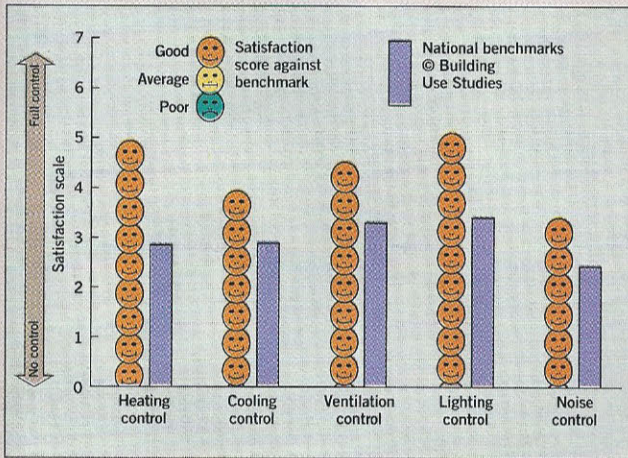
FIGURE 3: Occupant satisfaction with the building's control strategies.

Perceived personal control of heating, ventilation, lighting and noise are all significantly better than benchmarks, and control of cooling is also better (figure 3). These results reflect the fact that work areas are shared by only a few people and the means of control are straightforward and familiar – adjustable trvs, openable windows, blinds and light switches.

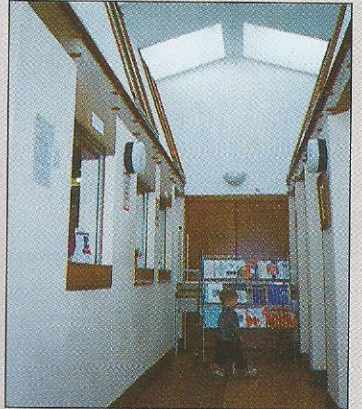
During the PROBE survey, artificial lighting was in use in all occupied rooms, except for the central corridor. The combination of low glazed areas and blinds – the latter driven by the need for privacy – means that most consulting rooms have poor daylighting.

The Woodhouse Medical Centre achieves an outstandingly low heating energy use, but the emphasis on minimising heat loss may have led to a neglect of the higher cost and CO₂ emissions of employing electric lighting for a building which is occupied predominantly during conventional office hours. Daylight provision is generally poor, except for that in the central corridor.

The daylight level in the central corridor was high at 3000 lux, but was poor elsewhere.

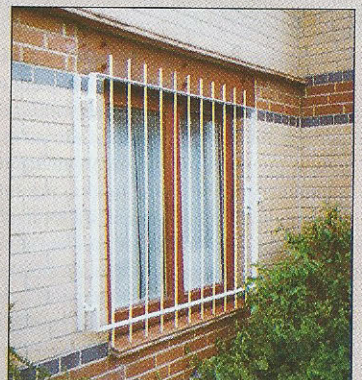
The dental practice has also suffered from several burglaries, and would have preferred more robust window frames than the existing ones which were levered apart during the entries. Although window security bars offer good protection, they also now severely restrict window opening.

Sign of the times: security bars on the dental practice. Now the windows hardly open.
