BY THE PROBE TEAM

PROBE

## 16: Marston Book Services

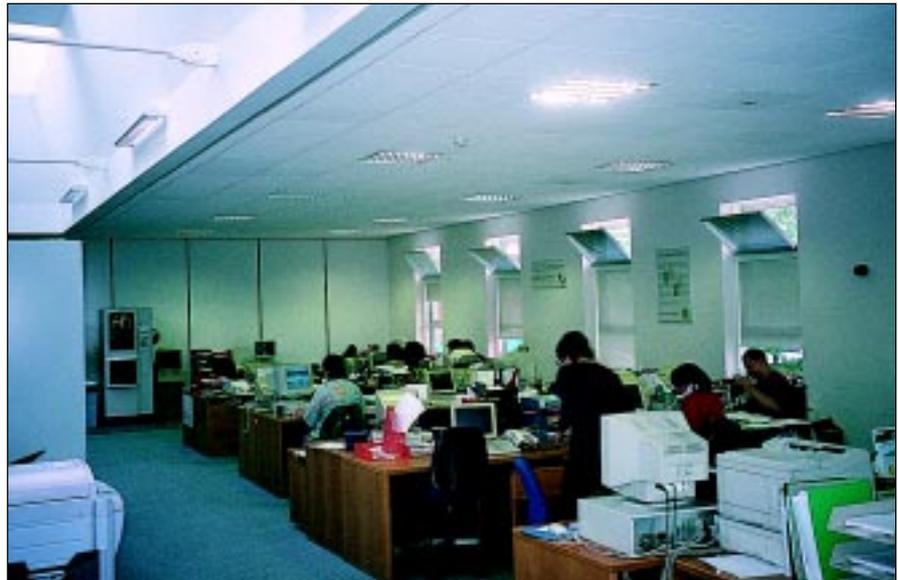
The glare from sun and sky is disappointing in view of the care devoted to the window system. This is due to diagonal sunshine coming past the ends of the light shelves, and bright spots on the blinds in bright sunshine.

The reported glare from sun and sky is disappointing in view of the care devoted to the window system. This seems to be due to diagonal sunshine coming past the ends of the light shelves and bright spots on the translucent blinds in bright sunshine. There are no blinds on the north facade, but bright skies can still cause problems with contrast glare and reflections in computer screens.

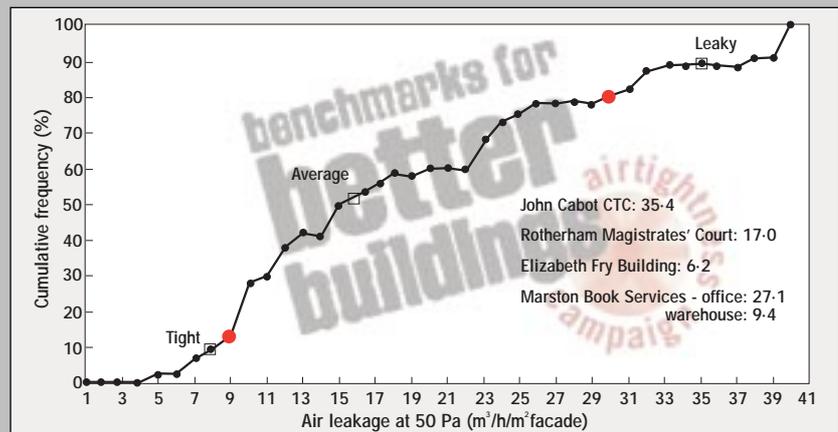
FIGURE 4: The air leakage data for Marston Book Services, plotted on the BRE/BSRIA rolling database.

The Q-value ( $Q_{50}/S$ ) for the offices was calculated to be  $27.1 \text{ m}^3/\text{h}/\text{m}^2$  of envelope area (calculated at  $1366 \text{ m}^2$ ). This puts the building near the 'leaky' group on the BRE/BSRIA database (figure 4).

This indicated significant air leakage through the roof structure of the office building, and at the junction between the office brickwork and the warehouse cladding, which occurs at the smoking room. In depressurisation mode, a ceiling tile was lifted manually, and a severe downward draught of air was detected from the office roof space.

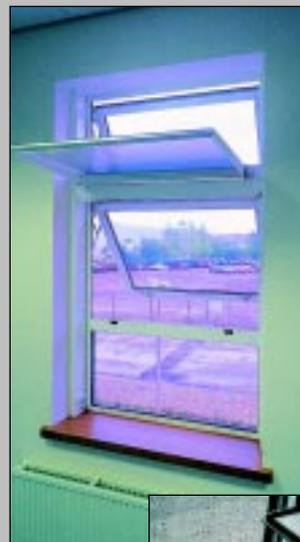
So how has the Interactive Window System performed? Occupants regarded the windows as successful in the main for ventilation, and particularly liked the performance of the upper motorised window, although some whistling occurred in high winds. However, the central window element performed poorly, as only a small wind was required to blow it shut.

The window hinges do not have sufficient resistance, and there is no slit-catch position.

Consequently, people sitting by the windows cannot control the draught, and feel that too much of the air goes over their heads.

Occupants liked the upper motorised window, but the central window elements close under only a small wind, leading to...
