BY THE PROBE TEAM

18: Portland Building

The Portland Building is the fifth educational building to be surveyed by the PROBE Team, and the last in the current PROBE series of building investigations.

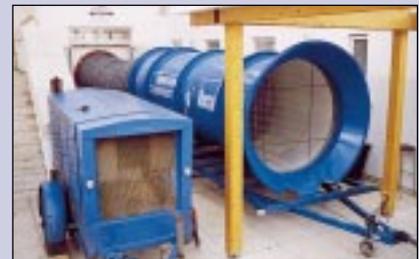
The air leakage audit showed that the roof/wall junctions on the third floor were very leaky. The junctions between the RSJs and timber beams were also found to be very leaky, with large gaps visible. Air was detected coming from the ventilation towers, indicating that these structures were not airtight.

The windows were found to be generally quite good, with minimal air leakage through them. However, there was significant air leakage around the south-facing timber bay windows, especially along the floor joint. The stairwell windows were also found to be slightly leaky at the frame wall junction.

All of the external doors had significant air leakage through them. The fire doors on the ground floor in the small lecture theatre leaked badly, both at the bottom and along the right-hand sides.

The double fire door at the bottom of the stairwell leaked very badly along the bottom and between the doors. The doors in the student common room also leaked down the middle. Significant air leakage was evident in all other external doors.

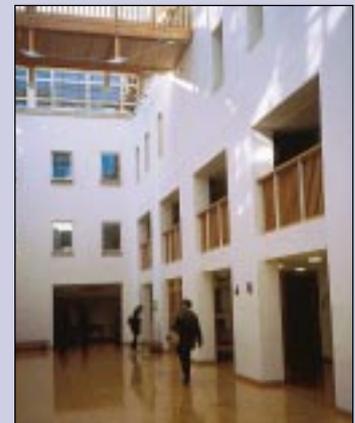
There have been several other difficulties with the Forum's rooflights. On occasions they have stuck open, and a special cherry picker has had to be used to reach them. Motors have also been failing. The Estates Department thinks they may be over-stressed and that pneumatic actuators might have worked better.

ABOVE: The Forum. A welcome circulation space, albeit with dysfunctional rooflight actuators (LEFT) and some reported noise problems.

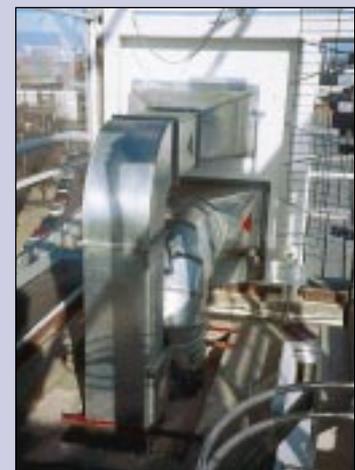
supply systems. A further cat ladder and trapdoor leads to the glazed ventilation turrets above, which house cold water storage cisterns, mechanical ventilation inlets and outlets and 2 m² of flat plate solar panels for hws preheating. The plantrooms are cramped, with some pumps inaccessible for maintenance.

ABOVE: The turret plantrooms. Attractive, but difficult to access and not airtight.
