# The Old Apple Store, Stawell

# The Old Applestore, Stawell

Technology Strategy Board Building Performance Evaluation Programme: Initial Occupancy Study

## **Final Report**

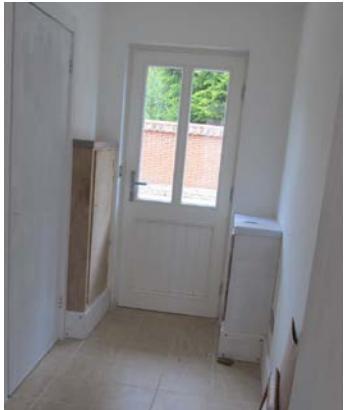
Figure 4 Stores for meter cupboards and invertor by front door

- 3.43. The arrangement of the front hall is simplified (fig 3); the provision of a bigger meter store would have been better as **the current inverter store overheats considerably and will need substantial ventilation openings** (fig 4).
- 3.44. The living room is more spacious room and the boiler changes from the kitchen side to the stair side of the building (fig 2 and 3). This has a knock on effect on the upstairs-the water services and the flue (fig 7).

- 5. Increase ventilation to solar system inverter cupboard to prevent excessive overheating and potential degrading of product efficiency.
- 6. Ensure all waste service controls are properly labelled and suitably located for easy access (not at the back of cupboards, which fill up).

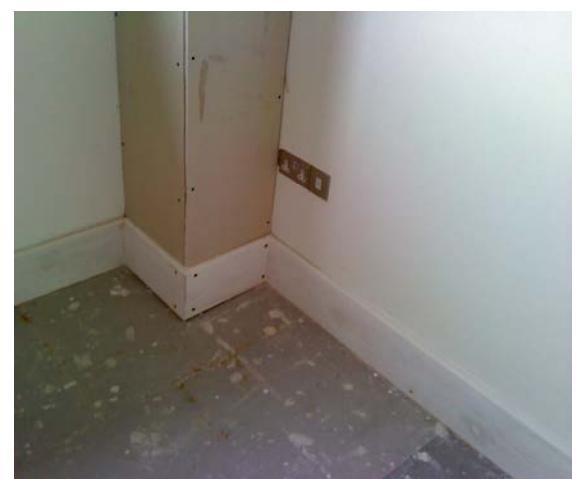
Figure 7 Boxed flue in bedroom 3

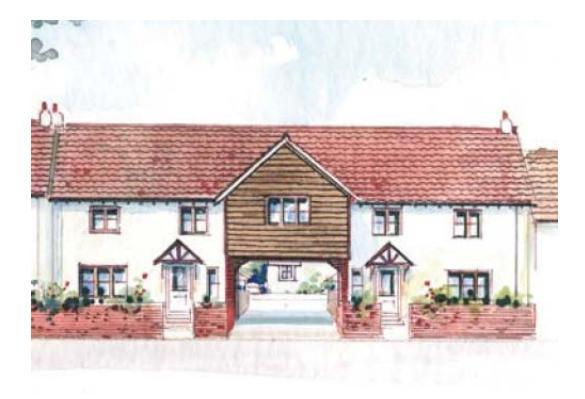
Figure 13 North elevation, sales brochure

- 3.49. The brochure drawings feature a curved archway in the alleyway (fig 13): this was not part of the design drawings.
- 3.50. The ground floor levels of houses 1, 2 and 3 have been raised by 500 mm from road level to facilitate headroom in the alley way. This gives a difficult level drop of 500 mm outside the french windows of No 1 and 2 and does not achieve a headroom adequate for deliveries of wood pellets which have to be dropped in the alley way and wheel barrowed around into the garages by the building occupants.

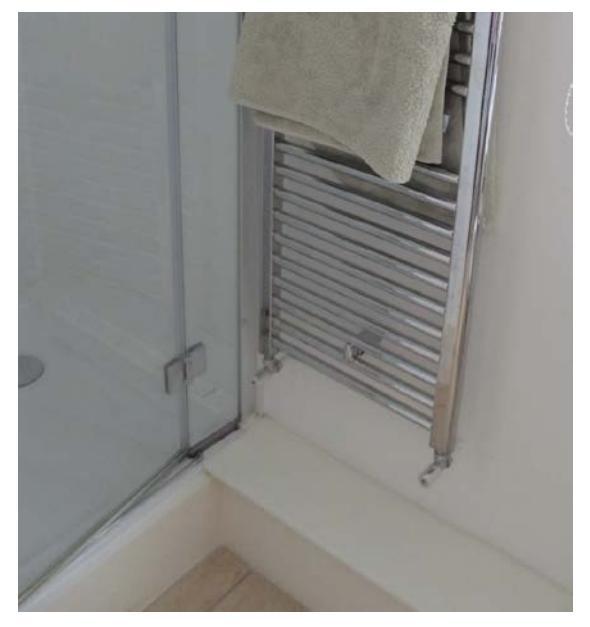
Figure 14 Towel rails in bathrooms heated by solar hot water

- 8.6. There is **no easy way of controlling** the flow or temperature of the **hot water towel rails** in bathrooms and airing cupboard which seems wasteful in terms of energy use.

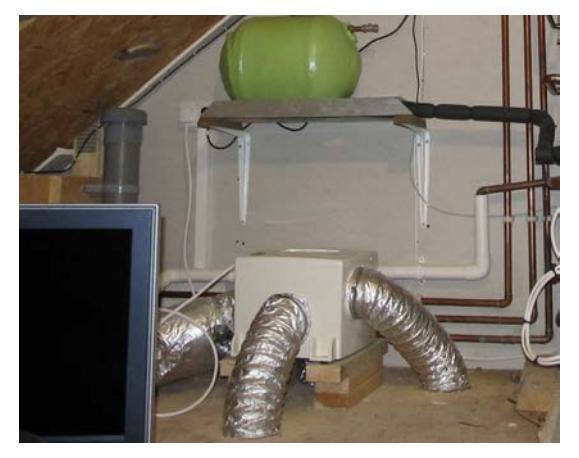
- 3.56. No ventilation drawings relating to the housing development appear to be available.
- 3.57. There is no mention of an MEV system in the original sales brochure, implying that a passivent system was still being deployed when this had in fact been changed. The developer stated that they had originally intended to install a passivent system in the three terrace houses (No.1, 2 and 3) but during the build it was discovered that the ventilation duct runs would not comply with passive vent regulatory requirements so an MEV fan unit had to be included and positioned in the roof space. This is not ideal for the resident because changes to the ventilation rate (1,2 or 3 speed) can only be achieved by rewiring the unit as there is no dial control (fig 15).

Figure 15 Ventaxia unit in roof space with no dial controls

- 5.10. Controls have not been provided for the ventilation installation. Adjustment of fan speeds is currently only afforded by re-wiring the fan terminal block. It is highly recommended that, as a minimum, a speed selection switch, possibly with timer for set-back mode (e.g. over-night to minimise noise nuisance) be fitted.

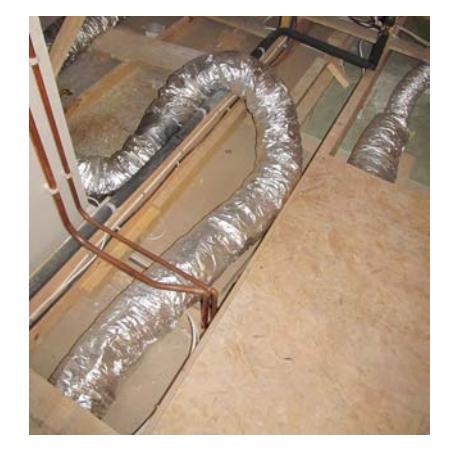
Figure 16 Long lengths of flexible ducting

- The MEV installation is primarily of flexible ducting which is not recommended in practice (fig 16) and the occupants of number 3 are unhappy because it the increased noise levels this produces.
- For the MEV to work effectively there must be some incoming air. This was not explained to the occupants of number 3 when they moved in: they enjoy the warmth and economy of their unit and find that opening the trickle vents whilst operating the MEV system decreases the temperature considerably (by 1-2 degC) and so have decided against this strategy.
- The location of services (solar, MEV, immersion heater control) in the roof space makes their servicing/adjustment inaccessible. This is problematic because it might be desirable to increase the ventilation rate when cooking for example, and then to turn it down afterwards.

- 5.8. Flexible ductwork has been employed throughout the installation of the continuous mechanical extract ventilation system (MEV). This type of ducting system, in conjunction with the excessive amount of installed bends will lead to unnecessary duct resistances, reducing air flow performances and increasing noise levels from the system. The main extract duct runs directly over the main bedroom ceiling (plasterboard with no acoustic insulation) to the external terminal. It is noted that occupants have complained about noise nuisance during the night.

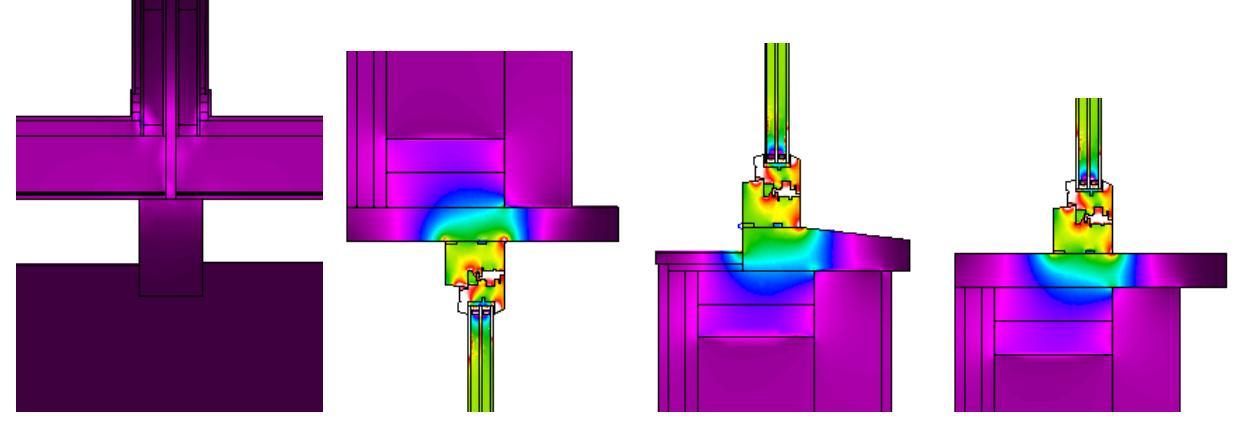
Figure 17 Thermal bridges with greatest contribution to y-value: Ground floor party wall(left), window head/jamb on timber wall (middle) and window cills (render and timber) (right).

- Overall, thermal bridging represents 9% of the fabric heat loss for this dwelling type.
- Window head, jamb and cill junctions on timber cladding create a clear thermal bridge with the timber going all the way through the wall at these junctions.

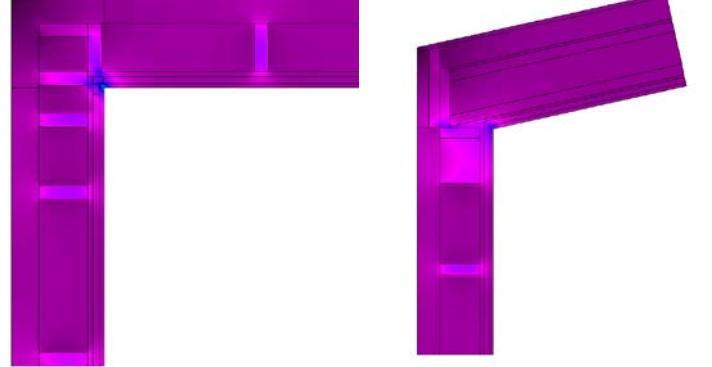
Figure 18 Thermal bridges with greatest contribution to y-value: External wall timber clad corner (left), and low roof eaves (right).

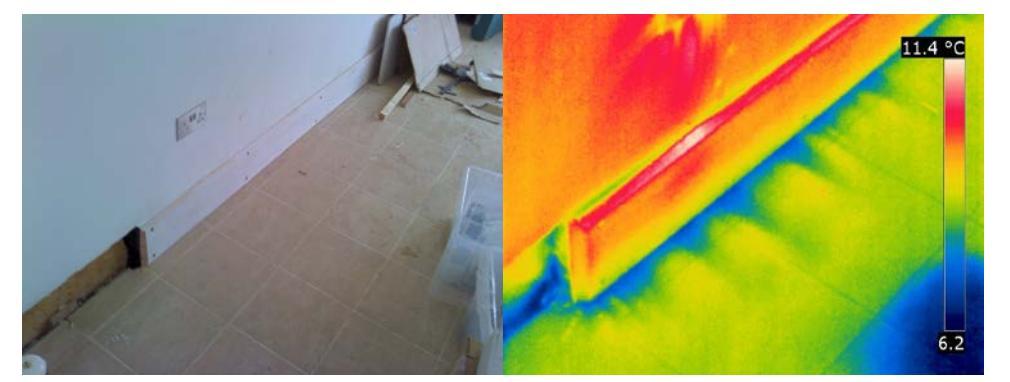
4.17. Infra-red imaging was carried out during the air pressure testing identified *air leakage under skirting boards, around door thresholds and seals, window frames and*

Figure 24: Living area party wall (to No1): air leakage around floor

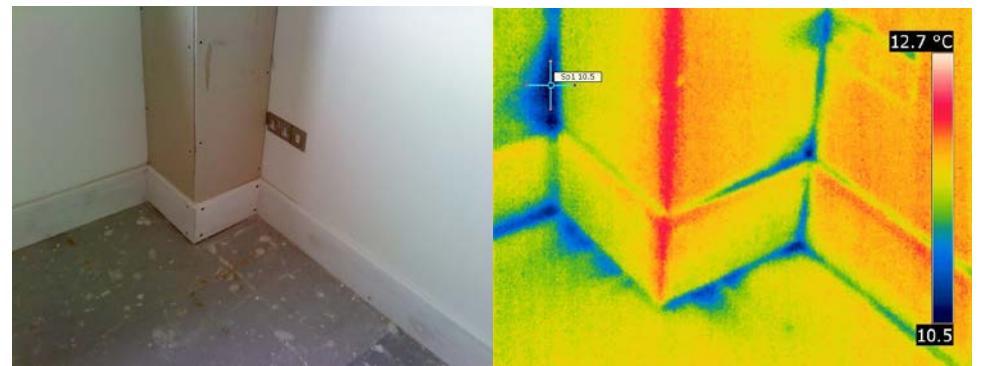
Figure 25: Air leakage around boxed in section

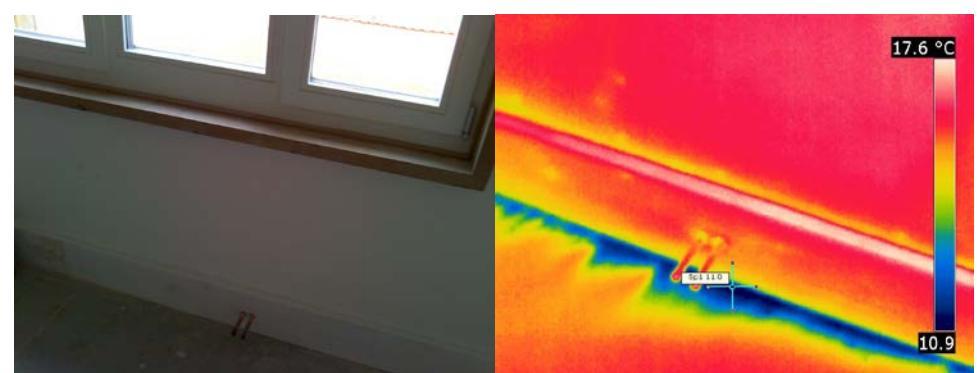
Figure 26: Air leakage under skirtingboard

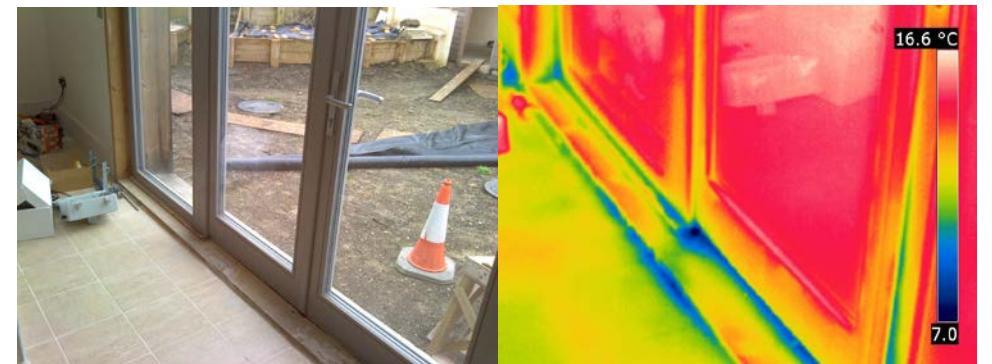
Figure 27: Air leakage around door thresholds and seals

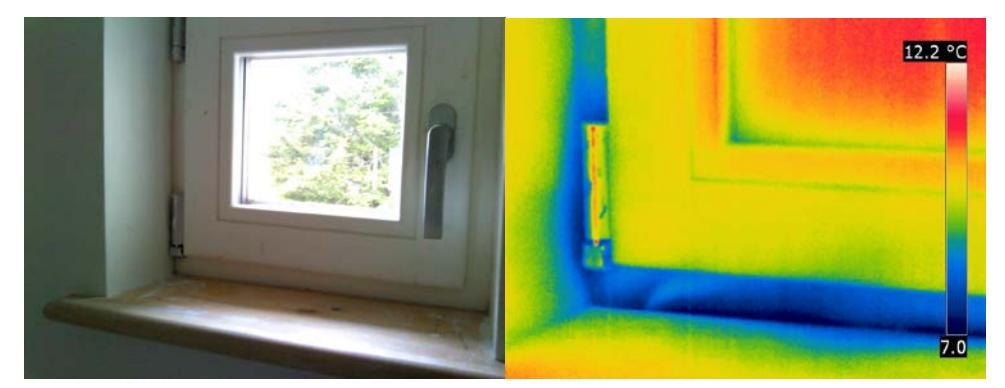
Figure 28: Air leakage around bathroom window frame

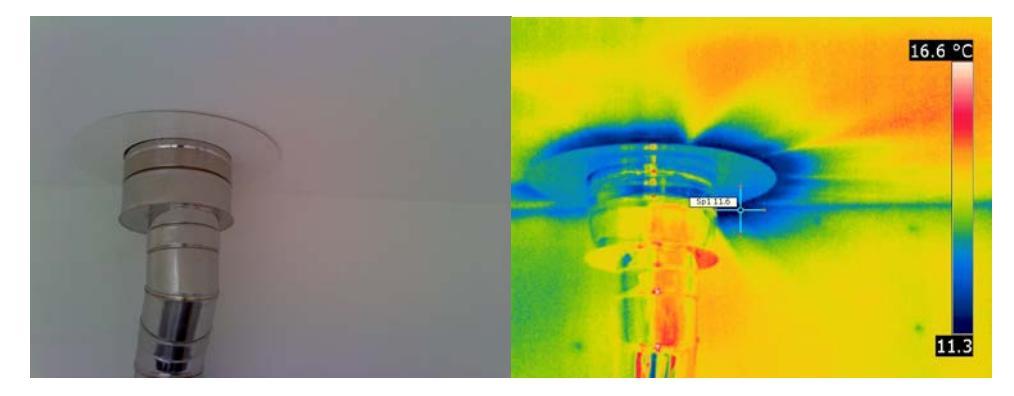
Figure 29: Air leakage through flue collar

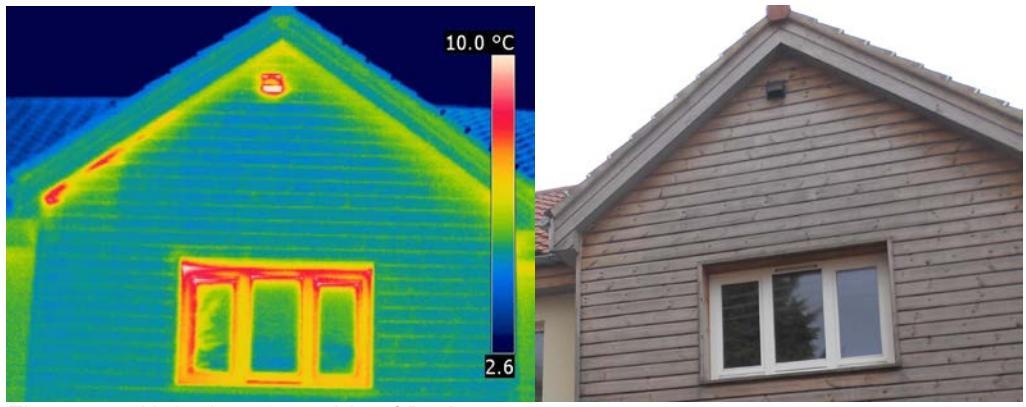
Figure 30: Air leakage at gable of Bedroom 2

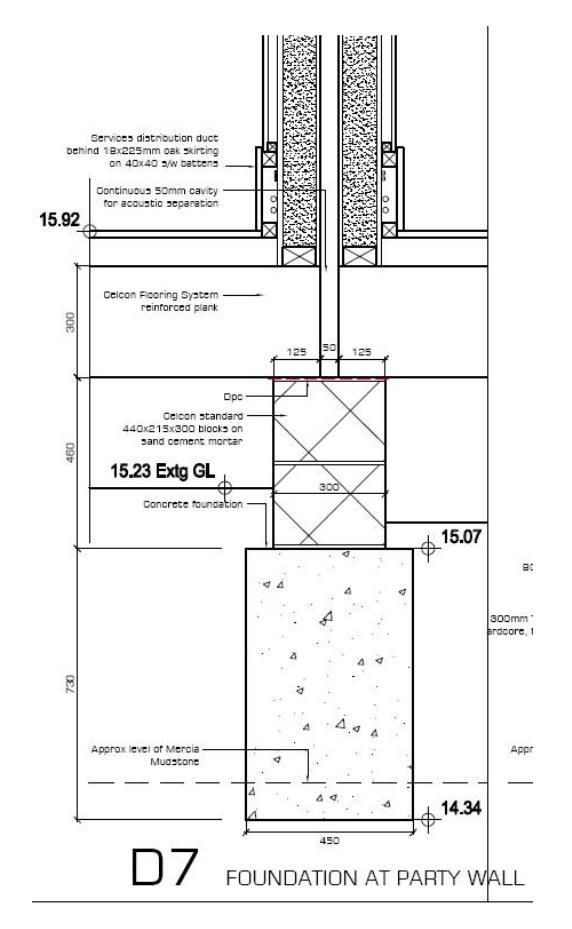
Figure 33: Section through party wall

- 4.33. The measured rate of average heat loss of 48.26W is much bigger than expected and was found to be approximately 2.65% of the total heat loss from the building.

- 4.34. There is some party wall thermal bypass, most probably due to the party wall to foundation construction as shown below, which shows an unfilled cavity in the wall allowing air currents and thermal bridging to occur at the base of the Celcon blocks abutting the foundations:

- 1. The air permeability measured by air pressure testing at 50Pa was higher than the target value, possibly due to the incomplete nature of the building work. Inspection by the testing house revealed air leakage in the roof space. All detailing should be fully complete before undertaking air pressure tests, and service penetrations require particular care.
- 2. Calculation of thermal bridging factor (y-value) is worthwhile for large projects as the default value can lead to errors in the projected heat loss. In this case, the thermal bridging was overestimated in SAP by a factor of 3.2
- 3. The party wall should be investigated further because heat flux measurements indicate greater than predicted heat flows. Further infrared, heat flux testing, and inspection would yield valuable lessons for future houses.

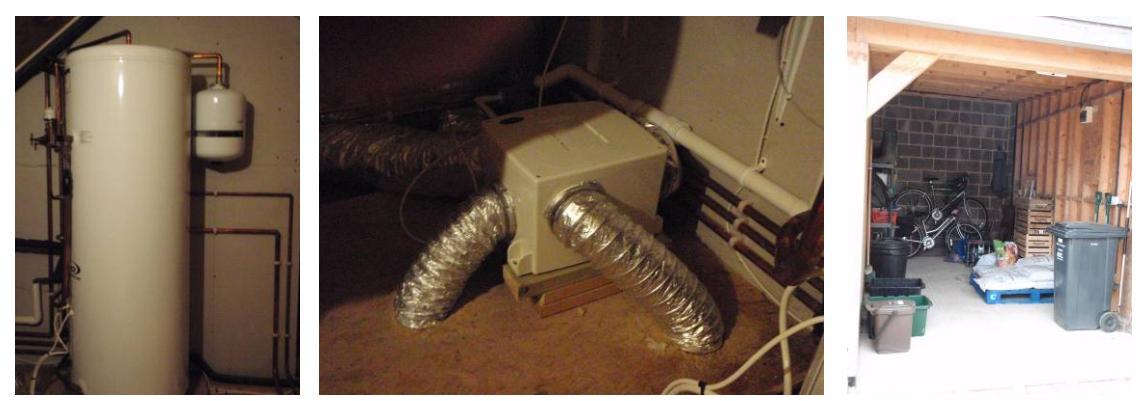
- 8.10. The MEV system is relatively poor; it runs constantly and cannot be adjusted without rewiring the unit which is located in the loft and not easily accessible (fig 38). As the system is noisy, the customers asked for it to be reset to a lower fan speed soon after they moved in. This setting does not seem sufficient to get rid of smells when cooking which linger around the house and in fact the installation and commissioning report (see section 5 of this report) found the MEV unit did not provide

8.11. Occupants are generally happy with the wood pellet boiler. However, they found that there was **no provision made for storing the pellets** (they get deliveries in 15 kg bags of 1 tonne a time). They use the car port for this purpose, having to forfeit the car being kept there (fig 39)

Figure 37 (left) hot water tank in roof with new pressure release tank, Figure 38 (middle) mechanical ventilation system in roof, Figure 39 (right) car port with pellet stored in it
