# **Building Performance Evaluation**

# **Final report**

Phase 2: In-use performance and post occupancy evaluation

Technology Strategy Board BPE ref no:	450069
Project title:	Monitoring of an estate near Rotherham
Lead organisation name:	Verco
Number of properties as part of BPE:	4

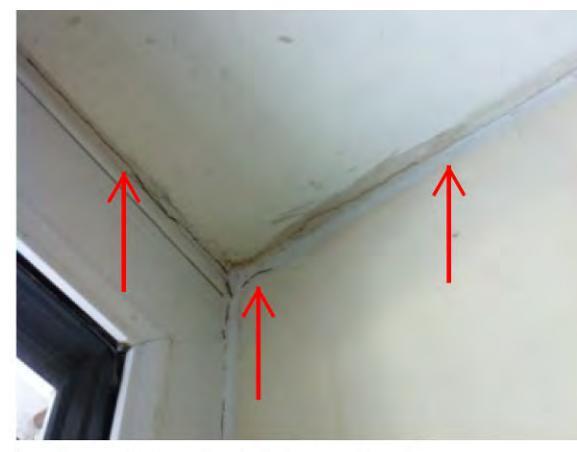
Leakage through shrinkage cracks

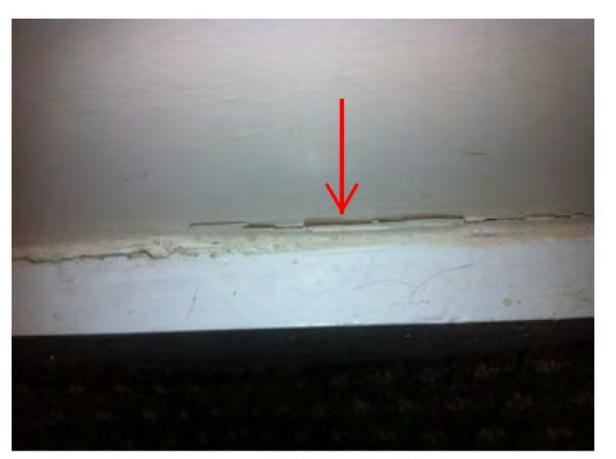
Leakage through shrinkage cracks

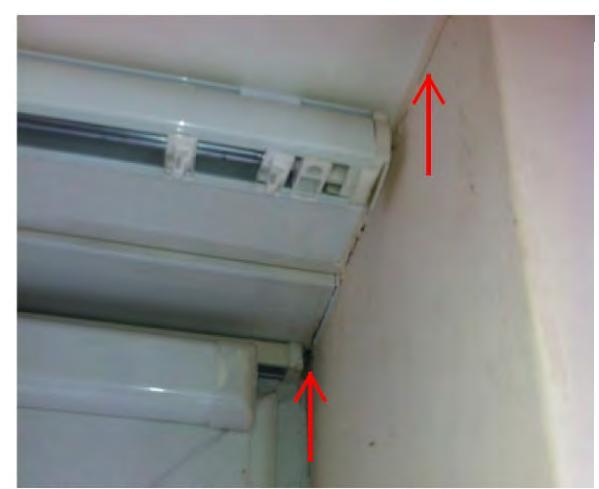
Leakage through shrinkage cracks

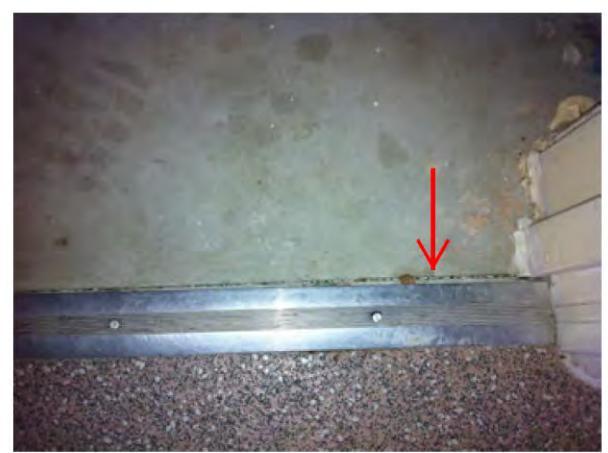
Leakage through floor joints

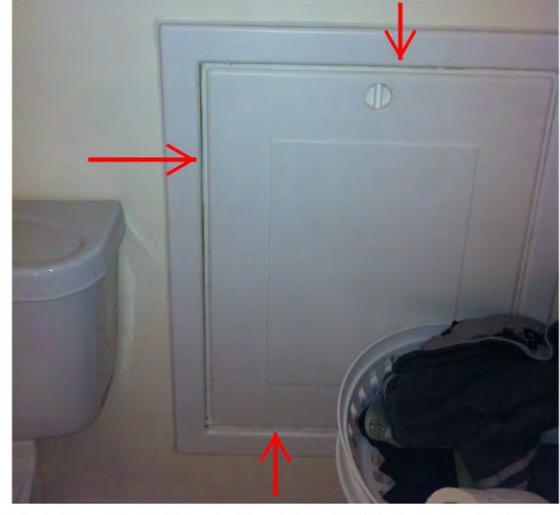
Leakage under skirting lifting floor covering

Significant leakage through WC access hatch

- The skirting board should be re-installed, ensuring the skirting sits flush with the floor level, not the lino flooring finishing level. Currently the skirting board finishes at the level of the lino, and the Mastic is sealed on top of the lino. This has resulted in the lino being able to come away from the floor very easily, which is a major issue for air infiltration.
- Investigate an improvement in the loft hatch insulation and sealing, as heat is currently being lost to the loft (the uninsulated space) unnecessarily.
- Investigate insulation and air tightness measures for the service hatch in WC. The solution here may not be clear-cut, since the air is lost to a service area, which is inside the building insulation envelope. There must therefore be a further leakage path in the building envelope. Improving the sealing of the hatch itself may be the most cost effective solution.

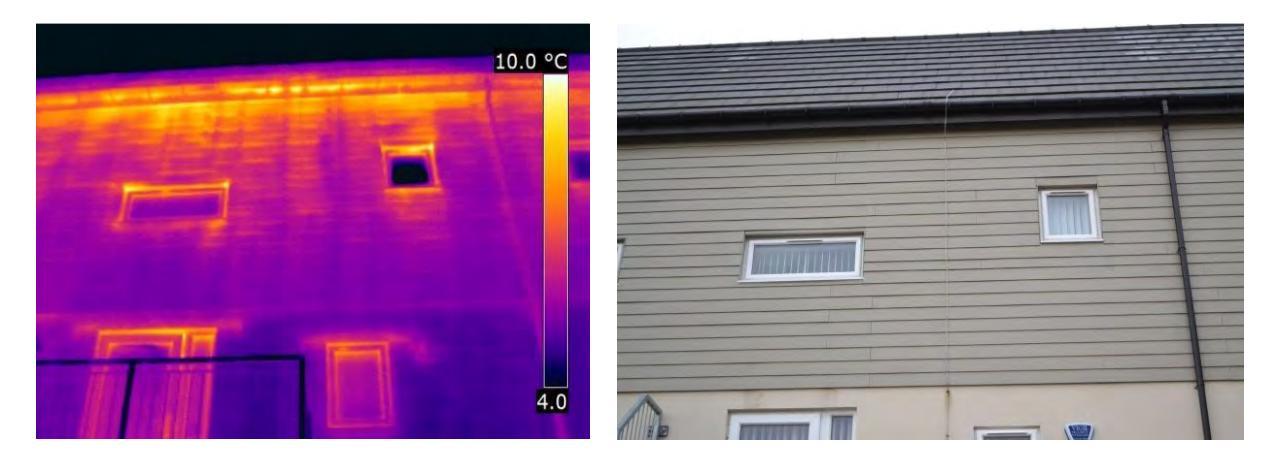
Image 6: Property 3C Front 2<sup>nd</sup> Floor. Observations: Elevated temperature at top of cladding. Note: cladding is ventilated. Potential leakage at window corners

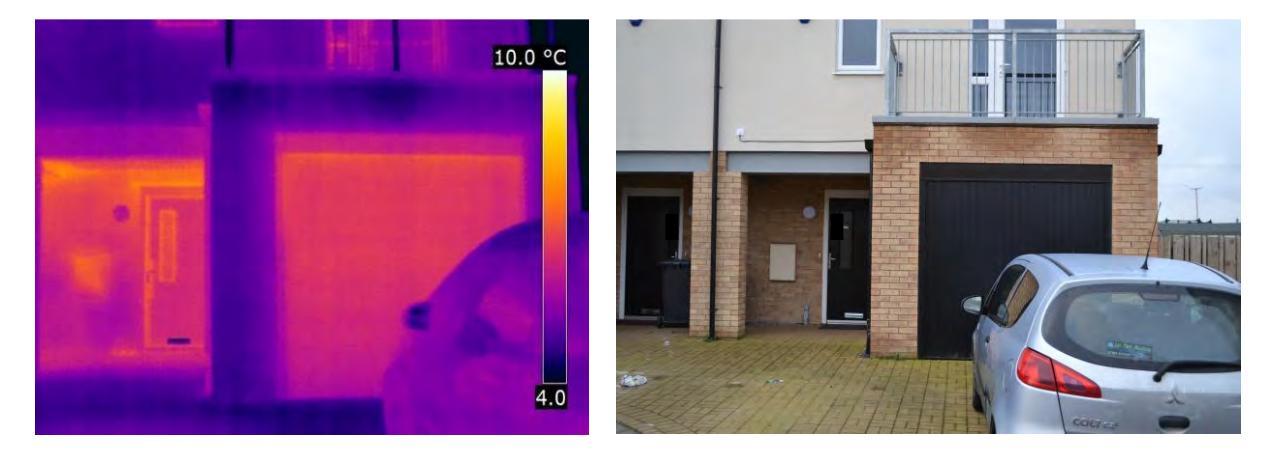
Image 7: Property 3A Front Ground Floor. Observations: Localised temperature elevation at meter box. Porch area temperature elevated, door had been in use.

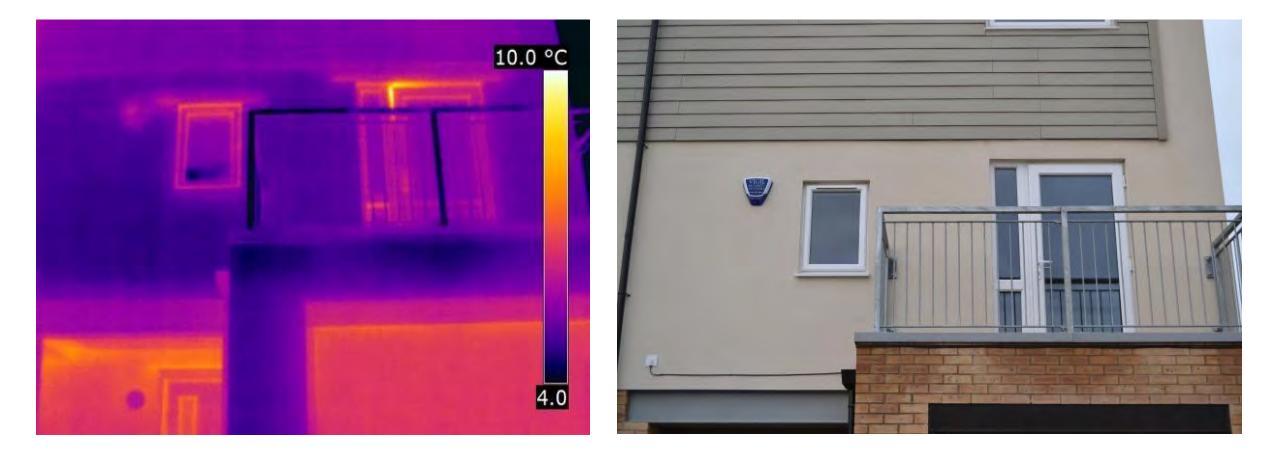
Image 8: Property 3A Front 1<sup>st</sup> Floor. Observations: Leakage at top left hand corner of door. Elevated temperature above window and door

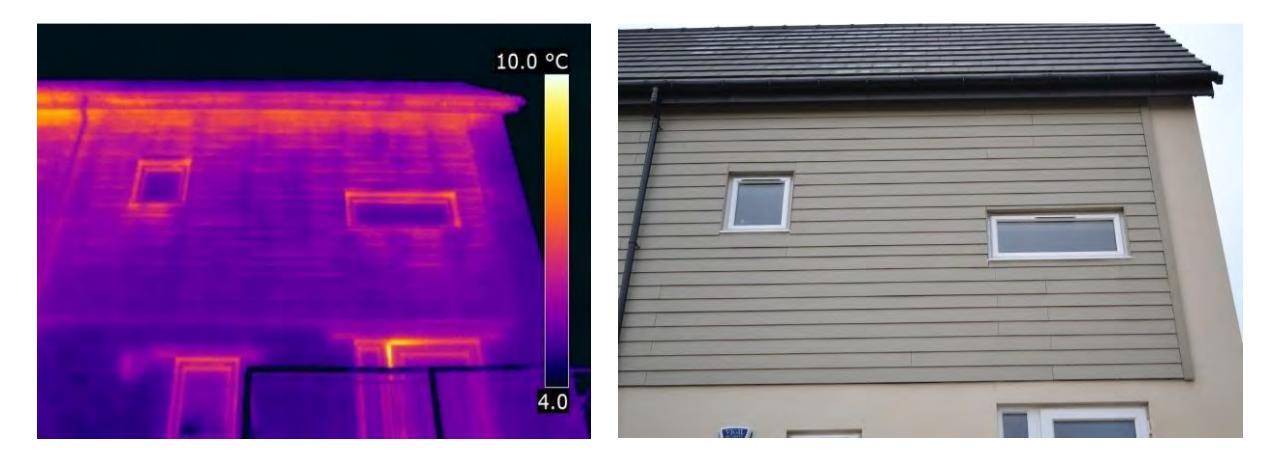
Image 9: Property 3A Front 2<sup>nd</sup> Floor. Observations: Elevated temperature at top of cladding. Note: cladding is ventilated

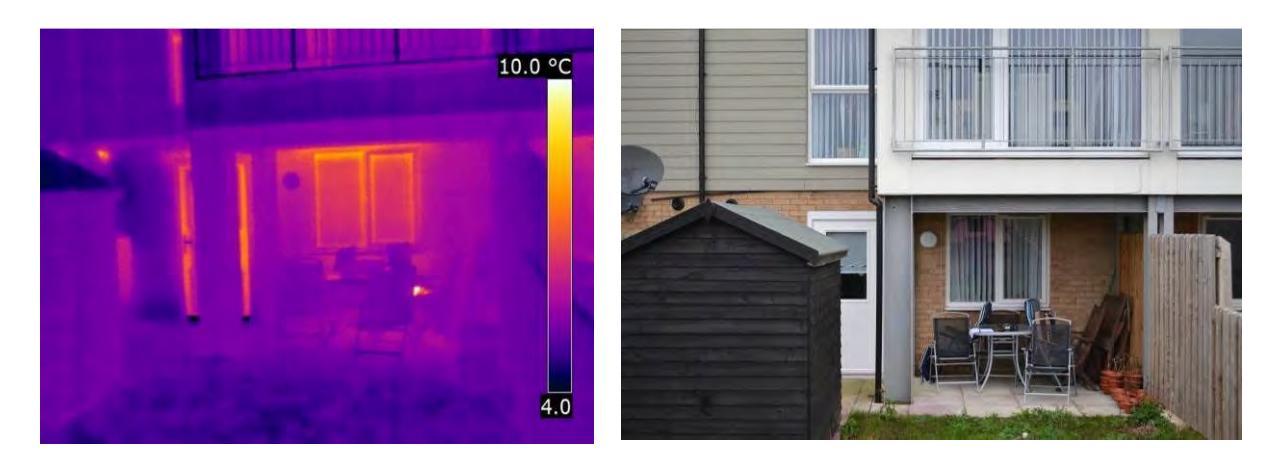
Image 13: Property 3C Rear Ground Floor. Observations: localised temperature elevation above window.

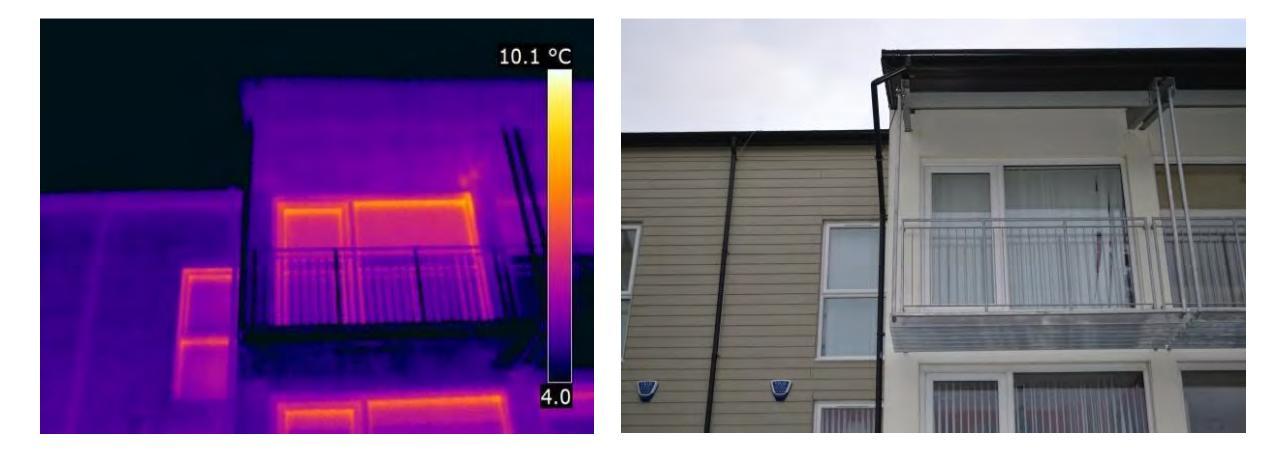
Image 15: Property 3C Rear 2<sup>nd</sup> Floor. Observations: Minimal localised temperature elevation to elevation top left of window

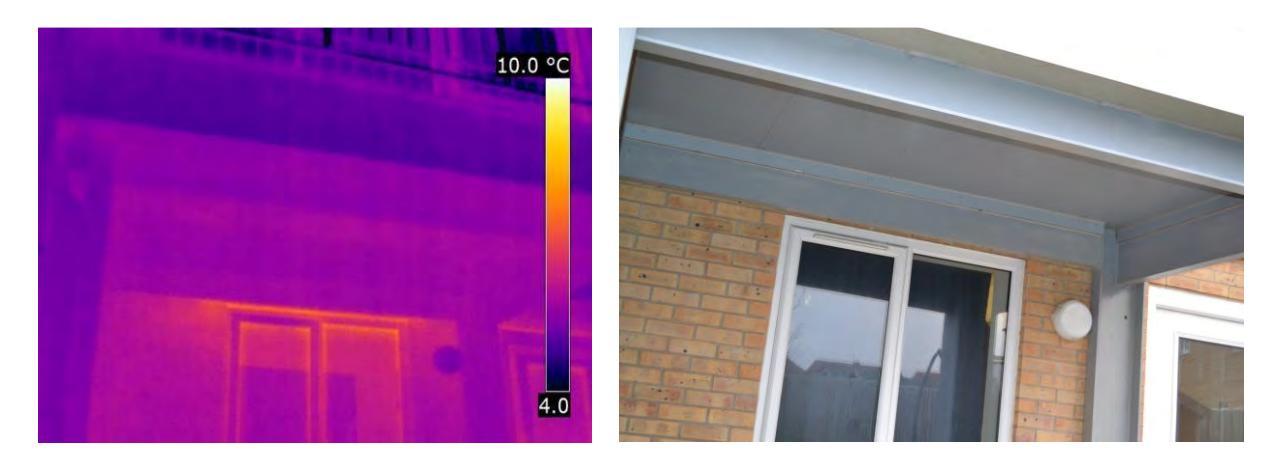
Image 24: Property 3B Rear Bay (Underside). Observations: localised heating above door.

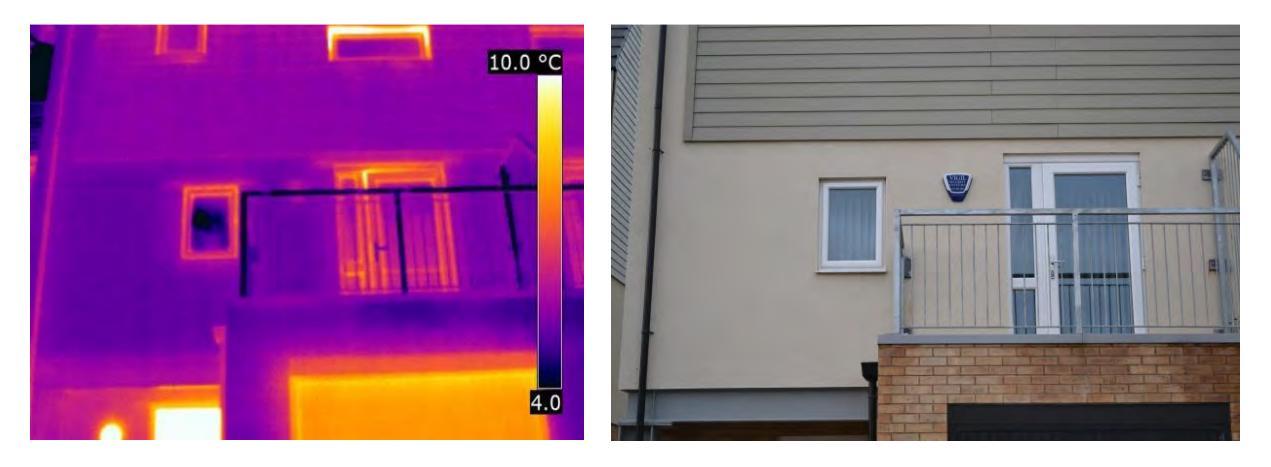
Image 27: Property 5B Front 1st Floor. Observations: Potential leakage at top left hand door corner.

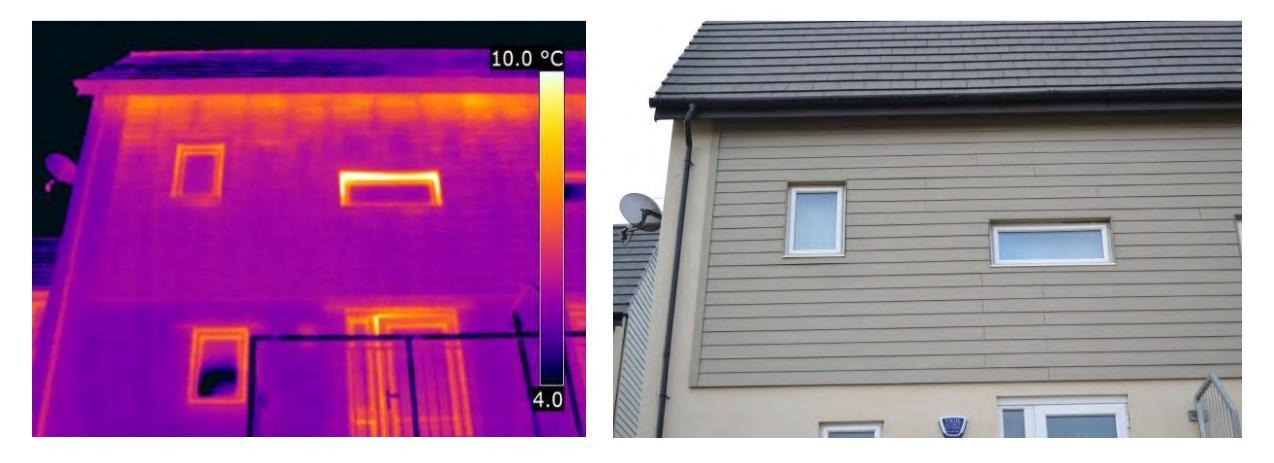
Image 28: Property 5B Front 2nd Floor. Observations: Localised heating at right hand window.
Driving Innovation

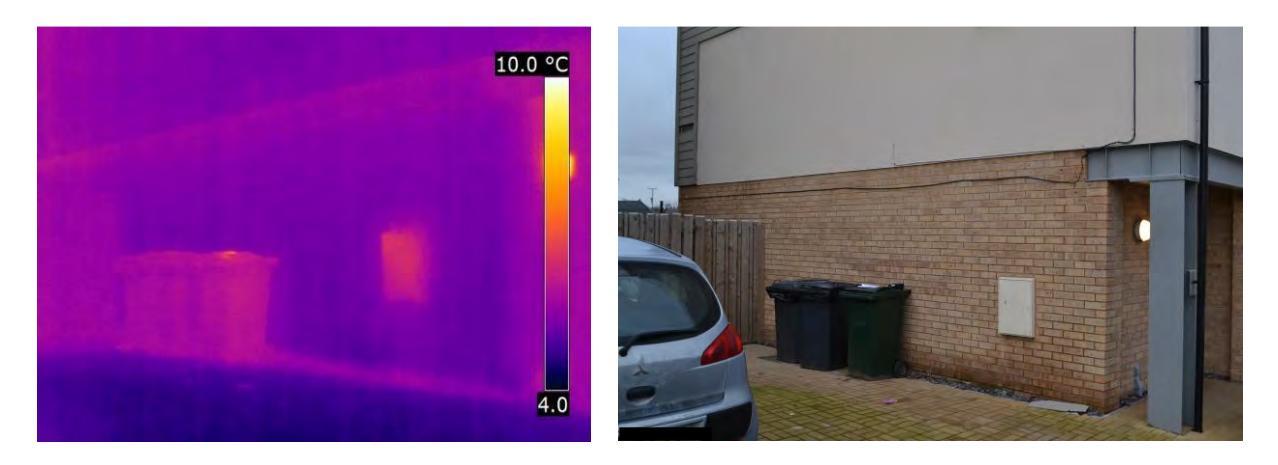
Image 38: Property 5B Side Ground Floor. Observations: Elevated temperature at meter box no other thermal anomalies observed
