South Place Hotel

Innovate UK project number	450112
Project lead and author	Hoare Lea and Partners Ltd.
Report date	2015
InnovateUK Evaluator	Robert Cohen (Contact via www.bpe-specialists.org.uk)

Building sector	Location	Form of contract	Opened
Hotels	London	Design and build	2012
Floor area (NIA)	Storeys	EPC / DEC	BREEAM rating

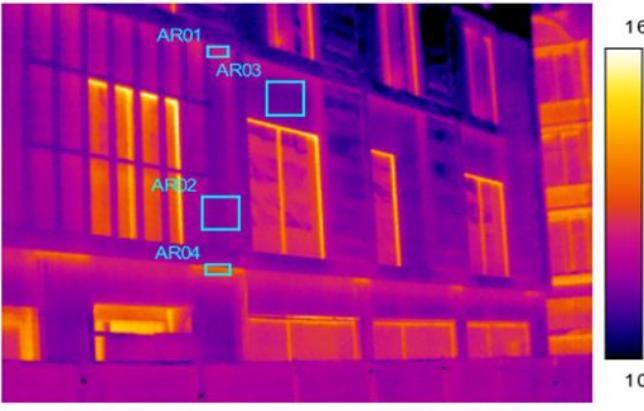
- There appears to be air leakage coming from under the cladding. However, bearing in mind the rainscreen cladding construction, this could also be from the convection of warm air within the cavity behind the panels that is leaking out.
- Thermal bridging was found around windows frames, especially in corner junctions;
- Cold spots were found around the windows caused by air leakages in the seal between the glass and frame, and also between the frame and wall. These were found to be fairly common throughout the building, and would be consistent with issues raised separately about noise penetration from outside - see section 8.3. It was noted however that despite these leaks, the building's tested air permeability was still good overall.

Figure 2 Air leakage on the bottom of external cladding on the south Place Elevation

It is currently understood that remedial actions were not undertaken on the issues identified above as the contractor considered the construction to be within acceptable standards. The BREEAM credit Ene 6 - Building Fabric Performance and Avoidance of Air Infiltration was awarded in the post construction review, on the basis that the thermography survey does not provide any direct recommendations for remediation to be carried out.

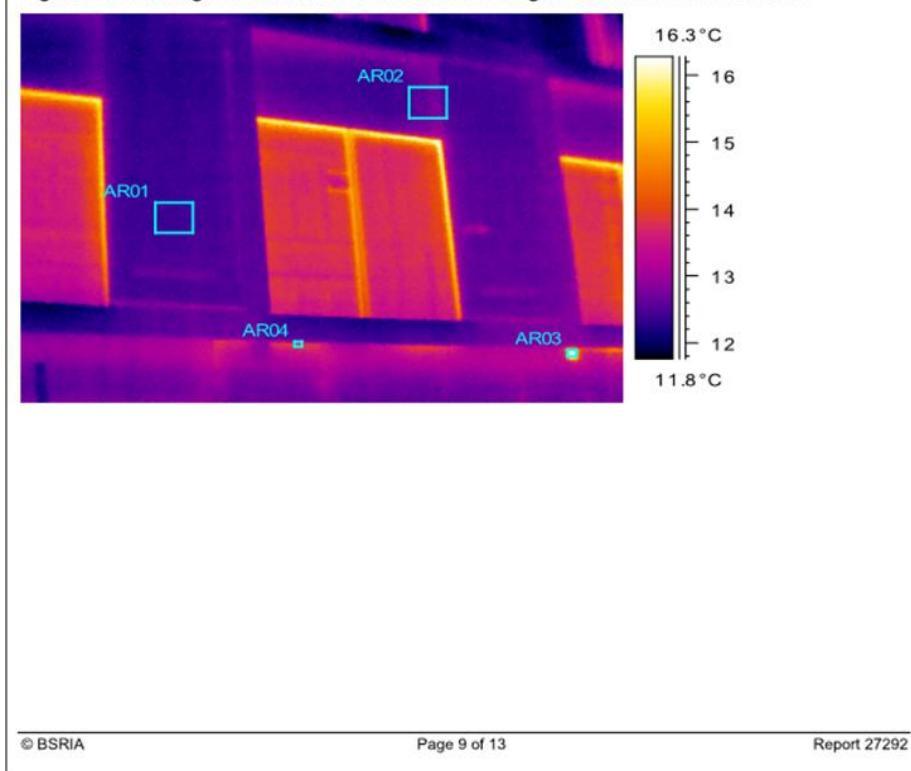
Figure 5.5: Extract from thermography survey – air leakage (from BSRIA)

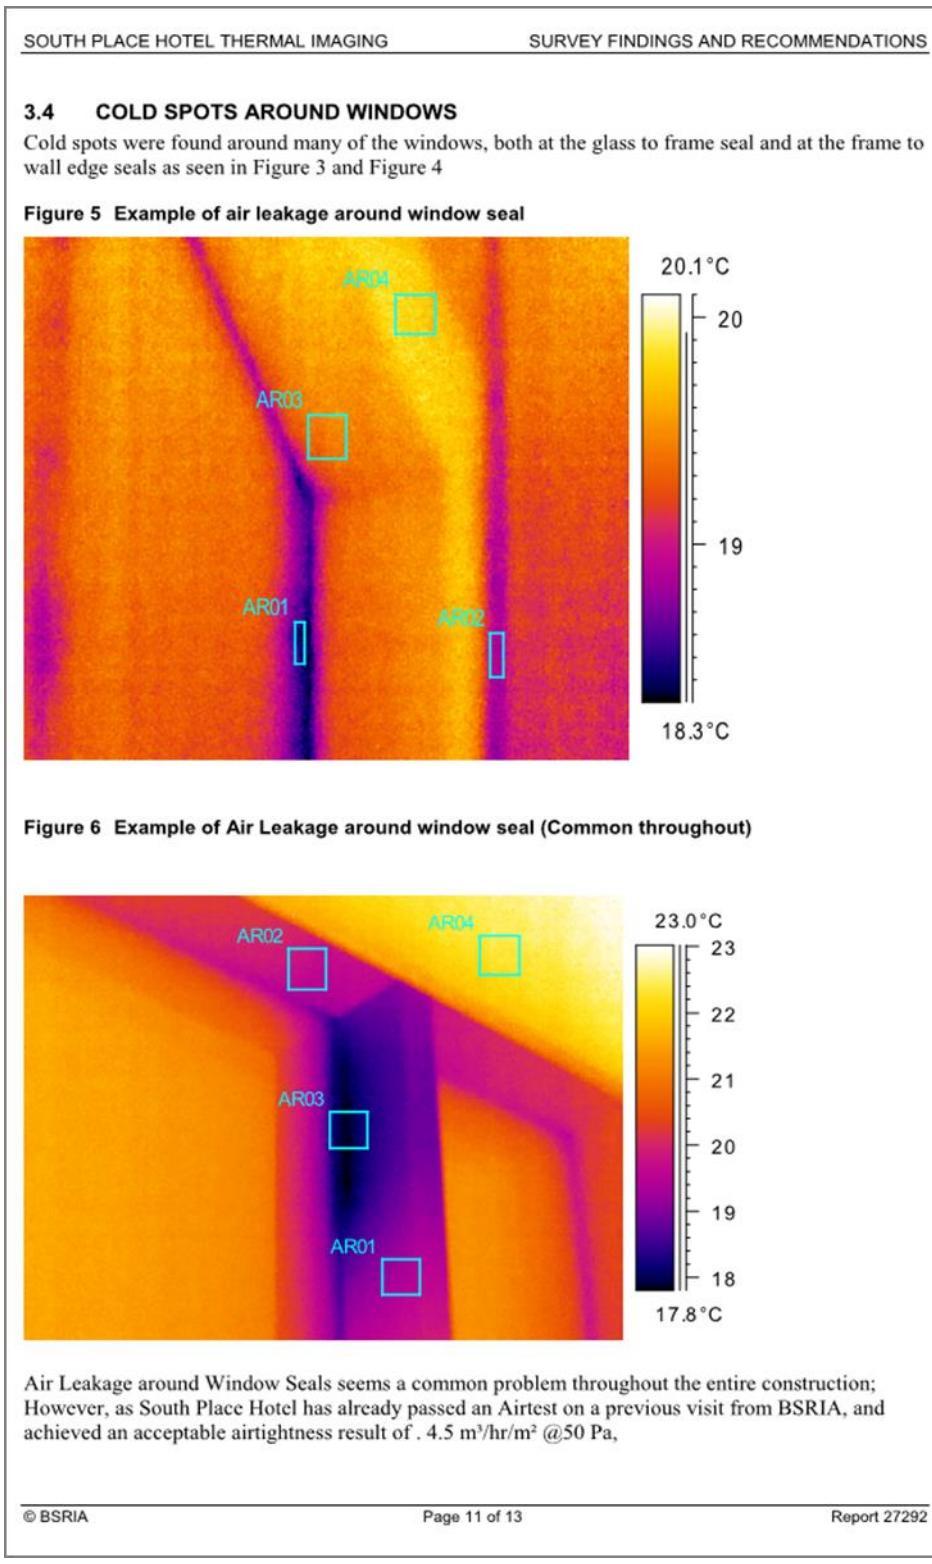
Figure 5.6: Extract from thermography survey – cold spots around windows (from BSRIA)

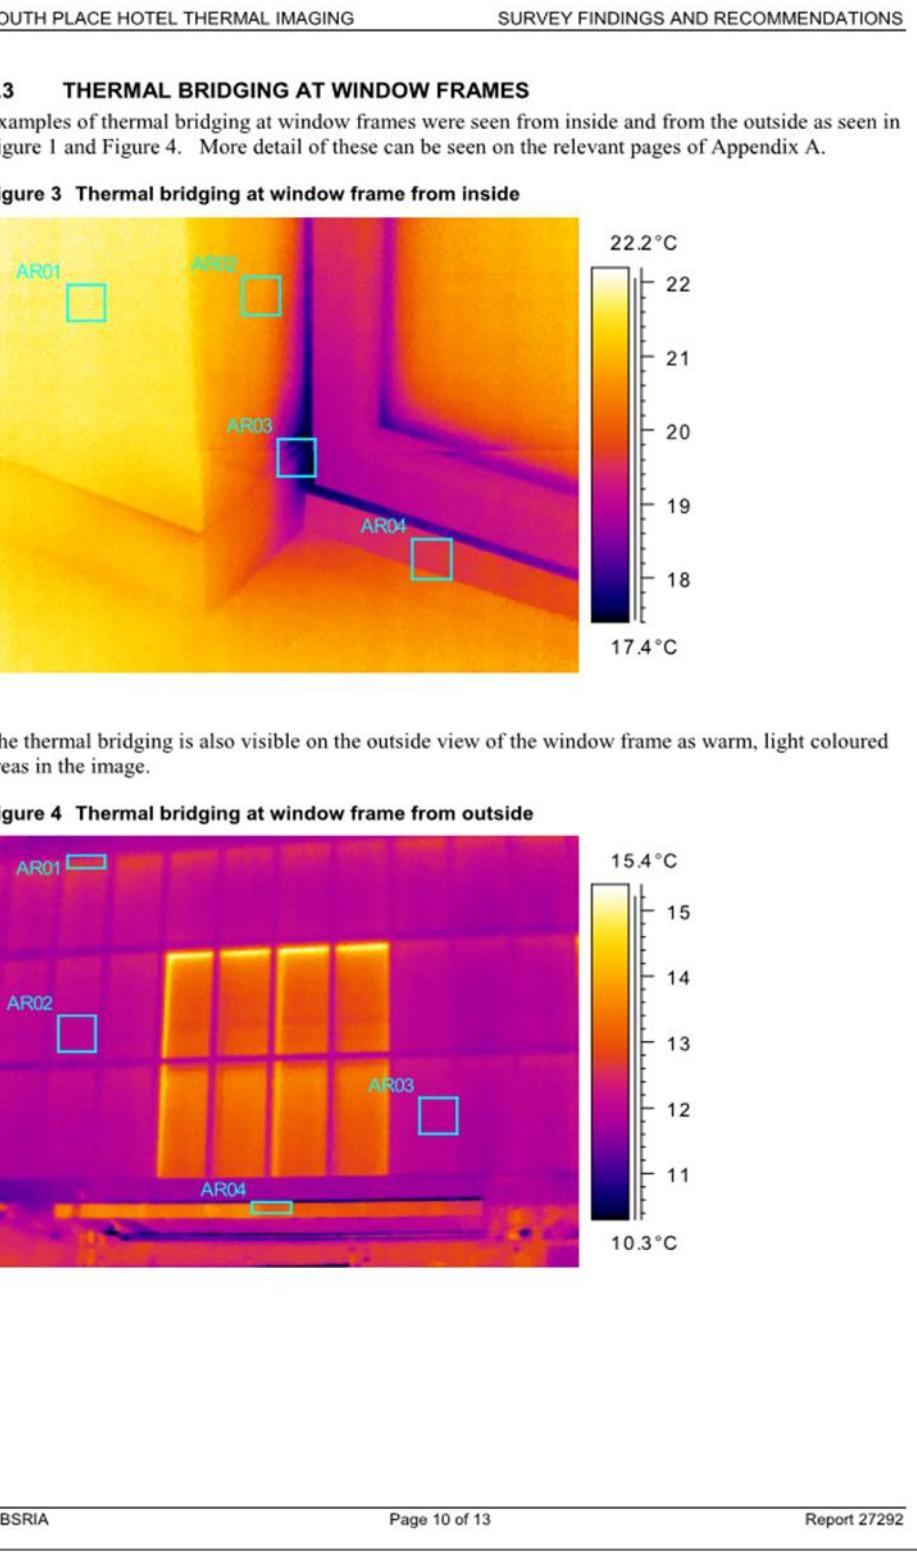
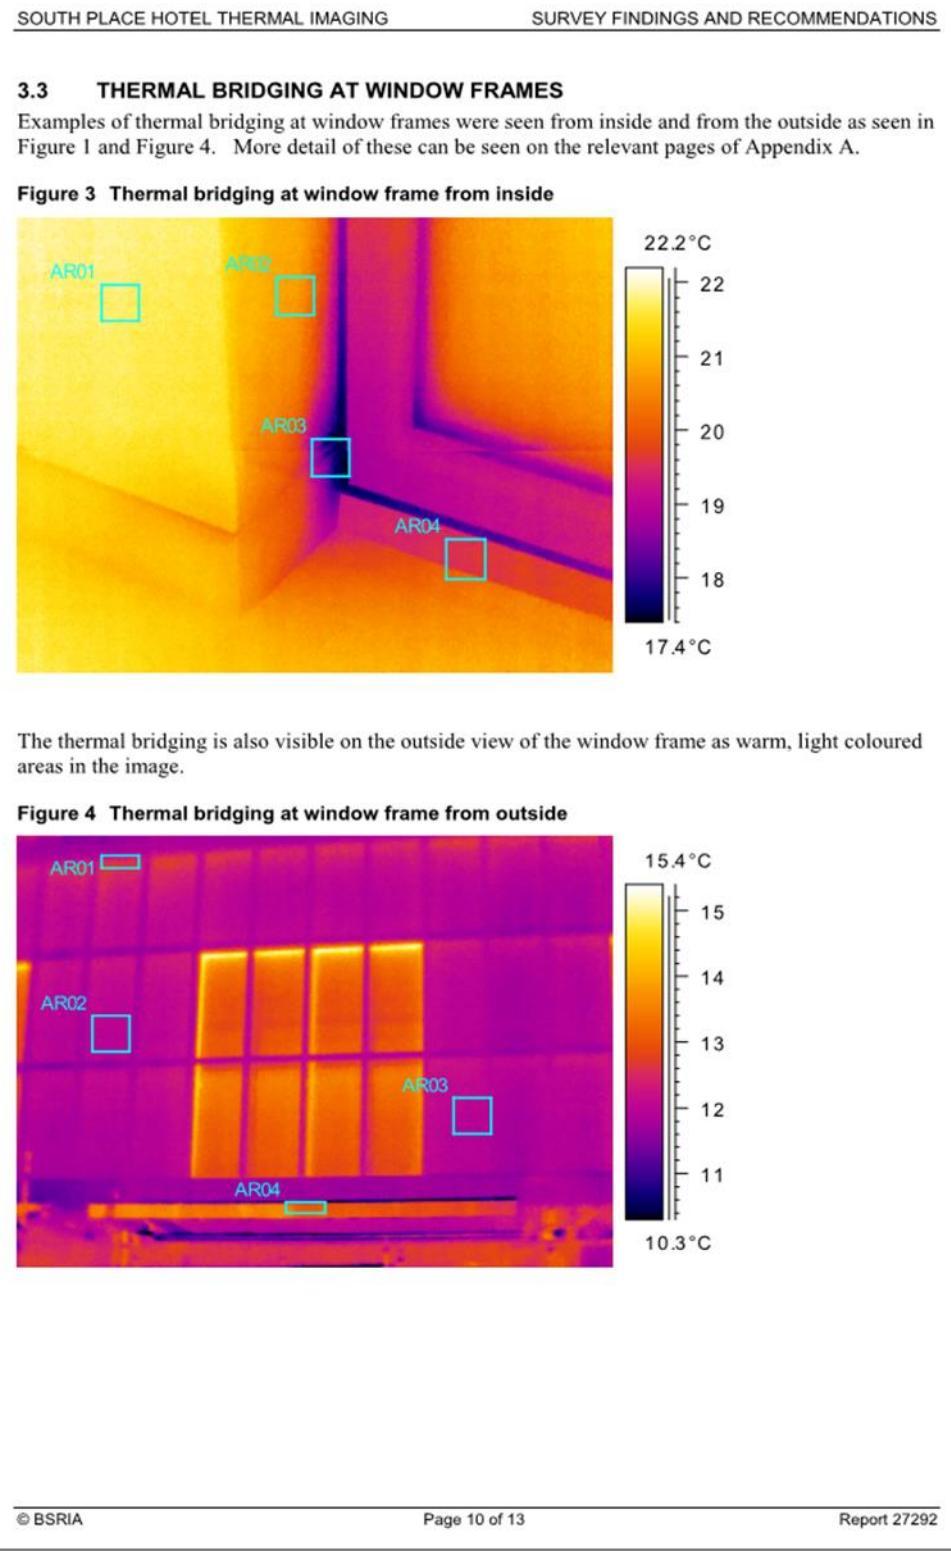
Figure 5.7: Extract from thermography survey – thermal bridging at windows frames (from BSRIA)

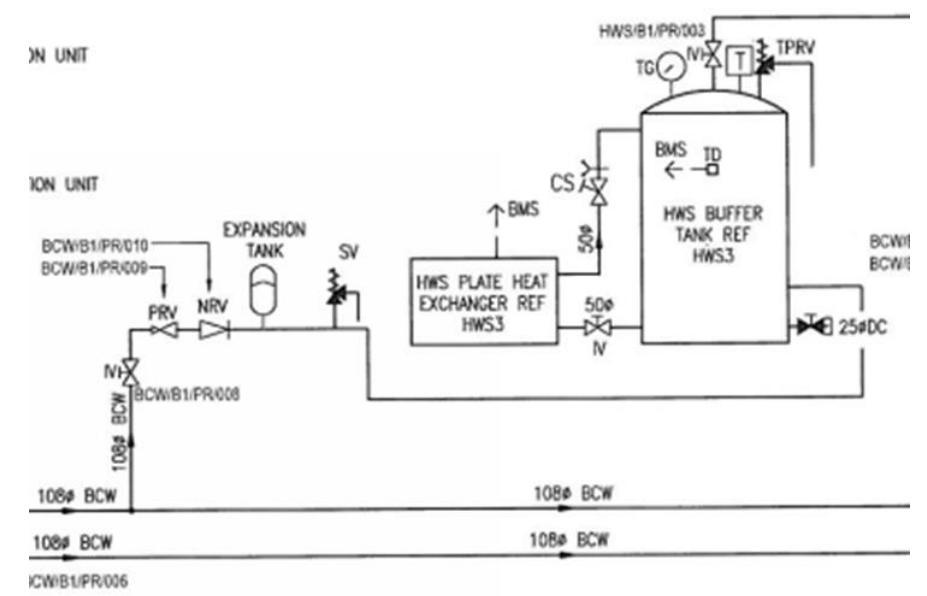
At the time of this report, the FM manager has reported recurring issues with the hot water temperature (on occasions below 55°C at the calorifier outlet) and this therefore remains an important defect.

Figure 7.1: Calorifier vessel and plate heat exchanger installation, before proposed remedial works

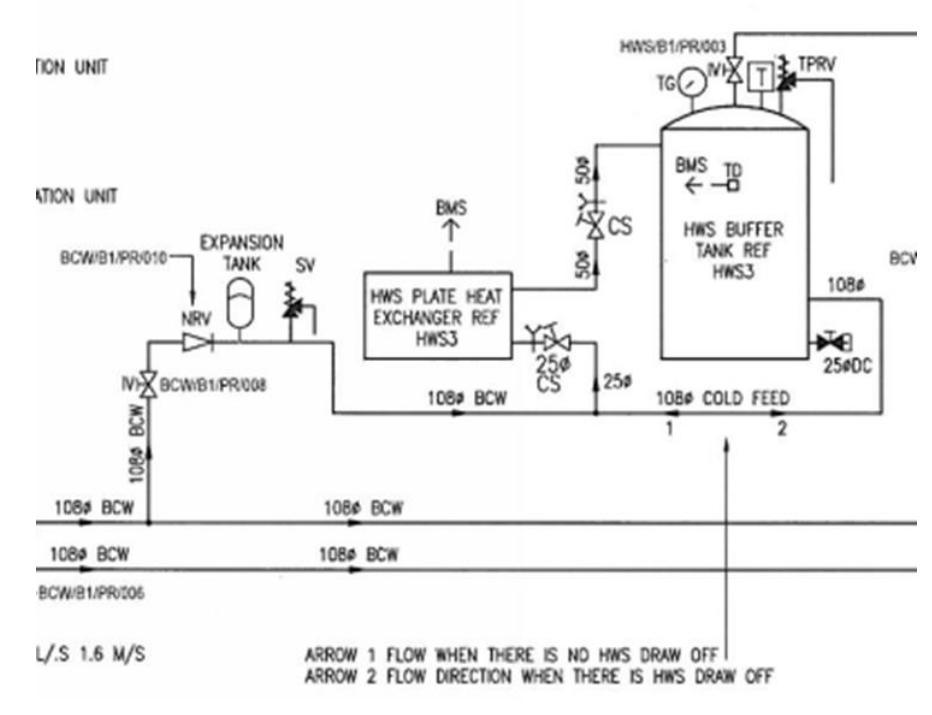
Figure 7.2: Calorifier vessel and plate heat exchanger installation, after proposed remedial works (provided by contractor, 15th January 2014)

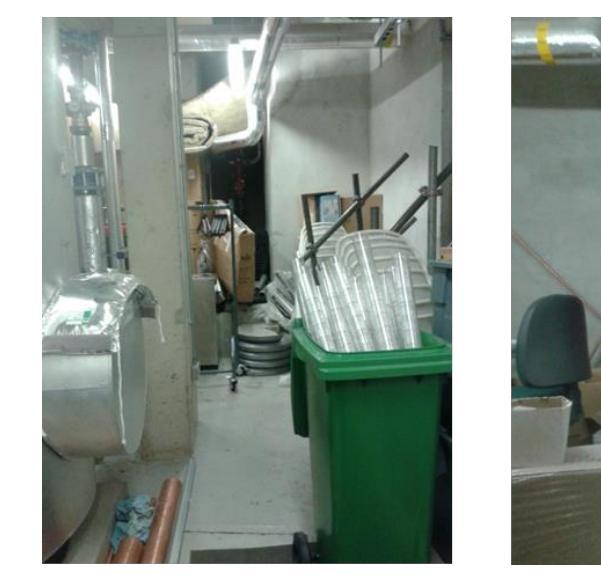
The omission of thermal storage was also thought to significantly affect the operation of CHP. The contractor was requested to review the viability of retrofitting thermal storage within the existing plant rooms, including an appraisal of technical feasibility (taking account of plant space), costs, and impact on CHP running hours using historic load data available from the previous year. A visit by the team to the plant room did identify possible areas, such as those that had at the design stage been identified specifically for that purpose. Those areas appear under-utilised, or serving for general storage - see pictures in Figure 7.3.

Figure 7.3: Visit to plant room, March 2014: areas intended at the design stage for thermal stores

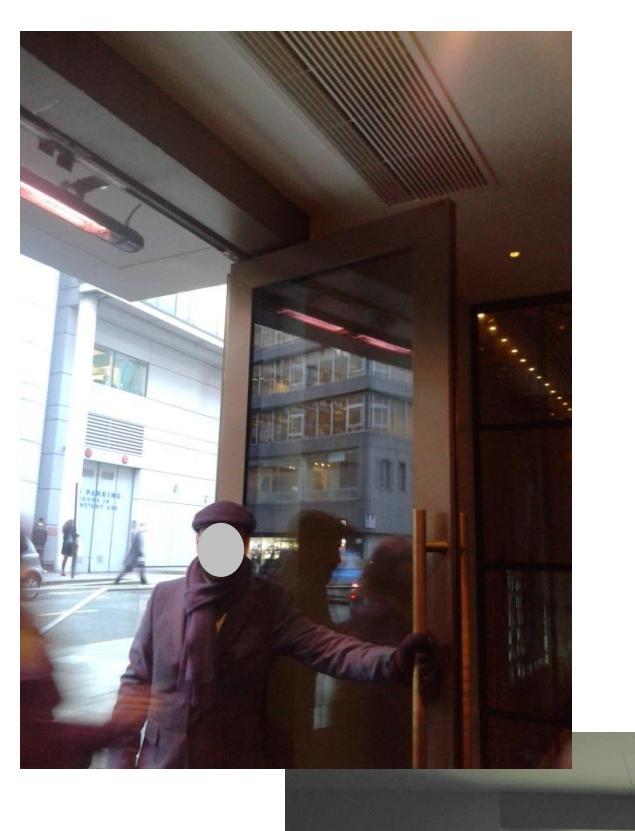
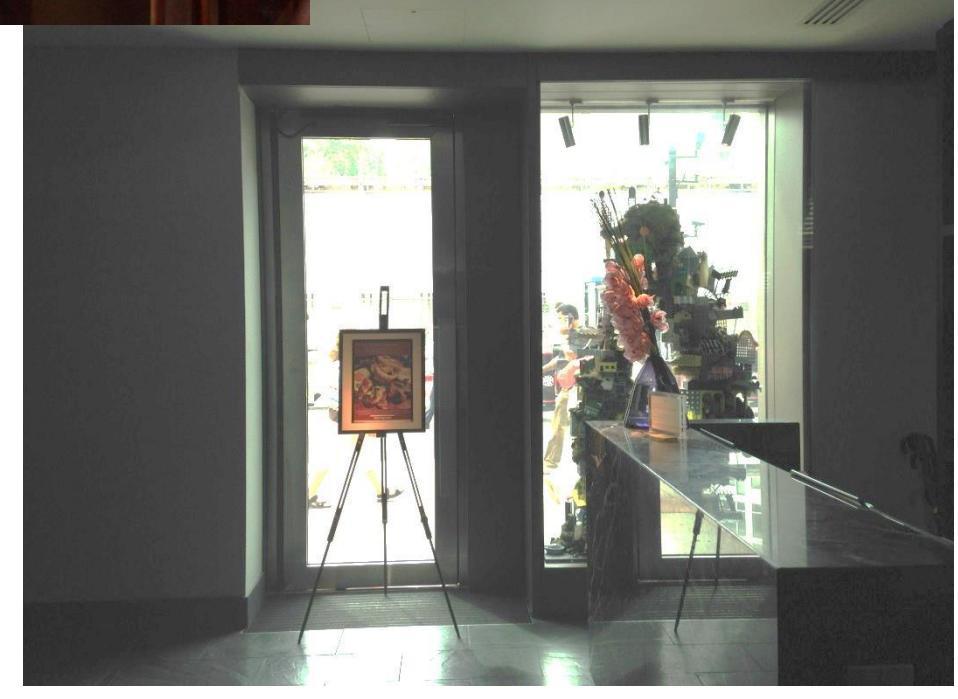
- Layout of ground floor, particularly around entrances and receptions. For example, the restaurant staff have noted that the reception desk is too far away from the main entrance to allow them to greet guests, which increases staffing requirement (= one near the entrance and one at the reception desk to take calls etc); a board is placed in front of the DDA door, used 'instinctively' by guests as the door straight in front of them when leaving the lifts to leave the building, while the door was meant for intermittent use and its frequent opening could lead to wear and tear, as well as discomfort for reception staff - see image 8.6 below.

Figure 8.5: The challenges of designing entrances for ease of use, DDA, and comfort: Top: retrofitted air curtain to hotel reception: Bottom:: restaurant reception desk (right hand side of the photo), felt by staff too far away from the main entrance (revolving door on the left hand side of the photo); board located in front of the DDA door

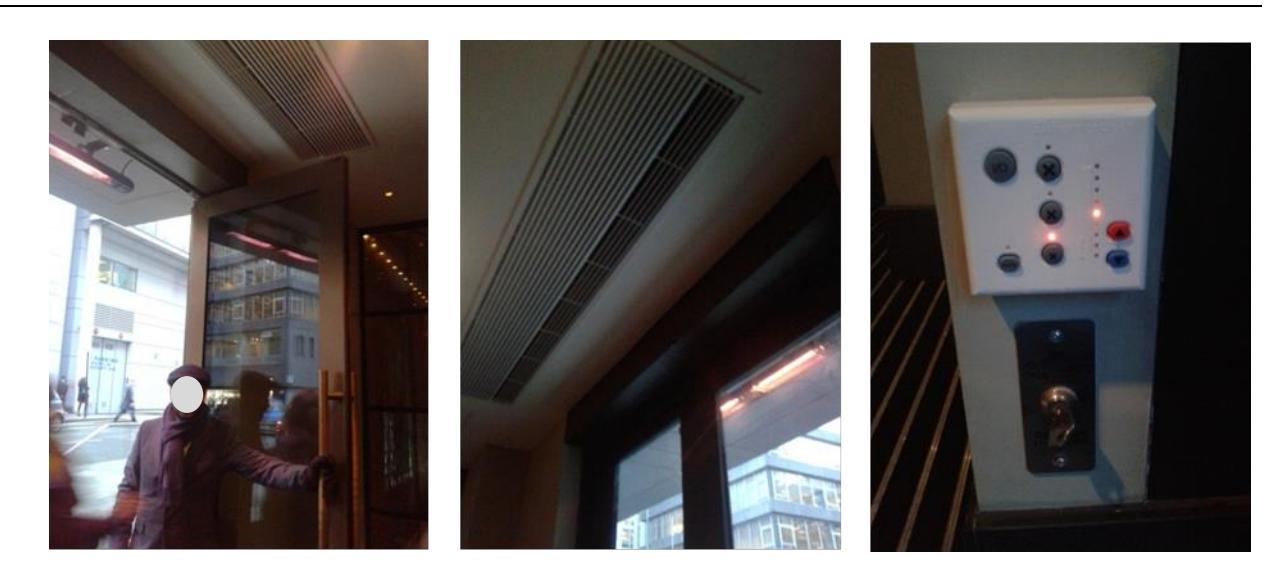
The heater was installed without prior knowledge of the BPE team, and without individual metering.

Figure 9.1: Over-door heater retrofitted by the hotel in Quarter 6
