# ENERGY AND ENGINEERING PROBE TECHNICAL REVIEW

BY BILL BORDASS, ROBERT COHEN AND MARK STANDEVEN

# THE NON-OFFICE BUILDINGS

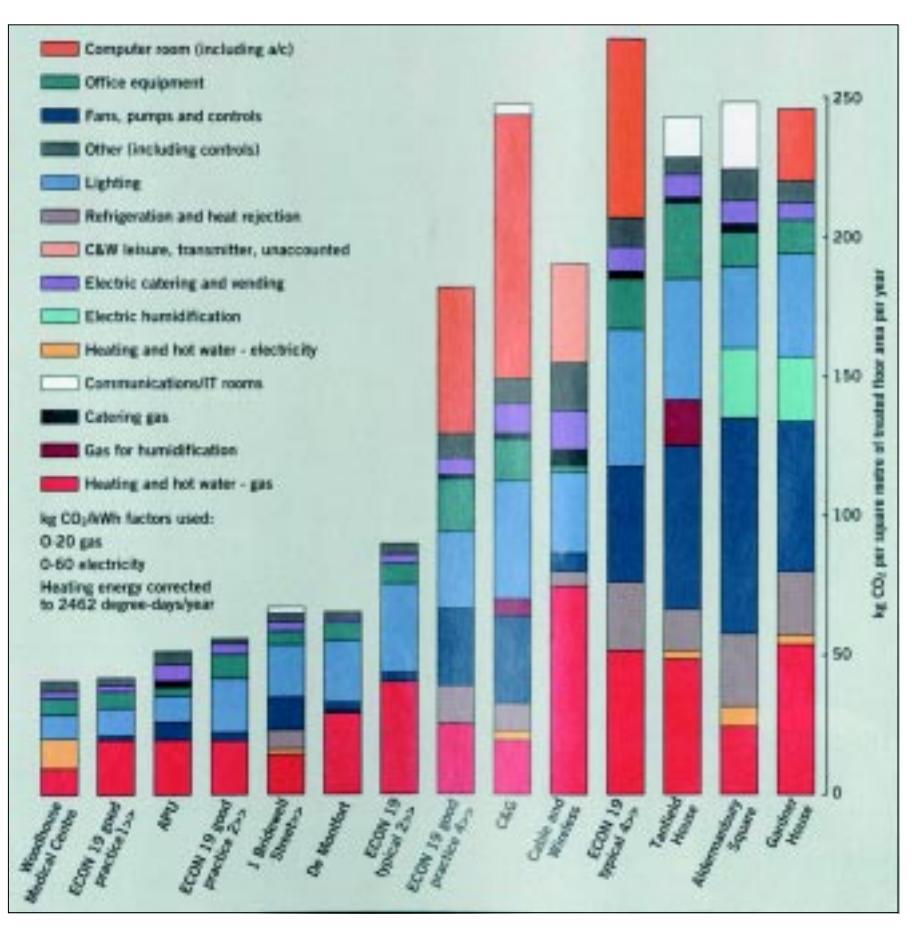
FIGURE 1: Annual CO<sub>2</sub> emissions for the PROBE buildings measured against ECON 19 benchmarks.

Figure 1 shows annual CO<sub>2</sub> emissions for all the buildings, using conversion factors of 0·20 kg/kWh for gas, and 0·60 for electricity. The data is bracketed between *ECON 19* "good practice" and "typical", and includes one of the best air conditioned offices surveyed under the EEO's Best Practice programme: 1 Bridewell Street. The electricity factor represents a typical level for the years in which the consumption data was collected – the current industry value is lower.

C&G is near the good practice level, while the others are just above typical. Energy consumption at Gardner House is anomalously high (by at least 20%) due to the extended plant run times, necessary until airtightness problems are sorted out. Gas/electricity consumption is currently 20% higher.

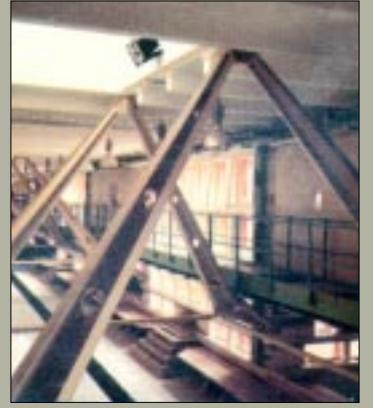
At Tanfield House the heat is rejected into office exhaust air handling units (ahus), avoiding the need for separate condenser units. However, the resultant coupling between office ventilation and heat rejection has led to problems with the full fresh air system, such as the need to operate the office exhaust fans whenever heat needs rejecting, for example outside normal occupancy hours.

Increased pressure drops and higher exhaust fan energy consumption has also resulted. Averaged over annual operating hours only about 7% of the design cooling load is being rejected whereas the coil resistance exists for 100% of the time.

Heat recovery means constant system pressure drops at Tanfield House.
