Co-operative Retail Services wanted its new headquarters building to be both energy efficient and humane. Have these green ambitions been realised, and did the chilled beams and displacement ventilation systems provide the promised improvements in occupant comfort?

17: Co-operative Retail Services hq

Five years ago, chilled beams, displacement ventilation and ice thermal storage were thought to offer improvements in building energy consumption and occupant comfort. The headquarters building for Co-operative Retail Services (CRS) was one of the first to benefit from this type of thinking.

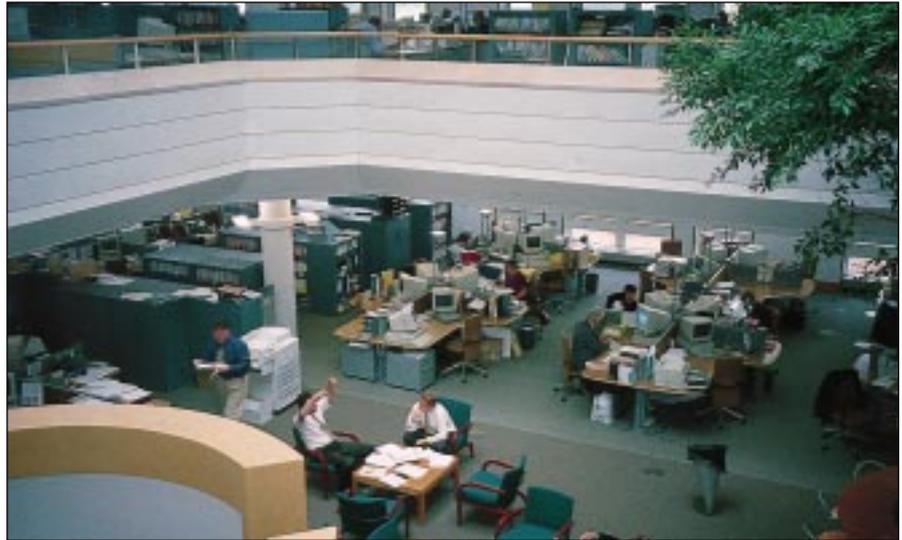
The ground floor offices at Co-operative Retail Services, viewed from an atrium. Due to the unreliable lighting control system, the metal halide uplighters tend to be on outside of normal office hours, contributing to an 'uplift' of 3-4°C to the supply air temperature in the first floor plenum.

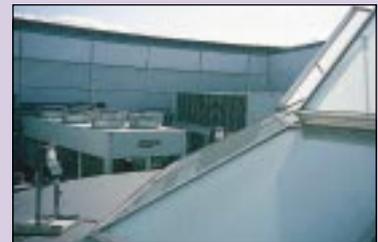
Condensors installed to serve the computer room chillers are located very close to the inlets serving the office chiller.

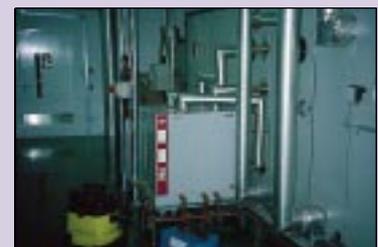
One of the rogue humidifiers which often runs in summer to replenish the moisture that is removed at the cooling coil.

As mentioned above, the main reason for this appeared to be the floor void temperatures of 20-23°C, as against 19°C design, hence increasing the dew point necessary to maintain the 40% rh setting. In addition, it appeared that the humidifiers were sometimes putting back moisture which had been removed at the cooling coil.
