201 Bishopsgate

Innovate UK project number	450027
Project lead and author	Verco for British Land plc
Report date	2013
InnovateUK Evaluator	Tom Kordel (Contact via www.bpe-specialists.org.uk)

Building sector	Location	Form of contract	Opened
Offices	London	Construction management	2008
Floor area (GIA)	Storeys	EPC / DEC	BREEAM rating
37,000 m ²	12	C (66) / N/A	Excellent

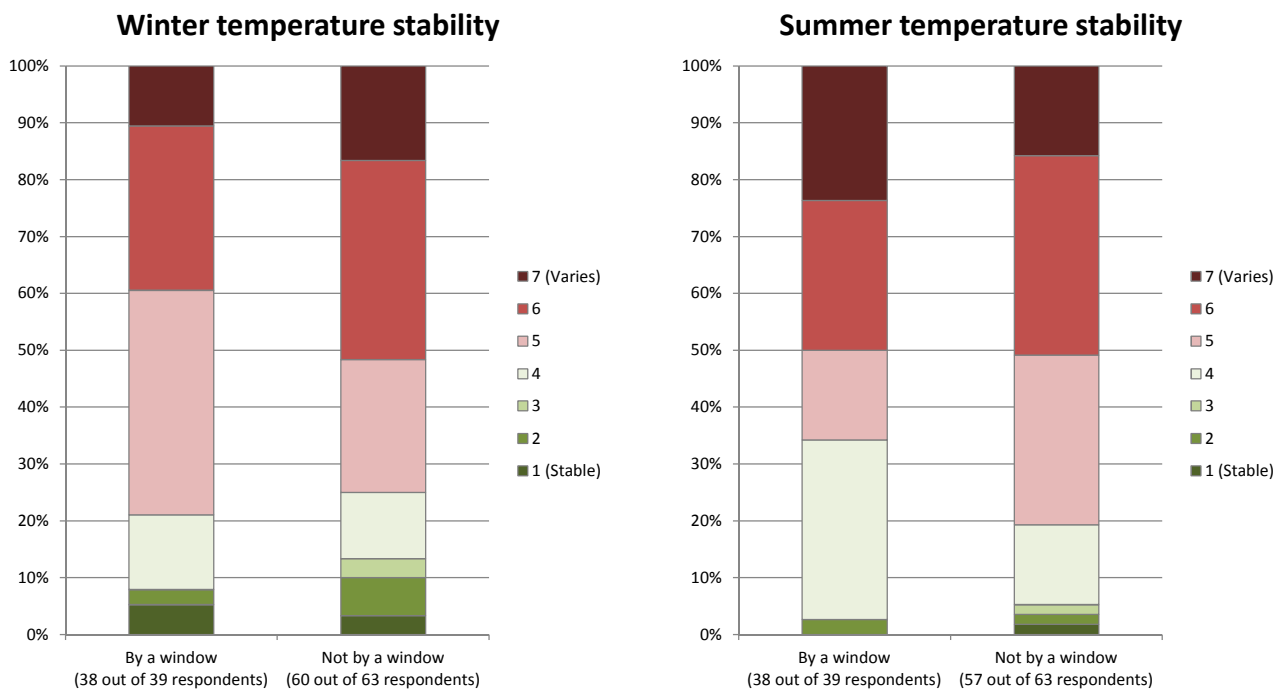
The graphs of temperature stability show a wide range of responses from occupants, although those who are not located by a window show slightly more satisfaction with this issue, with a slightly higher number of responses in the 1-3 categories. The effects of temperature stability therefore appear to be experienced across a greater area than the first few rows of desks. It is not possible to conclude whether close proximity to the facade has a direct effect on occupant satisfaction.

Figure 4 Perceived temperature stability depending on proximity to windows

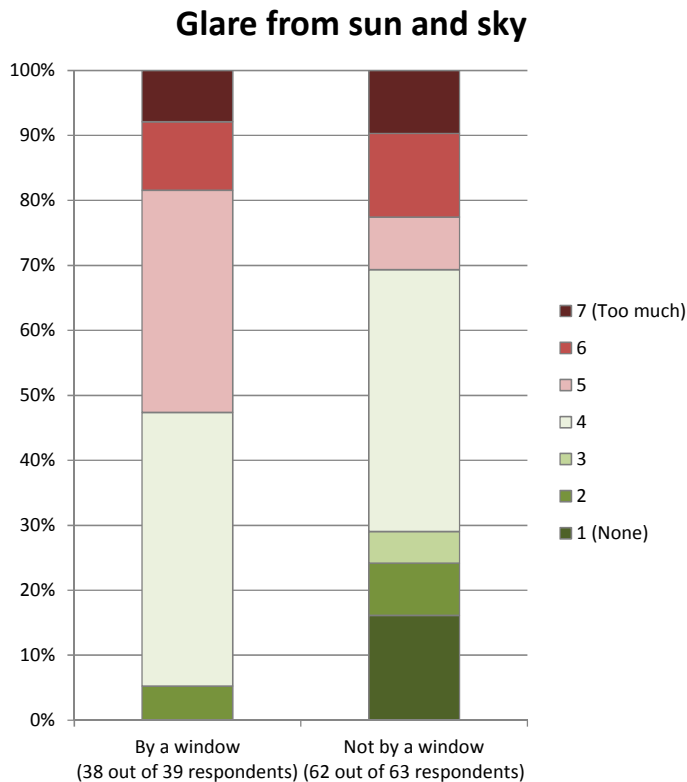
The following graph shows that there is greater dissatisfaction from occupants seated close to the façade, with a higher number of responses in the 3-7 scores. However, the number of responses in the highest scores (6-7) are higher for those occupants seated away from the façade. It could therefore be concluded that the issue of glare is experienced across a much greater area of the office space. This is further supported by some of the comments extracted from the survey responses, shown in the table below.

Figure 5 Perception of glare depending on proximity to windows

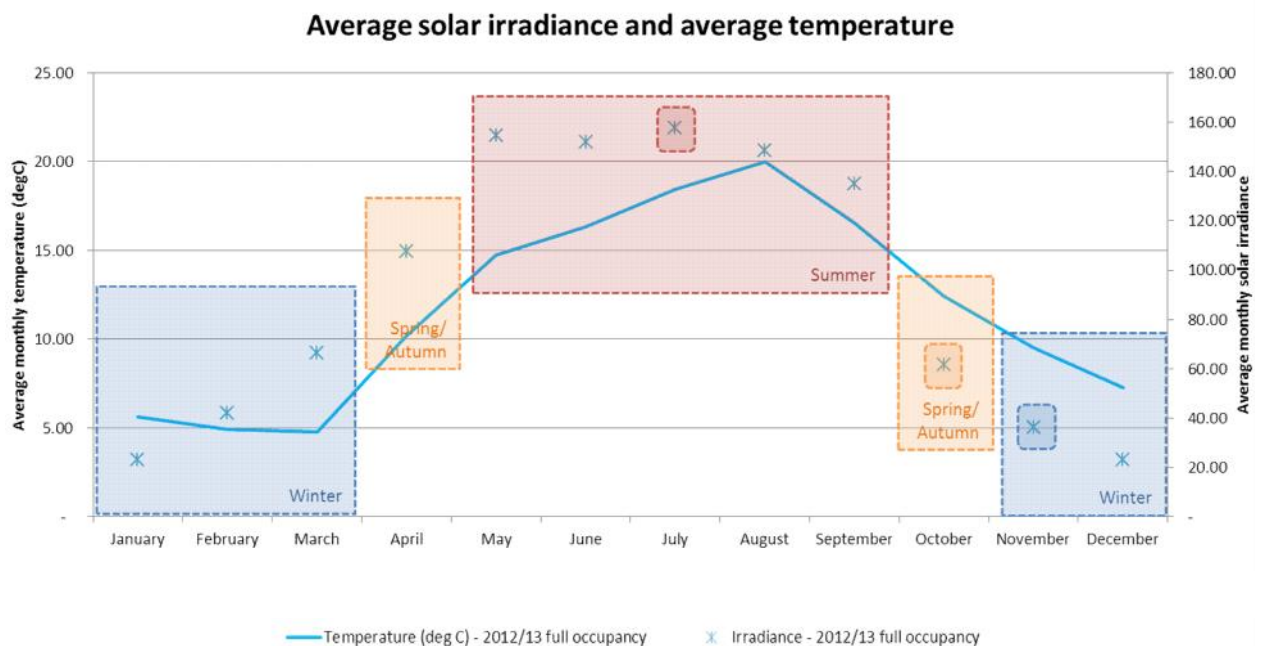
The categorisation of each month of the year is shown in the graph below.

Figure 7 TM22 analysis month selection

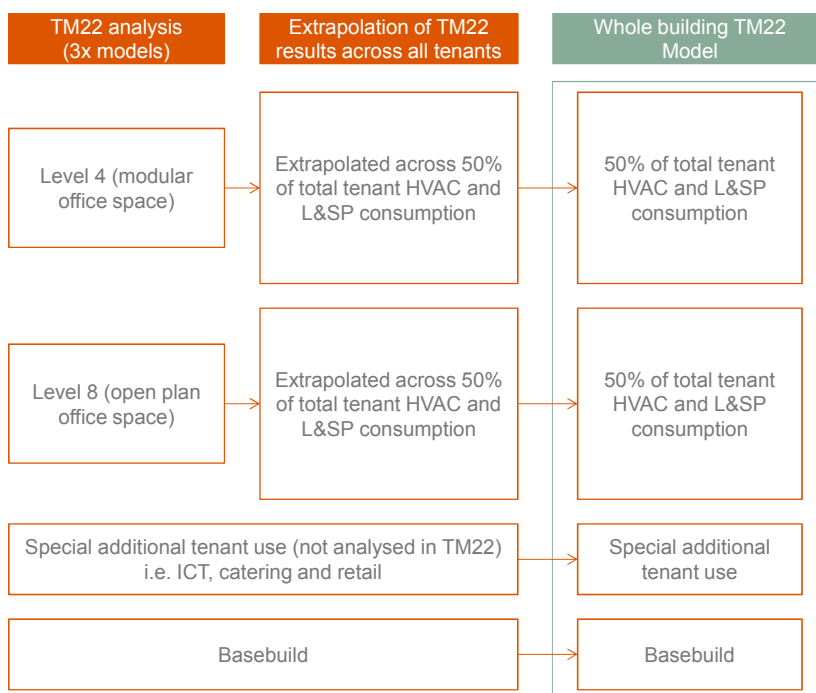
To build a model for the whole building, results from each of the tenant models for every end use have been added to the basebuild TM22 model. Energy consumption for major energy consuming tenant uses which are not found on levels 4 or 8, and therefore not modelled in TM22, and not separately sub-metered, but are known to exist within the building, have been estimated and also added to the whole building model – these

Figure 8 Process for scaling up each of the TM22 models for obtaining a whole building TM22 model

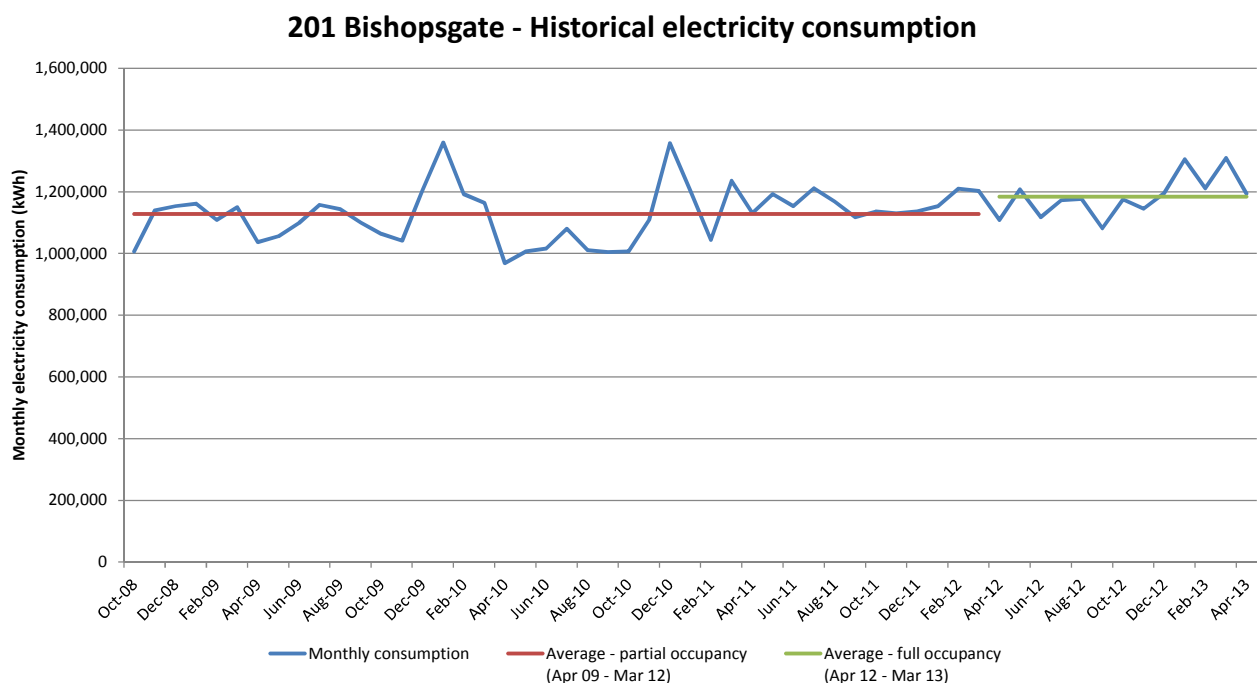
The graph shows two peaks in January and December 2010. The peak in January is likely to be as a result of an issue experienced with an occupier's BMS, which was incorrectly configured. The BMS was sensing a low temperature within the building and, as part of a fabric protection function, was starting the fan coil units, which in turn was placing a demand to operate the plant. This issue has now been rectified. The later peak may be due to fit-outs coming to an end and heat loads coming online.

In general, the higher consumption for 2011 is due to a higher occupancy – level 6 was occupied by this time, which includes a trading function, and the investment bank's number of employees working in the building increased. Full building occupancy was reached in April 2012. The reduction in energy consumption as a result of efficiency measures implemented may be counter-balanced by the increase in occupancy, thus explaining the relatively 'flat' consumption.

Figure 9 Graph of historical energy consumption October 2008-April 2013

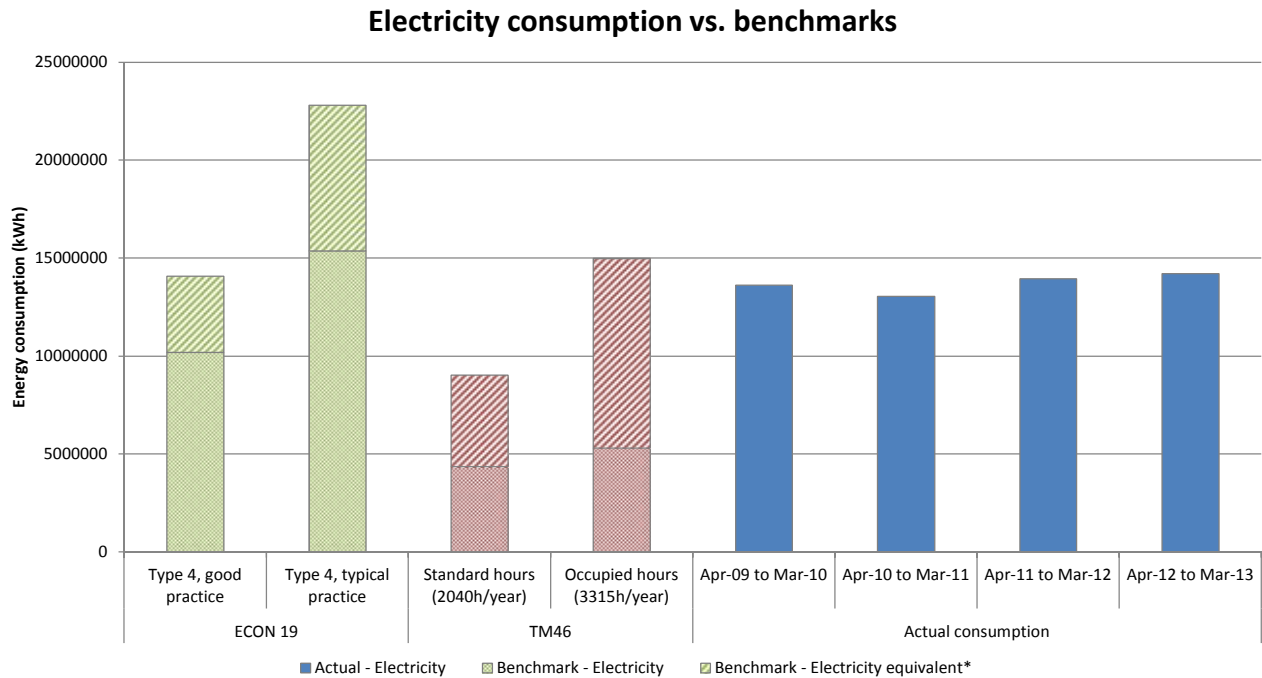
The graph shows that the building's total electricity consumption appears to be marginally better than the ECON19 'good practice' benchmark for an office of this type (type 4, 'prestige air conditioned'), and this performance has remained relatively constant, despite the changes in occupancy levels.

Figure 10 Comparison of historical energy consumption with ECON19 benchmarks

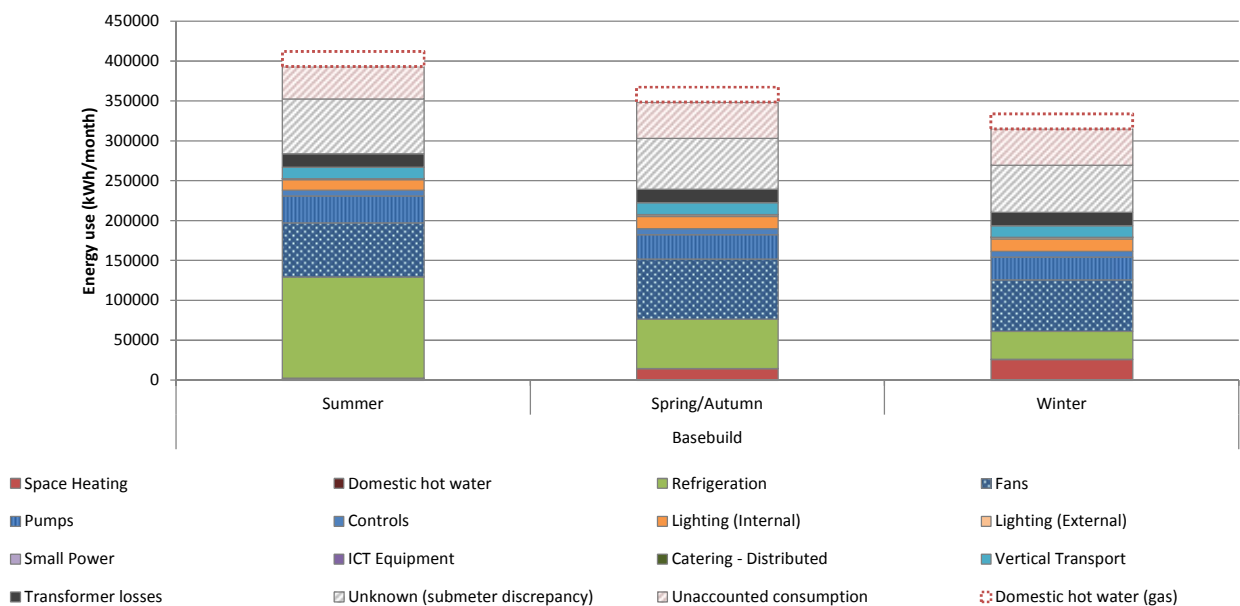
Figure 11 Seasonal variation of energy use in base build model

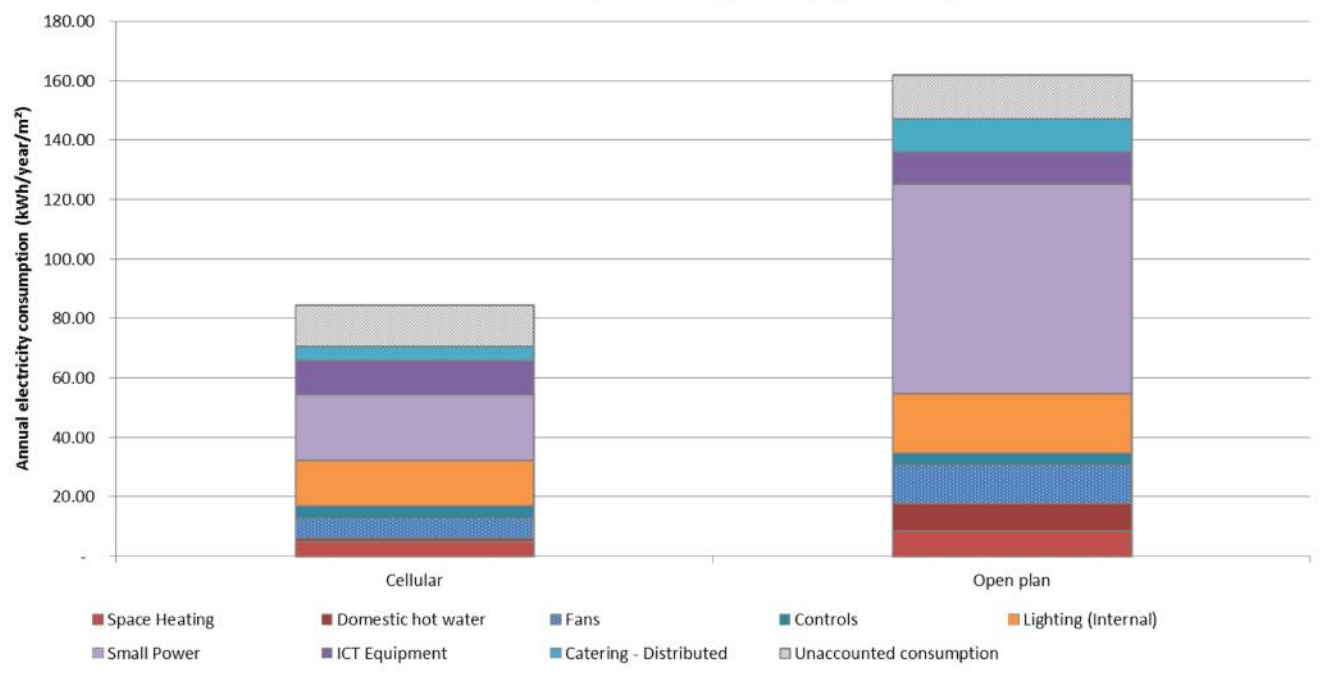
Interestingly, energy for space heating is higher on level 8 compared to level 4, despite the likely higher internal gains arising from a greater occupancy density and greater small power energy use. This may be partially caused by simultaneous heating and cooling in the fan coil unit system, known as ‘fighting’, which can often occur in open plan office space where there are inadequate controls settings (e.g. deadbands). This could also be exacerbated by solar gain where adjacent zones are experiencing very different environmental conditions – particularly, for example, during periods of winter sunshine. During a review of the HGI BMS, one fan coil unit’s setpoint was set to 24°C and was in cooling mode, whilst the adjacent unit’s setpoint was 27°C and was therefore in heating mode.

Figure 12 Level 4 versus level 8 TM22 analysis – whole year

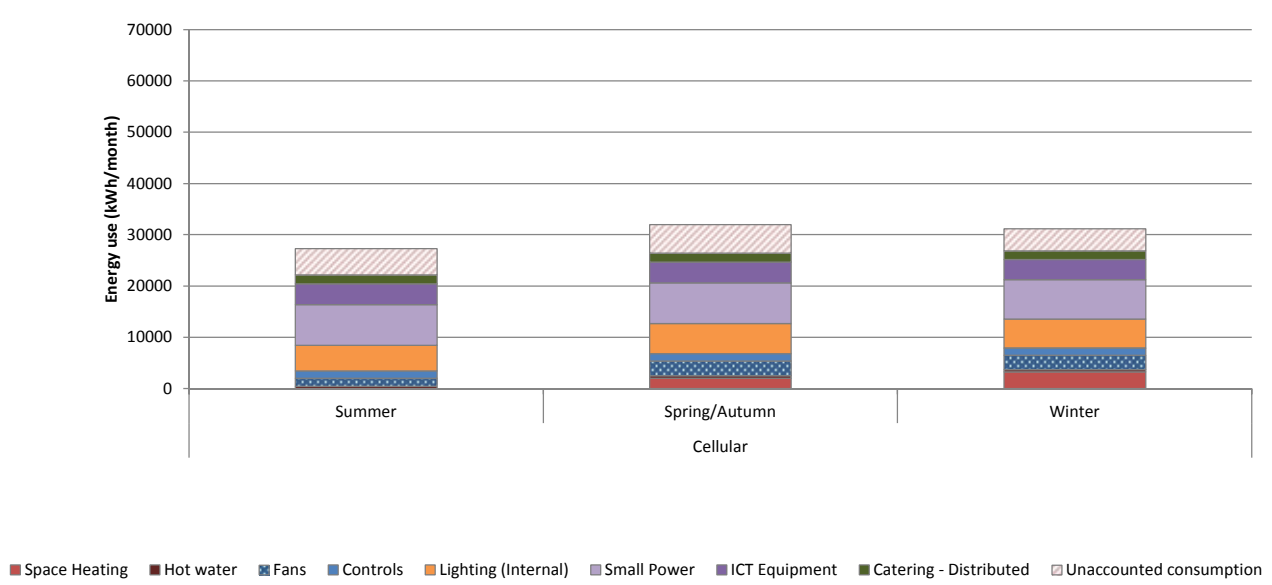
Figure 13 Level 4 TM22 analysis – by season

The breakdown between tenant and basebuild consumption is relatively consistent in spring/autumn and winter. However, in summer, the tenant consumption is slightly lower, whilst the basebuild consumption is slightly higher. This appears to be due to the reduction in heating energy, as indicated in Figure 13 and Figure 14 above.

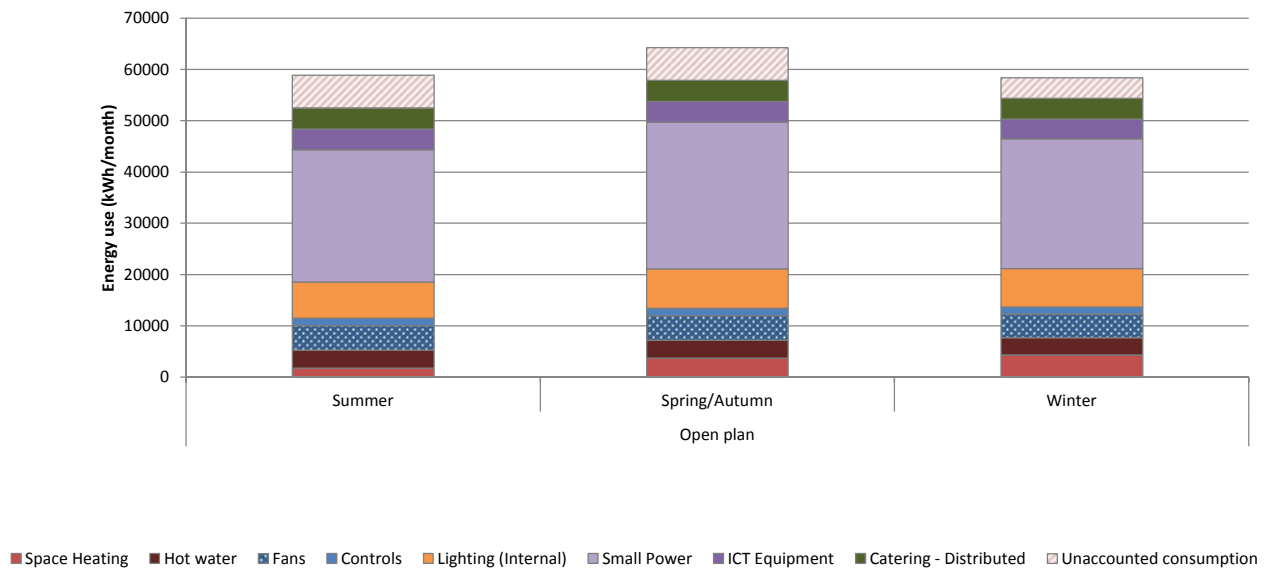
Figure 14 Level 8 TM22 analysis – by season

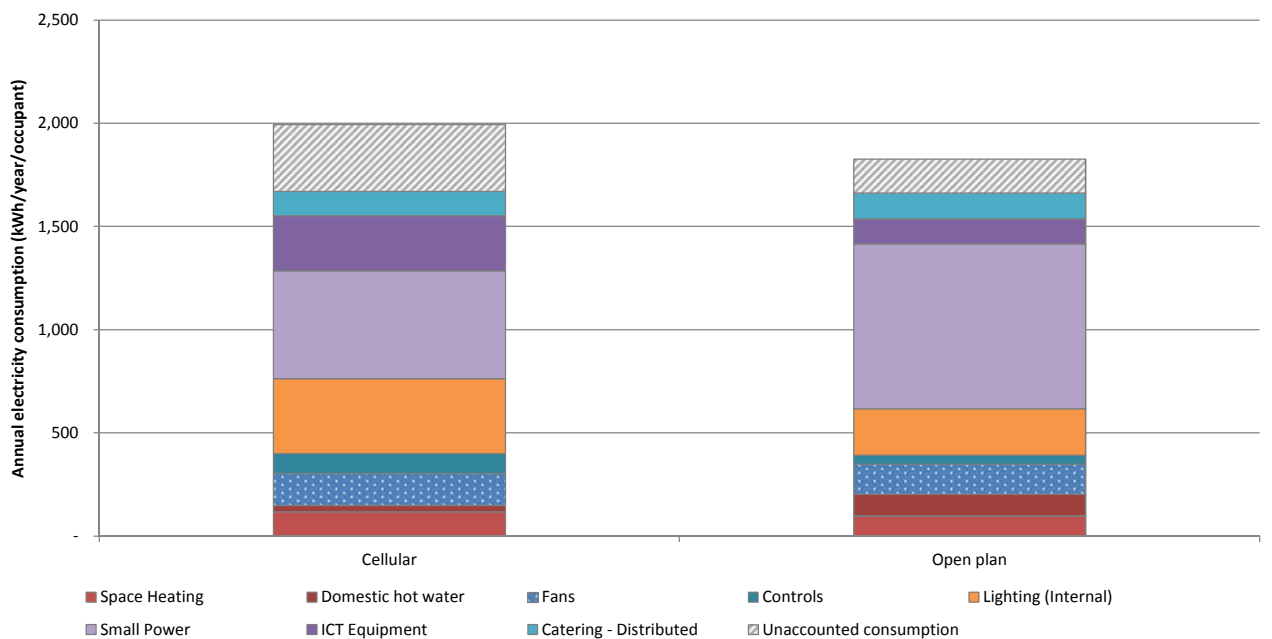
The following graphs show that occupancy density has a significant impact on energy consumption. The occupancy for level 4 is approximately 190 and, for level 8, approximately 397. This equates to 19m²/person and 11m²/person respectively. Taking this into account, the energy consumptions for each occupant type are in fact very similar, with only 7-8% difference over the year analysed. Lighting energy is shown now to be higher on level 4 using this metric, while small power remains higher on level 8.

Figure 15 Tenant energy consumption for each occupant type, normalised for occupancy – whole year

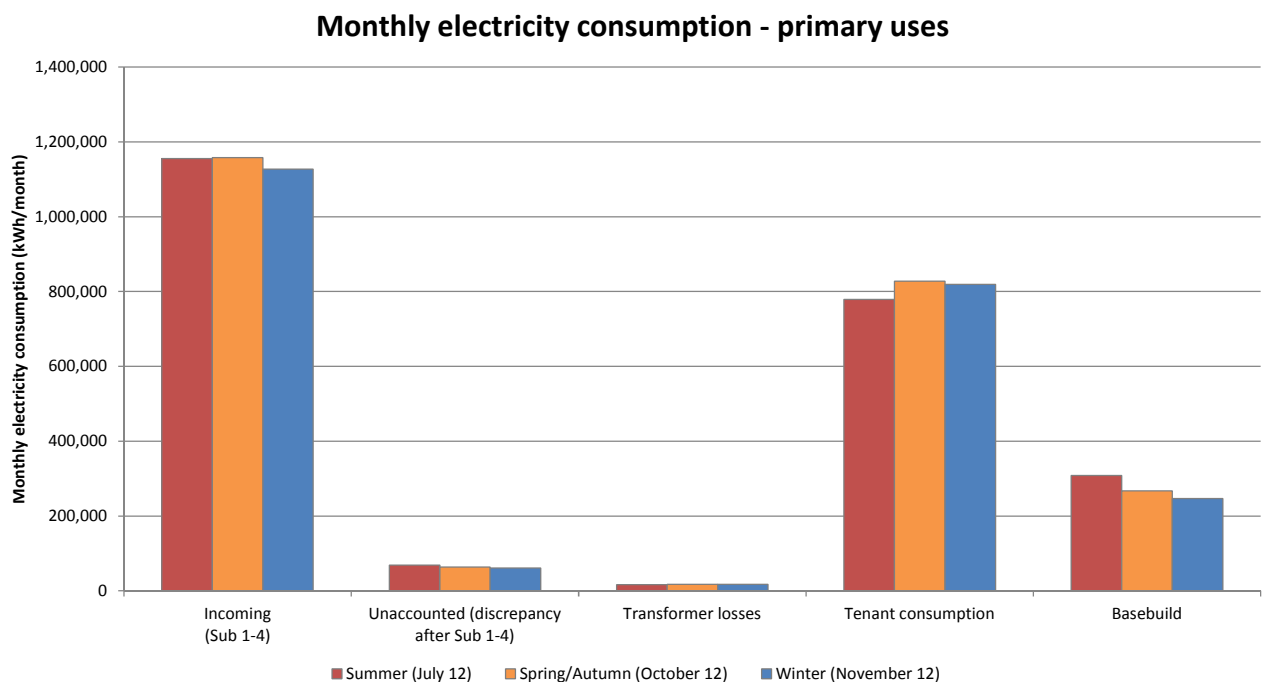
Figure 16 **Error! Reference source not found.** shows the electricity consumption for the primary uses within the building, comparing a spring/autumn month, a winter month and a summer month. It shows that, at the total consumption level, there are only small differences between each of the three periods – constant consumption across summer and spring/autumn, and a small increase of around 5% in winter.

Figure 16 Primary energy consumption – seasonal comparison

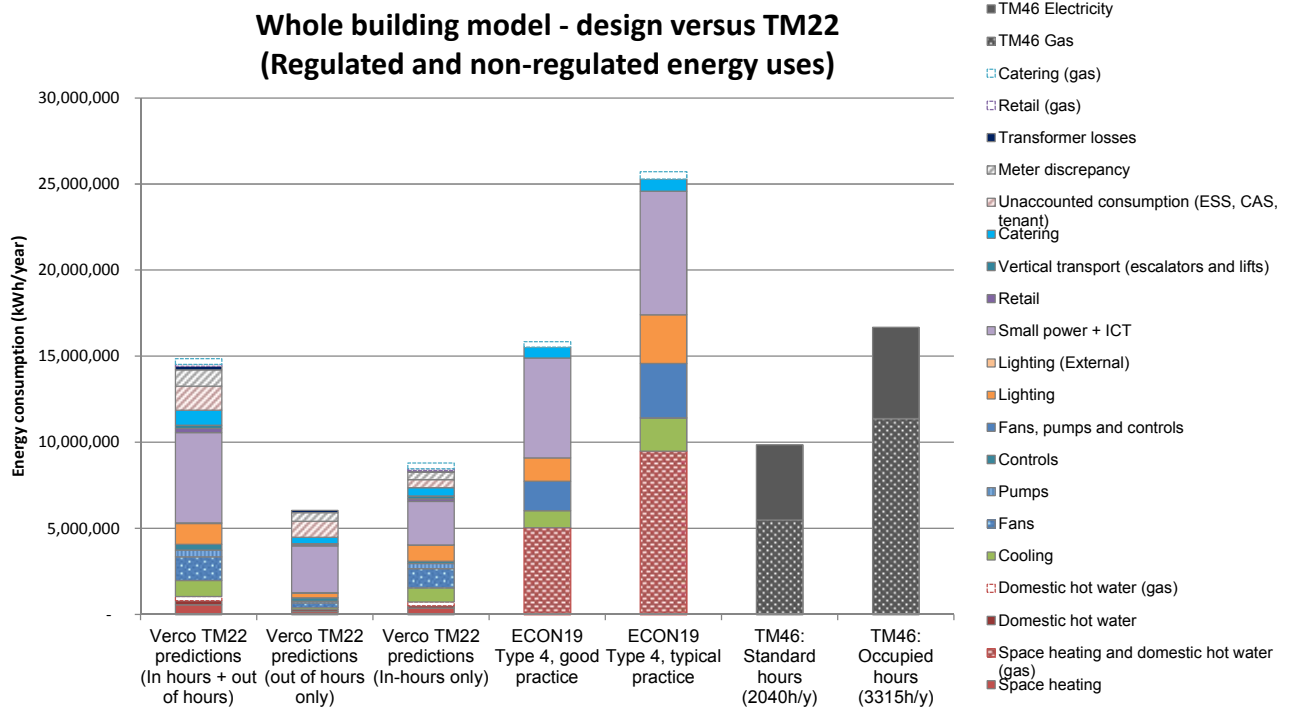
Figure 17 ECON19 versus TM22 predictions– breakdown by energy uses, regulated and non-regulated

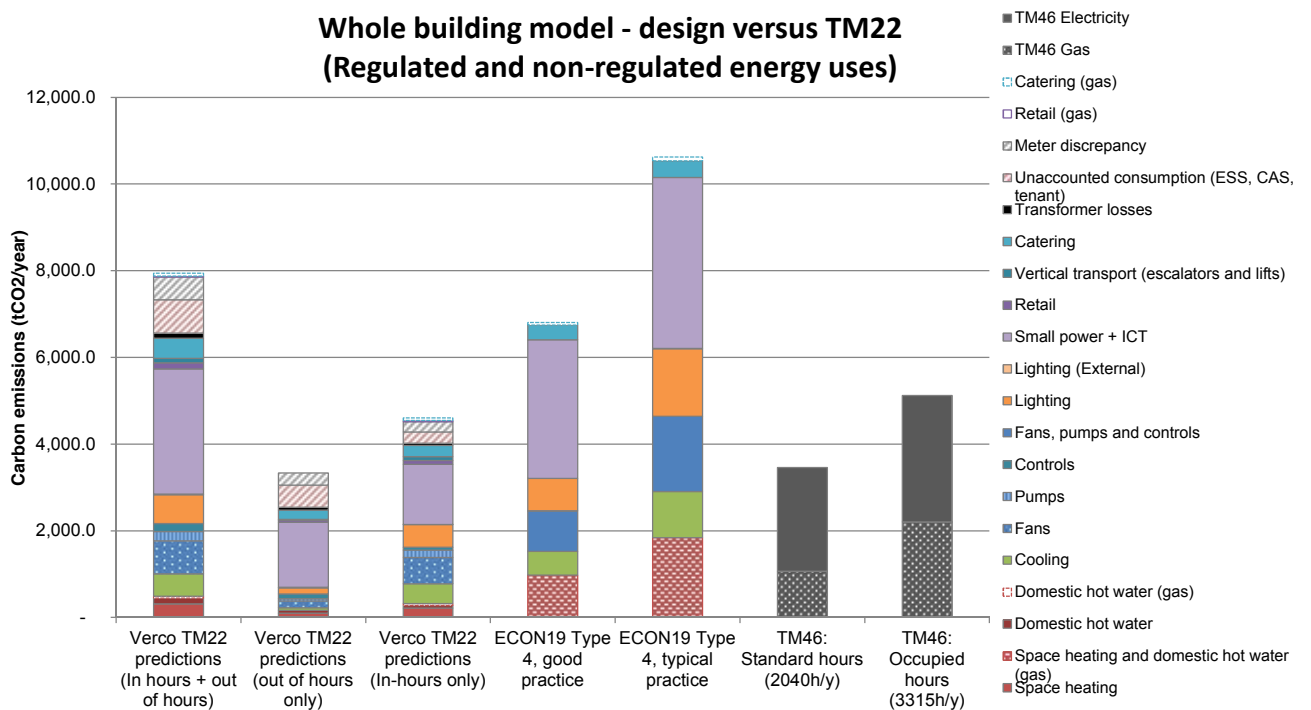
The graph below shows the results for regulated and non-regulated energy uses, expressed as carbon emissions. This demonstrates the change in performance as a result of using electricity for heating, when compared to a conventional office building – in comparison to ECON 19, the building’s performance now falls between ‘good’ and ‘typical’ practice.

Figure 18 ECON19 versus TM22 predictions– breakdown by carbon emissions, regulated and non-regulated

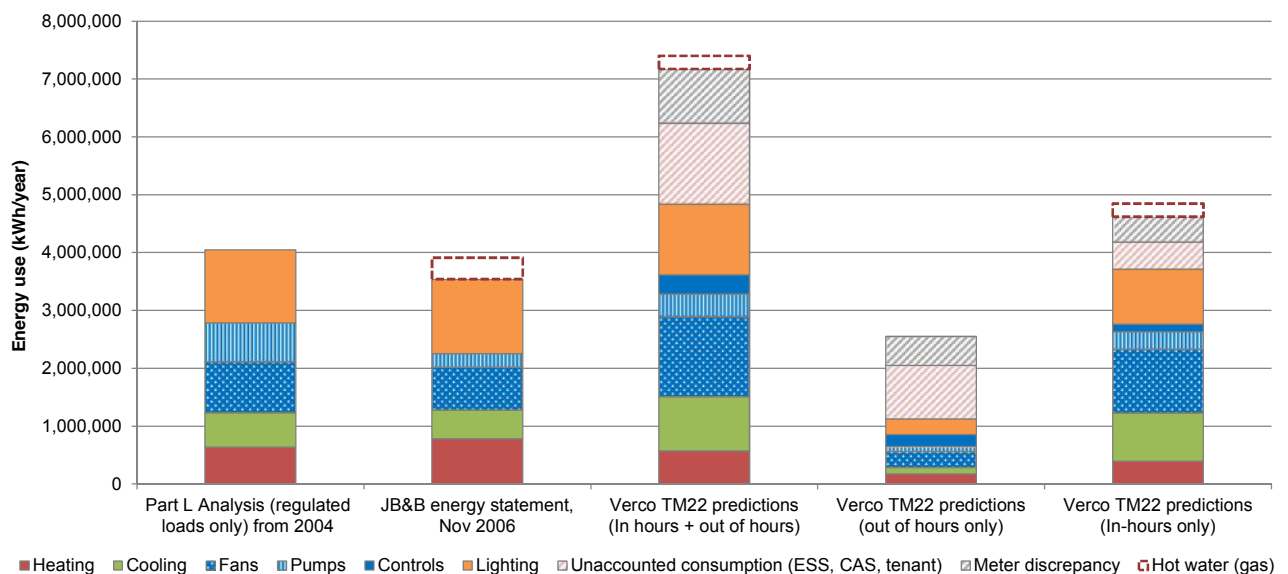
Figure 19 Design versus TM22 predictions– breakdown by energy uses, regulated only

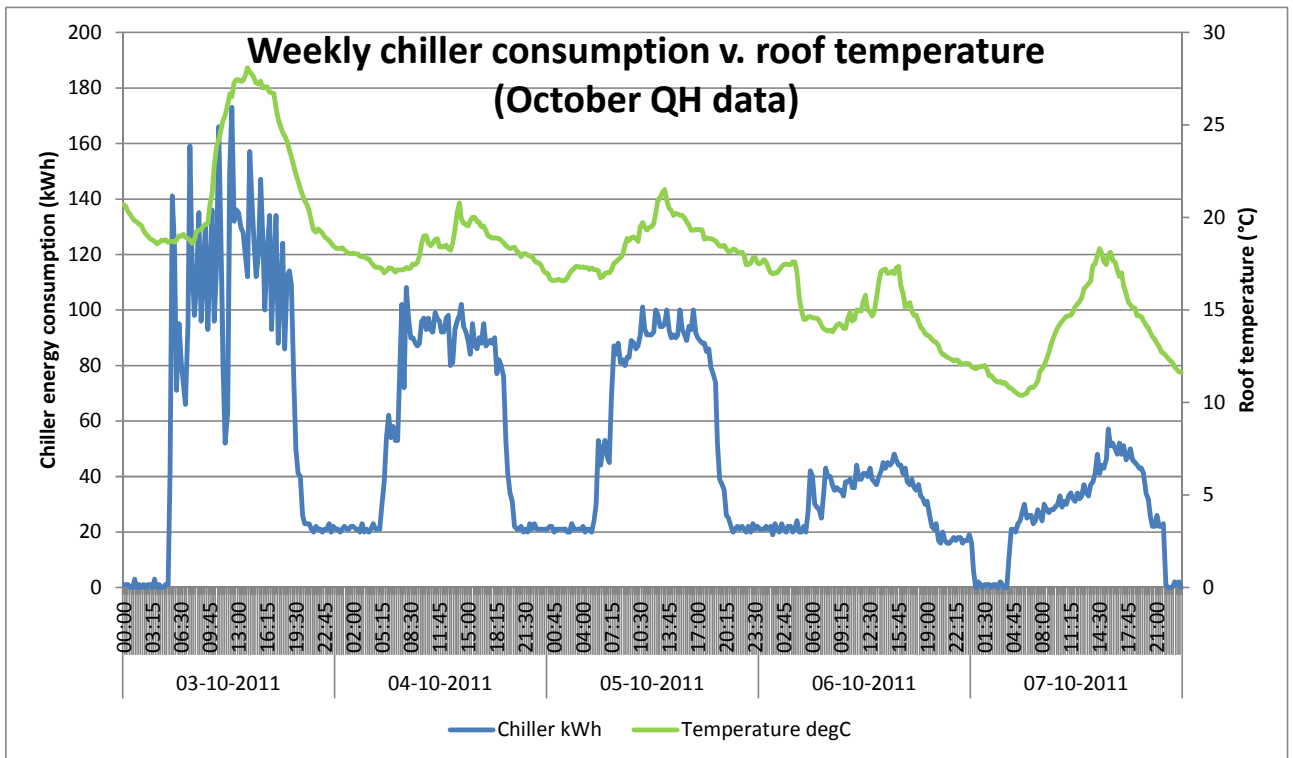
This is indicated by the graph in which shows a wide range in daytime external temperature with a corresponding range in chiller energy consumption.

Figure 20 Comparison of chiller electricity consumption with roof temperature

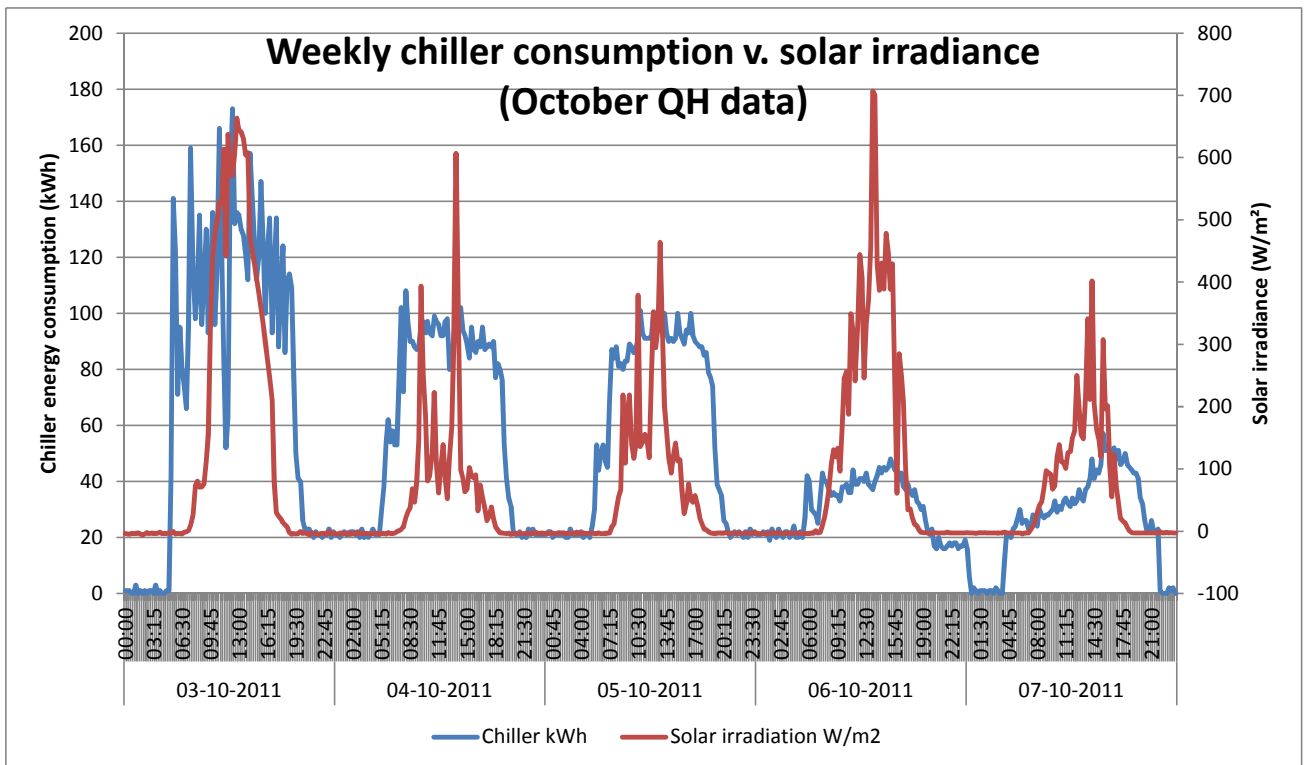
However, the correlation between chiller energy consumption and solar irradiance is less strong, as demonstrated in the figure below.

Figure 21 Comparison of chiller electricity consumption with solar irradiance

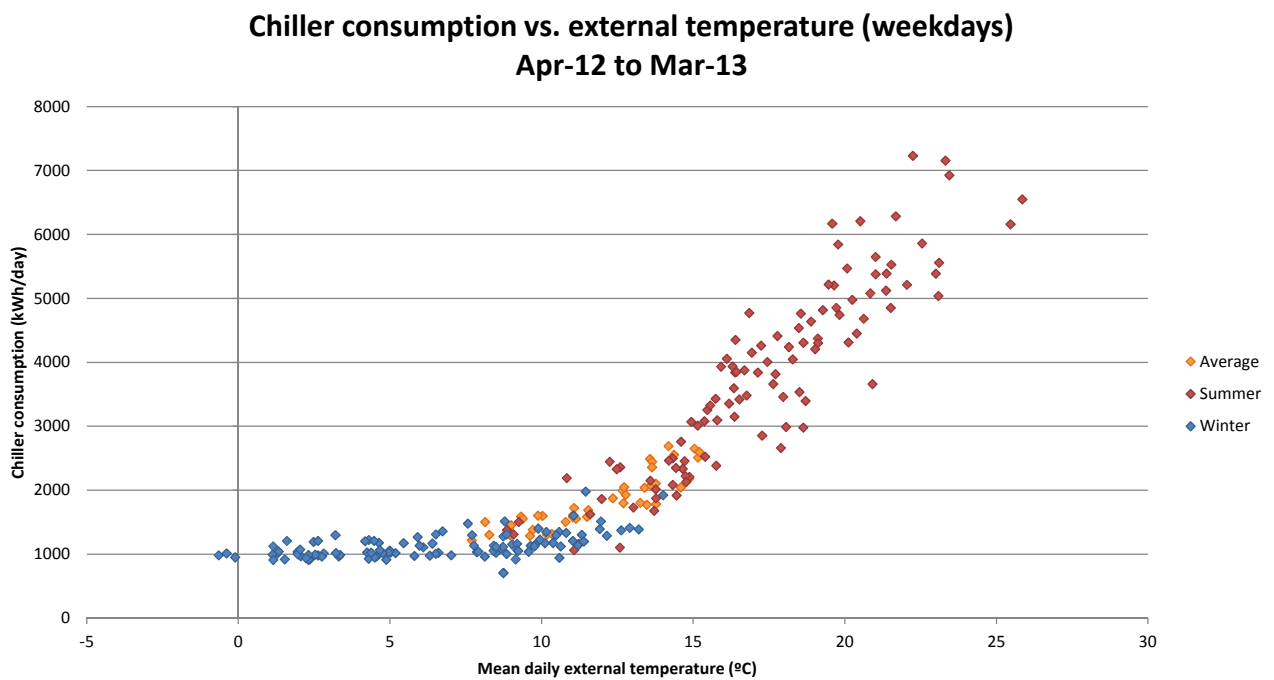
Figure 22 **Error! Reference source not found.** below confirms that there is a strong correlation between external temperature and chiller electricity consumption, above an external temperature of around 12-13°C. This is reasonably consistent with the supply air temperature in the building, which is around 16° - there would typically be 1-2°C of temperature increase through the ventilation systems as a result of fans and/or duct heat pick up.

Figure 22 Chiller electricity consumption vs external temperature: April 2012-March 2013

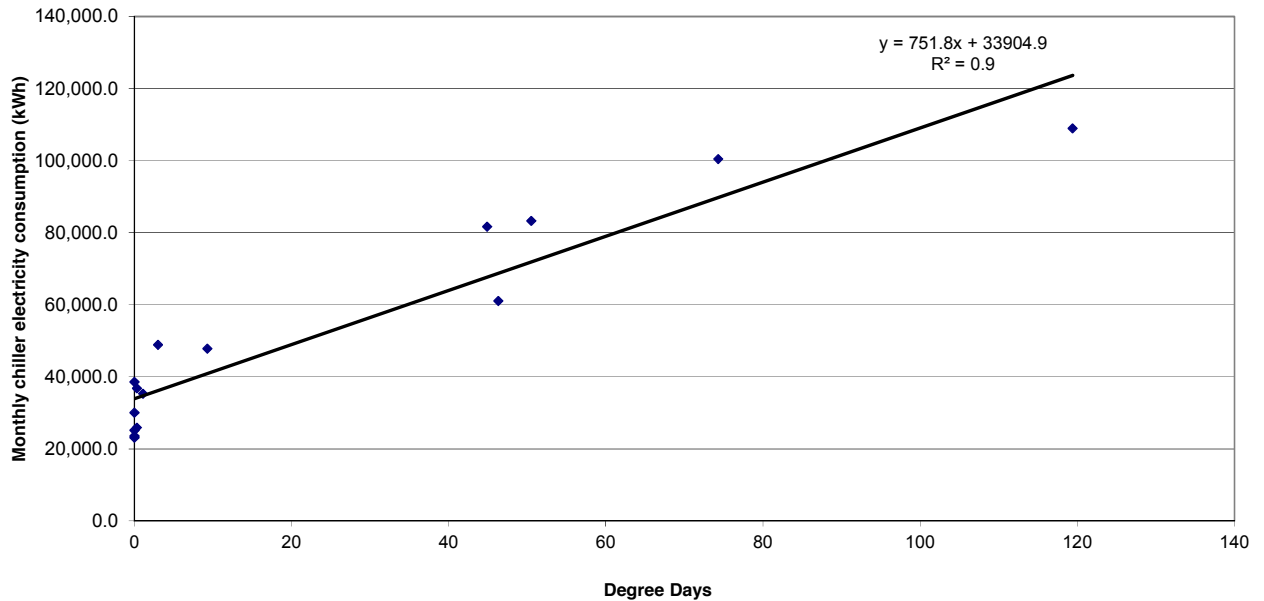
The following graph shows that the correlation between chiller energy consumption and external temperature is considered strong (R^2 value of 0.9) i.e. the external temperature has a significant impact on chiller energy consumption.

Figure 23 Relationship between chiller energy consumption and degree days

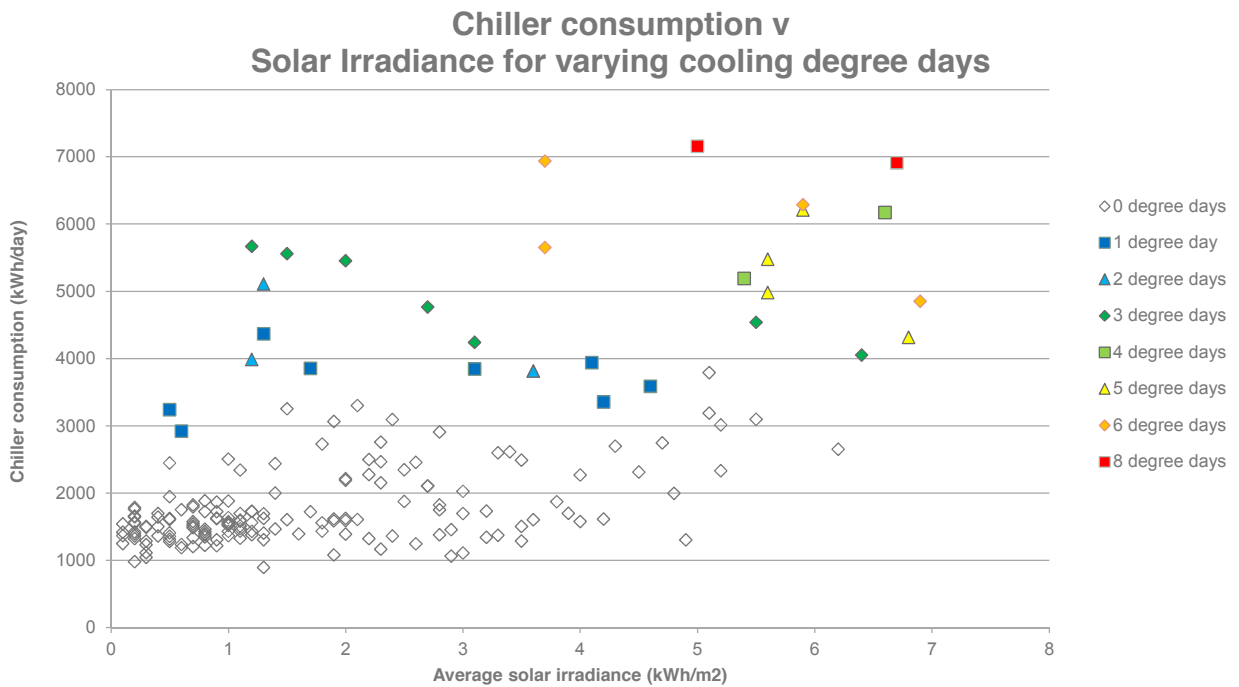
Figure 24 **Error! Reference source not found.** shows chiller electricity consumption versus solar irradiance for varying cooling degree days, over the same 12 month period. This analysis reinforces the premise that there is a poor correlation between these two variables, and suggests that external temperature and internal gains must be the dominating factors in chiller electricity consumption. There does, however, appear to be a relatively clear energy baseload at around 1200kWh/day which is likely to be due to 24 hour cooling. This equates to approximately 312MWh/year, which is a significant number of operating hours, particularly during the winter.

Figure 24 Chiller electricity consumption vs solar irradiance for varying cooling degree days: October 2011- June 2012 (weekdays only)

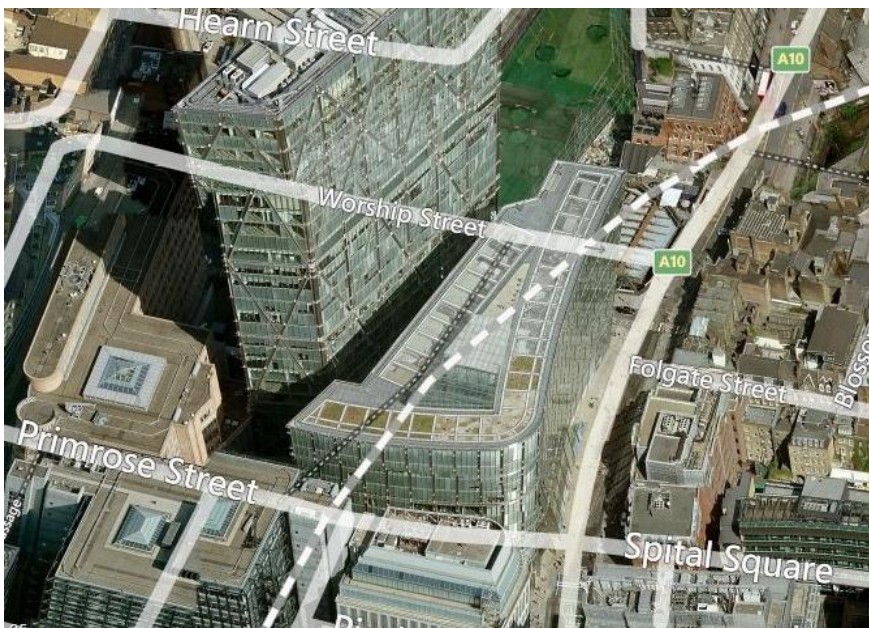
The figure below shows a bird’s eye view of the building, showing how it is shaded by other buildings - the west façade is heavily shaded by Broadgate Tower, the south façade is well shaded at the lower levels, and the east façade is relatively un-shaded. In addition to the intensive usage of the building, with longer than typical occupancy and high internal loads from small power and IT, this may also suggest why solar irradiance has such limited influence on chiller energy consumption.

Figure 25 Bird’s eye view of 201 Bishopsgate

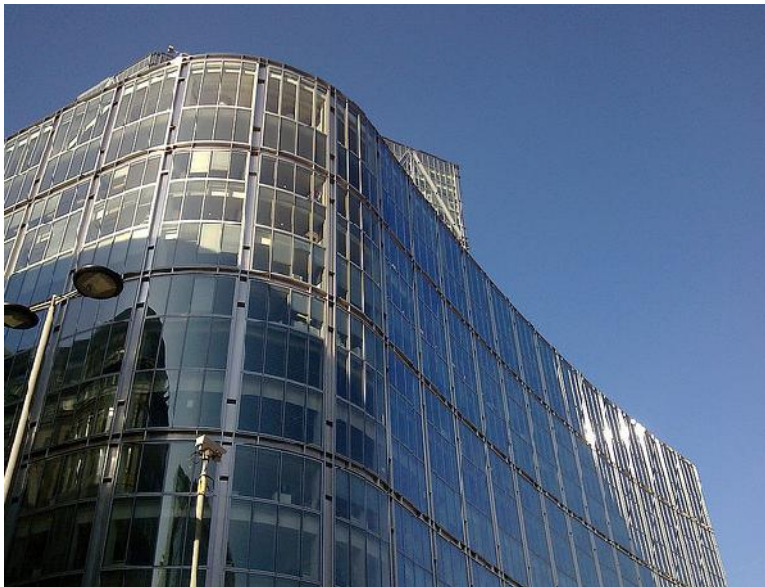
Given the fact that the building is highly glazed (see the figure below) - steel framed with an aluminium curtain walling system – the facade is a specific area of interest for this project. Our TM22 analysis suggests that cooling energy is around 100% higher than predicted in the design calculations. During the early stages of this project, it was identified that the building tenants had previously mentioned that there were problems with the solar shading within the building and comfort issues, suggesting the installed blinds are difficult to operate and therefore are often not used, which could also have a detrimental effect on cooling loads. However, it is now known that both glare from the façade and temperature variation, also likely to be a result of radiant effects from the facade are significant issues in the building, as indicated by the feedback in the occupant survey from level 8 occupants.

Figure 26 201 Bishopsgate's heavily glazed façade

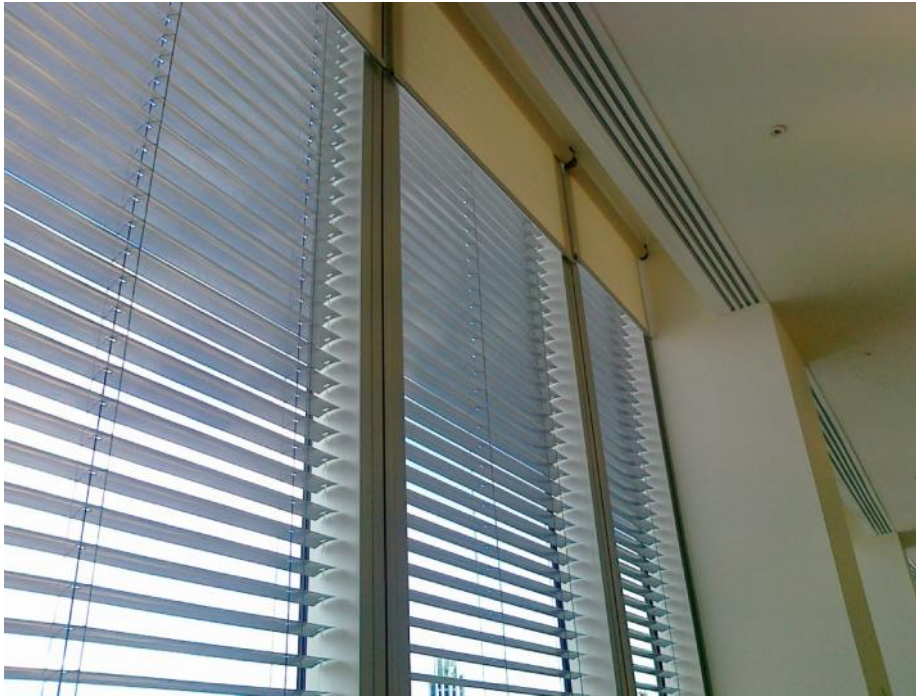
Hence it was determined that it is likely that surfaces will feel warm, specifically mullions, and metal blinds when lowered, despite the fact that the frames are thermally broken.

Figure 27 internal view of façade showing mullions and blinds

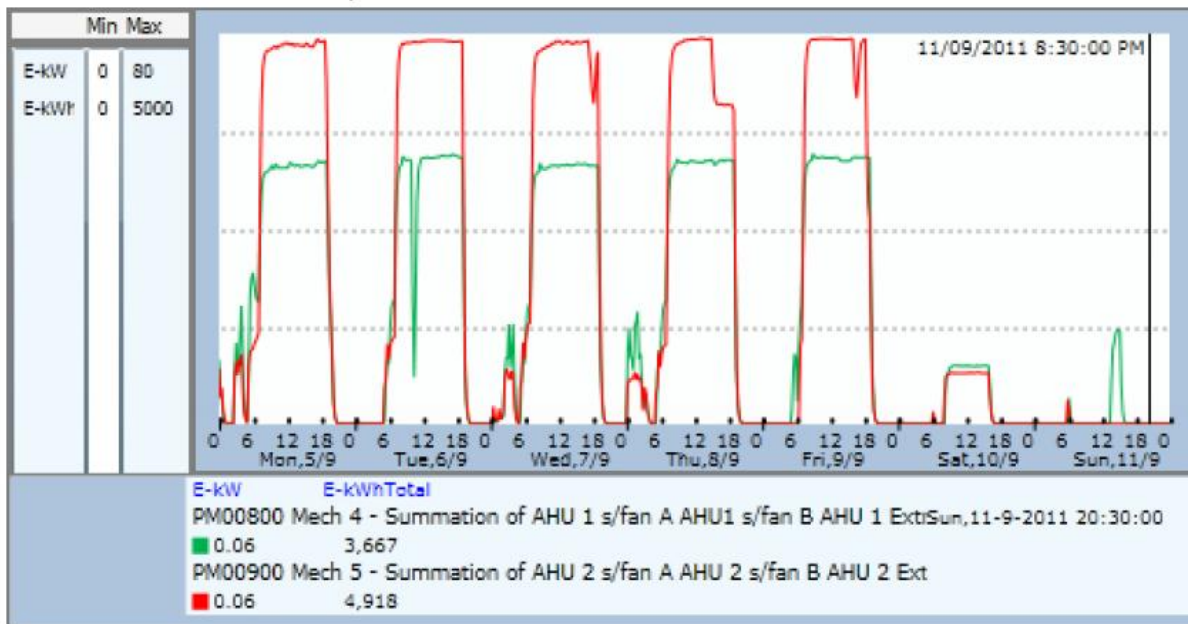
- Inconsistencies in operation were identified for AHU1 and 2. Again, it is understood from the client that the occupiers' BMS can override the central BMS. EP&T suggested that the AHUs might be coming on erroneously as the plant is coming on during the night, and that there could be an issue with the BMS. EP&T also suggested taking away the BMS plant control from any problematic occupiers. A change in control schedules was implemented, resulting in weekly loads dropping substantially, as shown in the graph below, with an estimated annual saving of 128MWh.

Figure 37 AHU fan energy consumption
