# Ancion Court

<b>Innovate UK project number</b>	450083
<b>Project author</b>	Connect Housing/Kiwa
<b>Report date</b>	2014
<b>InnovateUK Evaluator</b>	Fionn Stevenson (Contact via <a href="http://www.bpe-specialists.org.uk">www.bpe-specialists.org.uk</a> )

<b>No of dwellings</b>	<b>Location</b>	<b>Type</b>	<b>Constructed</b>
Two flats assessed	Marsden	2 bed apartments	2011

<b>Area</b>	<b>Construction form</b>	<b>Space heating target</b>	<b>Certification level</b>
63.7 m <sup>2</sup> and 55.5 m <sup>2</sup>	Block construction	Flat A: 2633 kWh per annum Flat B: 1941 kWh per annum	CSH Level 4

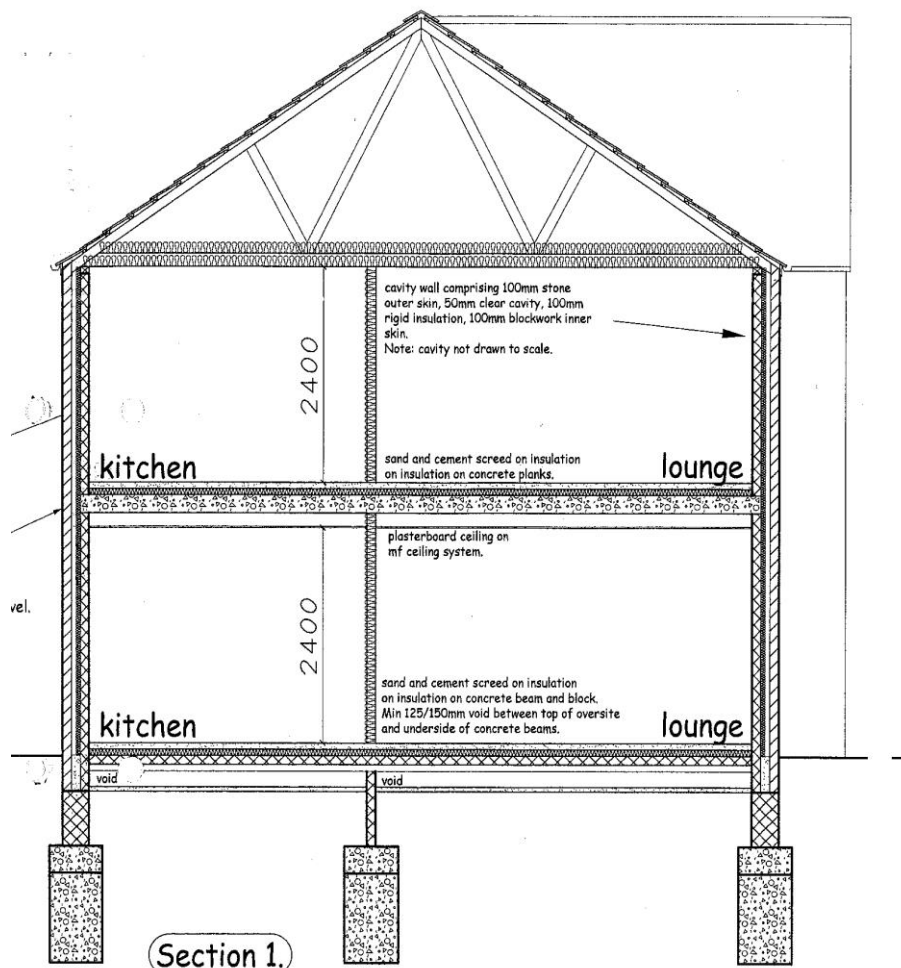
**Figure 8: Envelope construction (Colne Valley Design)**

Ancion Court was designed as a sustainable homes code 4 development, constructed of block and brick with a Yorkshire stone outer leaf. The wall cavity is insulated with 80 to 100mm of rigid thermal board (Kingspan Thermawall TW50) giving a design U-value of 0.20W / m<sup>2</sup>K. The building is damp proofed with Permabit bitumen polymer and sound proofing is fitted to internal surfaces.

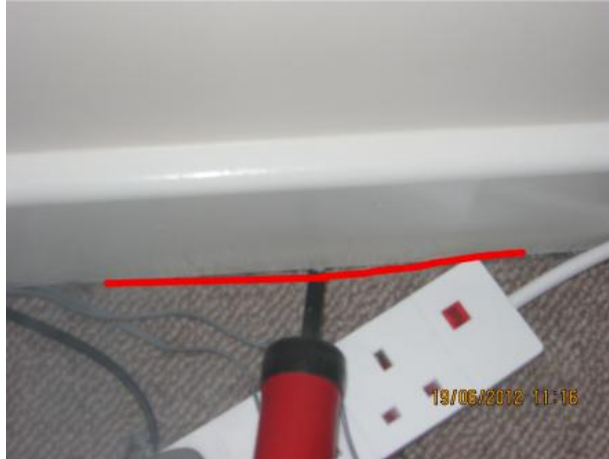
**Figure 11: Photographs of air tightness test work (Stroma Technology)**

Leakage at various points within both flats at the junction of skirting and floor. This had been sealed but mastic sealant was not consistent throughout.

All of these aspects can be rectified by building contractors and it is suggested that a further review of the development as a whole is carried out and aspects rectified as found. These issues should also be identified when considering new developments and the building contractors made aware that care is needed to finish these aspects properly to meet the required building regulations and design values.

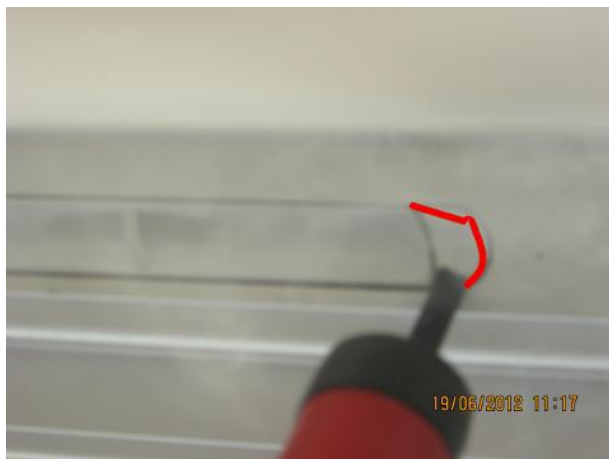
Various trickle vents were ill fitting and/or broken causing the ingress of air. In both flats.

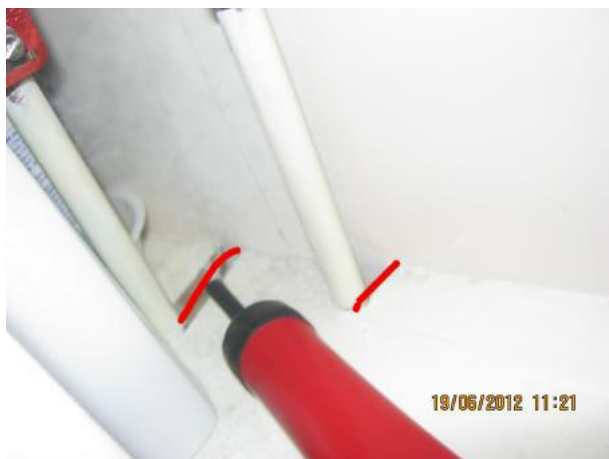
Toilet boxing in both flats was left unsealed allowing air ingress from ceiling void and loft space.

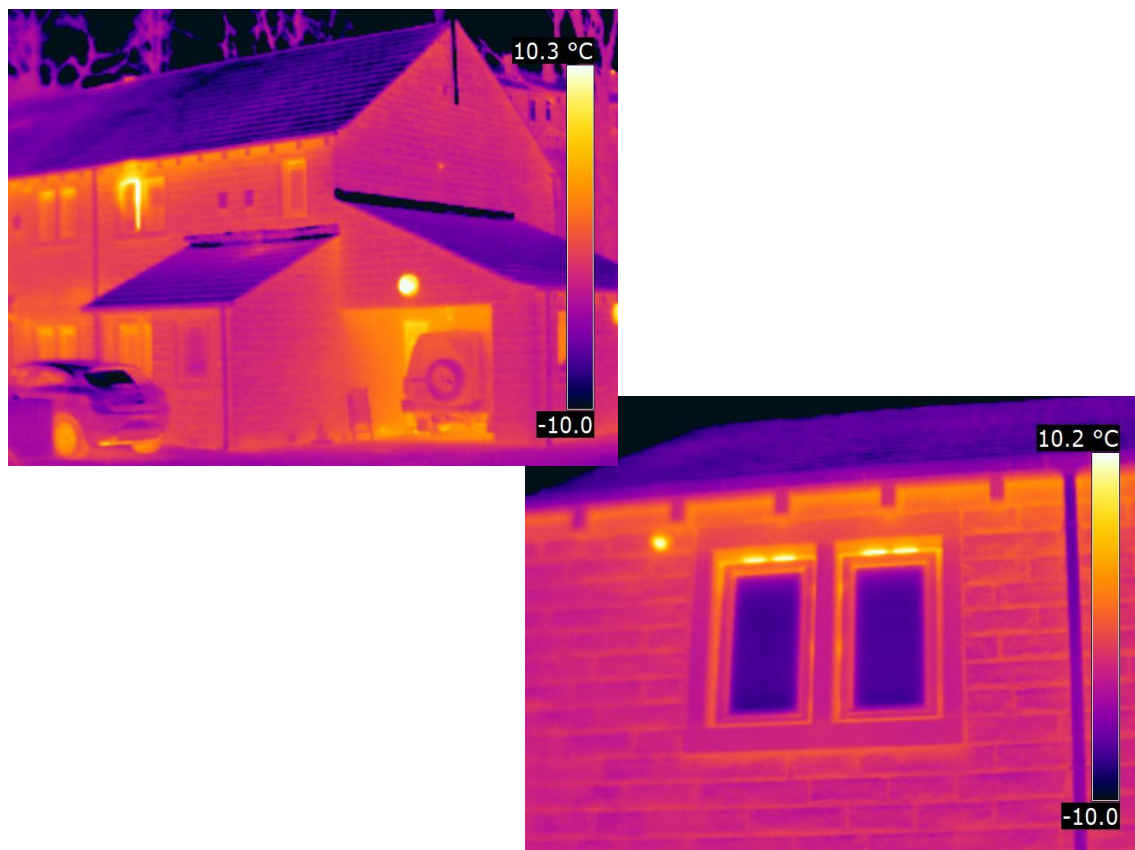
**Figure 13: External images showing thermal bridging through structural joints and trickle vents**

It should be noted that the pattern and location of the areas of heat loss are very much what would be predicted in a modern build constructed to Building Regulations of 2010 and are areas that could be improved on by further considering insulation practices suitable for corners and joints.

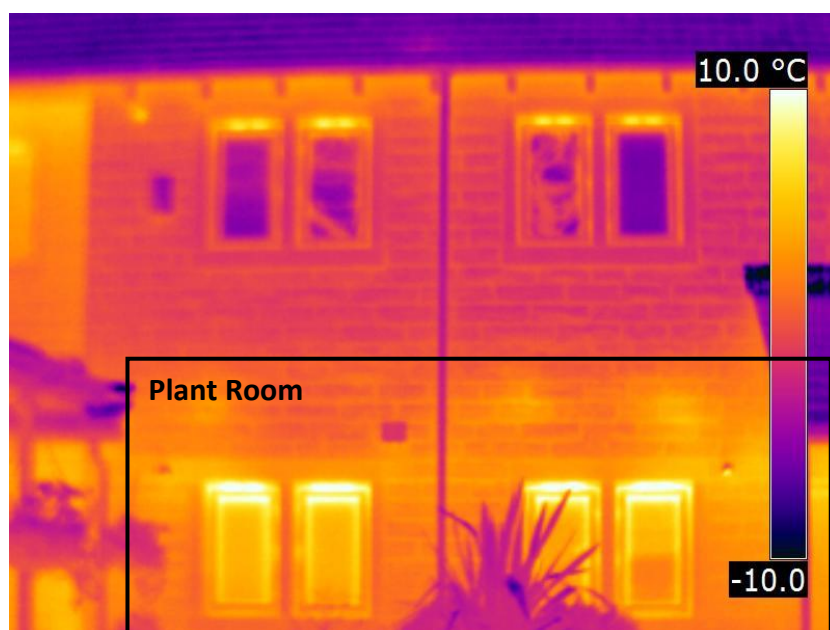
**Figure 14: Thermal image clearly showing location of plant room**

It was possible to identify the plant room from the external thermal images as the building fabric surrounding this was far warmer than the rest of the development. This is likely the result of the very high internal temperatures experienced in the plant room from the large volume of stored hot water and the number of exposed connections, valves and pumps. This high internal temperature was also evident in the communal flat whereby heat transfer from the plant room was clearly identified at the ceiling to wall boundary. It is suggested that the insulation within the plant room is surveyed and any exposed valves and connectors insulated where possible.

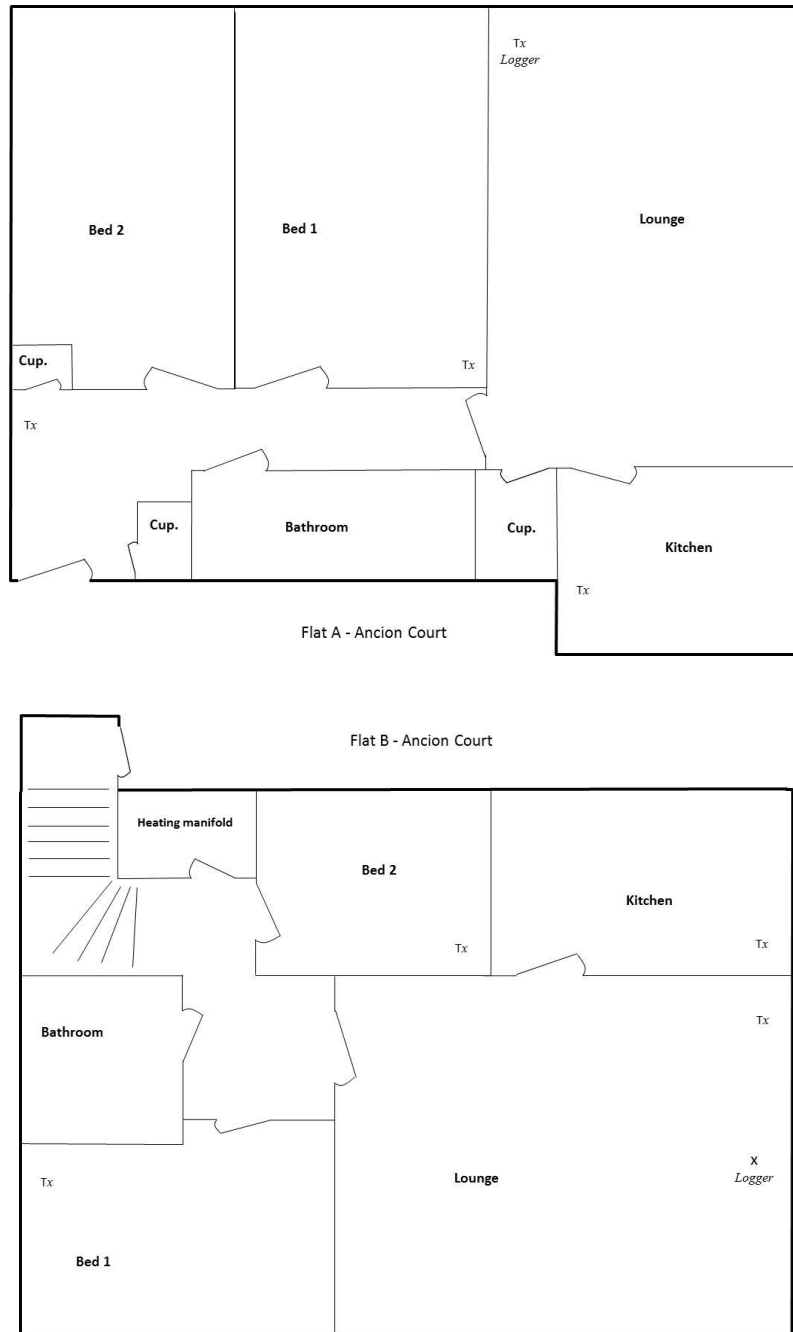
Figure 21: Property lay out showing temperature sensor (Tx) and data logger (Logger)

The monitoring system was a wireless configuration with stand-alone transmitters sending data to a central data logger without any hard wiring; thus ensuring minimal disruption to the resident. The raw collected data was downloaded from the data loggers on a weekly basis where it was then transferred to a database. The data was processed using a series of automated and manual processes to form daily and monthly summaries. At each download

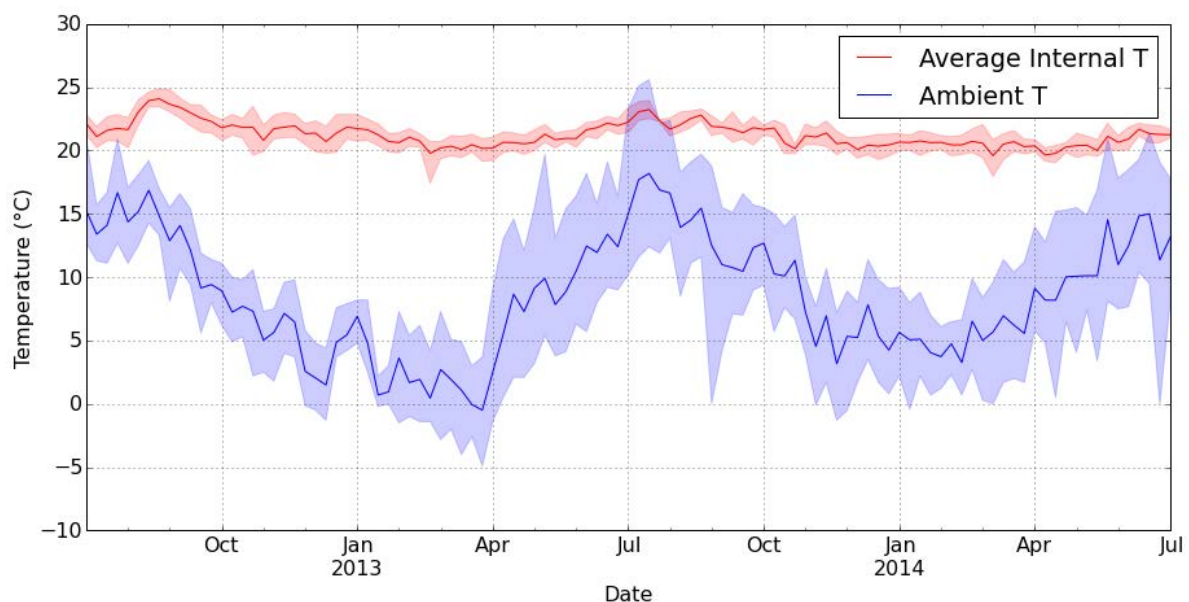
**Figure 22: Flat A average internal temperature**

Although external temperature (as depicted by the blue line) varies throughout the year, the internal temperature is very consistent with only minor temperature increases during the summer months when the highest external temperatures were observed. This supports the suggestion that the building is well insulated and does not suffer under or overheating.

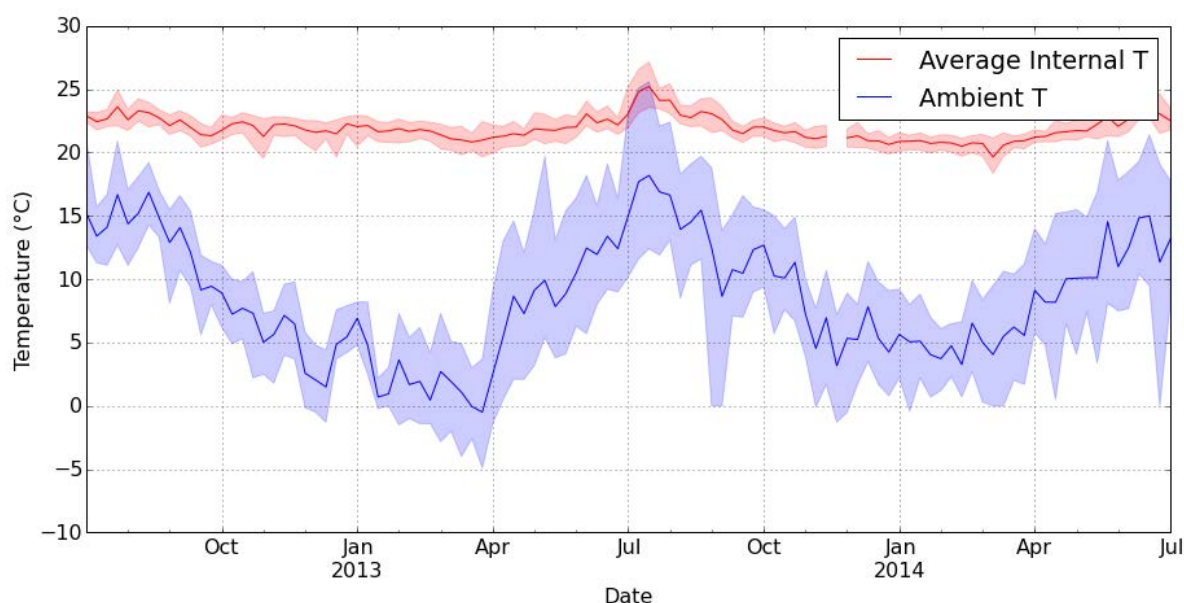
**Figure 23: Flat B average internal temperature**

Again the internal temperature is very consistent with only minor temperature increases during the summer months when the highest external temperatures were observed. These are more marked than in Flat A, which is likely to be the result of the fact that Flat B is on the first floor on the end of the development, whereas Flat A is on the ground floor in a corner position. This means Flat B is far more influenced by solar gains than Flat A which is largely overshadowed by the other properties and the trees to the rear of the development.

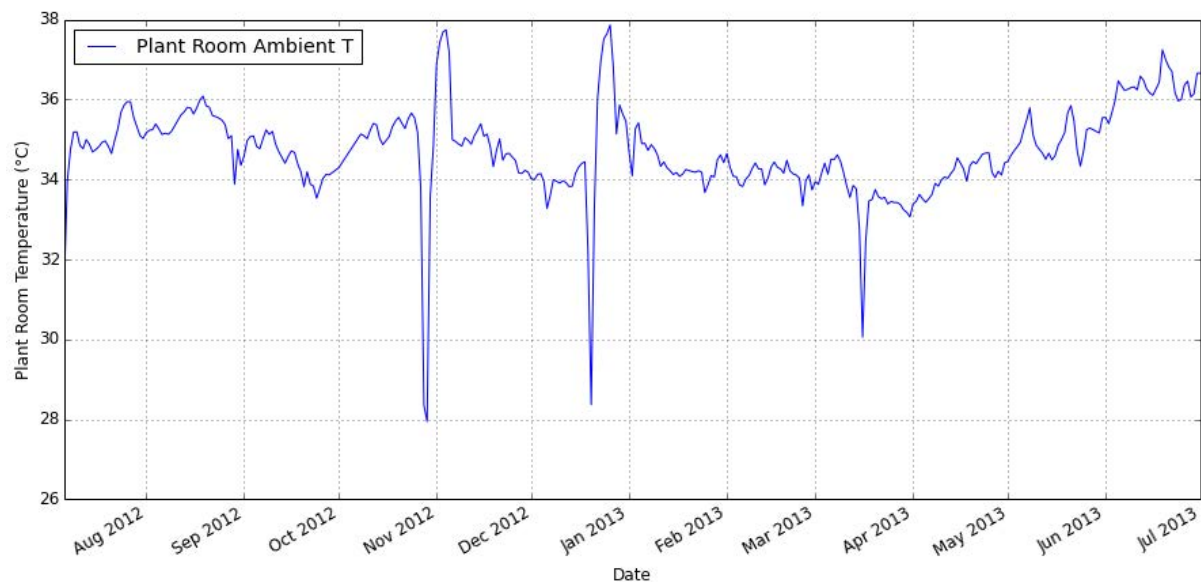
**Figure 35: Ambient plant room temperature**

This is also an important message for industry in the fact that heat given off by un-insulated valves and pipework is not controlled and therefore can have a negative impact on the internal temperatures of the building, particularly during summer months. This needs to be understood by specifiers at the design stage to ensure methods are put in place to insulate all aspects of the plant room including, valves, pipe connections and pipework.

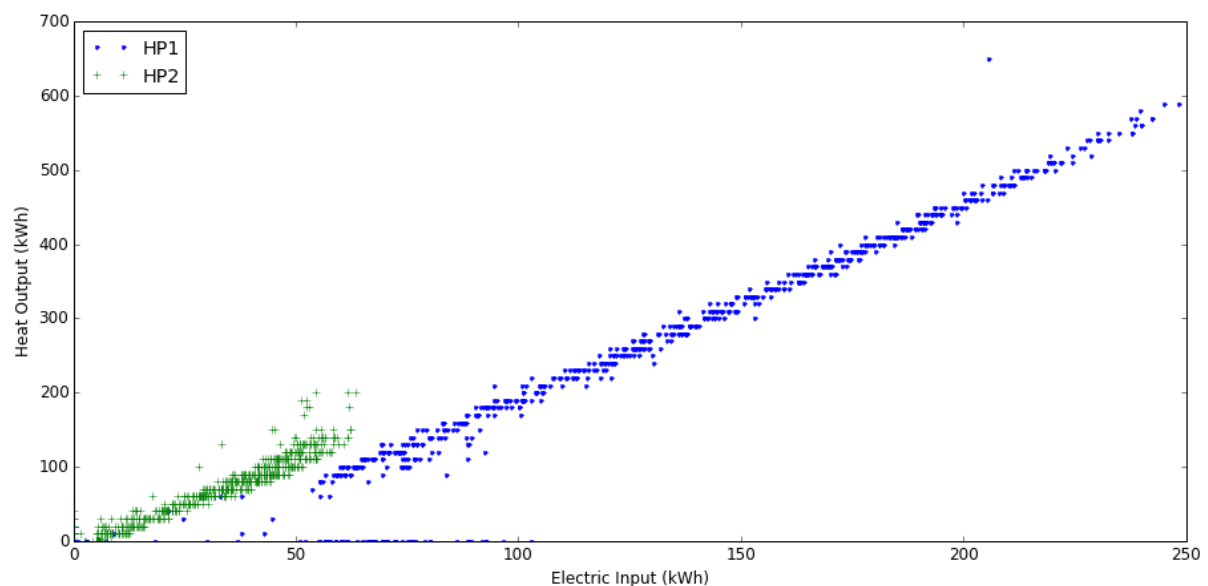
**Figure 38: Heat output and electricity used by the heat pumps**

It can be seen that both heat pumps follow an approximately linear load pattern. The ratio of heat to power is reasonably constant over the whole demand range, with heat pump 1 showing a fairly large offset from the origin, indicating a large standby/base electric consumption. This is discussed in further detail later.

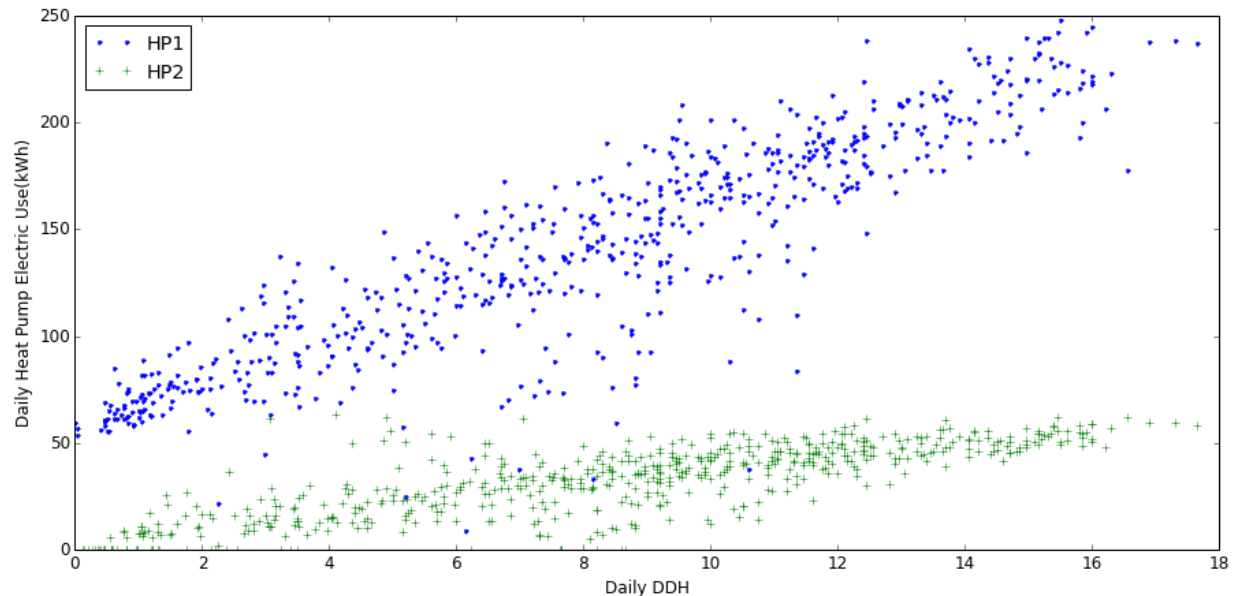
**Figure 39: Degree days and electricity used by heat pumps**

It can be seen that the heat pump electric demand and heat output, in the main, increase in a linear manner as the heating demand increases indicating that control on the whole is reasonably good.

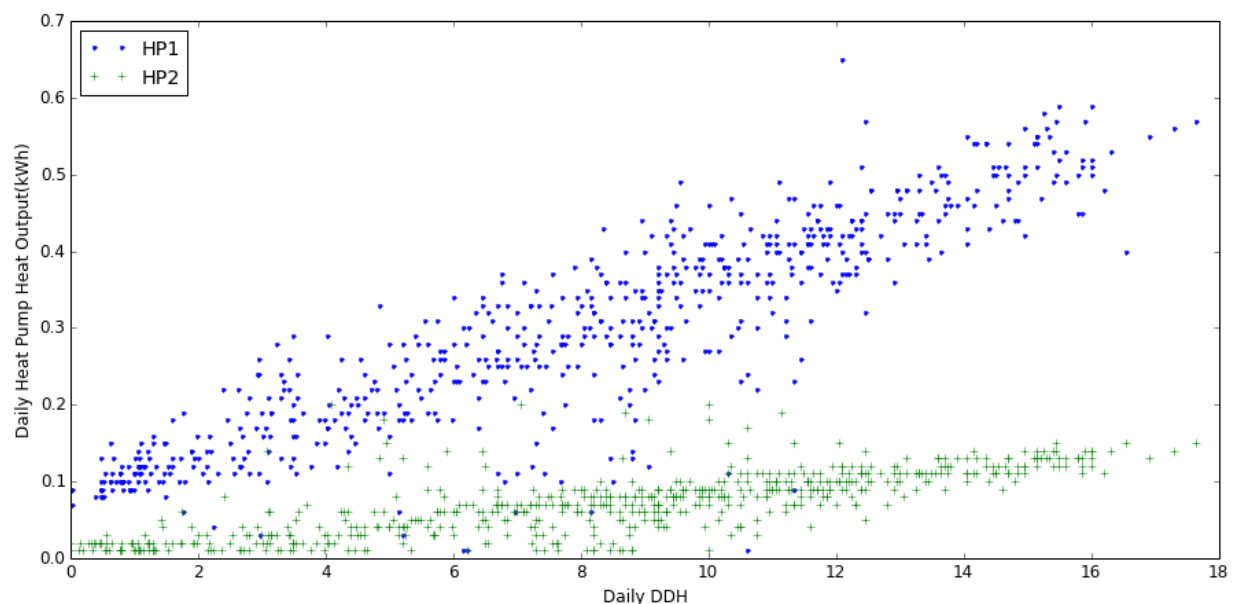
**Figure 40: Degree day heating and heat output from heat pumps**

Heat pump 1 shows a positive intercept on the heat output graph indicating there is a base load to cover, which in this case, is clearly the DHW demand.

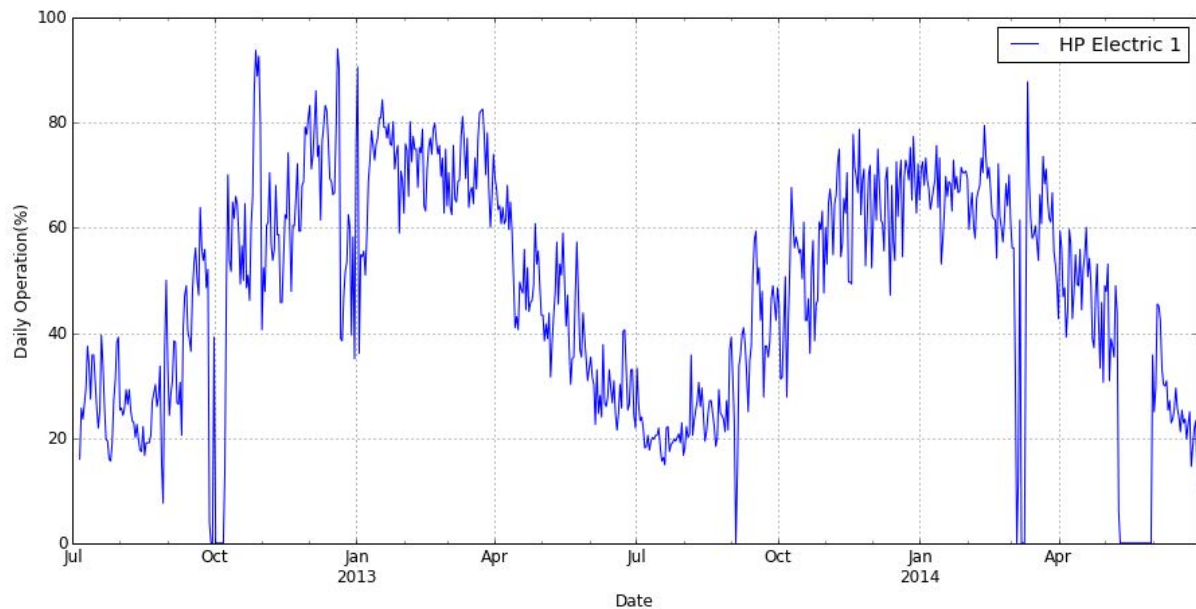
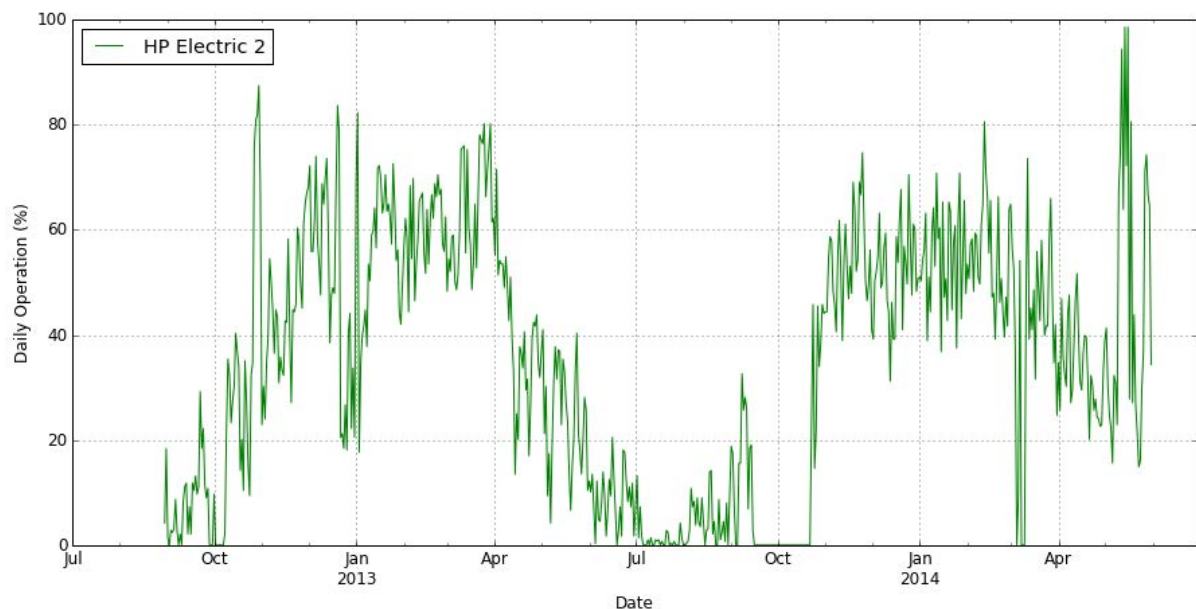
These graphs show that the majority of the load is covered by the HP1 with the smaller HP2 mainly active over the colder months. It is clear that even in the cold winter of 2012/2013, HP1 was operating in a cyclic mode. This may point to the small heat pump turning on slightly too soon, as ideally the full load should come from the lead heat pump (HP1). The number of starts per day (see following figures) is relatively high.

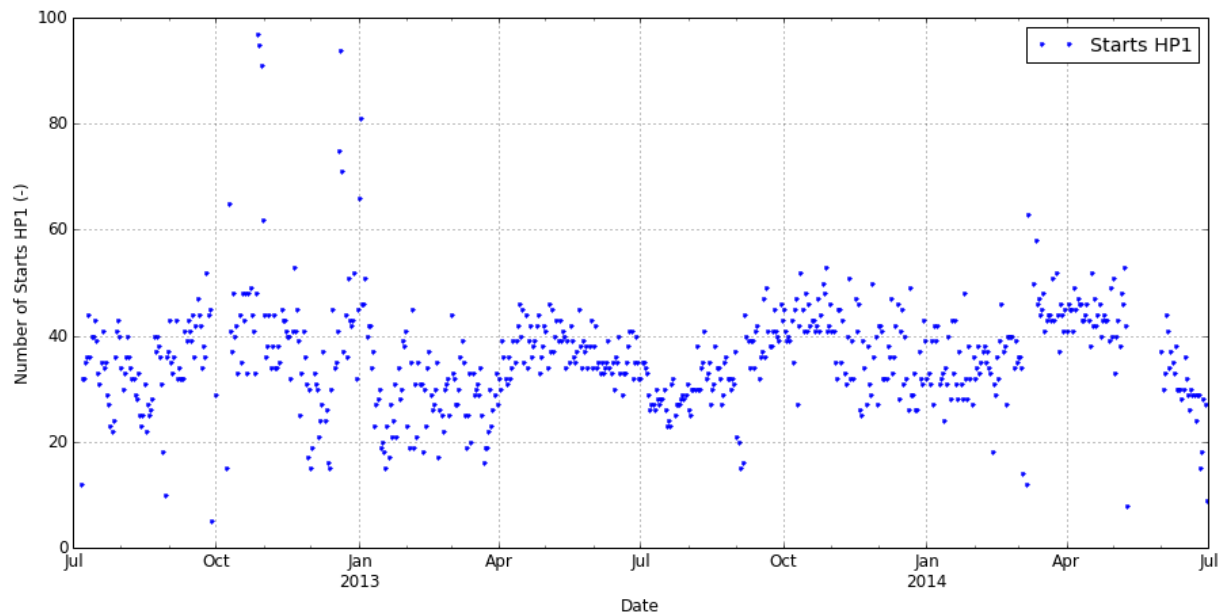
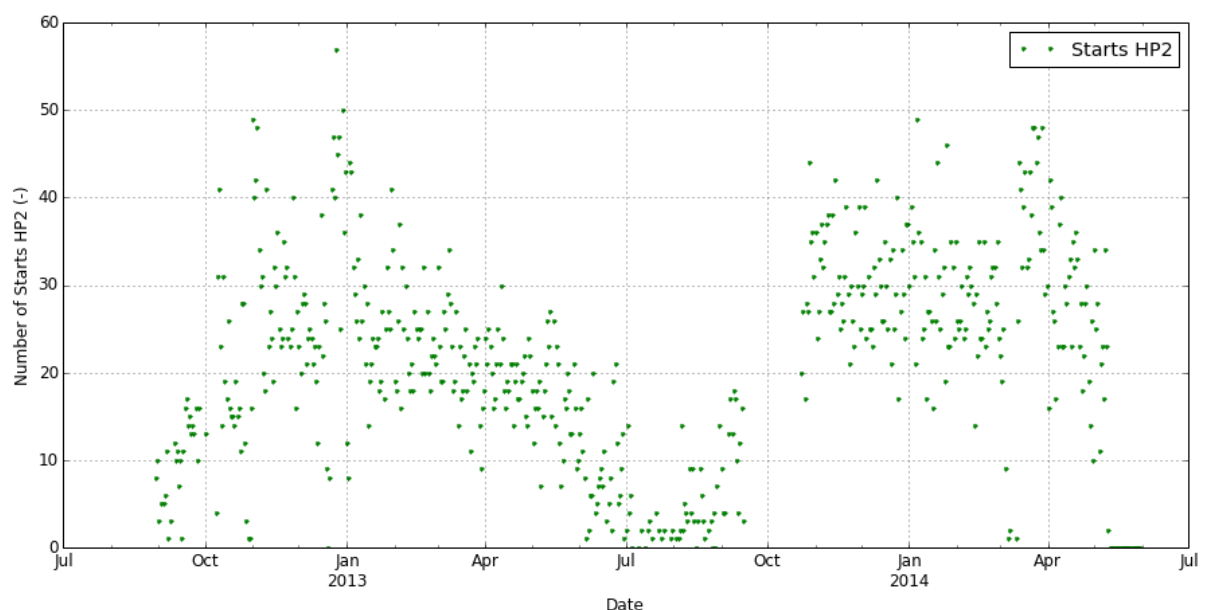
For HP1 the number of starts is quite consistent throughout the test period, but HP2 follows a seasonal trend. On some days there are an exceptionally high number of starts, in excess of 90 starts/day for HP1 and over 50 starts/day for HP2. Cycling has several detrimental effects including increase in wear on the heat pump and compressor, as well as difficulties with the heat pump mass heating and cooling regularly reducing efficiency. This cycling needs to be investigated further but may suggest the buffer storage has insufficient volume to maintain consistent operation.

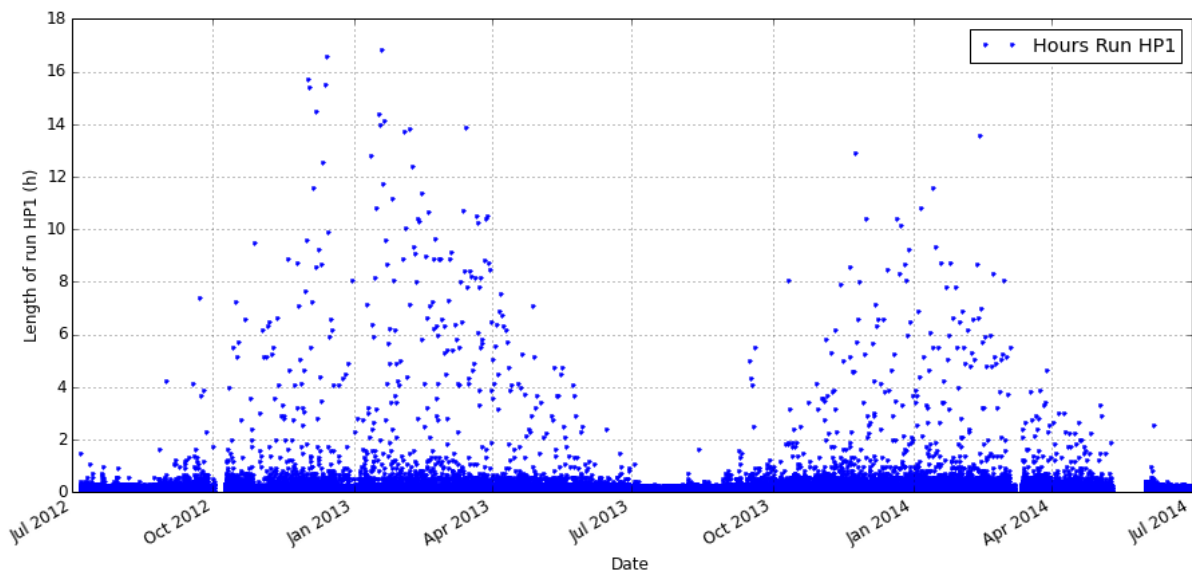
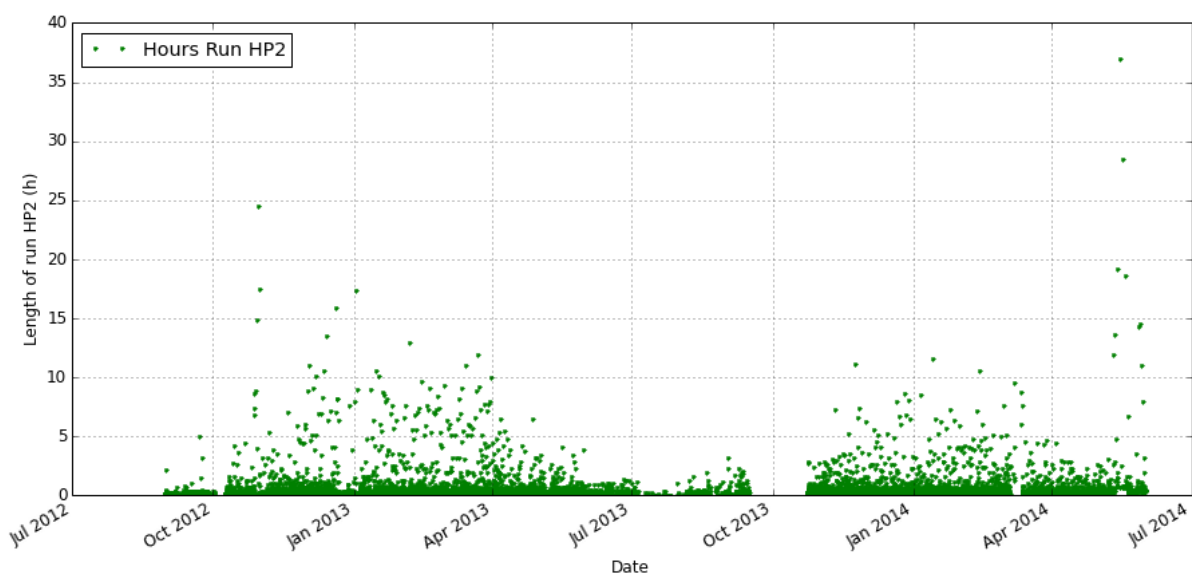
When operational the run length of both heat pumps is predominantly very short – less than 1 hour as can be seen by the high density of the dots near the x-axis of the following graphs. This supports the high number of starts and cyclical nature discussed above and leads to poor performance of the heat pump.

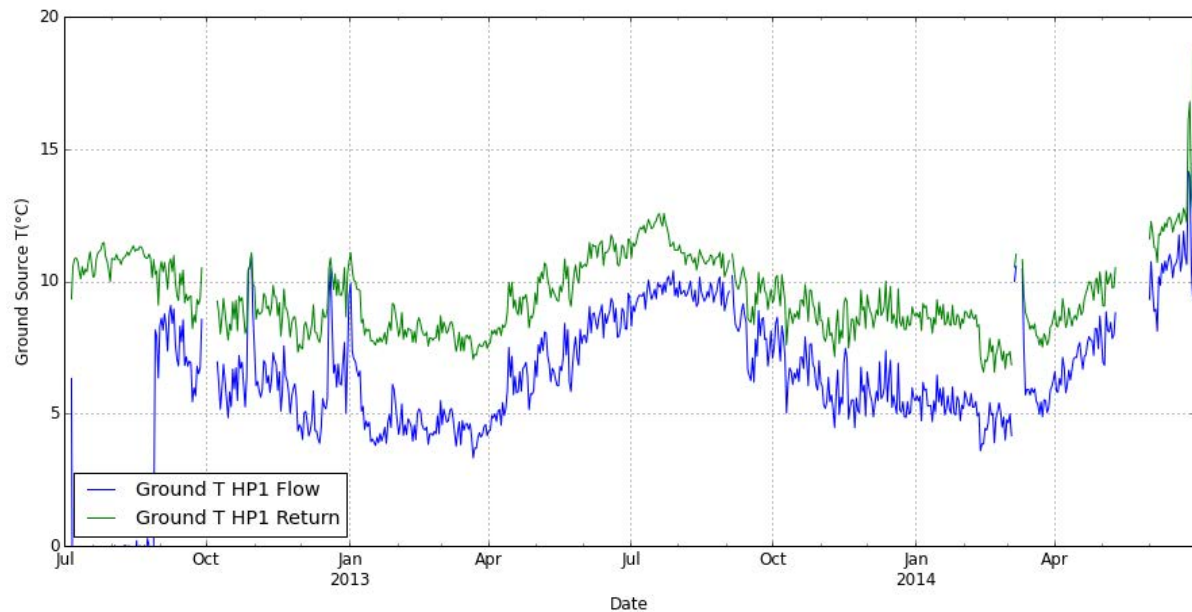
**Figure 48: HP1 Ground temperatures**

Temperatures from the ground loop (again daily averages, during 'on' periods) seem to be maintained at very acceptable levels. There is a noticeable dip during the winter months, but this is recovered in the summertime. There does not appear to be a continual decrease, so it can be assumed that the amount of heat taken from the ground by the heat pump is currently not causing any sub-soil issues. This would include freezing of the ground loops which can occur if the boreholes are too close together or incorrectly sized. If the ground loop freezes, heat extraction becomes difficult and thus the system will fail to operate successfully.

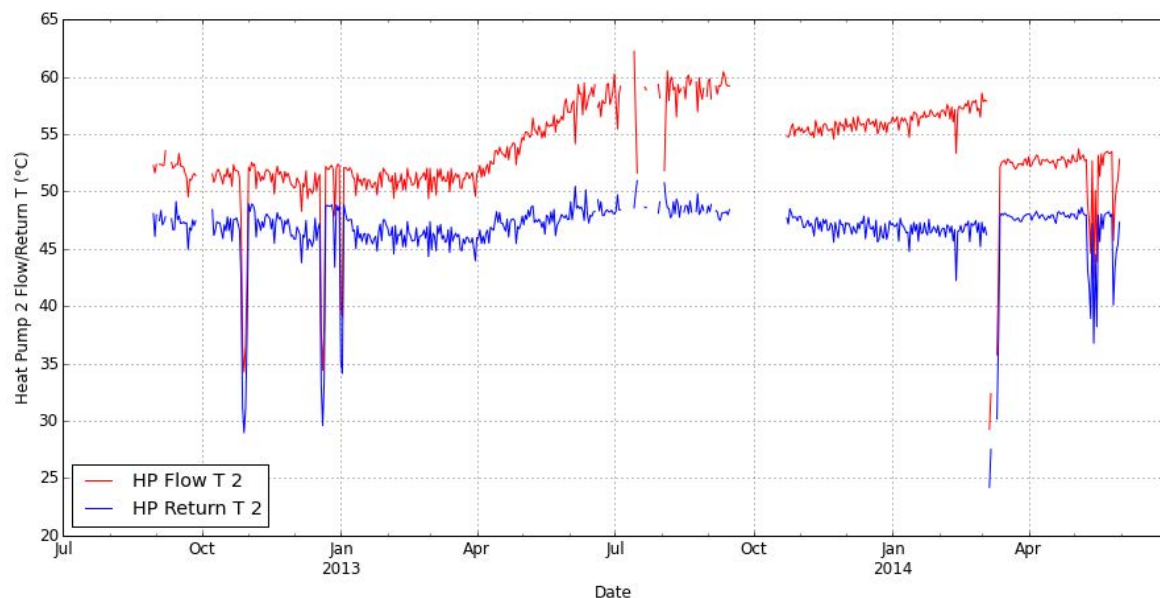
**Figure 49: HP2 flow and return temperatures**

For heat pump 2 flow temperature are very high again at nearly all of the operating times, reaching close to 60 °C during the summer of 2013. This will impact on the efficiency of the heat pump. Ideally, a normal maximum operating temperature of 45°C would give a much enhanced performance.

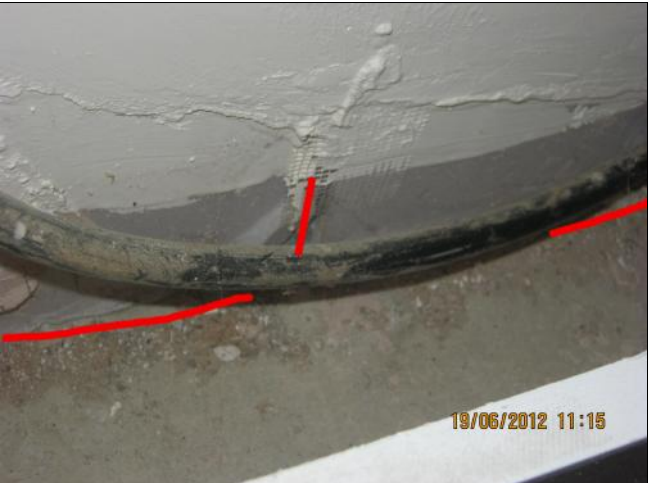
Foot of dry-lining unsealed at foot of stairs distribution cupboard. Flat 15

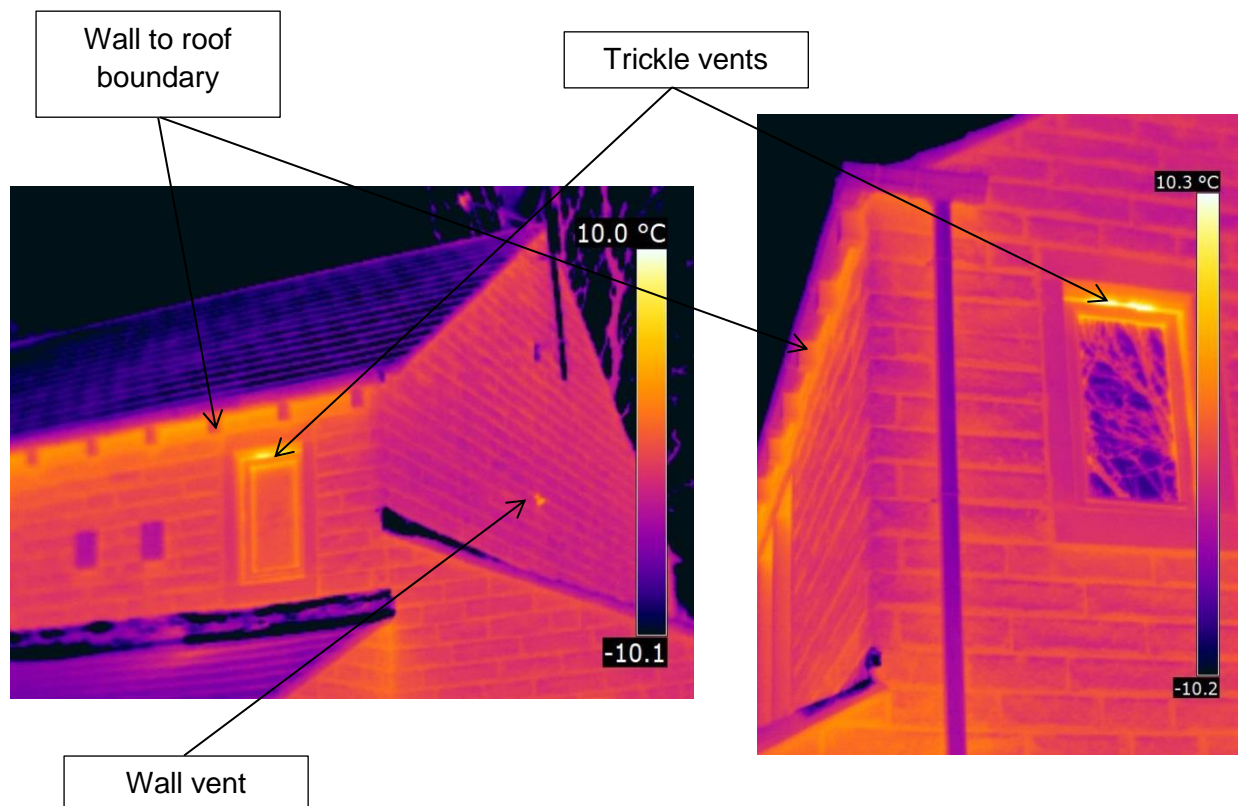
The following two images were taken on the rear NE corner of the development.

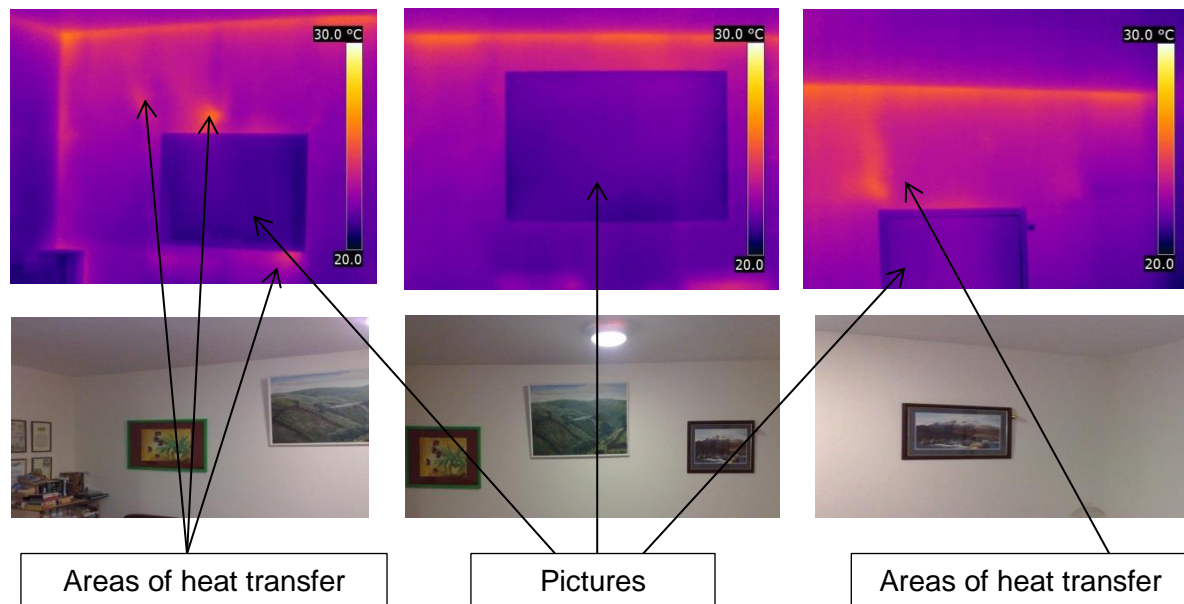
In these images the heat transfer between the plant room and communal space is clear particularly between the wall and ceiling and to a lesser extent through patches in the wall (indicated as areas of heat transfer in the image above).

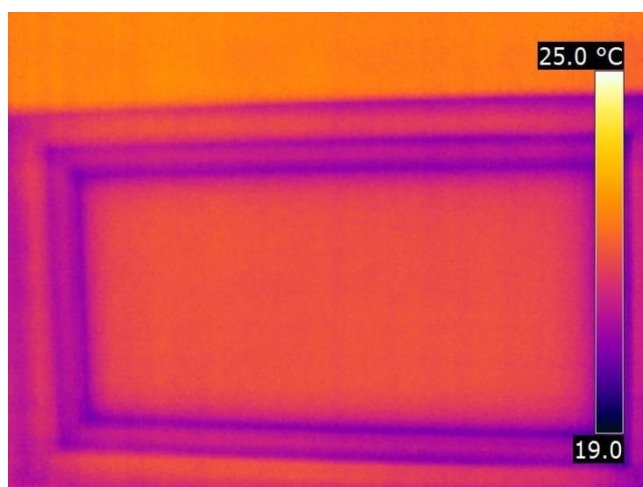
The resident in Flat B often complains that the stairwell is cold. Thermal images were taken at the foot of the stairs and it was shown that there is significant cold air ingress surrounding the door, and from the floor to wall joint at the bottom of the staircase (shown below)
