Angmering Community Centre

Innovate UK project number	450048
Project lead and author	Low Carbon Building Group, Oxford Brookes University
Report date	2015
InnovateUK Evaluator	Unknown (Contact www.bpe-specialists.org.uk)

Building sector	Location	Form of contract	Opened
Community Centre	Angmering	Traditional	2010
Floor area	Storeys	EPC / DEC	BREEAM rating
563 m ²	Single	A (24) / N/A	N/A

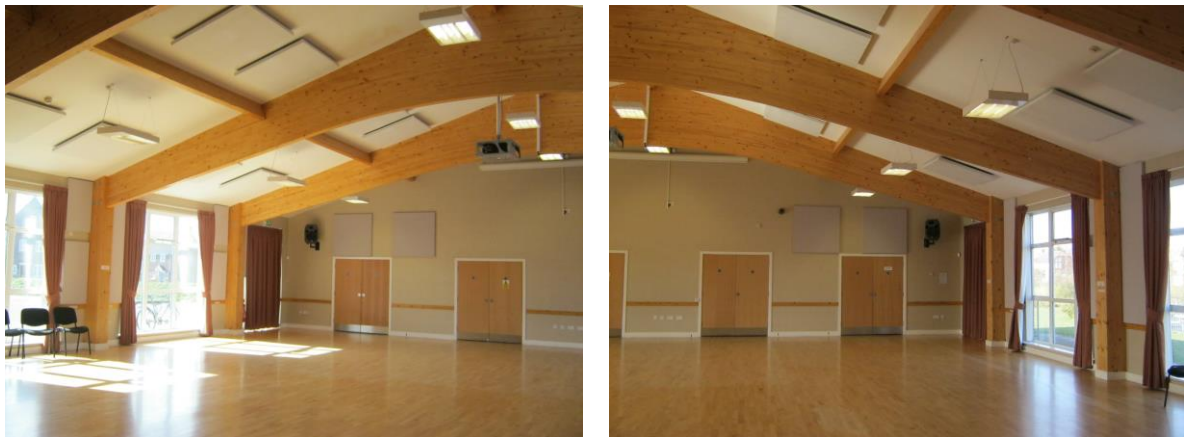
Figure 3 Main Hall. Size and layout of the space allows for various activities to take place, ranging from dance classes to film screenings.

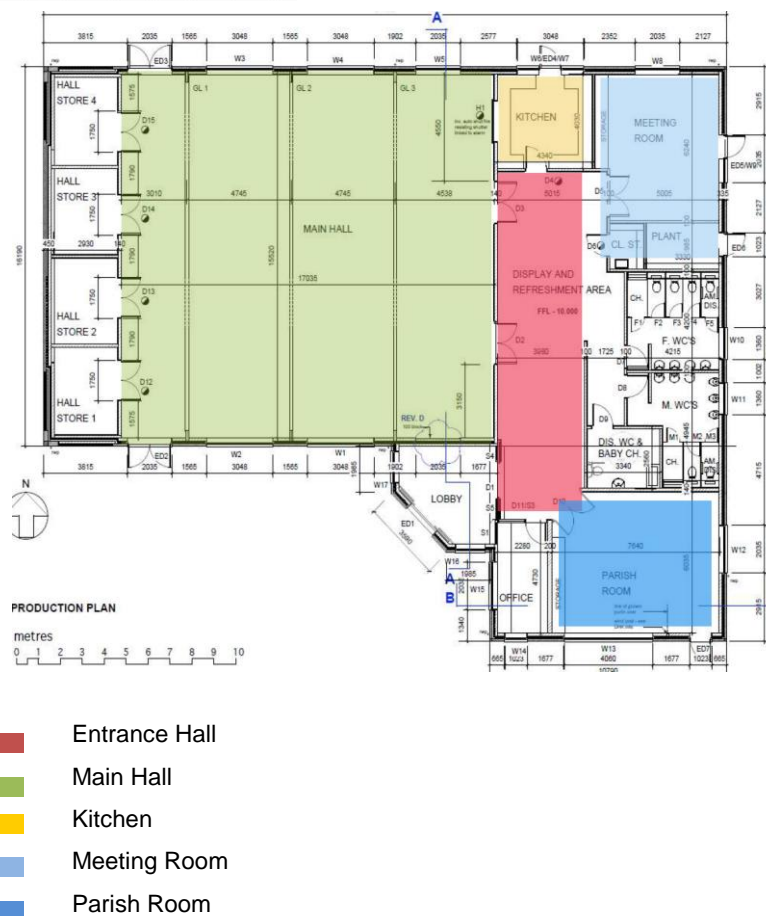
Figure 5 Angmering Community Centre plan

The total area of the site is just under 0.2 Hectares and the gross external area of the centre is 563 m². It is a single storey timber frame building that consists of a large Main Hall which can seat 200 people and has a semi-sprung wood block floor, two Meeting/Activity Rooms (one carpeted, one with vinyl floor covering), a central Display and Refreshment area and a fully equipped stainless steel semi-commercial kitchen (Figures 2-5).

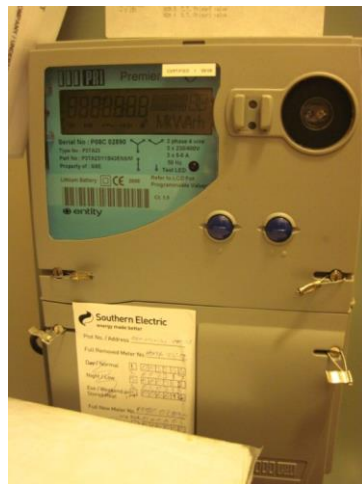
Figure 8 Electricity meter

Electricity is supplied from a three phase electrical feed and consumption is recorded through the electricity meter in the cleaner's storage room (Figure 8). There are three sub meters on the side of the main distribution board meter that, according to the electrical contractors (AJ Taylors), include the buildings' small power, the lighting circuits and the electrical requirements of the GSHP and underfloor heating (Figure 9). These sub-meters do not hold historical data.

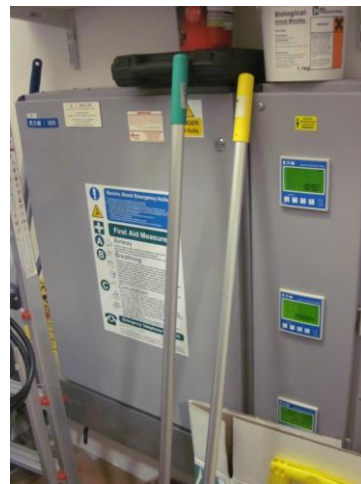
Figure 9 Sub-meters

- The existing meters and sub-meters do not hold any historical data and additional arrangements had to be made to monitor energy use.
- The three sub-meters in the cleaner's store room were found to display inaccurate values as their cabling was not correct. The electrical contractors (AJ Taylors) were unaware of the problem.

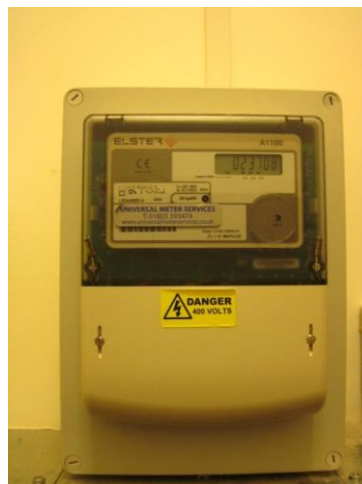
Figure 10 PV generation meter

The Centre generates its own electricity by means of an array of 60 **photovoltaic panels** on its roof which are capable of providing 10.2 kW peak with an estimated annual yield of 8200 kWh. Any excess power generated is fed back to the grid via an import/export meter installed by SWALEC. At times of high demand backup is required from the mains supply. The electricity generated from the PV panels is metered through a generation meter located in the cleaner's storage room (Figure 10). The panel controls are located in the externally accessible plant room. The solar PV meter does not store data; however, there is a display unit in the Display and Refreshment area that shows current usage, total generation to date and CO₂ saved (Figure 11). Feed-in tariff income from the PVs has helped the running costs of the building. According to the Chairman of Parish Council the PVs are doing very well in balancing the electricity demand of the GSHP.

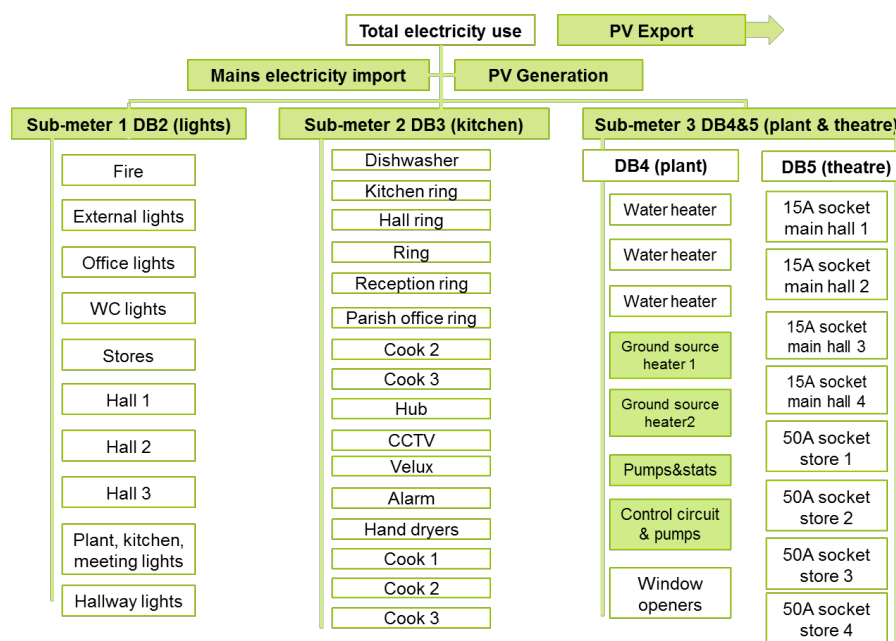
According to the Pre-Visit Questionnaire² of the building the three sub-meters installed by AJ Taylors are providing energy data on a) the buildings' small power; b) the lighting circuits, c) the electrical requirements of the GSHP and the Main Hall small power (Figure 17). However, data reconciliation that was done after the review of the sub-metering system and the installation of additional sub-metering showed that there is a residual amount of energy that is not being measured by the three sub-meters. That energy accounts for about 500-900kWh/month and follows a daily profile similar to that of lighting. TM22 analysis also points to the fact that this residual amount is lighting.

Figure 17 Existing electrical schematic and areas monitored. Original sub-metering arrangement

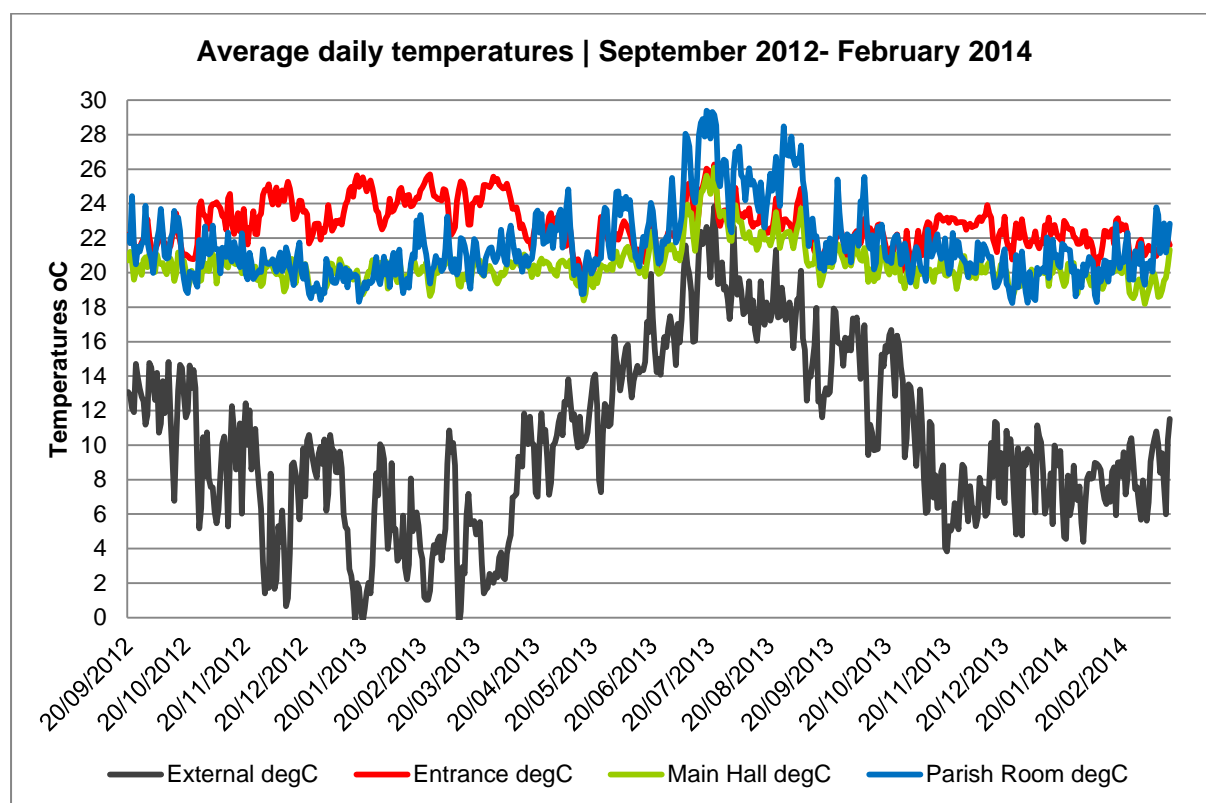
As shown in Figure 20 internal temperatures during the monitoring period remain mostly within the band of 20-24°C. The entrance hall shows higher temperatures and some instances of overheating during the winter months, suggesting that less heating is needed in this space. Overheating is observed during the summer months (June-July), especially in the south-facing Parish room indicating that measures might need to be taken to prevent the building from overheating. According to management, there are no plans to install a cooling mechanism. The Centre would benefit from the installation of external shading in the south facades and night-time ventilation.

Figure 20 Average daily temperatures (September 2012 – February 2014)

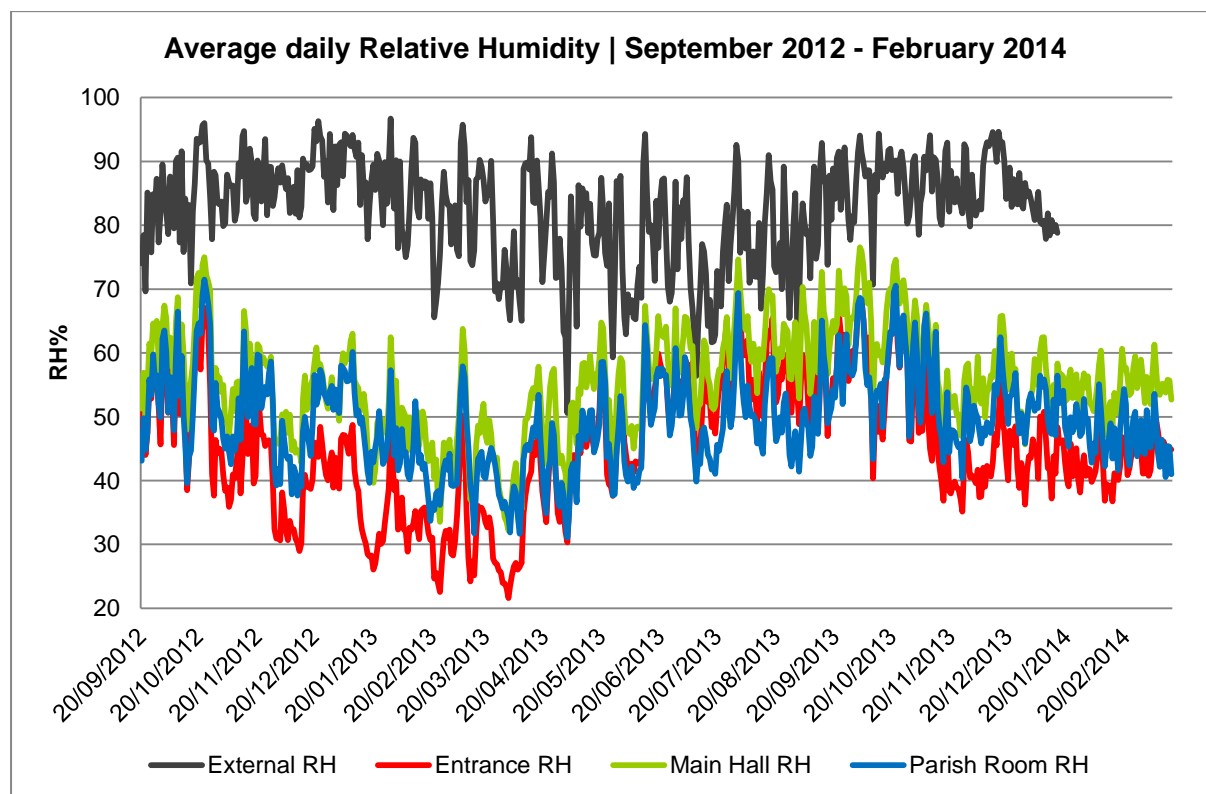
Figure 22 shows that RH levels in the Main Hall and Parish room remain within the CIBSE recommended range of 40-70%. The RH in the Entrance Hall is significantly lower; falling under 40% from December to April, possibly due to a lack of sufficient ventilation and high temperatures in the space.

Figure 22 Average daily Relative humidity (September 2012-February 2014)

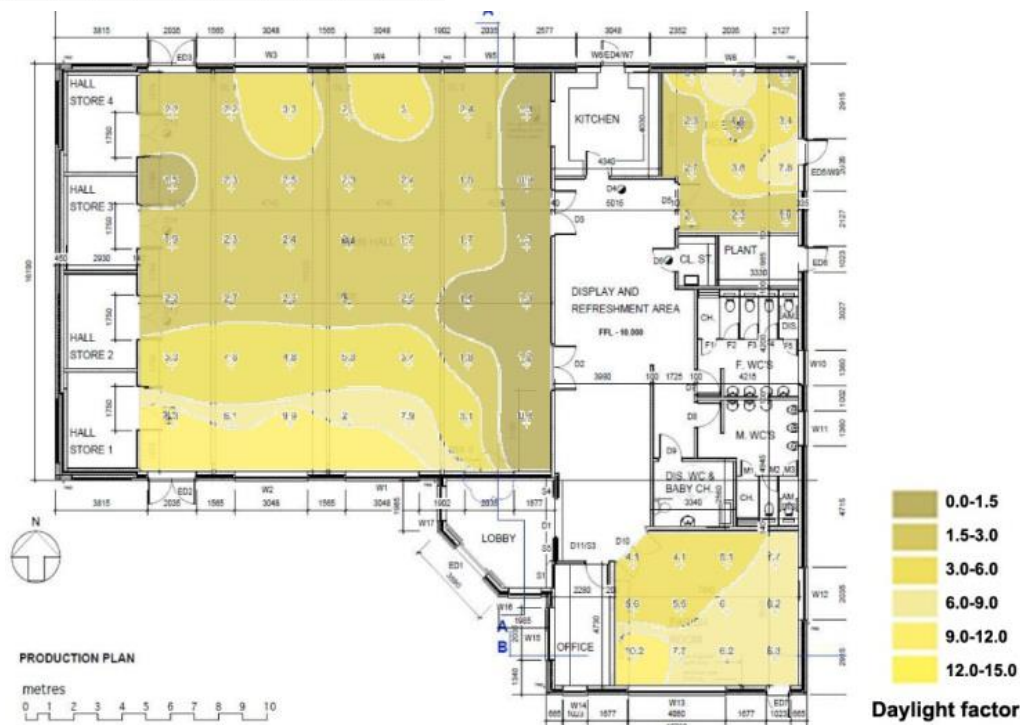
Spot measurements taken on 3 May 2012 showed that, in general, the daylight levels in all the spaces that were measured were adequate but supplementary artificial lighting is needed depending on the nature of the activity undertaken within the space (meeting, sport activity, etc.) (Figures 24, 25). Wide variations in light levels between the areas closest to windows and the interior areas in the same room were observed. The main hall was adequately lit on its southern side with some darker areas identified in the middle and eastern side of the room, indicating the need of artificial lighting if uniform lighting levels were to be achieved.

Figure 24 Daylight factor analysis of the building's main spaces.

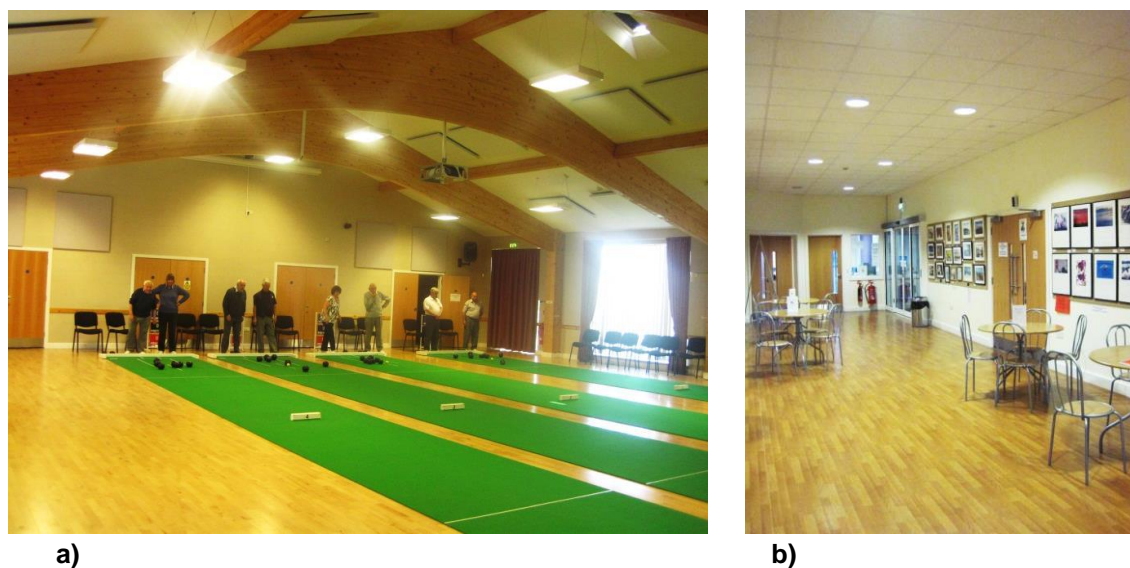
Although some areas do not seem to need artificial lighting, members of staff mentioned that the building users express a feeling of gloominess when the artificial lights are turned off.

Figure 25 (a) While the Main Hall is in use the artificial lighting is always on to support the activities. (b) The lights in the Entrance Hall are on during the whole day due to the lack of natural lighting sources.

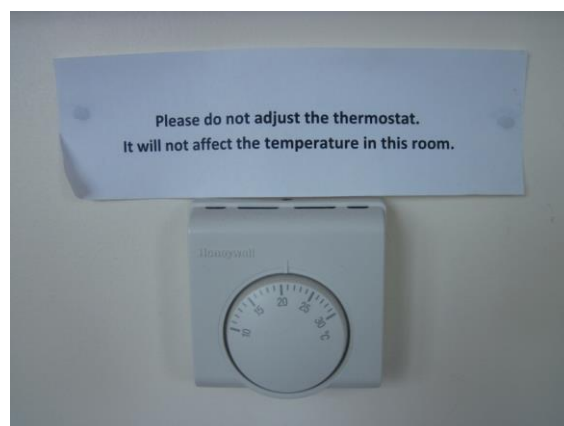
Management believes that occupants have good control over their environment as they can easily open the windows. However, users are advised by management not to use individual room thermostats in the meeting rooms because there have been cases where users turned off the heating completely and then, due to the heating system, it took many hours to bring the temperature back up to comfortable levels (Figure 26). According to the Chairman of the Parish Council (Building owner) who was the head of the client team during the design phase, *'it is best to make things as automated as possible in a community centre building and give users simple controls'*.

Figure 26 The lack of a centralised Building Management System (BMS) where room temperatures could be controlled leads the users to experiment with the individual thermostats.

- The occupants have no control over heating. The caretaker controls the heating system and one set temperature is used for the whole building. In a public building that hosts such a variety of activities it is recommended that the management team is in full control of heating and that the heating system is zoned. Occupants, however, feel they have good control over their environment because they can open the windows which are effective and easy to operate.

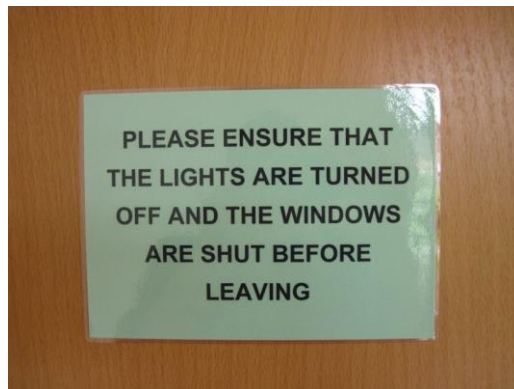
Interviews with occupants revealed that they find all the controls easy, accessible and effective. Furthermore, occupants feel they have good control over their environment because they can open the windows. Occupants also find labelling around the building and on controls to be helpful (Figure 27).

Figure 27 Notes are indicating the proper use of lights and windows are placed in the community spaces.

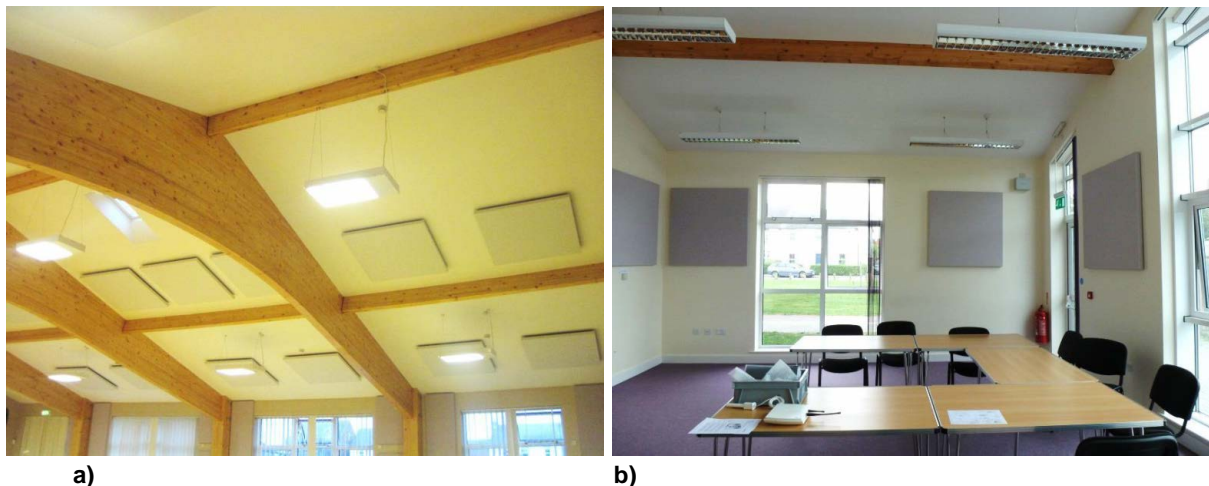
In the case of the ACC, it is believed that an acoustic consultant was not used in the initial design stages, nor at specification. A number of issues relating to acoustics and noise were found in the first months of the ACC opening to the public; external noise restrictions from the building's residential location limited the use of the natural ventilation strategy during the first months of use; and a poor acoustic performance of the Main Hall and Meeting Room 1 was also documented in the early stages of the public opening of the building as the reflecting sound was too loud and there were reverberation issues due to the hard materials used and the lack of sound absorbing panels. The problem affected the usability of the spaces as they could not be used for film projections, music performances or talks.

A simple acoustic test was undertaken in the hall by the project managers approximately 6 months after the centre was opened to the public and it was agreed that the contractor would pay for additional acoustic material on the east end wall of the hall. However, this was still found unsatisfactory to a number of users, particularly dance groups. In March 2011, the Parish Council agreed to undertake professional acoustic testing. The resultant report is held with the Parish Council and it proved a need to reduce echo and reverberation in the hall (Appendix).

Figure 28 (a) Acoustic panels placed on the ceiling of the main hall. (b) Acoustic panels placed on the walls of the Meeting Room 1.

Following on from a successful resolution of the acoustic issues in the hall (Film shows started again in December 2011), the Trustees then paid for acoustic wall panels (Figure 28) to be installed in Meeting Room 1, at a cost to the Charity of £1,767 ex. VAT.

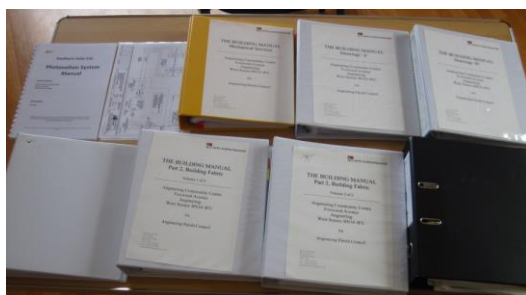
The handover documentation available on site (Figure 33) included:

Handover documentation checklist	Available on site (✓)
Legal contract	x
Drawings (<i>incomplete</i>)	✓
System Specifications	✓
Commissioning records (<i>incomplete</i>)	✓
Log book	x
Strategy for energy and metering	x
Building User guide	x
White goods' manuals guarantees	✓

Figure 33 The handover documentation that was available on site.

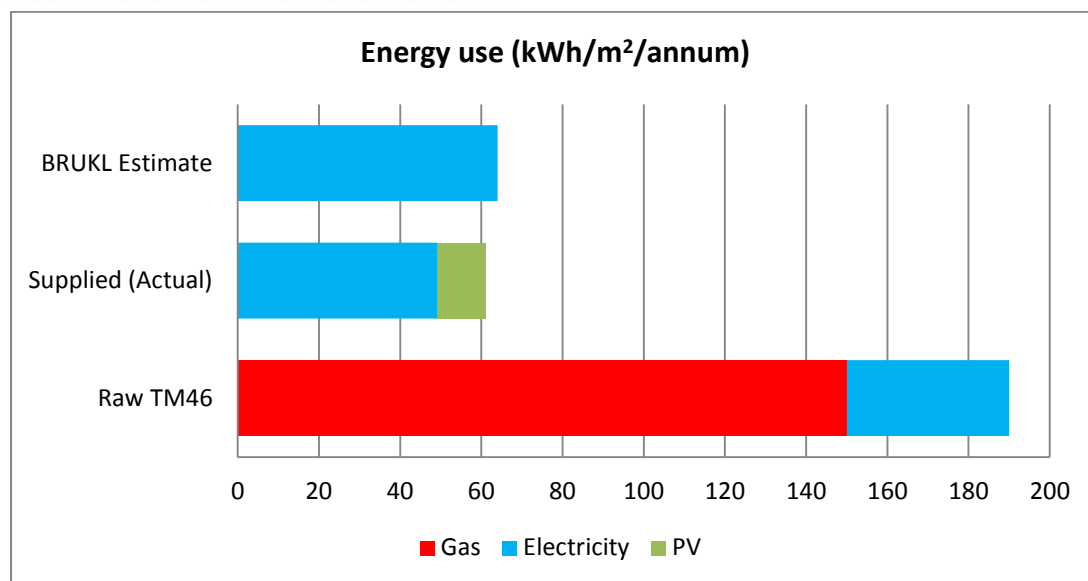
The actual energy use (grid and PV generated electricity) of Angmering Community Centre is 5% lower than the estimated annual energy use (from BRUKL) including appliances, heating and hot water, lighting and auxiliary end-uses. (Figure 36b).

Figure 37b Annual energy use, actual and BRUKL estimate

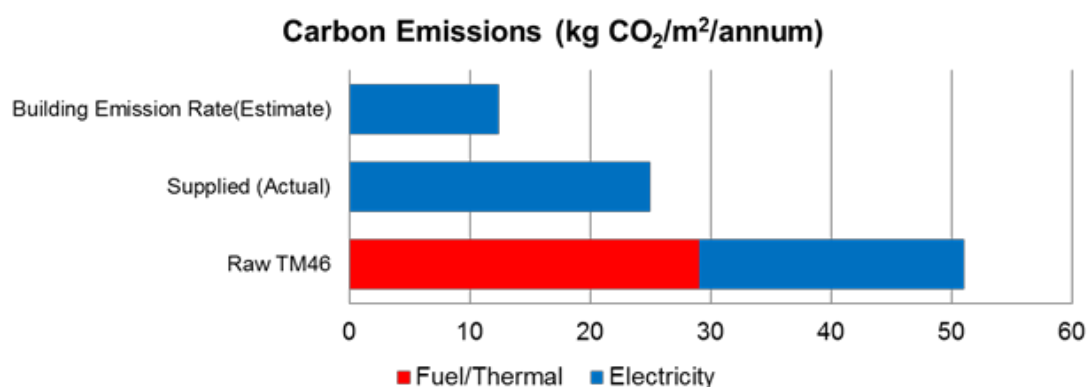
The carbon footprint from actual energy use of Angmering Community Centre is 25 kgCO₂/m²/annum while the estimated Building Emissions Rate (from BRUKL) is 12.4 kgCO₂/m², which is almost 50% lower than the actual emissions for 2013 (Figure 37b). It should be noted that BRUKL does not count all end uses of energy especially catering energy use or electricity used by plug loads.

Figure 37b Annual carbon emissions, actual and BER estimate

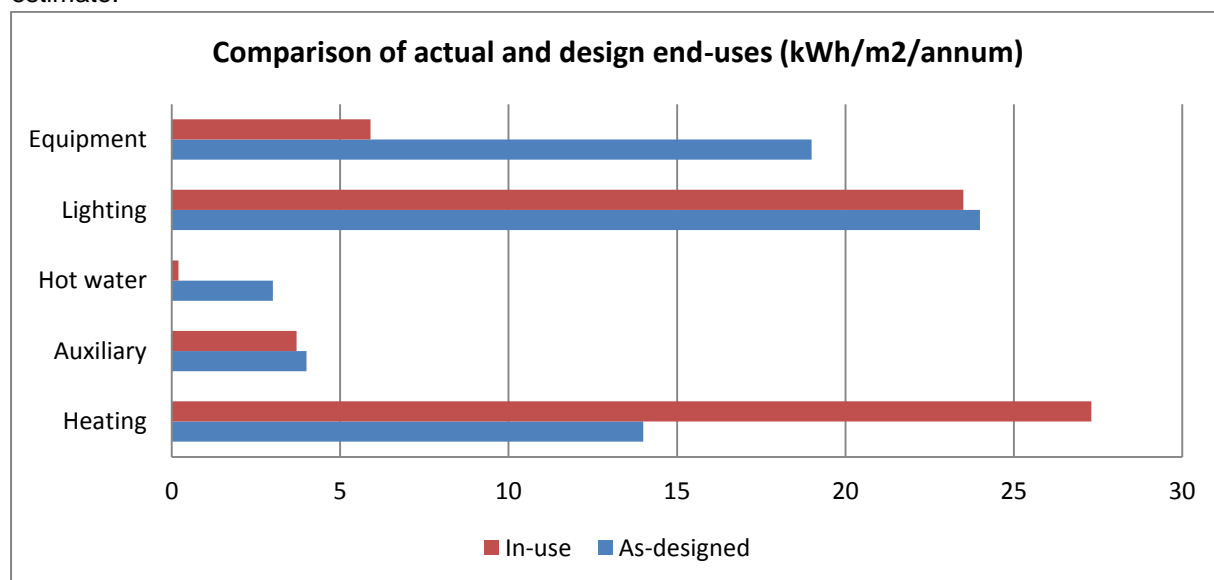
A comparison between the actual and the estimated (from BRUKL) electricity use of end-uses shows that the building is performing similarly to its design target (Figure 39b). Actual heating energy use is 48% higher than the design estimate, but electricity use of equipment is actually 69% lower than the estimate.

Figure 39b41 Comparison of actual and as-designed (from BRUKL) electricity use (kWh/m²/annum).

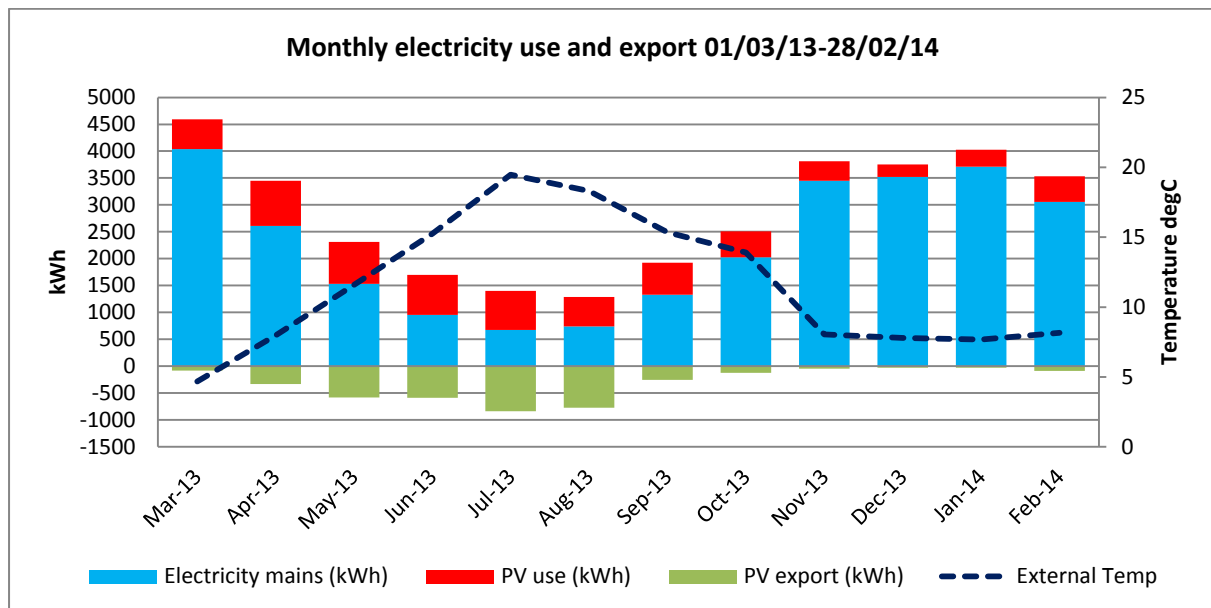
On a monthly basis, grid electricity import drops from 4,000 kWh in March 2013 to 700kWh in July 2013 (Figure 44). PV generated electricity used in the Centre ranges between 25-750 kWh/month. During this period PV generated electricity exported back to the grid gradually rises from nearly 0 kWh in March 2013 to 800 kWh in July 2013.

Figure 45 Monthly electricity use and export (March 2013 – March 2014)

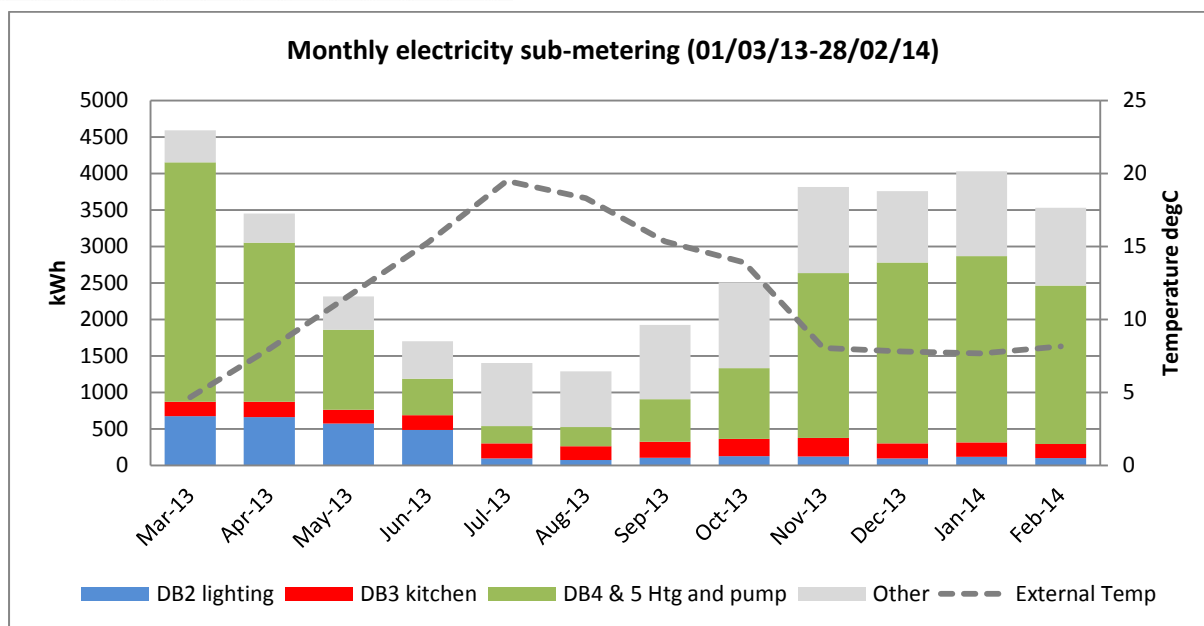
A residual amount of 500-1,200 kWh per month indicates that not all electricity use is monitored. This amount is attributed to lighting (shown in TM22 analysis). From August 2013 onwards, there appears to be a decrease in lighting use and a simultaneous increase of the amount of electricity not included in the sub-metering. The BPE team has investigated this but were unable to identify the source of the issue. Despite this, however, there is potential to decrease electricity use for lighting through the use of LED high efficiency lamps. The ACCA have considered that option but are struggling to get the funds to buy the new lighting fittings. This cost could have been avoided if LED lamps had been originally specified.

Figure 46 Monthly electricity sub-metering (March 2013 – March 2014)

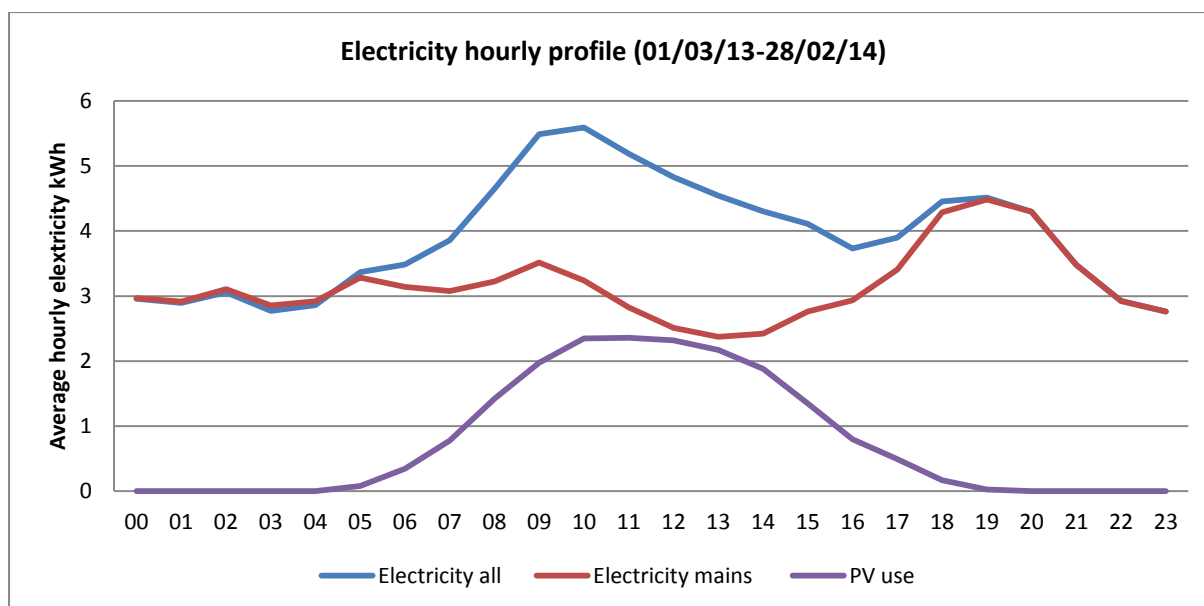
The hourly profile of grid electricity and PV generated electricity is shown in Figure 46. Average hourly grid electricity import ranges between 2.5-4.5kWh. Grid electricity import drops during the day when PV generated electricity is being used and peaks around 19:00. PV generated electricity use peaks at midday reaching 2.5kWh at 11:00. Baseline consumption is around 3kWh/hour.

Figure 47 Grid and PV generated electricity hourly profile (March 2013 – March 2014).

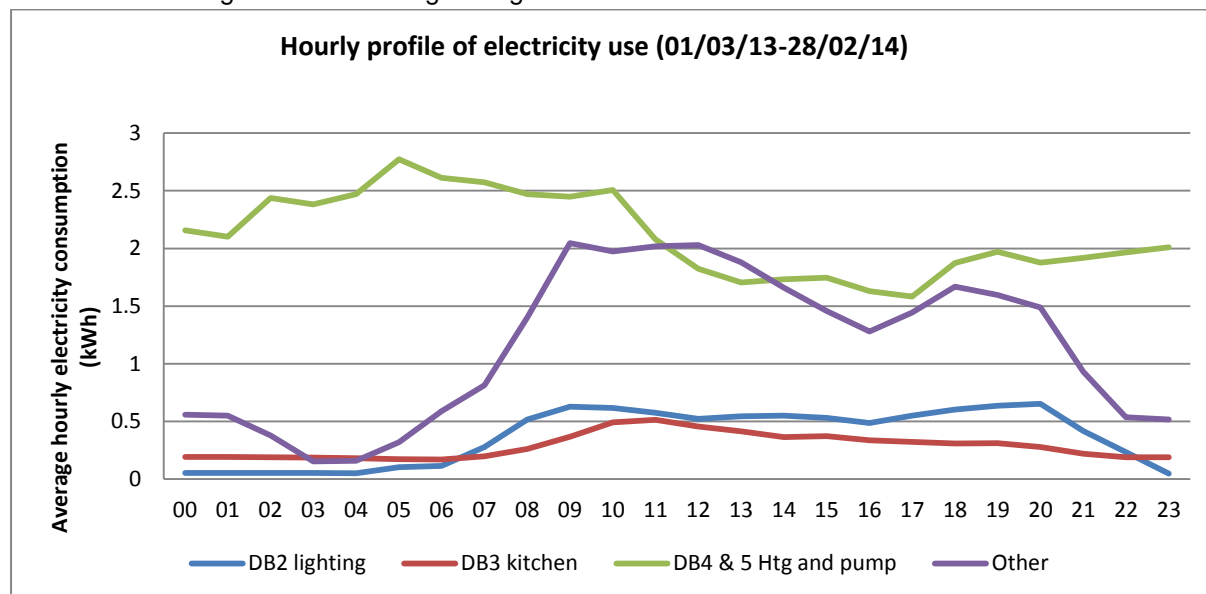
Electricity used in the kitchen is low throughout the day, peaking at 11:00. The trend of the 'Other' electricity is similar to that of lighting indicating that part of the lighting energy consumption was not included in the original sub-metering arrangements.

Figure 48 Hourly profile of electricity sub-metering (March 2013 – March 2014).

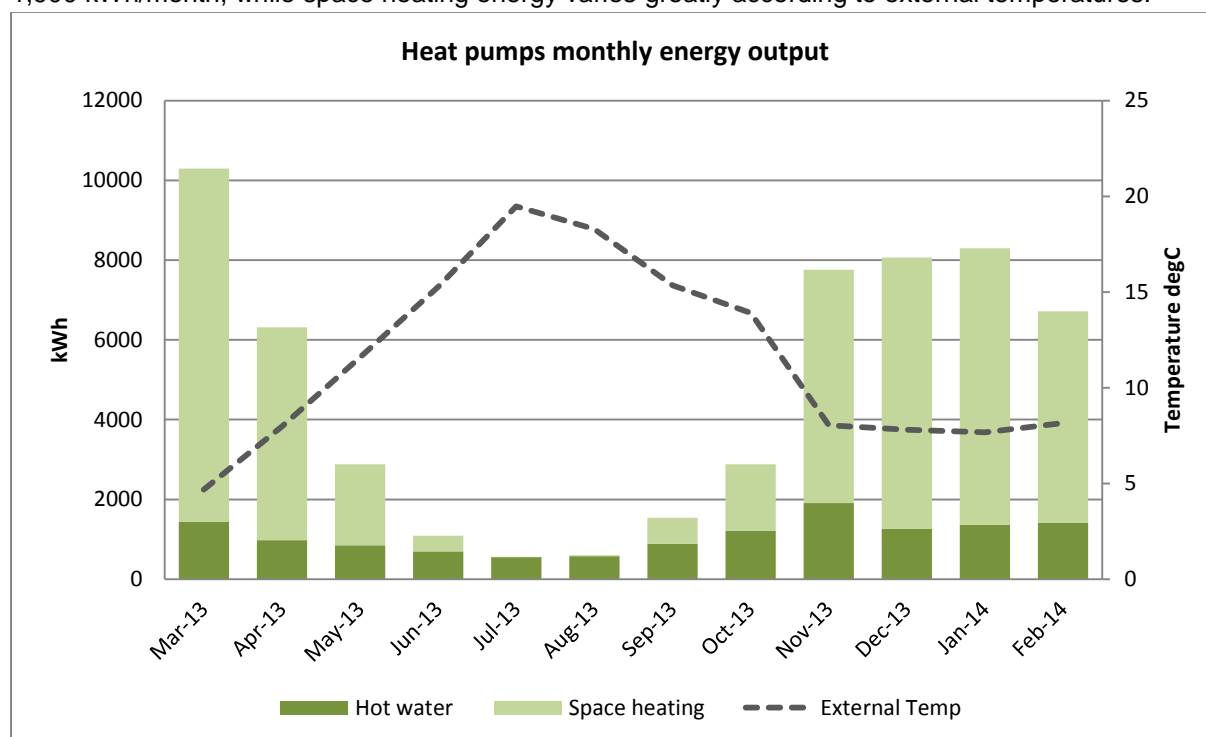
Figure 48 shows the monthly energy output from the GSHPs. Hot water energy ranges from 600-1,900 kWh/month, while space heating energy varies greatly according to external temperatures.

Figure 49 Monthly heat pump output

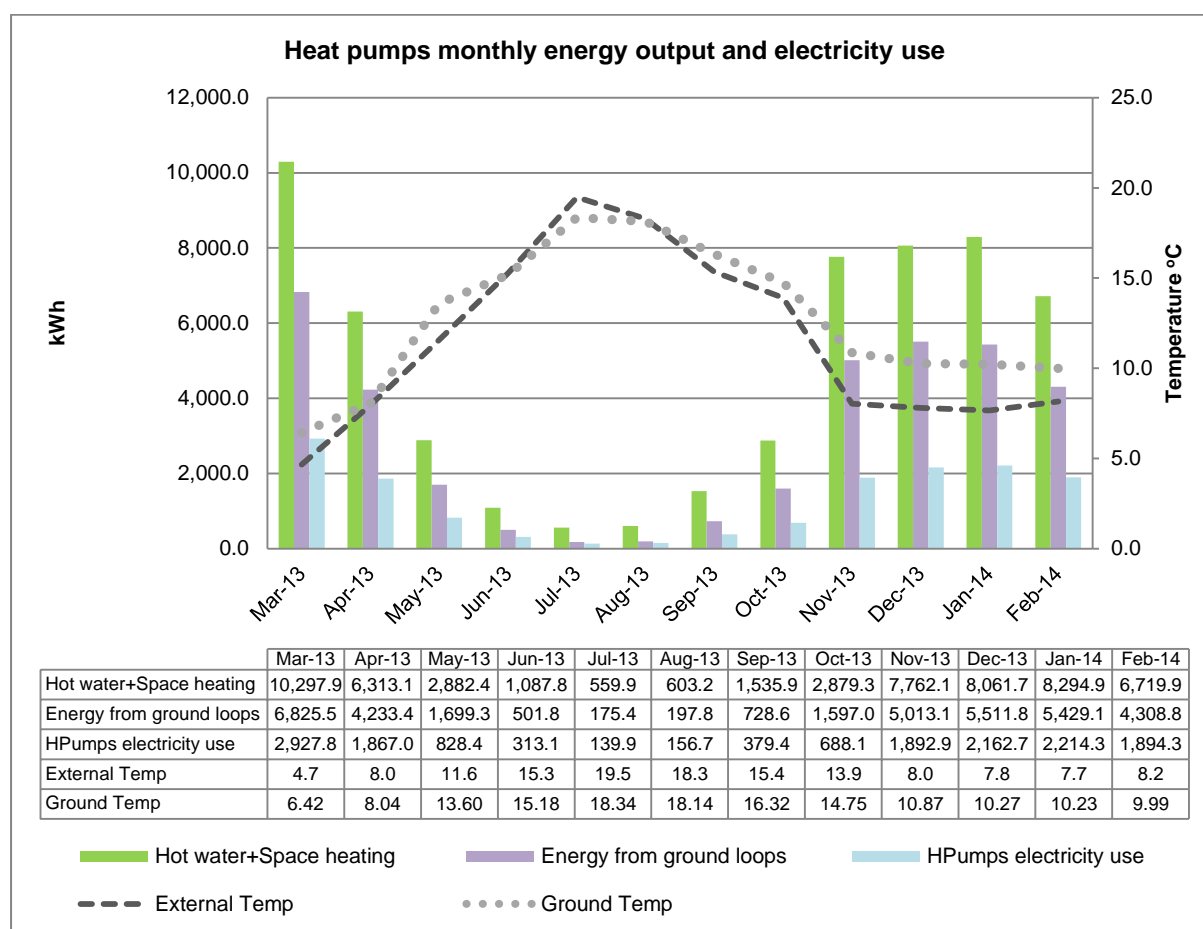
As shown in Figure 49 the heating energy closely follows external temperature. From March to July energy demand for space heating and hot water gradually drops from 9,000kWh to 500kWh. Energy from the two ground loops gradually drops from 6,000kWh in March to 170 kWh in July. Electricity use of the heat pumps drops from 2,500kWh in March to 100kWh in July.

Figure 50 Monthly heat pump performance (March 2013 – March 2014)

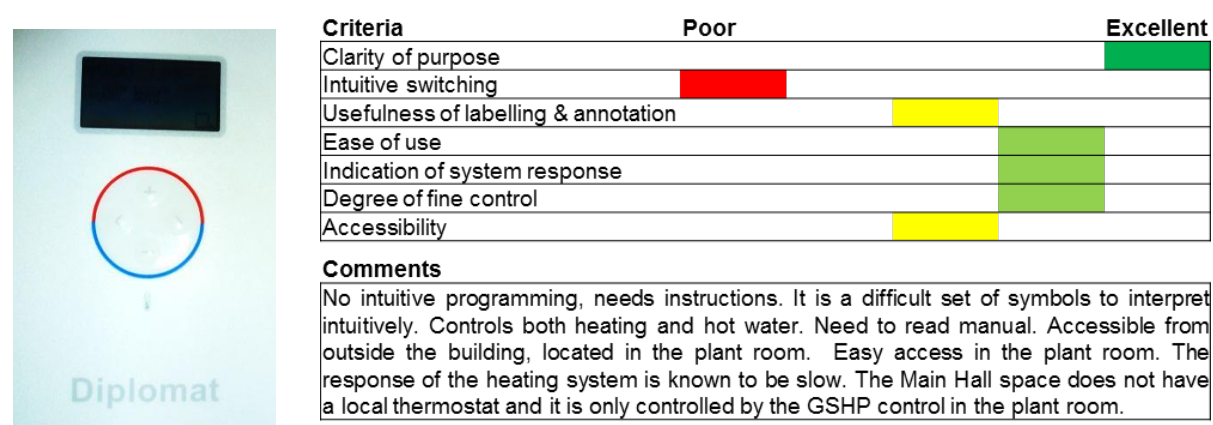
- The usability of heating and hot water control of the GSHP is not intuitive and needs instructions on how to use it properly (Figure 50). The GSHP controls are located on the GSHP and are accessible from outside the building, in the plant room. The part time caretaker is responsible for operating the GSHP and is the only one who has received training on how to operate the GSHP and understands the system. During the handover review, the Heat Pump system manual that was provided to the management as part of the handover documentation was found to be very technical. It would be recommended that the other members of staff, Chairman and members of the Trustees responsible for the operation of the building also receive training on how to operate the GSHP and that a more easy to use manual is provided by the installer.

Figure 51 Evaluation of heat pump control

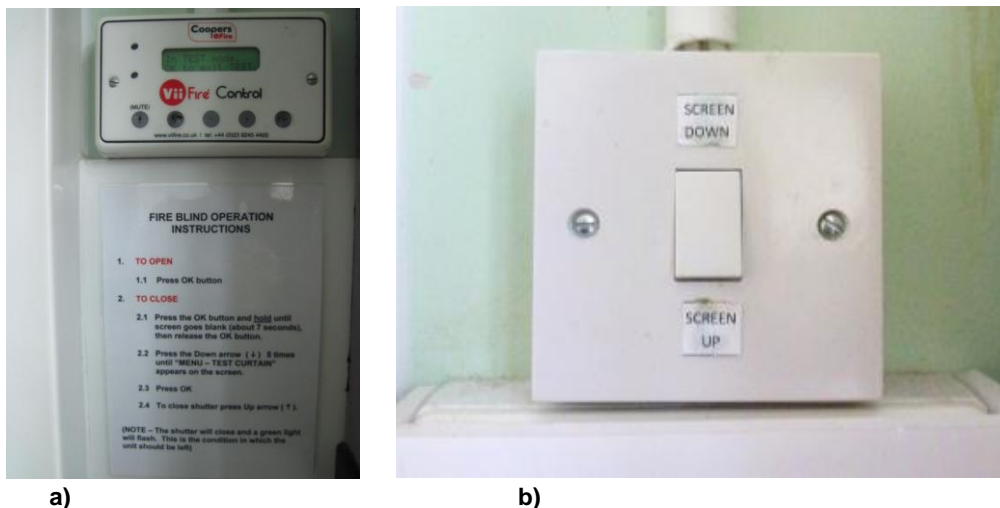
- After the control of the kitchen hatch was changed it is easy to use and intuitive (Figure 51). Good labelling and annotation has been added by management. Occupants reported that the previous control was very complicated to use. The new control for the kitchen hatch is still linked to the fire alarm and is set to come down automatically during a fire. The full controls can now only be accessed by an engineer and not the general public – thus safeguarding the settings.

Figure 52 (a) Old kitchen hatch control. The fire blind mechanism instructions reveal the complicated control interface design of the appliance. To open the curtain you have to press the 'down' arrow while to close it the 'up'. (b) New kitchen hatch control

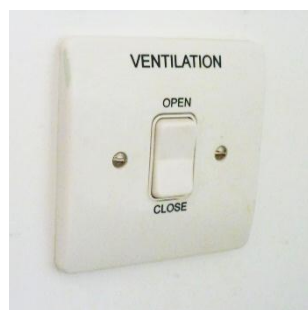
- Windows and doors purpose is clear. Windows are intuitive to open and offer security.
- Top windows are difficult to reach and operate. Motors were added to the top windows of the Main Hall which allows users to open them by operating a switch.
- Electrical windows control interface is intuitive to use and well labelled (Figure 52).

Criteria	Poor	Excellent
Clarity of purpose		
Intuitive switching		
Usefulness of labelling & annotation		
Ease of use		
Indication of system response		
Degree of fine control		
Accessibility		
Comments		
Control not clearly visible, located behind drapes. Intuitive switching and easy to use. Not clear view to the windows from the location of the control. Very good labelling indicating its purpose and how to operate

Figure 53 Evaluation of electrical window controls

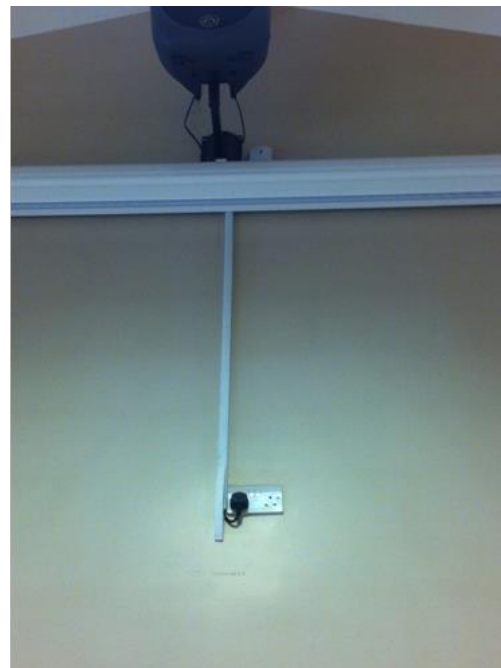
Figure 57 The screen in the Main Hall and the double socket are always switched on

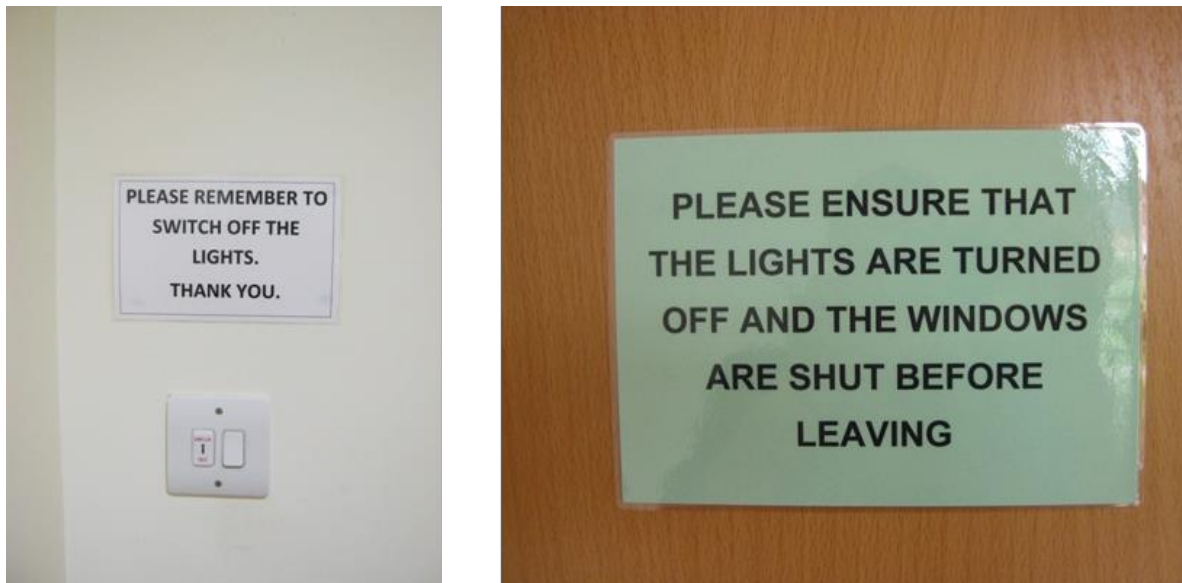
Figure 58 Notes were put by the management to remind people to switch off the lights.

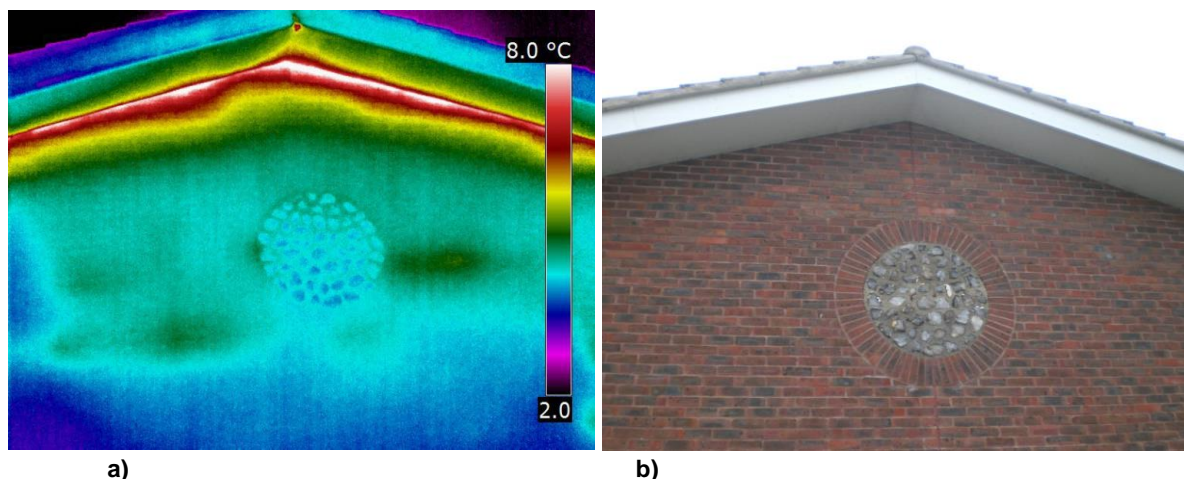
Figure 59 (a) West pitch roof soffit thermogram. Note: Thermal abnormality is likely to be due to air leakage from the building. (b) West pitch roof soffit digital photograph.

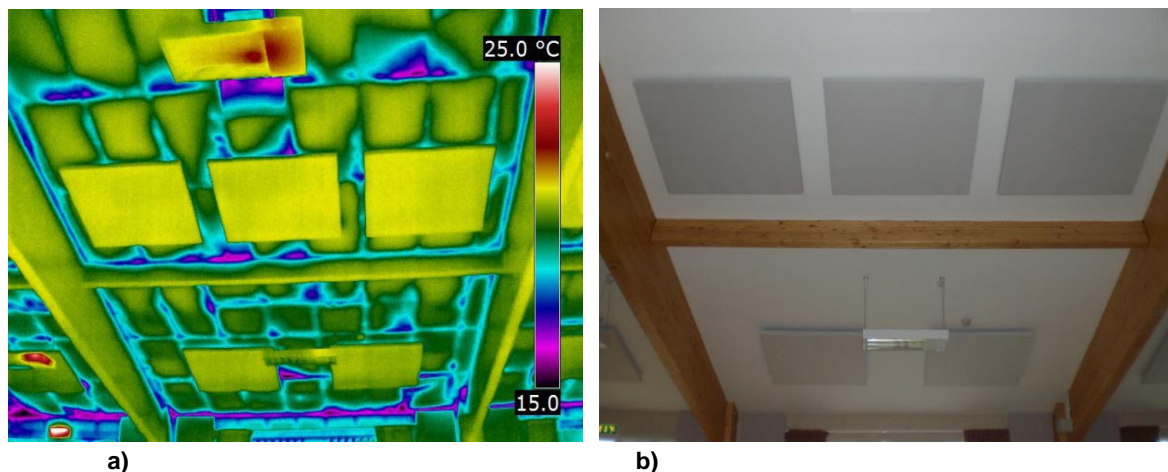
Figure 60 (a) Main hall ceiling (centre) thermogram. Note: Cold areas are evident on the ceiling skim finish / plasterboard layer. The cause of this is likely to be behind these construction elements from cold air leakage between the edges of the structurally insulated panels (sip's) as they are probably not well butted together. Furthermore in some areas there may also be a space between the plasterboard and the adjacent sip which is creating cold voids. Similar thermal phenomena were also found in the Parish Room and the Office ceilings. Confirmation of this may be possible if access into one of these areas can be obtained via a suitably located electrical fitting and a fiberscope. (b) Main hall ceiling (centre) digital photograph

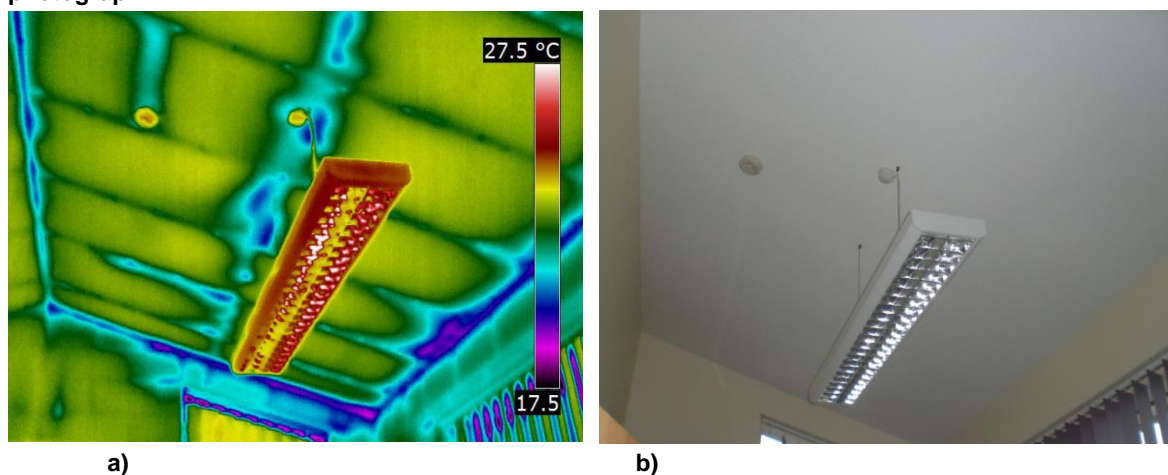
Figure 61 (a) Office ceiling thermograph. (as previous image). (b) Office ceiling digital photograph
