Angmering Community Centre

Innovate UK project number	450048
Project lead and author	Low Carbon Building Group, Oxford Brookes University
Report date	2015
InnovateUK Evaluator	Unknown (Contact www.bpe-specialists.org.uk)

Building sector	Location	Form of contract	Opened
Community Centre	Angmering	Traditional	2010
Floor area	Storeys	EPC / DEC	BREEAM rating
563 m ²	Single	A (24) / N/A	N/A

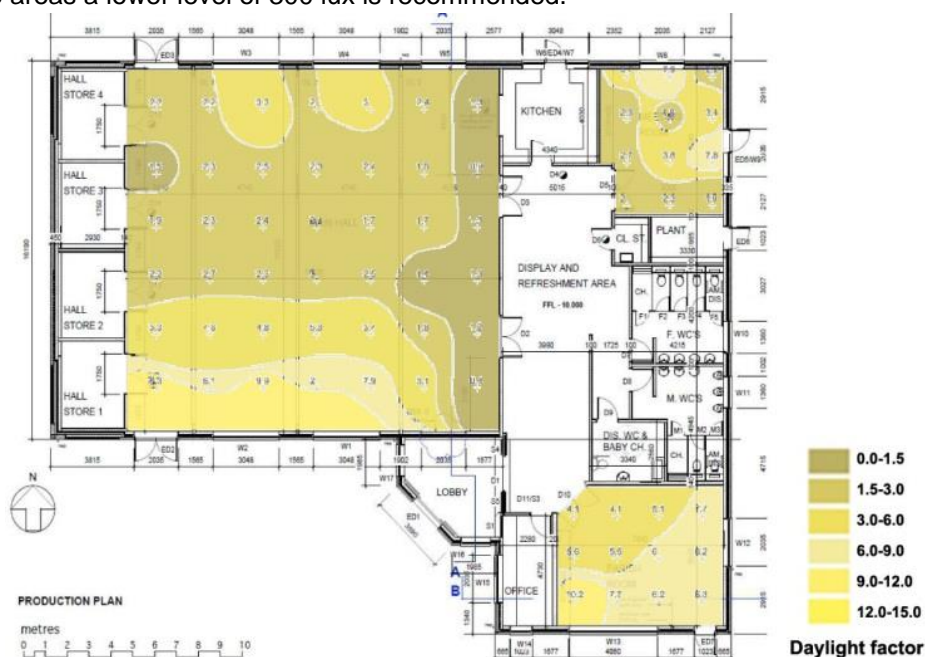
Figure 64 Daylight factor analysis of the building's main spaces.

In general, the lighting levels within all the three spaces were found to be adequate but supplementary artificial lighting is needed depending on the nature of the activity undertaken within the space (meeting, sport activity, etc.). Meeting room 1 was found strongly daylit while the main hall and the meeting room 2 had parts where the light levels were particularly low. Wide variations in light levels between the areas closest to windows and the interior areas in the same room were observed. Although some areas do not need the artificial lighting, members of staff mentioned that the building users express a feeling of gloom when the artificial lights are turned off.

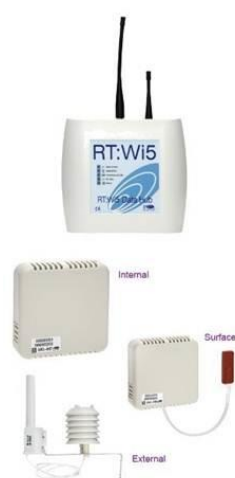
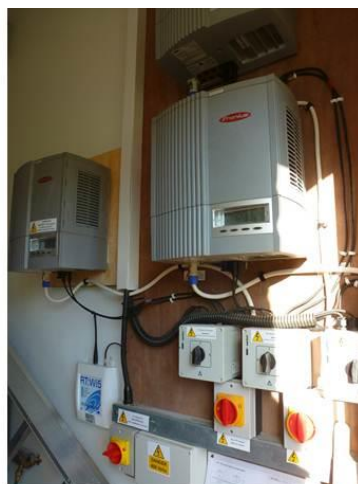
Figure 69: Left: The Wi5 data hub, the Internal Temperature/Humidity and CO₂ transmitters and the external temperature/humidity transmitter. Right: The data hub is placed in the plant room.

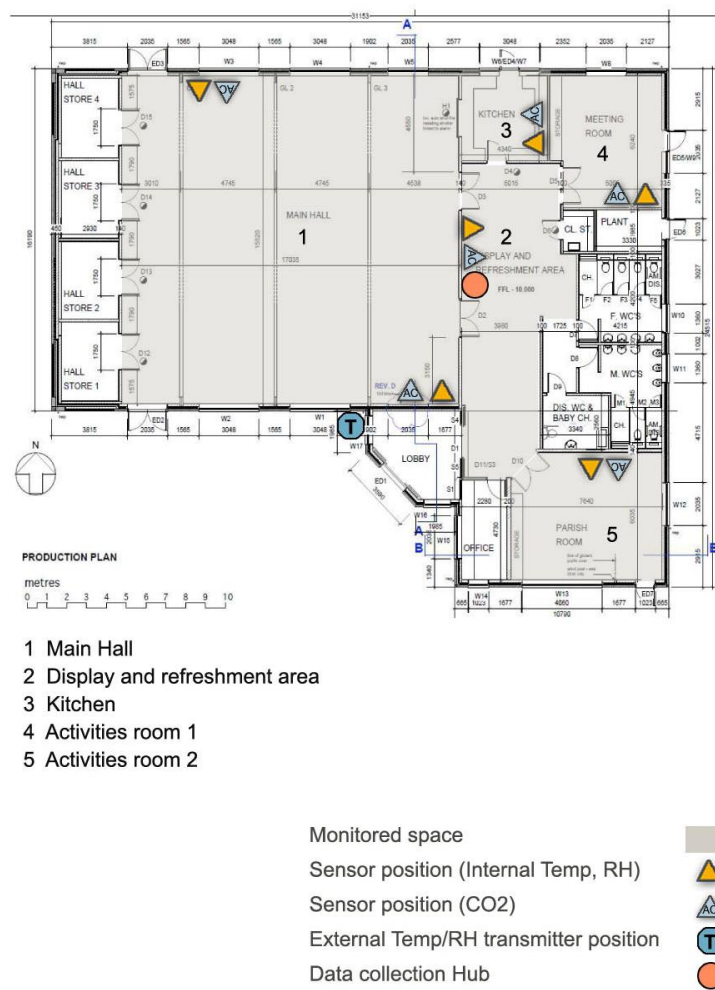
Figure 70 Location of monitoring equipment on plan

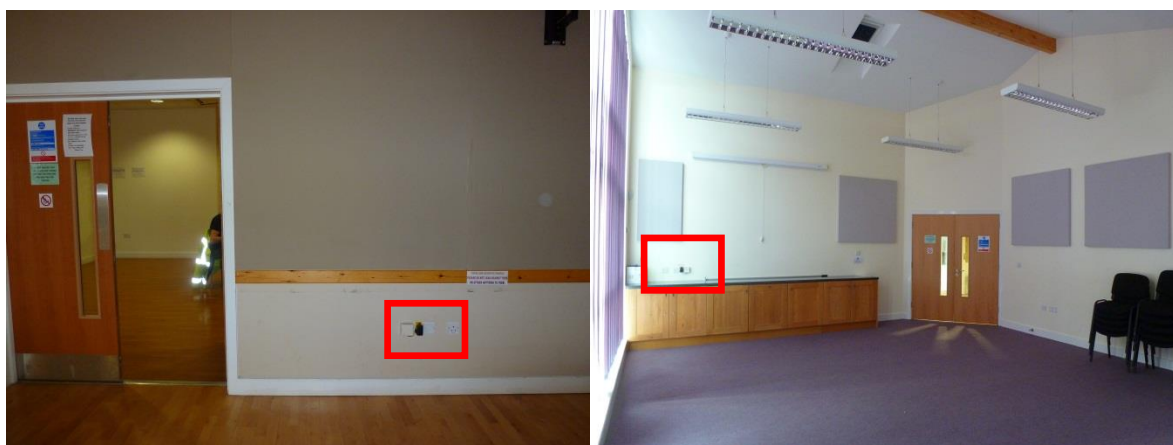
Figure 71: Temperature, humidity and CO₂ transmitters placed in key areas of the building.

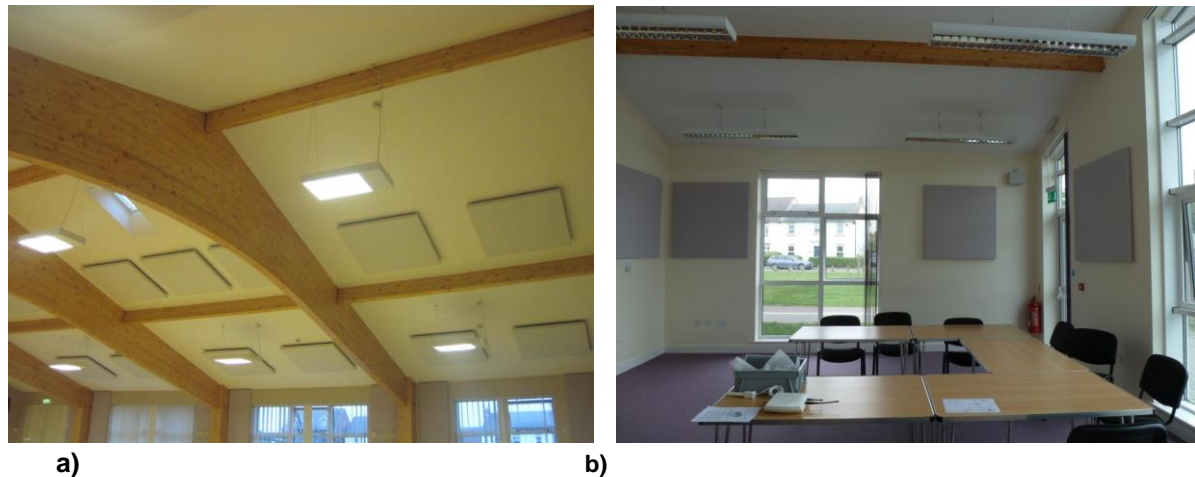
Figure 94 (a) Acoustic panels placed on the ceiling of the main hall. (b) Acoustic panels placed on the walls of the Meeting Room 1.
