# Avante Housing Development

<b>Innovate UK project number</b>	450011 (related to 450077 and 450078)
<b>Project lead, authors, and client</b>	School of the Built Environment, Oxford Brookes University, CA Sustainable Architecture, and Four Walls for Crest Nicholson PLC
<b>Report date</b>	August 2015
<b>InnovateUK Evaluator</b>	Tom Kordel (Contact via <a href="http://www.bpe-specialists.org.uk">www.bpe-specialists.org.uk</a> )

<b>No of dwellings</b>	<b>Location</b>	<b>Type</b>	<b>Constructed</b>
150 (2 plots sampled)	Maidstone, Kent	Private & social housing	2007 - 2011

<b>Area</b>	<b>Construction form</b>	<b>Space heating target</b>	<b>Certification level</b>
85.2 m <sup>2</sup> (Sample)	Timber panel	52.3 kWh/m <sup>2</sup> per annum	EcoHomes (Excellent)

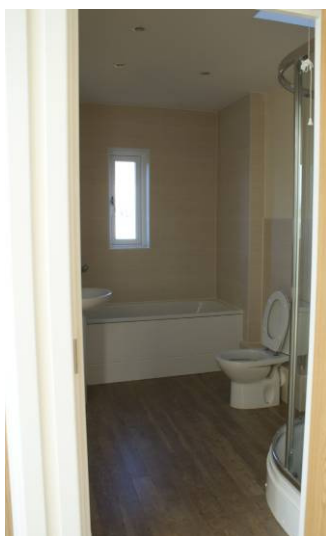
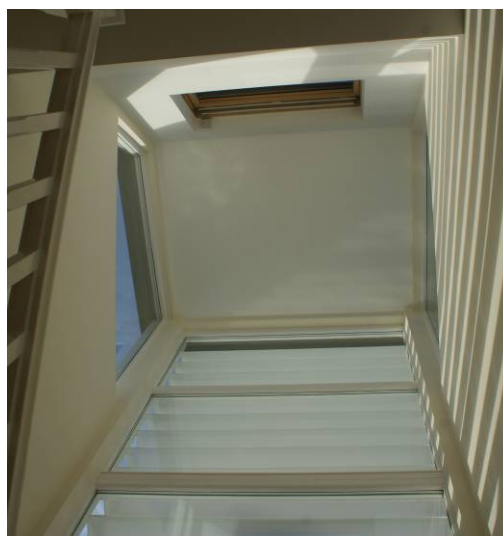
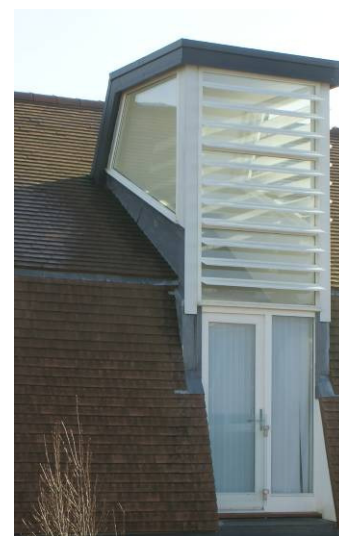
- 3.3. A number of significant discrepancies have been identified particularly in relation to: external fabric detailing which involved substitution of roofing and cladding materials and alteration to patio doors and windows, changing the layout of bathroom spaces which involved adding an additional door, breaking down the glazing elements of the innovative lantern feature and adding a velux window to it (see photos 1,2,3 below), and altering the number of radiators, boiler position, and layout of MVHR ducting (see figure 1 and 2 below).

**Photo 1 - Plot 44 – 1<sup>st</sup> Floor Bathroom (two doors into it); Photo 2 – Plot 44, Lantern with 4 glass panes and Velux vent window; Photo 3 - Complex leadwork weathering around lantern in apartment block.**

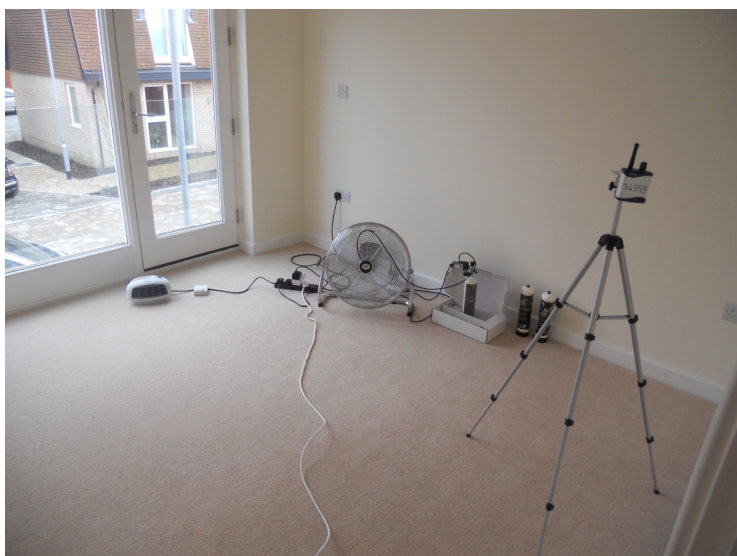
**Photo 5 Co-heating test equipment in Bedroom 2**

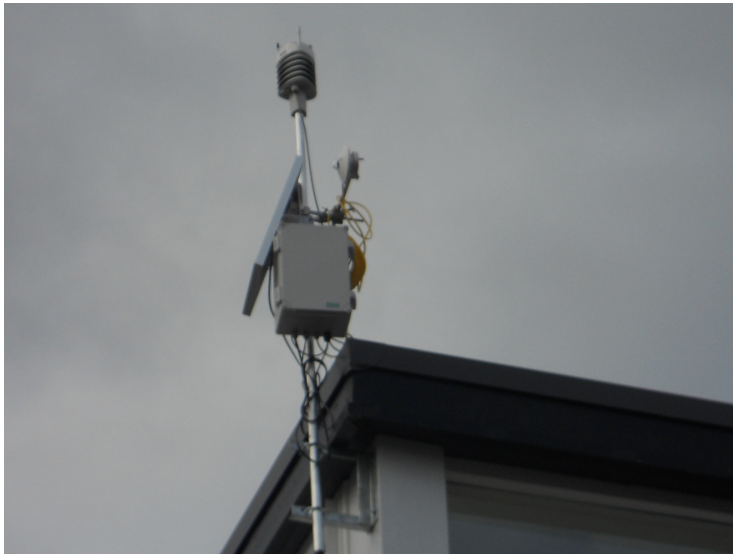
- 4.9. A weather station mounted at roof level records outside temperature, relative humidity, solar radiation on the vertical plane (South-facing), wind speed and direction.

Photo 6 Weather station at top of roof lantern

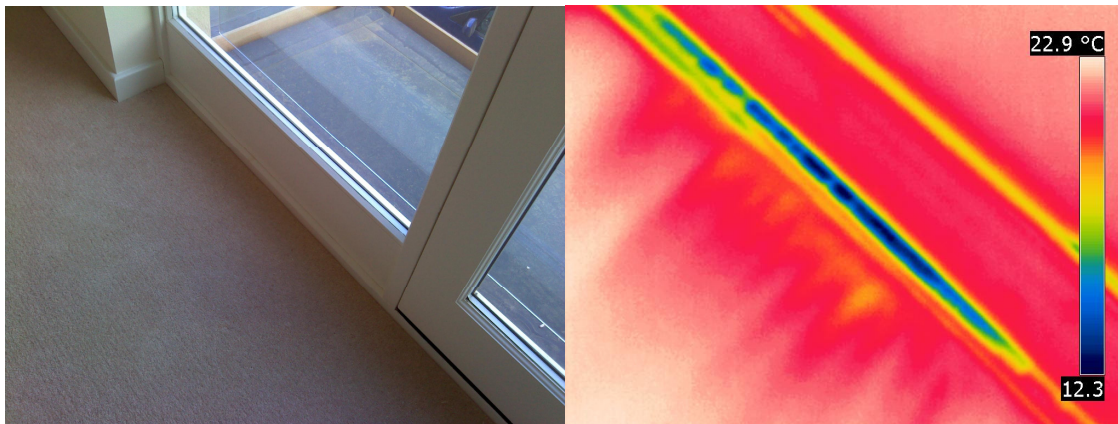
**Photo 9 Air leakage under Bedroom 2 glazed panel**

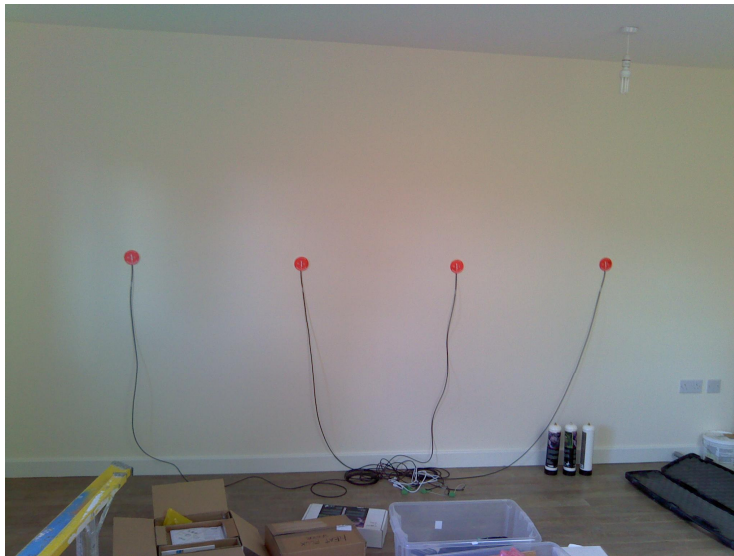
- 4.25. An array of four heat flux sensors (HFS) was installed on the living room party wall to record heat flux every ten minutes throughout the co-heating test. Not knowing the precise construction of the party wall, which is of framed construction rather than SIPs, this regular array was considered the best arrangement at the time.

Photo 12 Heat flux sensors on living room party wall

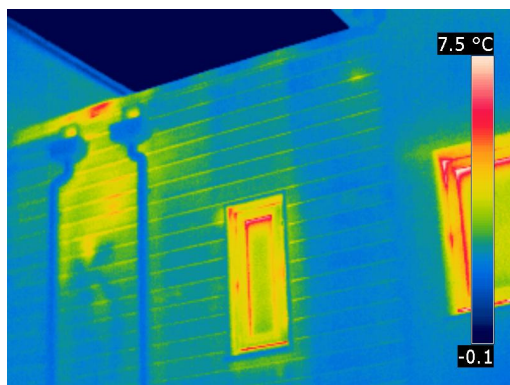
Photo 14 Outside rear elevation – party wall junction showing heat loss at parapet.

- 4.29. Several weeks following this testing, it was discovered via drawings obtained from SIPS manufacturer that **the party wall consisted of unforeseen complex timber joist supports within the SIPS party wall panel which would account for further significant thermal bridging**. When the house next door is unoccupied and unheated, the party wall effectively becomes an external wall and so this thermal bridging is important.

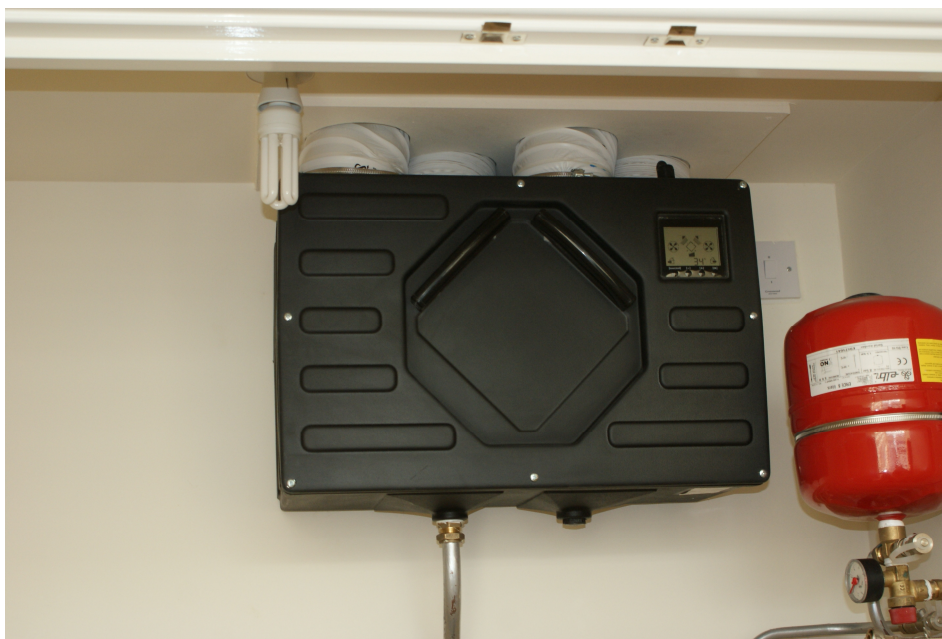
Photo 15 Greenwood HRV 1 unit with flexible ducting in airing cupboard

- The second issue relates to **commissioning**. The systems have been fully commissioned by the installation engineer following guidance from the manufacturer. However, **problems were found with the set-up configuration with the installer's air flow measurement instrument**, which resulted in higher readings to the order of 1.5 to 2 times greater than actual. Hence, the installation engineer has inadvertently reduced the supply and extract fan speeds and adjusted terminal valves such that the values, as displayed on the commissioning air flow instrument, matches the manufacturer's notional design values. Consequently, the design flow rates have not been met.

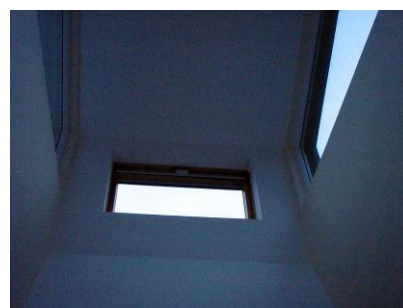
Photo 18: rooflight in lantern

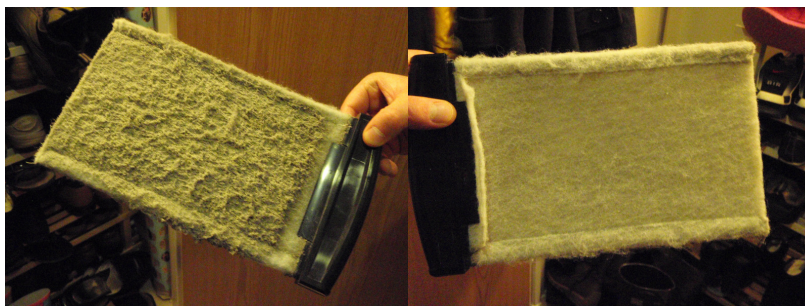
- 8.8. **Customers do not seem aware of the maintenance requirement for the MVHR filters** – the MVHR unit displays a regulated warning symbol to indicate that the heat exchanger filter should be cleaned but the occupant did not know this was necessary nor how to carry out the task. Most occupants reported cleaning the filters that slide out of the front of the unit, but **in one case the filters were clearly inaccessible and difficult to reach**. In another case we showed the occupants during the walkthrough where they were located and how to take them out and found them so clogged up that the customer cleaned them during our visit (see photo 25).

Photo 25 MVHR filter as found (left) and after cleaning (right)

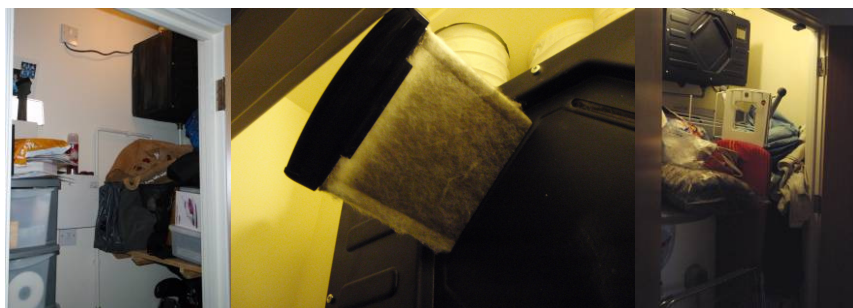
- 8.9. **Access to the MHVR units is quite difficult in some layouts** (see narrow cupboard in photo 26). The display panels are not easy to see and the maintenance of the filters is difficult or not possible, in some cases, due to the unit being placed out of reach or clashes with door frames (photo 27). **The occupants also tend to fill the cupboards with shelves and use them as storage (photos 26 and 28) which makes access to the boost switch that has been located normally on the rear wall difficult**. It would be better to position such a switch in a location that allows easier access and is connected to the need for boosting the air flow (e.g. in the kitchen as suggested in the commissioning report).

Photo 26 (left) narrow inaccessible cupboard with MVHR, photo 27 (centre) door frame clashes with filter, Photo 28 (right) MVHR cupboard as storage
