Ayr Campus, University of the West of Scotland

Innovate UK project number	450089
Project lead and author	BRE Scotland
Report date	2014
InnovateUK Evaluator	Unknown (Contact www.bpe-specialists.org.uk)

Building sector	Location	Form of contract	Opened
Higher education	Ayr	Design and build	x
Floor area (GIA)	Storeys	EPC / DEC	BREEAM rating
17,835 m ²	3	B / N/A	Excellent

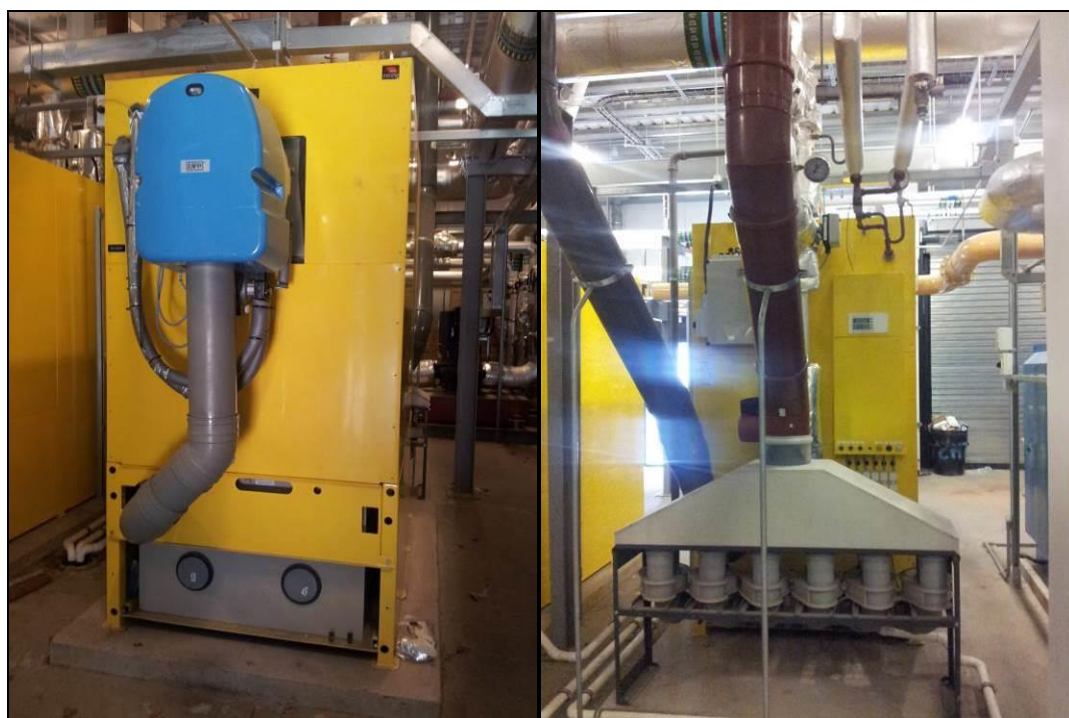
Figure 4 – Atlantic biofuel boilers

technology. This was disappointing for the University as previously this has been a key design feature for the new build campus.

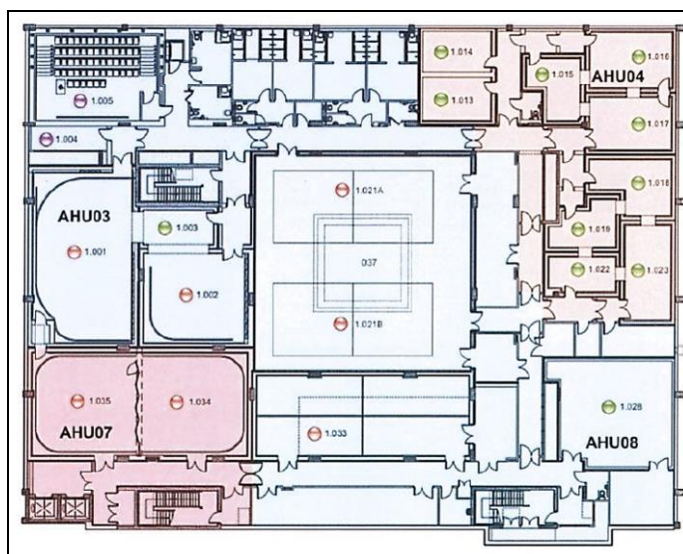
Figure 6 - Basement heating options

Figure 6 illustrates the heating / cooling systems servicing the basement level. The VAV unit, marked in purple, services the lecture theatre. Green indicates FCUs or a combination of both VAVs and FCUs, which service the smaller rooms. The underfloor heating system, marked in red, services the gymnasium and drama studios. Other 'red' areas indicate the trench heating on the upper levels, primarily around the classroom perimeters and within the library area.

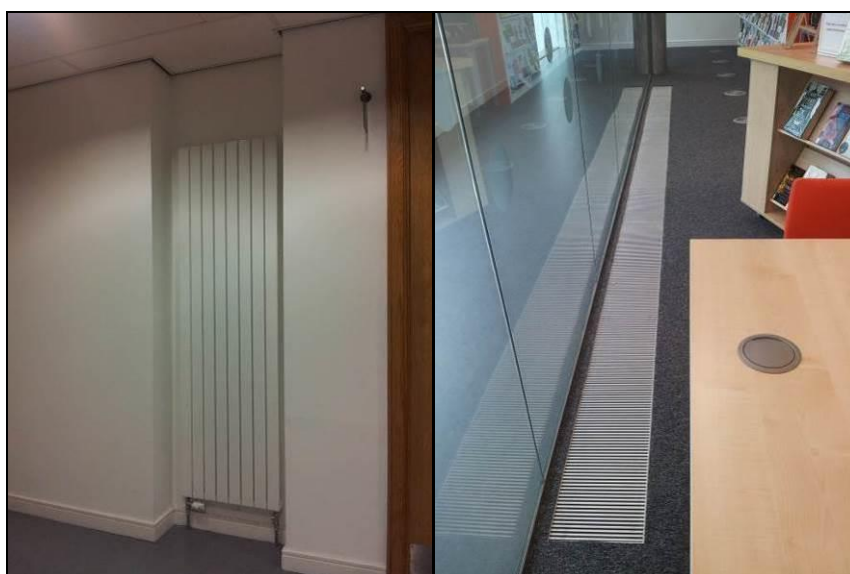
Figure 7 – Examples of heating provision; a radiator in the basement's corridor and trench heater in the library

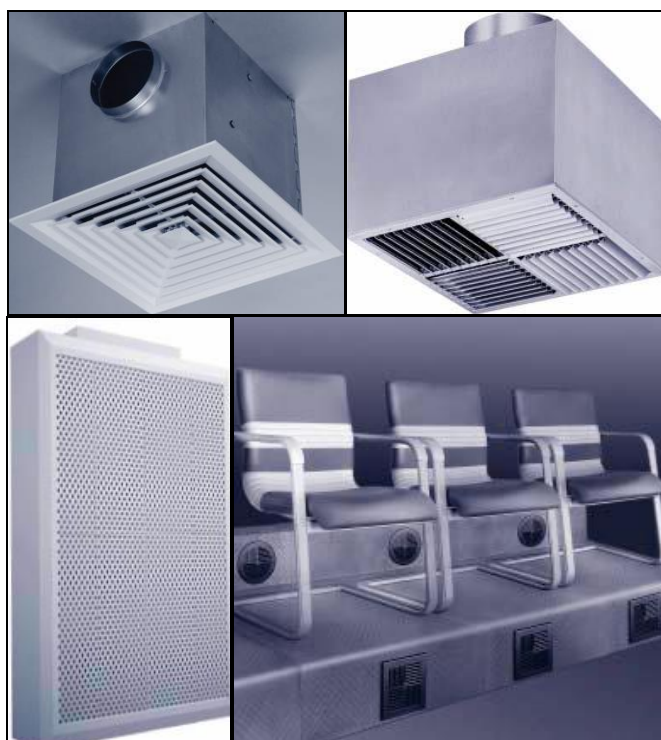
Figure 11 – Diffusers variety (from top left, clockwise); Ceiling, Ceiling Swirl, Displacement, Staircase swirl

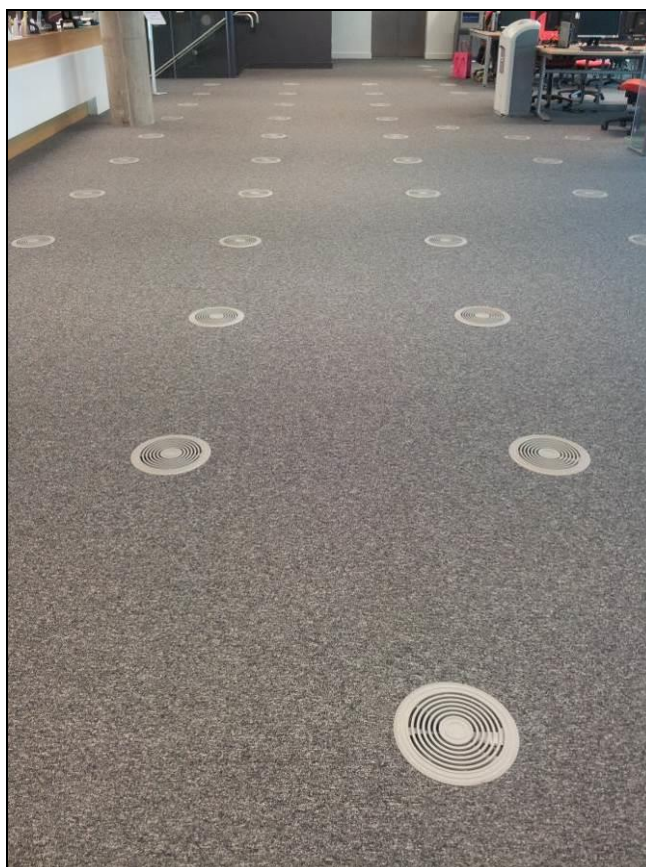
Figure 12 – Movable floor diffusers in the library

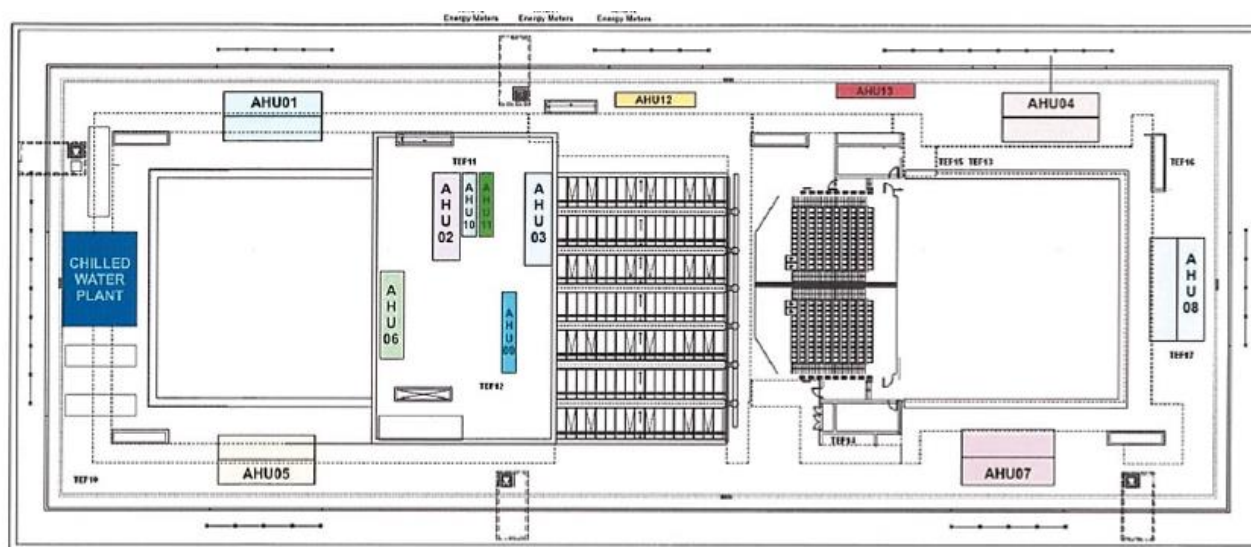
Figure 13 – Roof top plant

There are 13 air handling units operating within the campus. Their arrangement and the zones in which they operate is illustrated in Appendix **Error! Reference source not found.** Figure 13 indicates the roof top plant and the location of the air handling units.

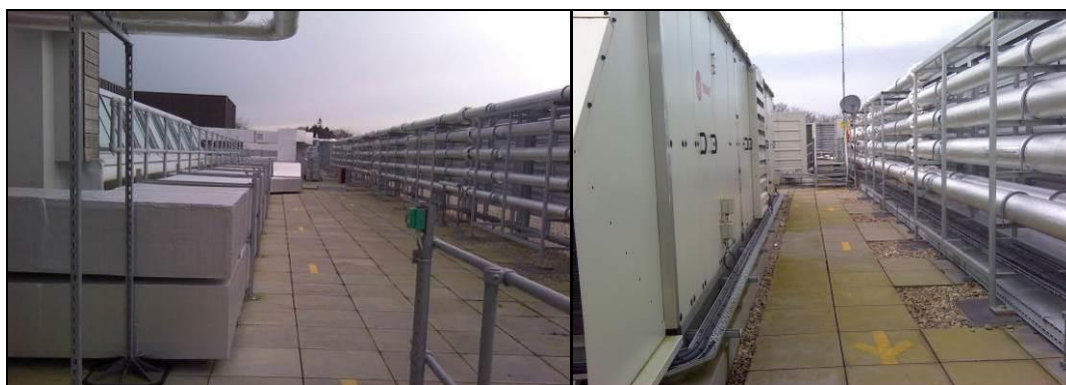
Figure 14 – Images of roof top plant; air ducts, an air handling unit and water pipes

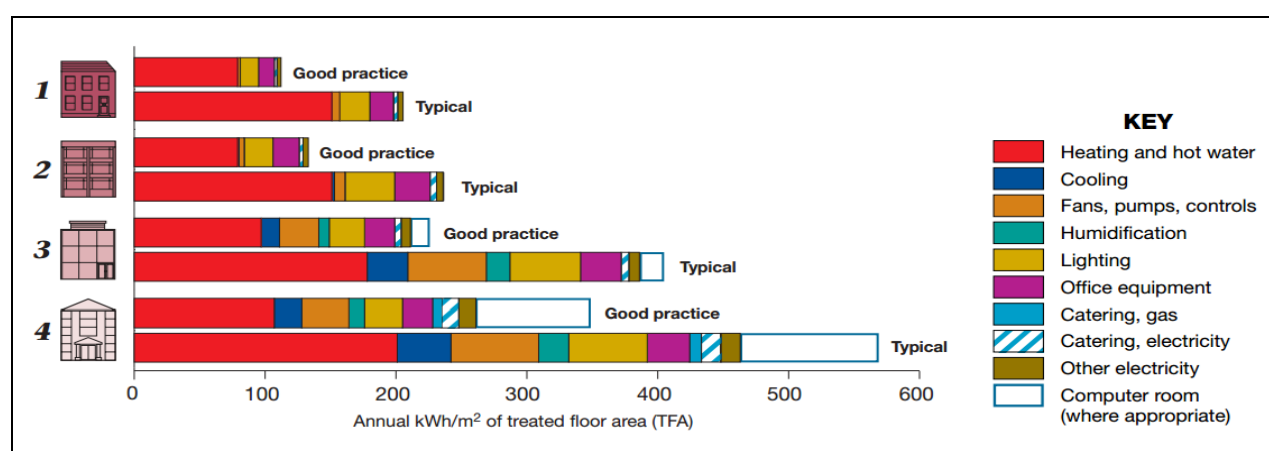
Figure 15 below illustrates typical energy uses against 10 categories for 4 different office types from the Energy Consumption Guide 19 (ECON19) – Energy use in offices. Although it refers to office type buildings, it does help to provide a good indication of what equipment has the largest influence on the overall energy consumption.

Figure 15 – Energy use indices (EUIs) for good practice and typical examples of four office types (ECON19 – Energy Consumption Guide 19, Energy use in offices)

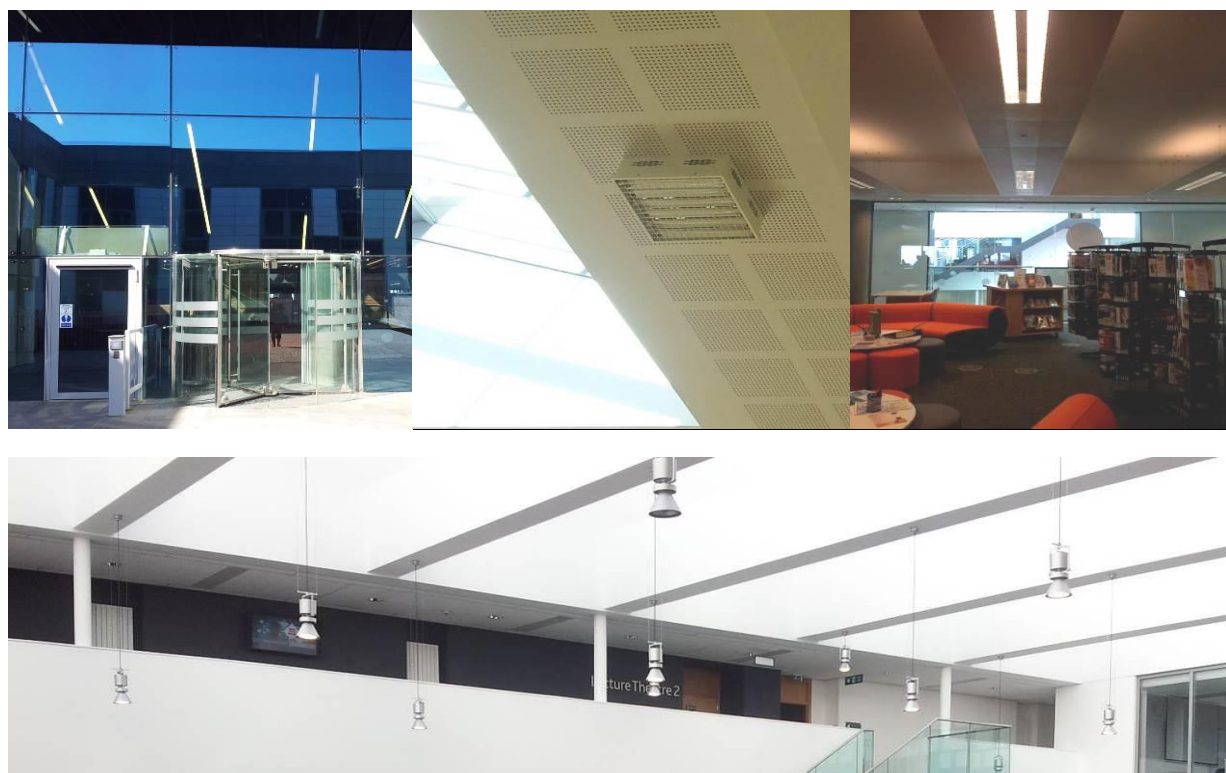
Details of the system and lighting controls are included in Section 0. Figure 16 provides examples of light fitting types that have been installed across the Campus.

Figure 16 – Variety of different light fittings in the reception area, gymnasium, library and atrium

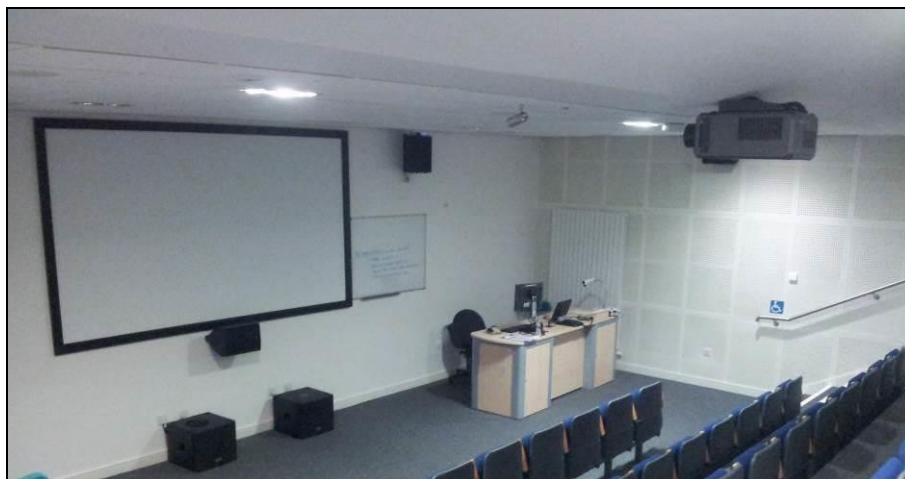
Small power items and other specialised equipment that is present on the Campus will greatly contribute to the overall electricity consumption. Therefore, ensuring that office equipment is controlled and operated efficiently e.g. not operating when unnecessary or powered on when not in use is important and can help to accrue operational savings for the Campus. Computers, monitors and other small powered equipment that is in operation can also contribute to secondary heating gains, hence causing a risk of overheating in naturally ventilated spaces or a greater cooling load requirement in air-conditioned areas. In order to help avoid this and to reduce the requirement for cooling, care should be taken to ensure that all of these electrical items are powered off when not in use.

Figure 17 – Small power equipment in the lecture theatre

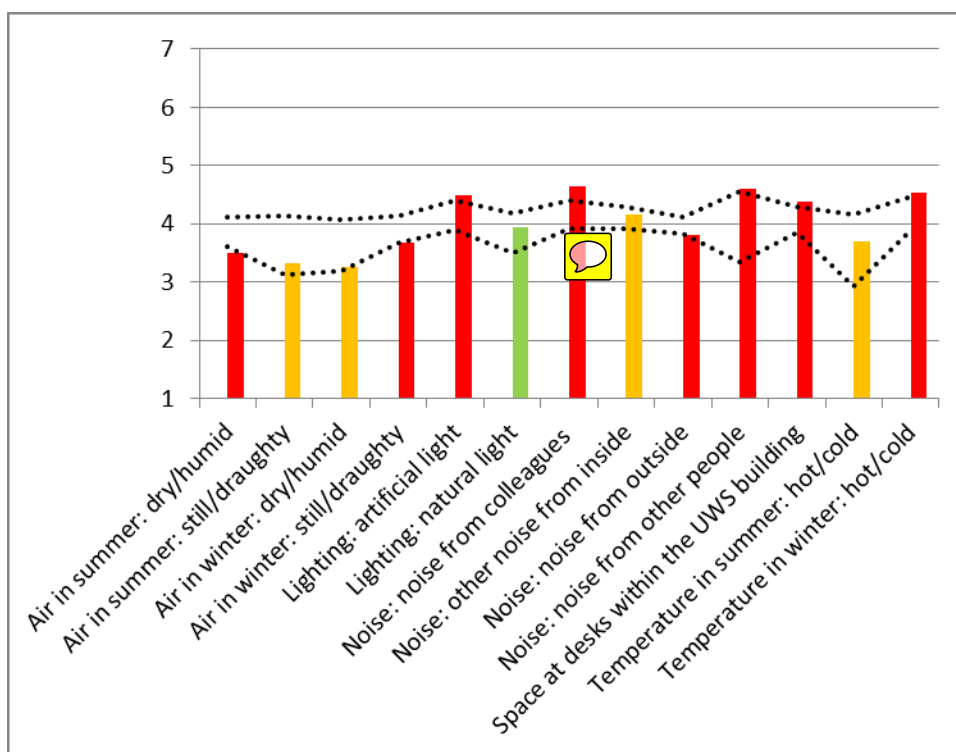
Figures 24, 24 and 26 summarise responses for each of these categories, highlighting the ideal scores, the low scores and the high scores from the BUS.

Figure 24 - BUS results – mid scale score (4) being ideal
(Dotted lines indicate ideal or acceptable results range)

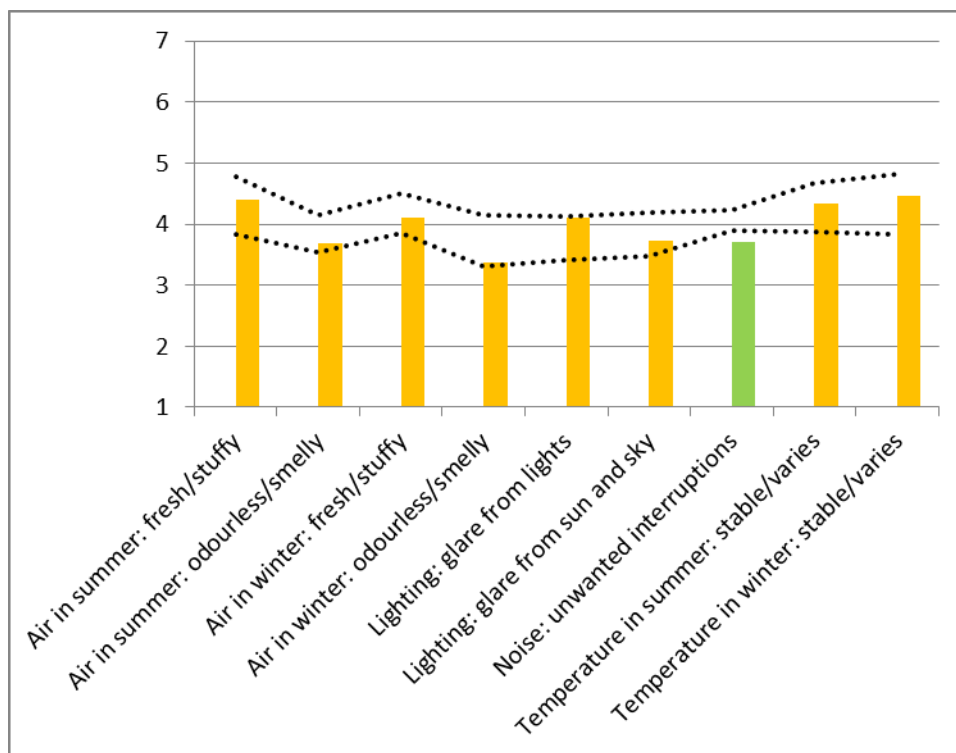
Figure 25 - BUS results – low score (1) being ideal
(Dotted lines indicate acceptable results range, values below the lower line would be ideal)

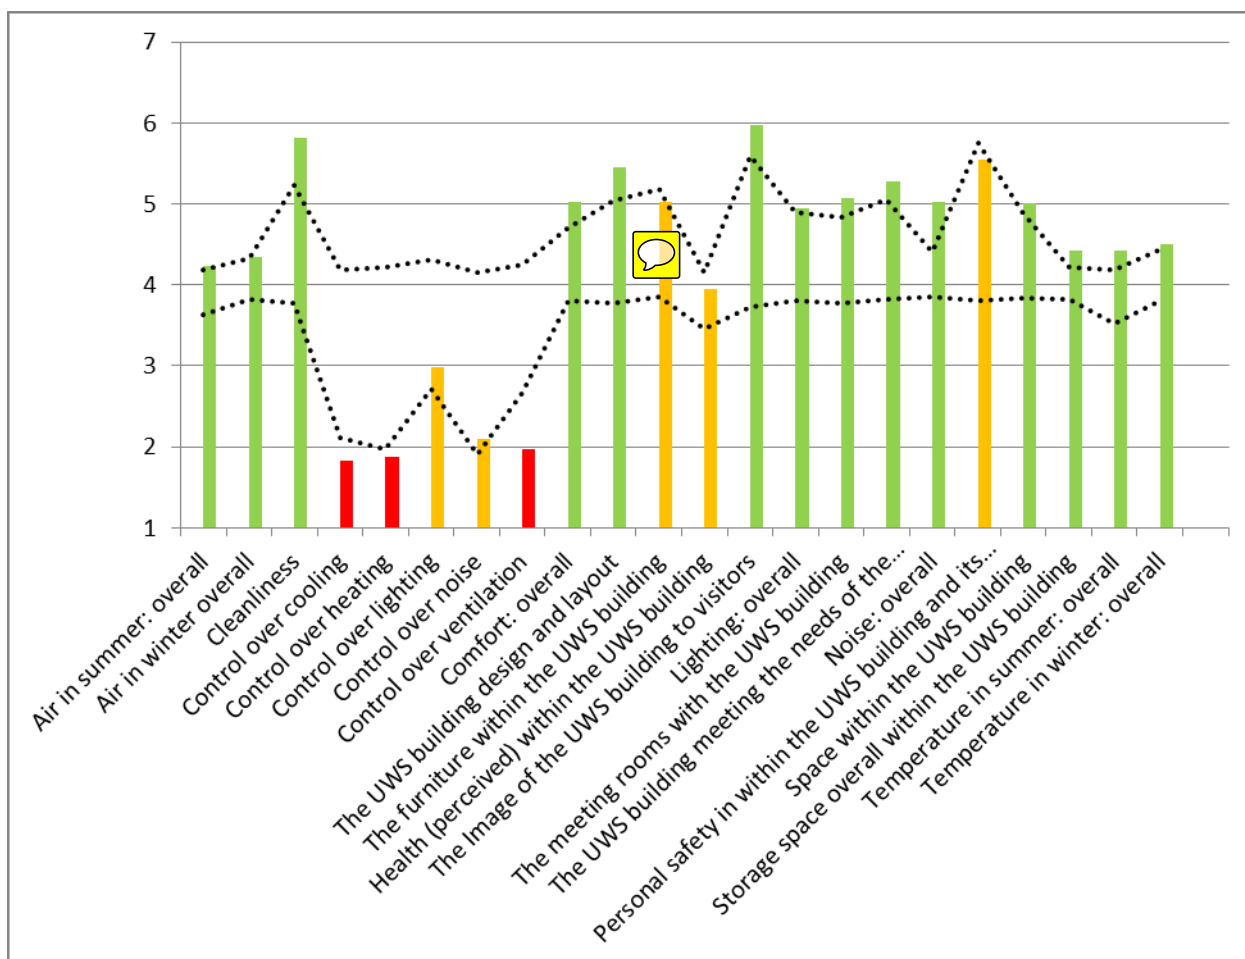
Figure 26 - BUS results - high score (7) being ideal
(Dotted lines indicate acceptable results range, values above the top are ideal)

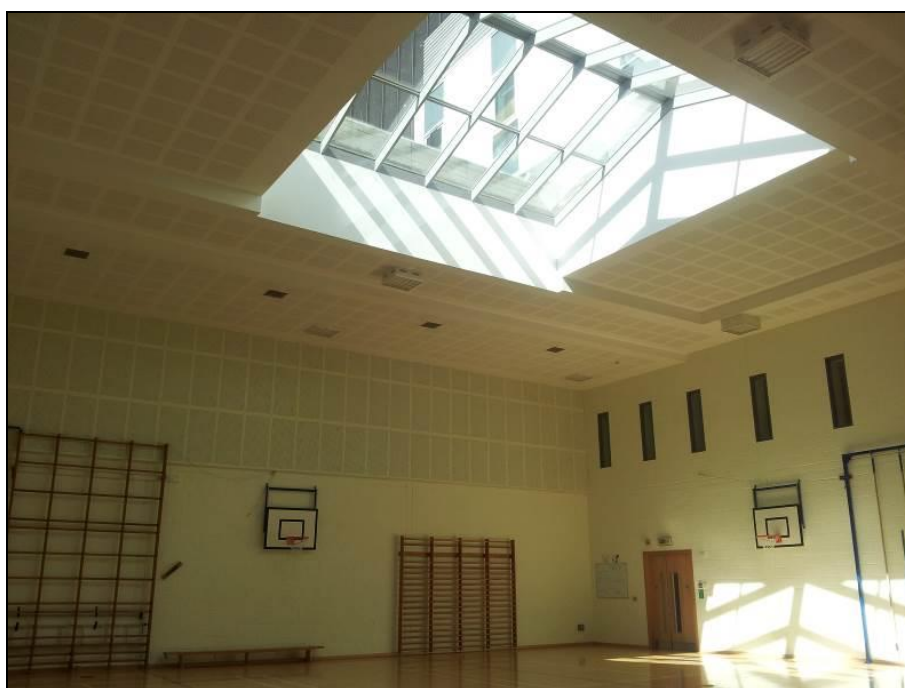
Figure 31 – Naturally lit gymnasium in the basement

The building's artificial lighting is viewed by BUS respondents as being too much rather than too little, although it does not fall within the area of ideal or acceptable, the score does not suggest a major problem. Natural light entering the building received a positive score falling into an ideal range. It means that the occupants feel that the amount of natural light is neither too low nor too high. In terms of glare from; artificial lights, the sun and the sky the scores fell within an acceptable range. Although there is room for improvement, especially with the use of artificial lights, lighting overall received a very positive feedback with a high level of users' satisfaction as shown in figure 32.

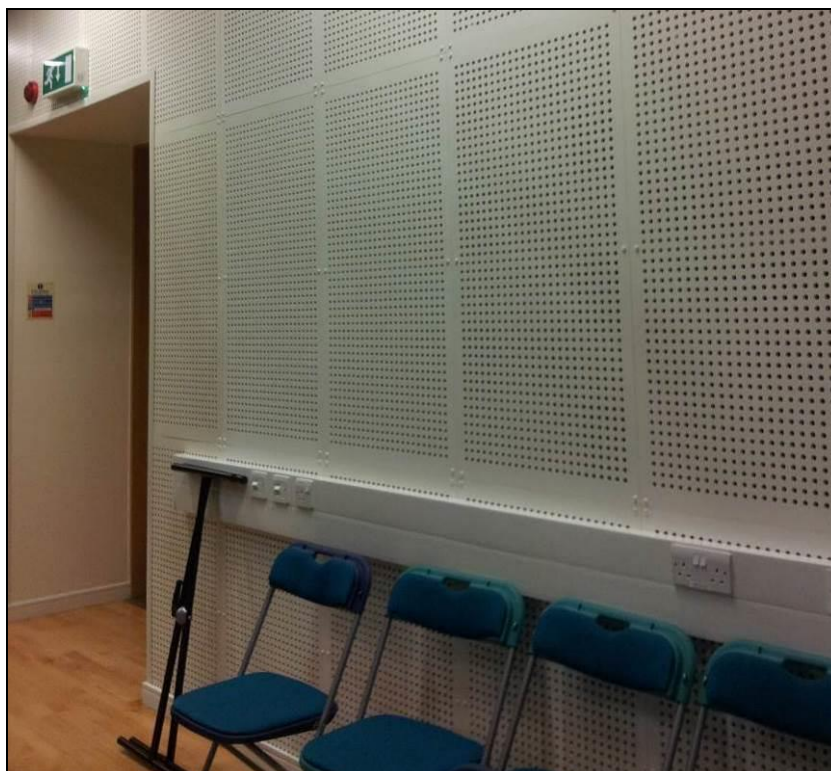
Figure 33 – Wall mounted acoustic panels in the performance studio

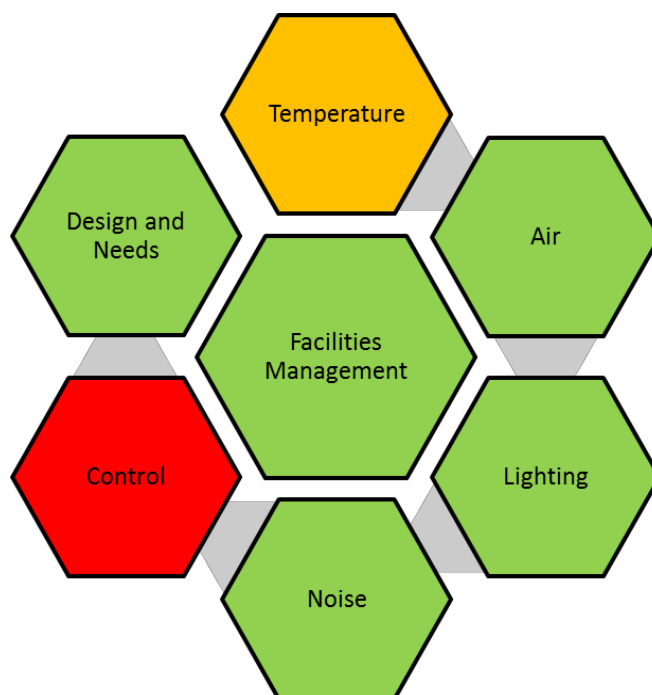
To summarise the overall feedback in relation to air quality, lighting and noise levels, design and needs and facilities management was positive. Temperatures during summer and winter periods could be improved, especially in terms of being too cold in the winter and too hot in the summer within the campus. A lack of control over building services raised the most concerns from the BUS respondents.

Figure 43 – BUS Survey – Overall Results

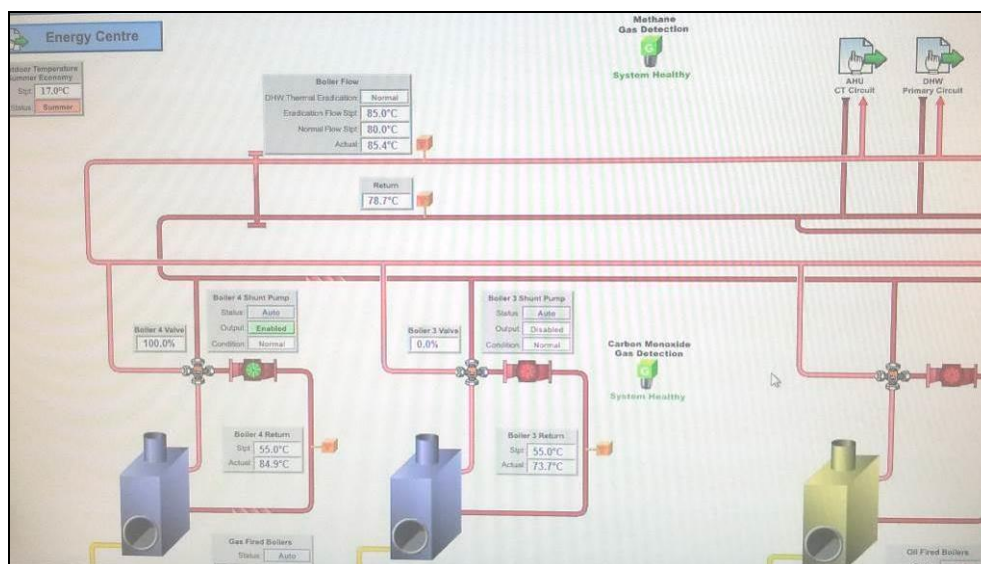
Figure 51- BMS; Gas and Biofuel boilers

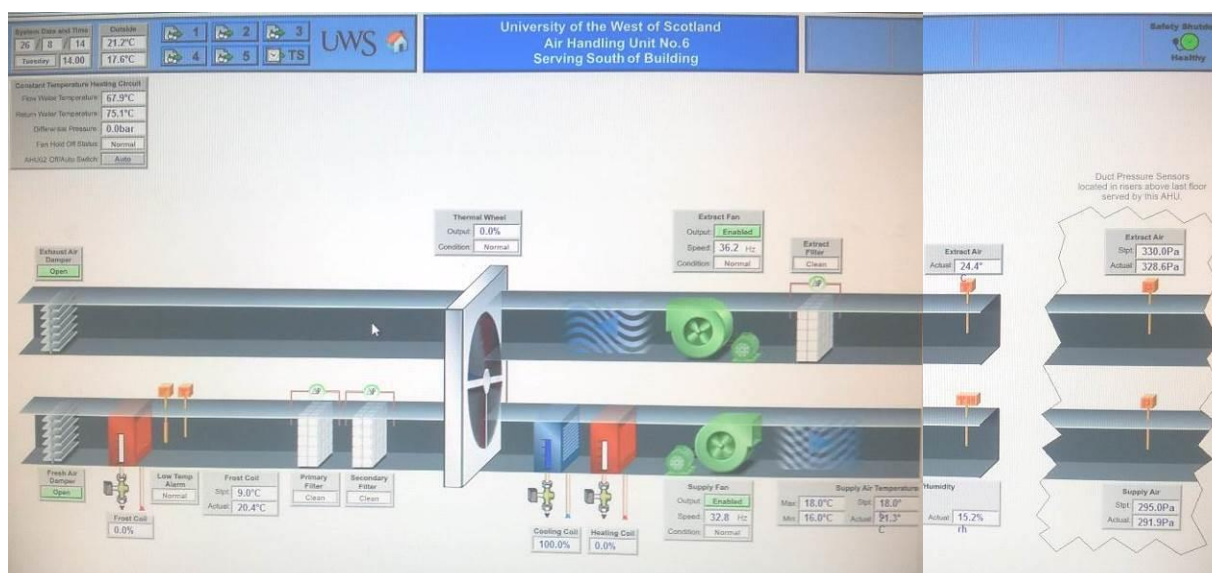
Figure 52 – BMS; Air Handling Unit 6

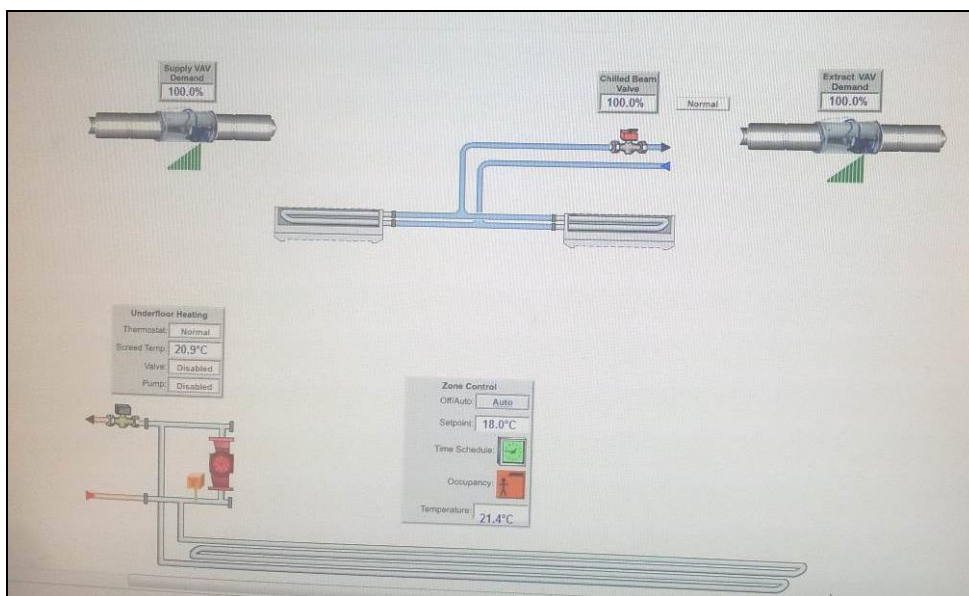
Figure 53 – BMS; underfloor heating in the cyber cafe (room 2.093)

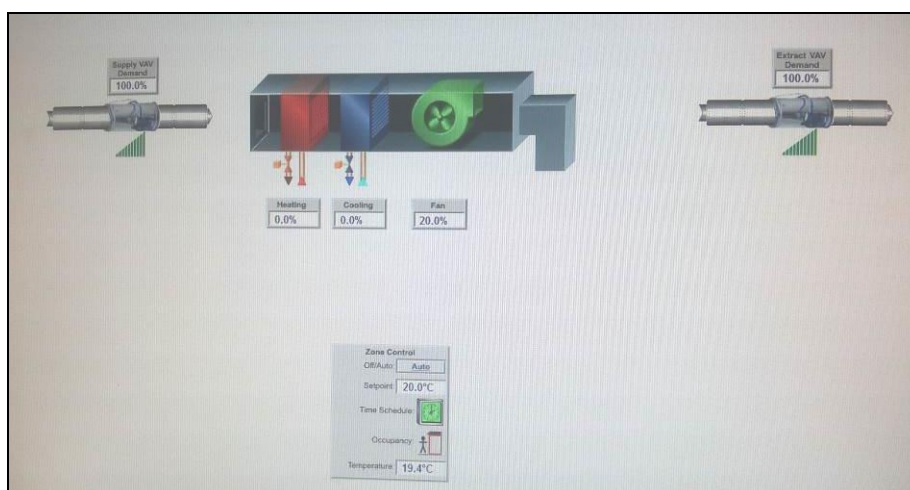
Figure 54 – BMS; Variable Air volume system / Fan Coil Unit in the TV control room (1.003) in the basement

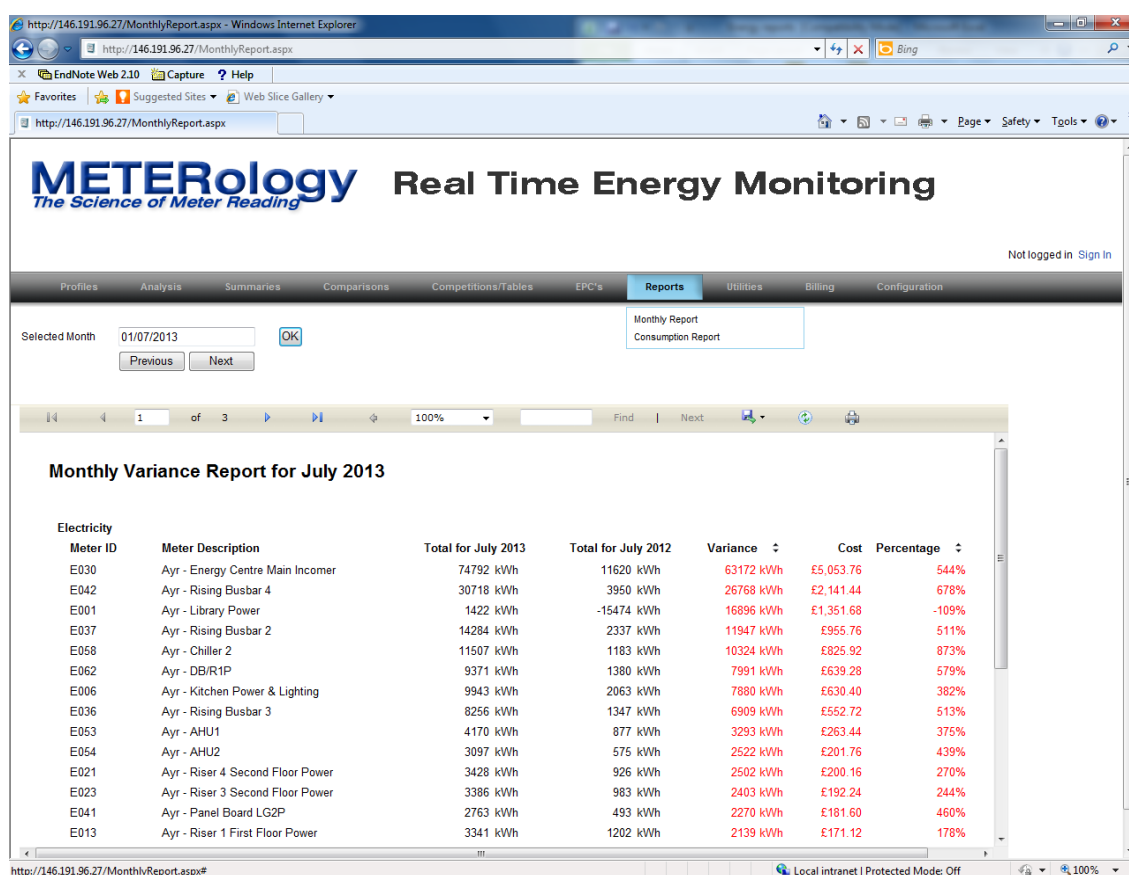
Energy consumption within the UWS Ayr Campus is monitored via 58 meters and sub-meters. All readings can be viewed through the AMR web application. Figure 56 illustrates a sample screen view of the system.

Figure 56 - Remote energy monitoring for the Campus

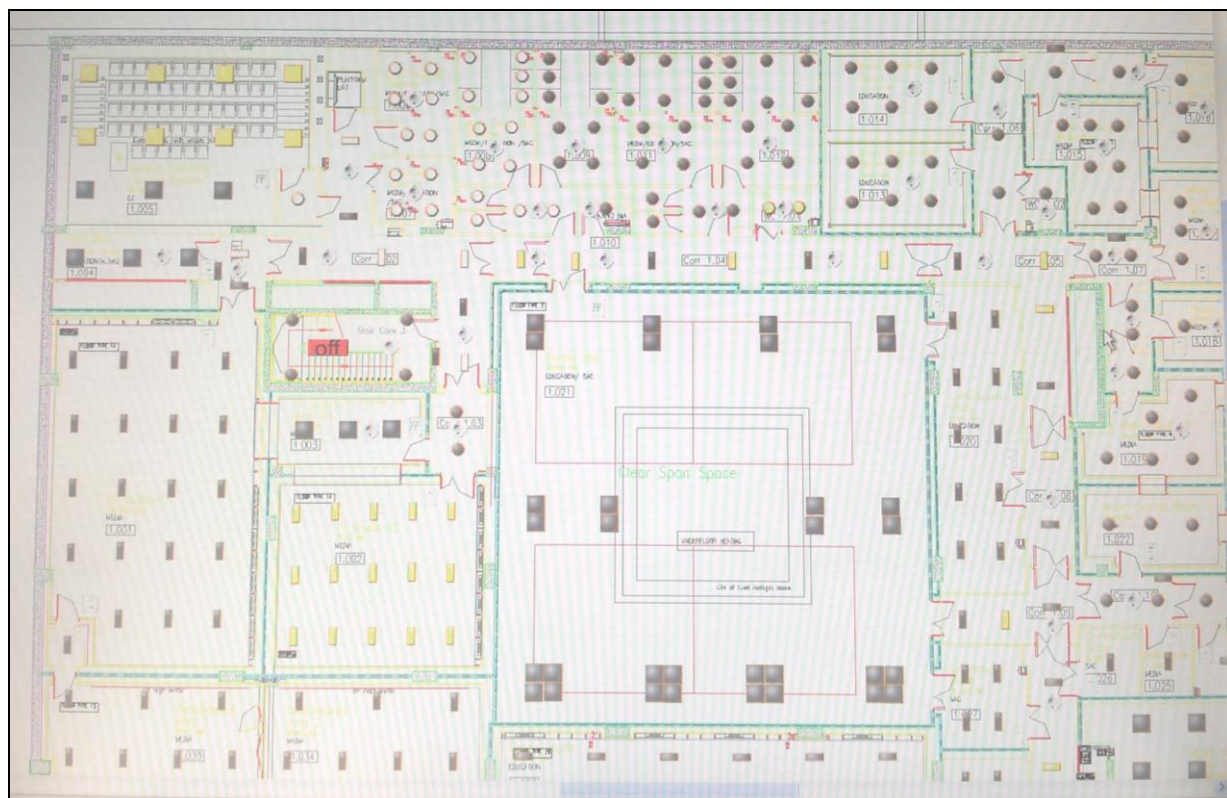
from both the Estates and end user side, has resulted in some occupants struggling to efficiently operate the system.

Figure 57 – DALI; Basement lighting
(Note, the lights are on in the lecture theatre and the TV studio)

It is recommended to provide a programme of training for the;

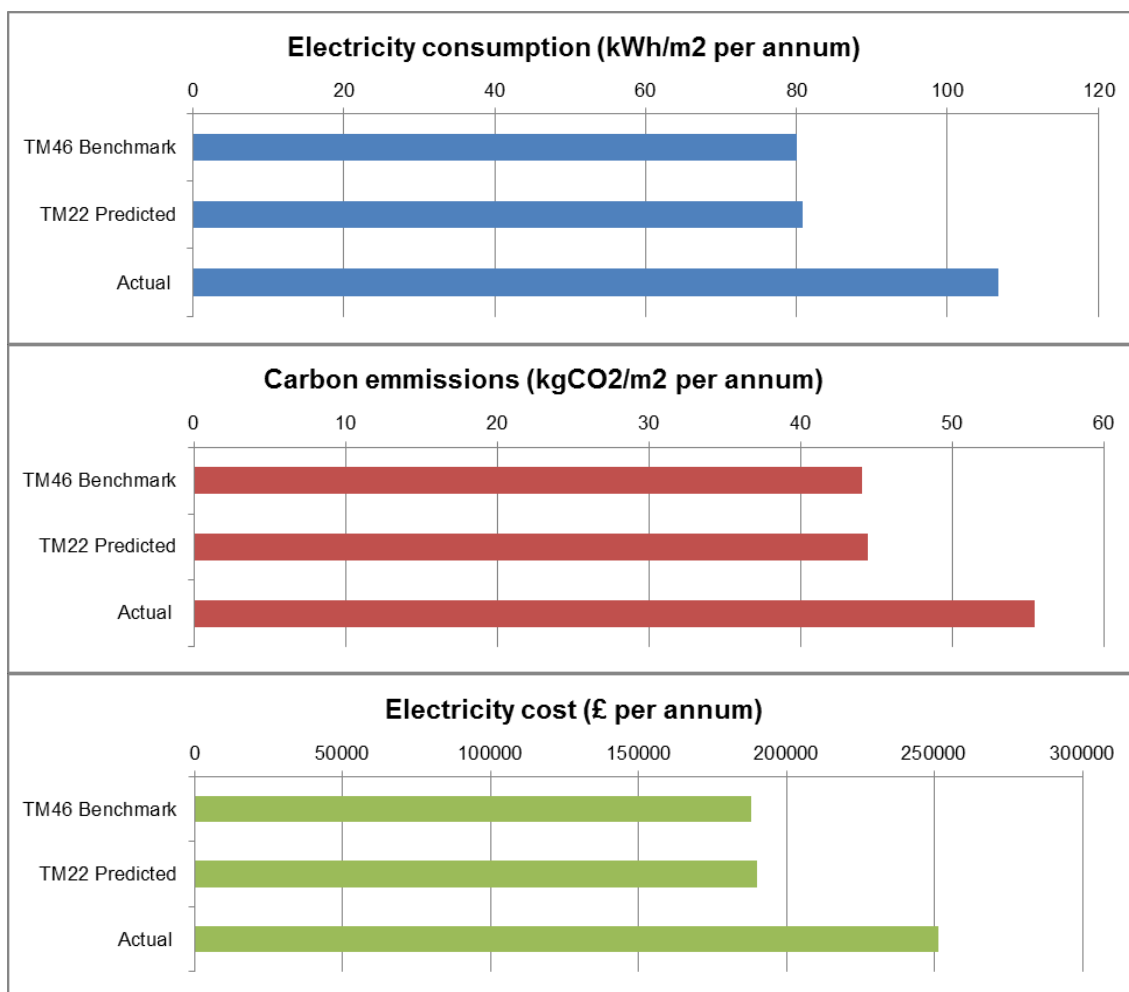
A comparison exercise between what is recognised as a TM46 benchmark versus the TM22 predicted and Ayr Campus actual electricity consumption figures is illustrated in Figure 62. This shows variances in carbon emissions and the annual electricity cost for each of the three different values.

Figure 62 – Electricity consumption, carbon emissions and costs (2013)

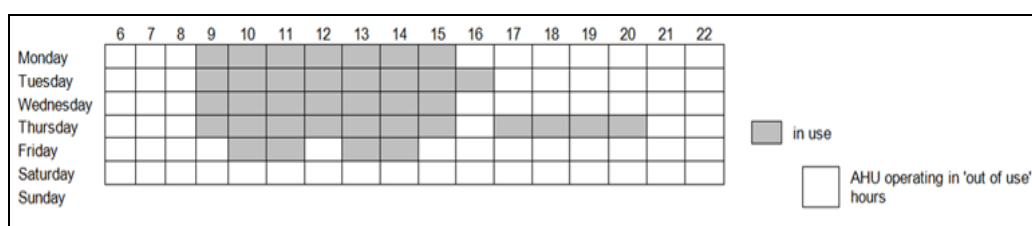
AHU 13 serves lecture theatre 1. A difference between its operating hours and hours during which the room is in use is illustrated in Figure 65 Figure 80. The diagram shows that this lecture theatre was only required to be in-use between 9 am and 5 or 6 pm during the week. The only late night classes were organised for a Thursday night (until 9pm) during Trimester 2. It is clear that those operating hours are much lower than the default university time clock - 6.30 am to 10.30 pm.

Figure 65 – Actual vs. potential in-use hours of AHU 13 during Trimester 2 (Lecture theatre 1)

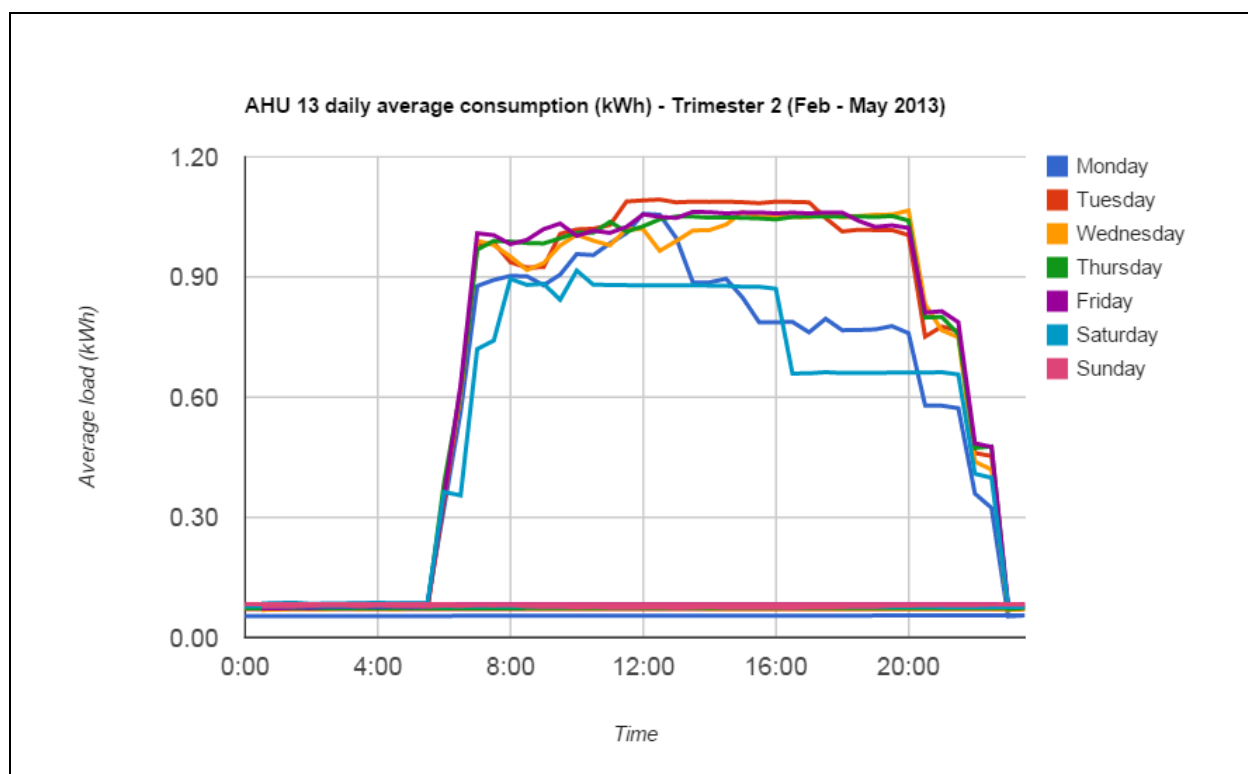
In addition to this diagram, graphs below provide an illustrative representation of those differences. Both graphs show average load by a weekday. The first graph is based on actual meter readings (January till July 2013). In addition to differences in consumption by a different day of the week, it shows that there is some electricity supply requires for 'base load' conditions.

Figure 66 - AHU 13 – Actual Average daily electricity consumption (kWh) during Trimester 2 (Feb- Mar 2013)

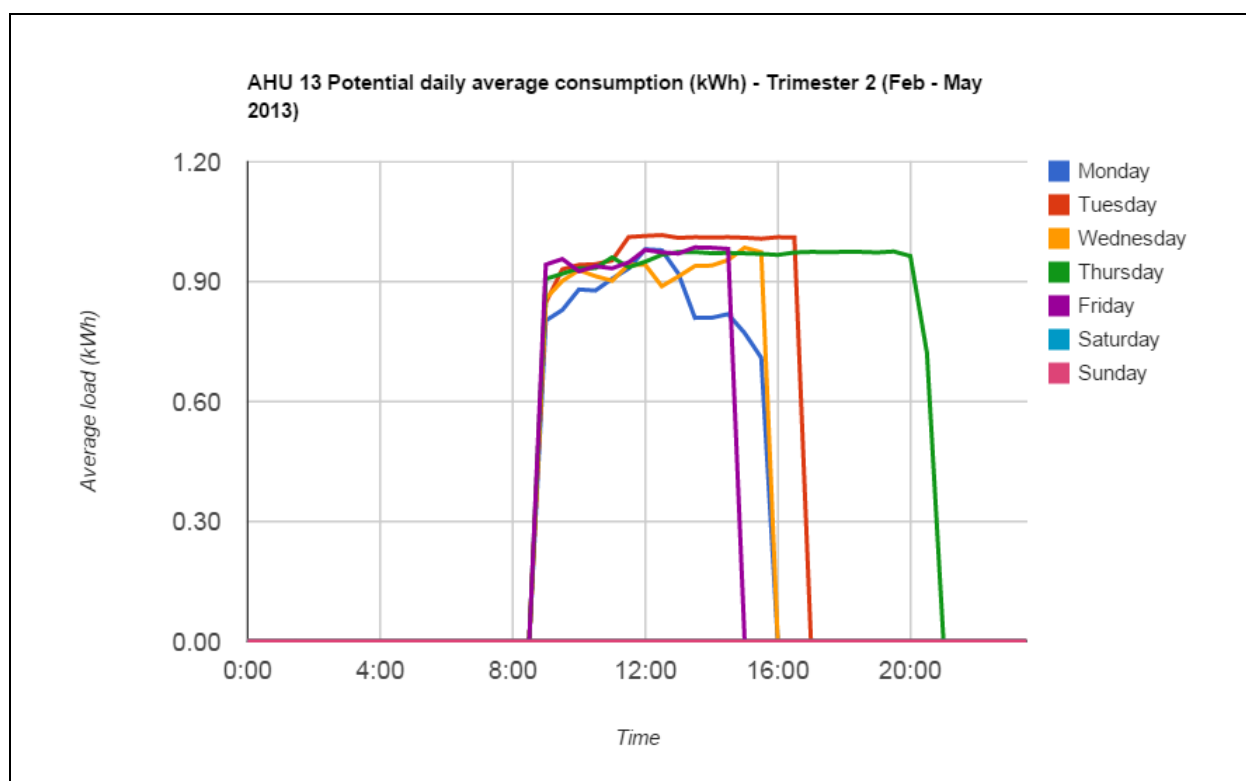
The second graph illustrates potential consumption for each day of the week based on the timetable analysis and excludes the 'base load'.

Figure 67 - AHU 13 – Potential average daily electricity consumption (kWh) during Trimester 2 (Feb- Mar 2013)

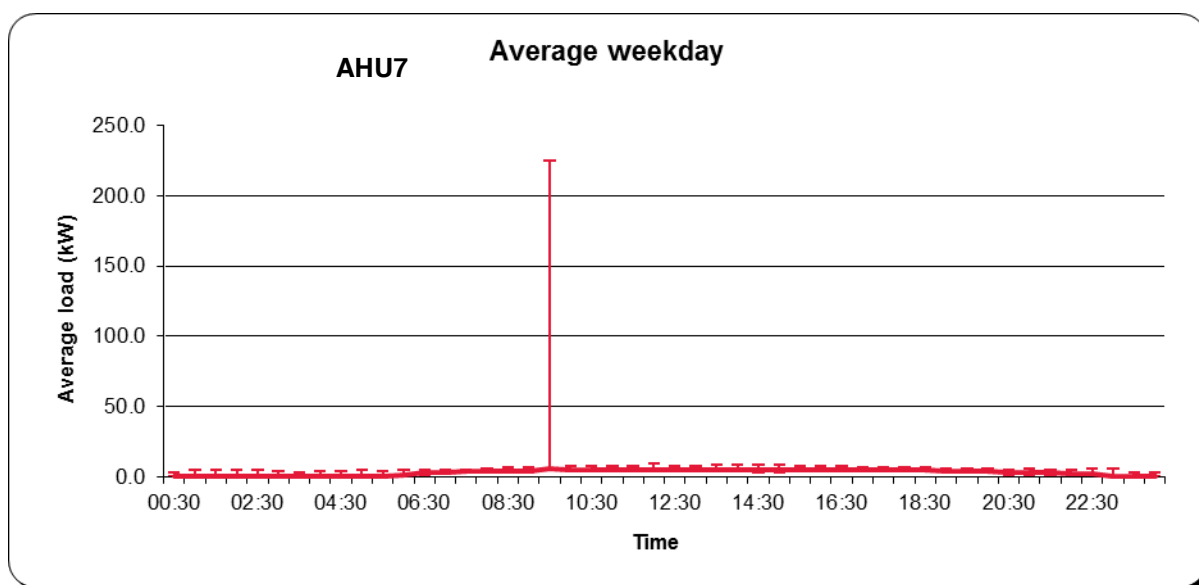
Figure 68 shows the output graph for Air Handling Unit 7 (AHU 7). It is noted that there is one figure significantly larger than the remaining figures which is believed to be an anomaly. Removing this anomaly provided much clearer results, which can be seen in a graph shown in Figure 69.

Figure 68 - Average weekday energy use for AHU7 during monitored period

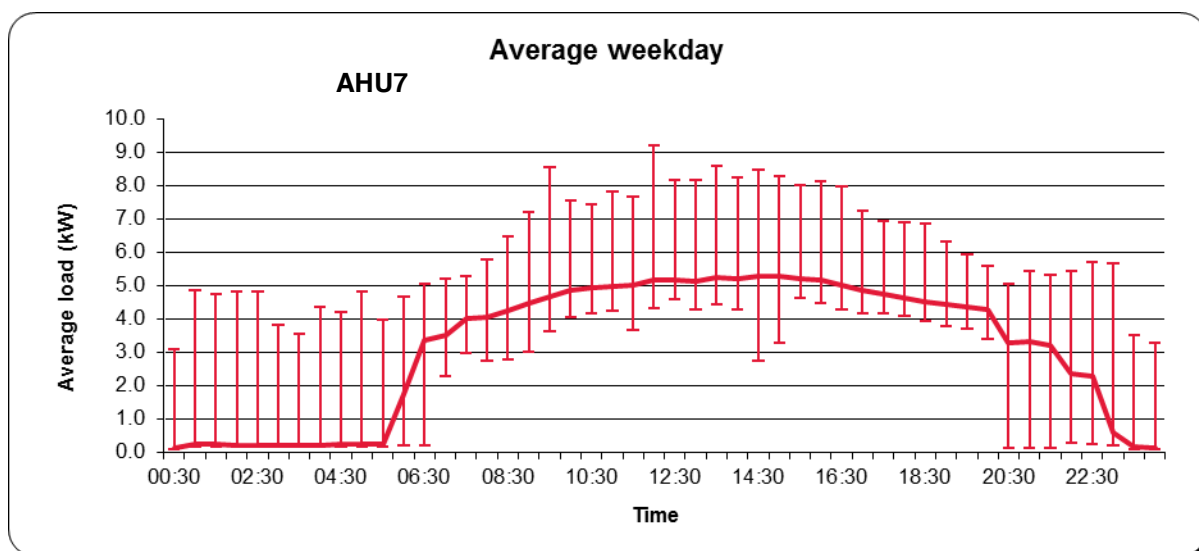
Figure 69 - Average weekday energy use for AHU7 during monitored period after revision

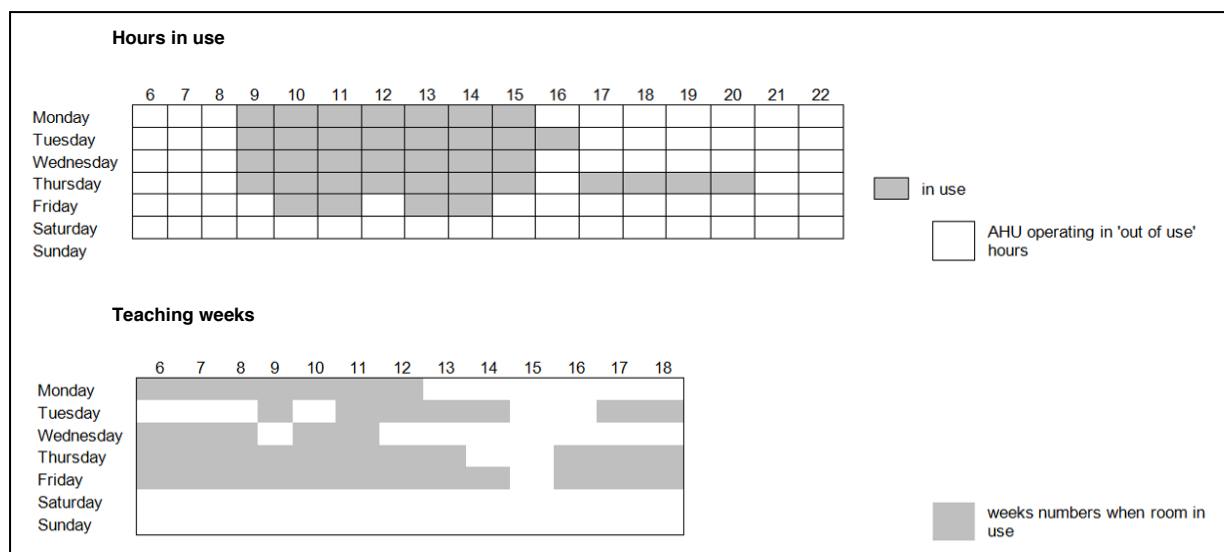
Figure 80 – AHU 13, lecture theatre 1 in-use analysis

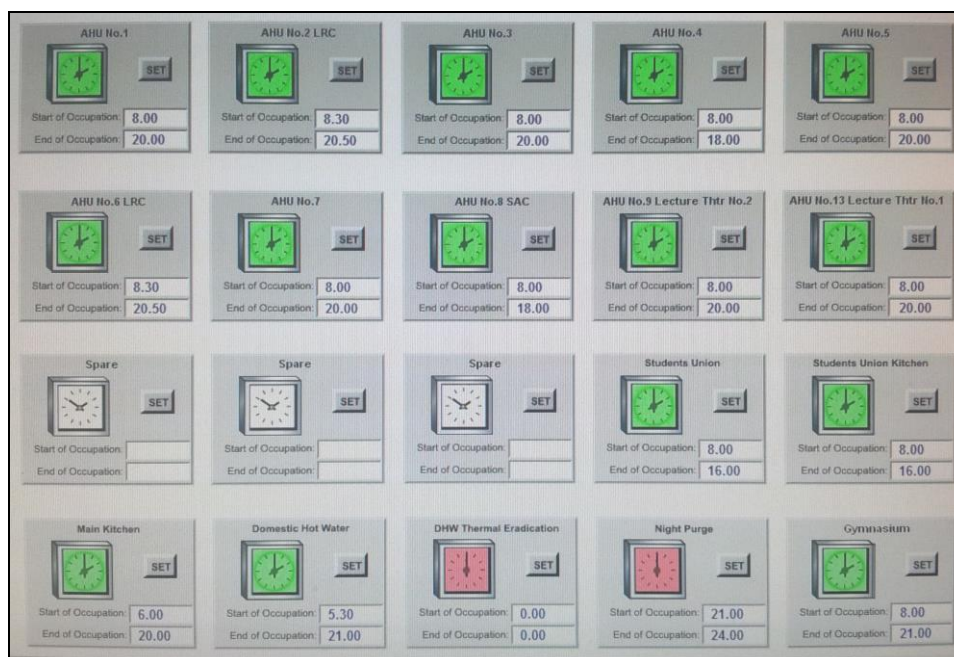
Figure 83 – Revised time settings of air handling units

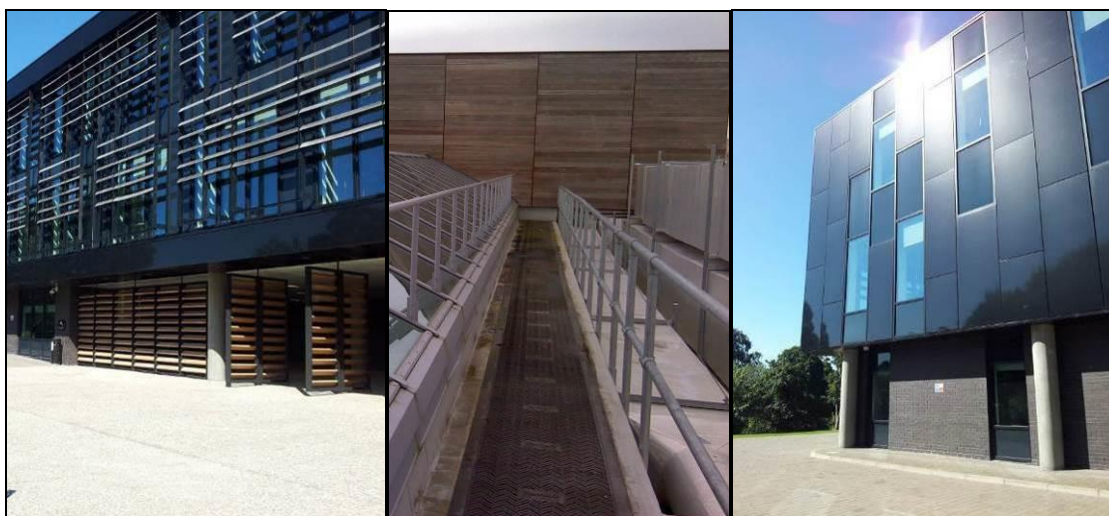
Figure 84 – Building façade: solar shading over curtain walling, horizontal timber cladding around the lecture theatre, composite granite rainscreen cladding.
