Ayr Campus, University of the West of Scotland

Innovate UK project number	450089
Project lead and author	BRE Scotland
Report date	2014
InnovateUK Evaluator	Unknown (Contact www.bpe-specialists.org.uk)

Building sector	Location	Form of contract	Opened
Higher education	Ayr	Design and build	x
Floor area (GIA)	Storeys	EPC / DEC	BREEAM rating
17,835 m ²	3	B / N/A	Excellent

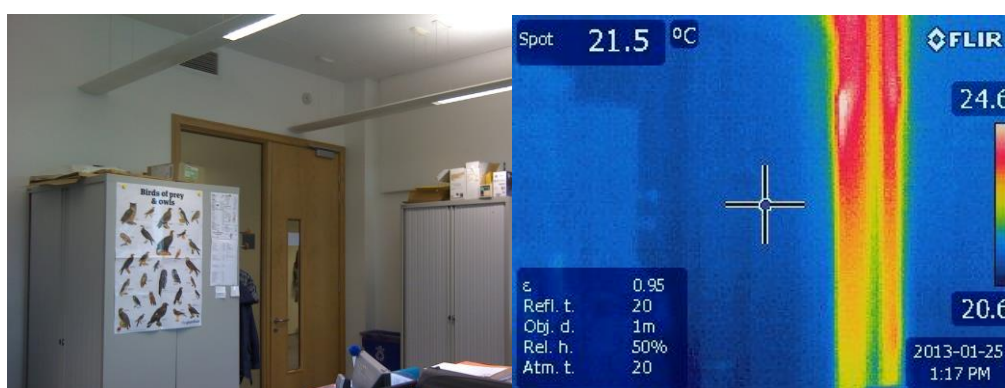
Figure 95 – No blockages within space heating flow and return pipework (located behind plasterboard)

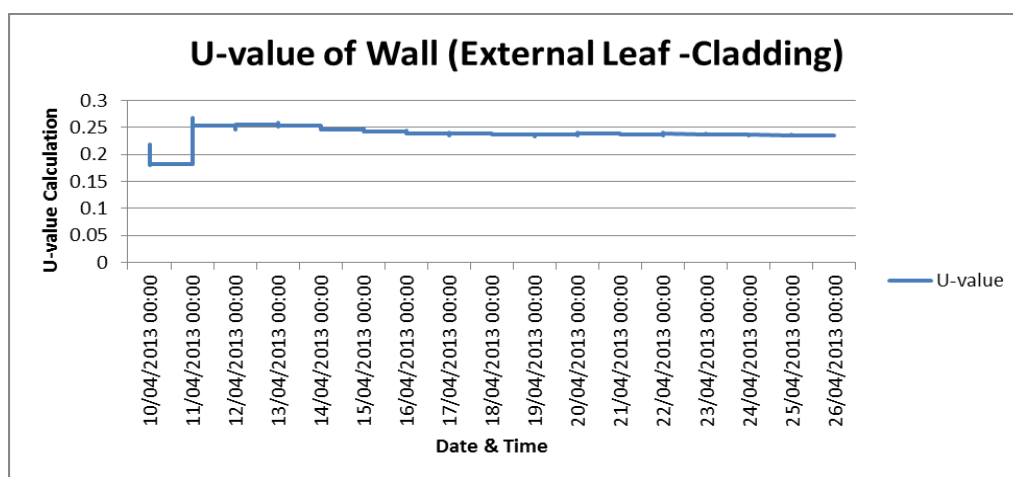
Figure 97 – Wall U-Value Calculation (First Floor)

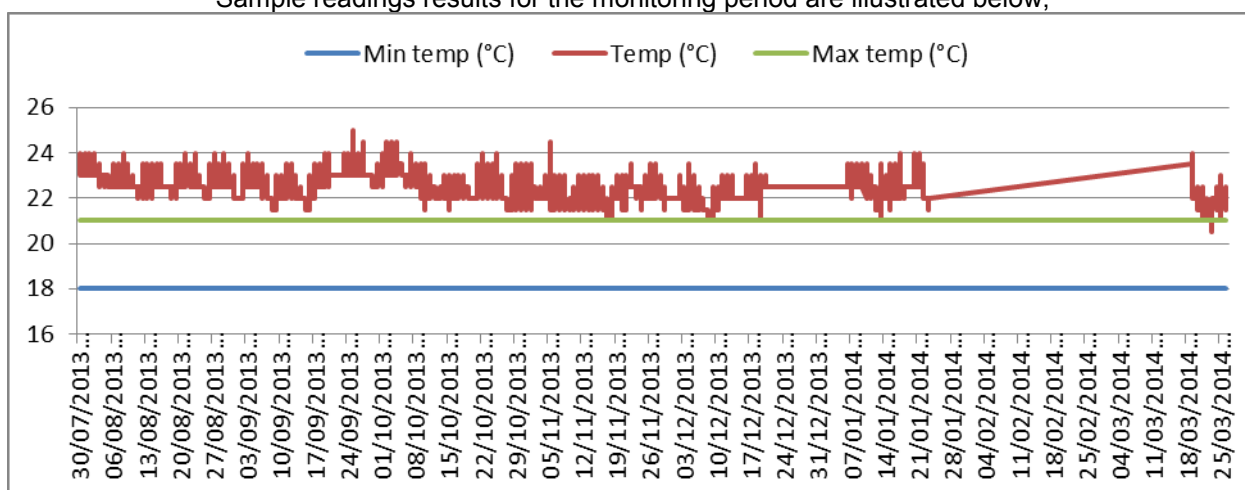
Figure 99 - Temperature readings in the office

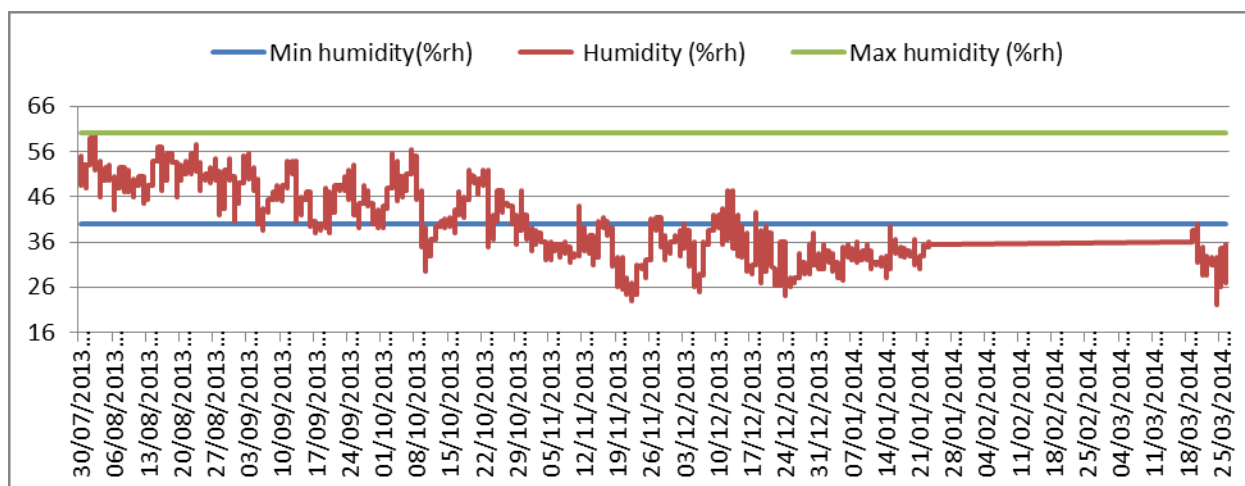
Figure 100 - Relative humidity readings in the office

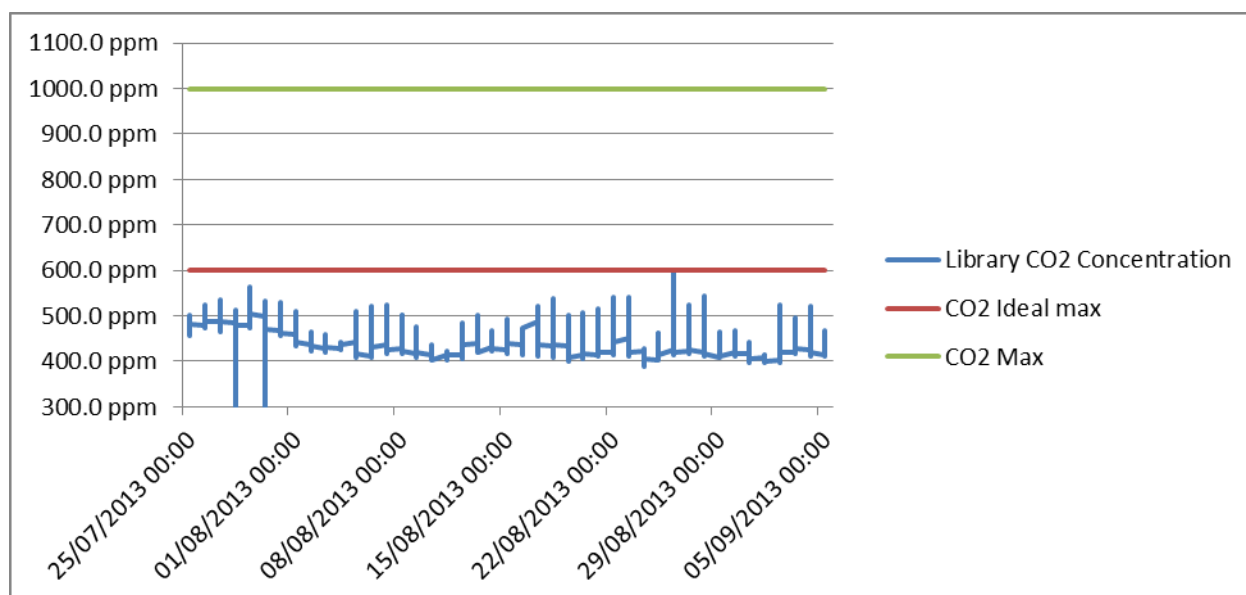
Figure 101 - Air quality readings in the library
