Innovate UK

Building Performance Evaluation Programme

Findings from Non-Domestic Projects

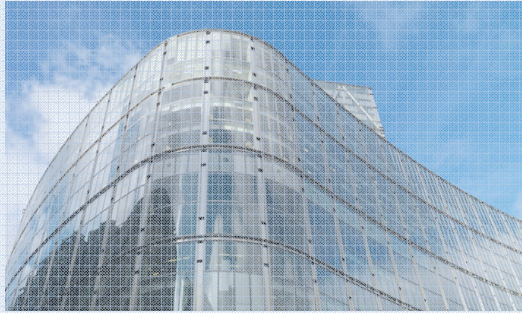
201 Bishopsgate is a high spec office in the City of London, with a floorspace of more than 37,000m² over 14 storeys, designed for low energy performance, despite the inclusion of a highly glazed façade. Each occupant has access to their own locals controls for lighting and HVAC, allowing for a great level of personal climate control. Linked to this, there was a focus on sub-metering of landlord and occupant areas, and tenant engagement.

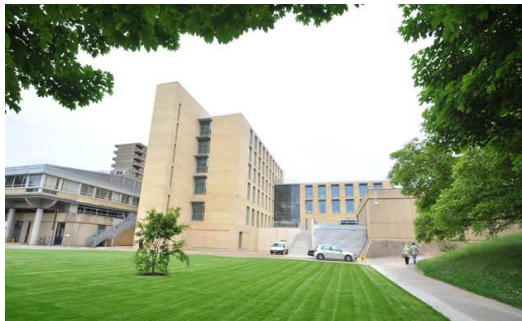
The **Bath Campus** study includes 'R5 - Woodland Court', a new 355 bed student residence, and '4 West', a 5,200m² mixed university building (both refurbished and new). Fabric energy efficiency and air tightness was considered, particularly for 4 West, which received planning permission prior to the 2006 update to the Building Regulations. Both projects have roof mounted solar thermal arrays, and achieved BREEAM 'Excellent' ratings. (Note figures in this report are for Woodland Court.)

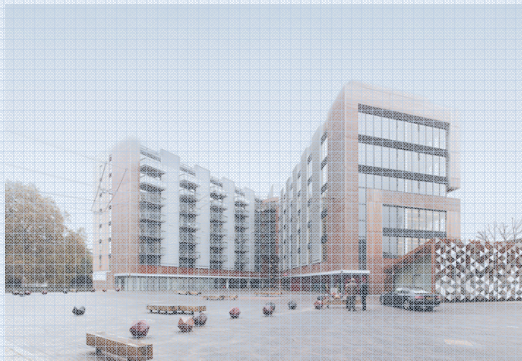
The **Bermondsey Square** development in London is made up of two blocks, the first being a 79-bedroom hotel and the second including offices, retail space and apartments. Heating is provided through a district heating network from a local plant room, served by gas boilers, with an evaporative cooling system specified for the offices. The building is primarily naturally ventilated. In this multi-tenancy building, 'Green Leases' and engagement were explored to address the impact of the users on overall environmental performance.

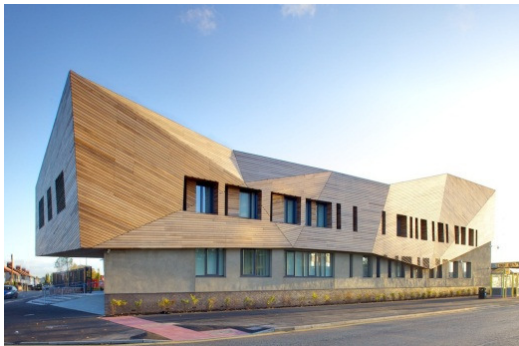
The **Blue Bell Health Centre** in Liverpool is a 2500m² scheme designed with high levels of insulation, air tightness and triple glazed windows, and mechanical ventilation with heat recovery, following Passive House principles. It also includes solar hot water panels, and a heat pump to provide space heating and supplement the water heating.

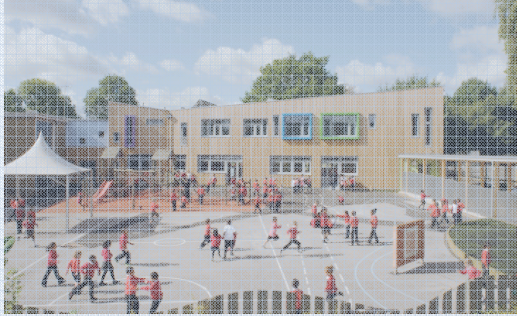
Bessemer Grange Primary School is a 1950s school with a new extension built in 2010, housing a Children's Centre and an Early Years Centre. The new building had high environmental ambitions and scored in the top 5% for user satisfaction with comfort and performance. It was built using a 'glulam' timber frame, with 120mm of insulation in the walls and a sedum roof. It achieves low gas consumption, but electricity use is high and there are problems with the solar water heating.

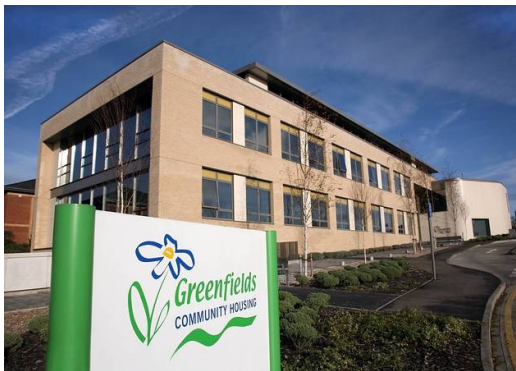
Greenfields Community Housing HQ has office accommodation for around 100 staff, and community facilities for its tenants. It has three ground-source heat pumps, and mechanical displacement ventilation in winter, using a thermal labyrinth. It got a BREEAM 'Very Good' rating, although the interface for its BMS was omitted from construction for cost reasons. There were also problems with heat-pump controls. The server room alone uses as much energy as heating and cooling for the whole building.

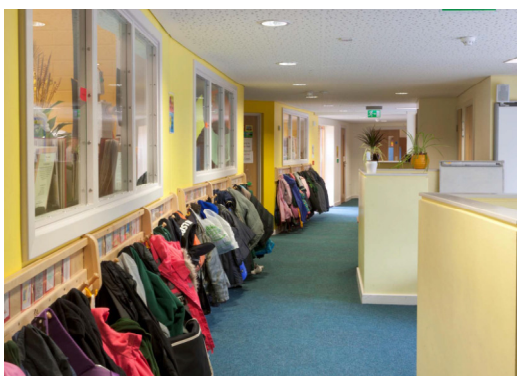
Castle Hill Primary School in Kingston upon Thames has a classroom extension of 820m², a new dining hall of 300m², and a PV array. Air tightness for the dining hall was disappointing, at 11.85m³/m²/h. The new buildings did well on overheating, but sometimes had high CO₂ concentrations, suggesting ventilation issues. Electricity use was lower-than-expected for both buildings, but gas use in the dining hall was 4.5 times higher than the design estimate.

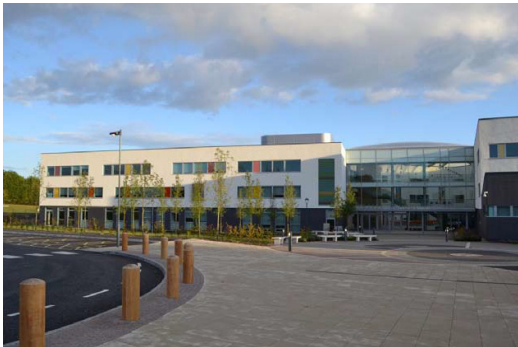
Cressex Community School in High Wycombe is a 11,600m² three-storey secondary school with a biomass boiler. It consists of four blocks, arranged around an atrium. It has good insulation and airtightness, with few thermal bridges. The biomass boiler has had problems with the fuel store, with fuel getting wet. Occupants also report concerns about temperature and humidity.

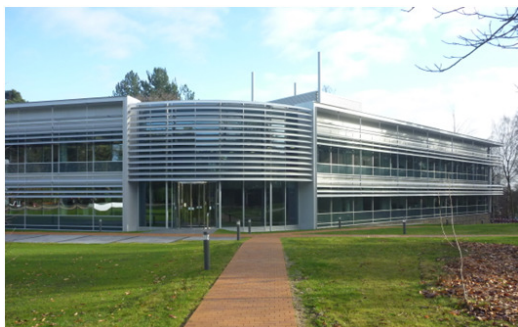
Eli Lilly Research Office is a two-storey building with a steel frame structure and lightweight curtain walling with overhangs to limit solar gains. It was designed for 130 people, but in fact current staffing is much lower. It has natural ventilation using Passivent, with mechanical ventilation and cooling for use in summer.

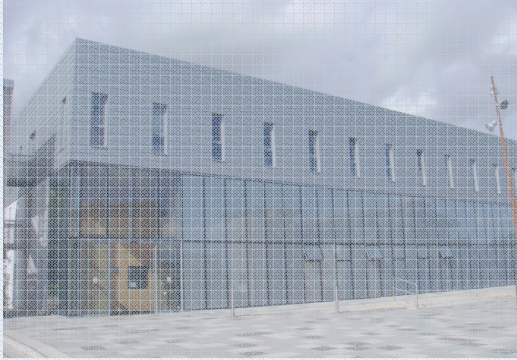
Jarman School of Arts comprises drama and film studios, computing and editing suites, a large art gallery, teaching rooms, academic and administrative offices. The steel-frame structure has exposed concrete ceilings, and zinc cladding externally. The building was well received, but there are problems with noise, and thermal conditions. Energy use also rose each year for the first three years, and there are problems controlling the under-floor heating.

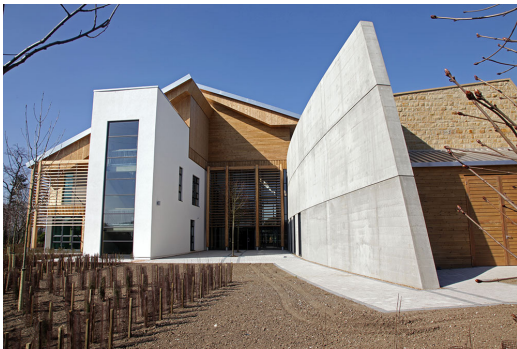
The Sustainable Construction Academy in Kent is a 2,900m² intended to teach about construction. It has workshops and teaching spaces, with a café and offices, arranged around an atrium, but it is currently under-used. It has a 26.7 kW solar electric array on the roof. The installed biomass boiler has now been decommissioned because of complexity and cost.

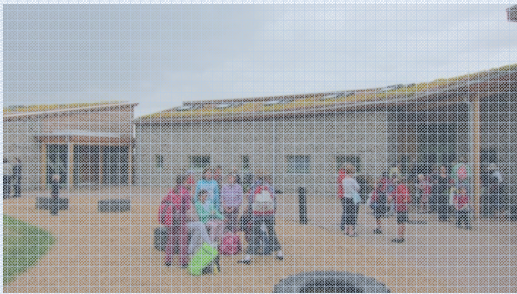
Staunton on Wye Primary School in Herefordshire is a three-classroom school for 90 pupils, with a pre-school for 26. It has a timber frame construction, with local stone on the north facade and timber cladding on the south. It has a green roof and natural ventilation. Very high insulation values include triple-glazed windows. Good ventilation during winter needs the teacher to intervene.

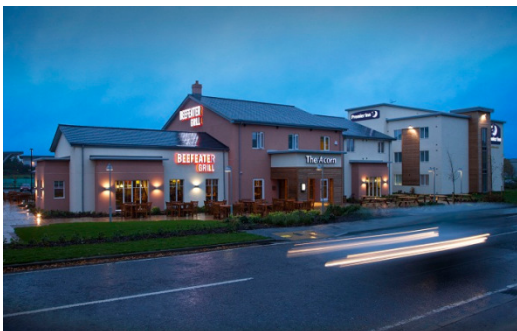
Premier Inn and Beefeater Restaurant in mid-Sussex is a 60-bed hotel with a 220-seat restaurant. It has a ground-source heat pump and heat-recovery ventilation, and originally it aimed to reduce usual energy consumption by 70%. It uses a 140mm timber frame with triple glazing. There are LED lights with auto controls. Post construction, there were problems with air tightness and thermal bridges.

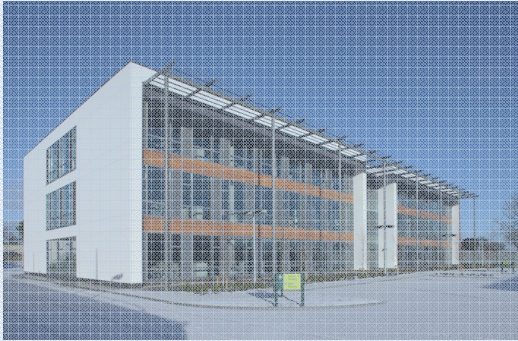
Graham Head Office in Hillsborough, N Ireland, is 3,200m² and provides office accommodation for 250 employees. It has a 240 kW biomass boiler that needs to be cleaned out every two weeks, with an oil backup boiler. The design got an 'Excellent' BREEAM rating. It has good daylighting and natural ventilation using BMS-controlled louvres as well as windows. One third of electricity use is for the server room and outdoor lighting.

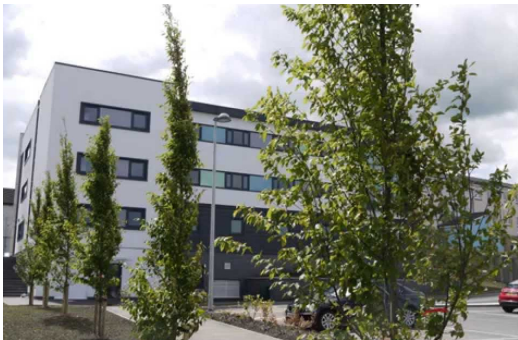
Ore Valley Business Centre in Scotland provides office space for start-up companies. It was designed to accommodate 45 people on each of three floors, but it is currently under-occupied. It uses the Termodeck ventilation system, which appears to have worked well, although local electric heaters are used to supplement the central heating system. The BPE identified high energy use for lighting.

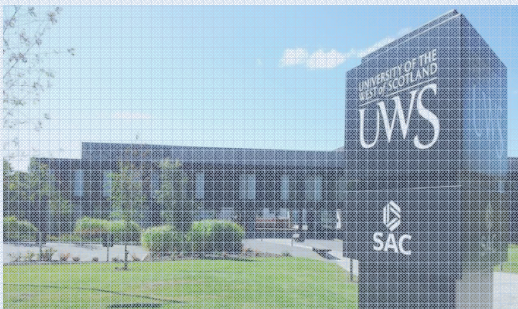
University of the West of Scotland Ayr Campus is a 17,800m² building for up to 4,000 students. It has biofuel boilers, but these proved problematic – particularly because of difficulties achieving the correct biofuel mix – so backup gas boilers are used instead. The campus has mechanical cooling including fan coils, and mechanical ventilation.

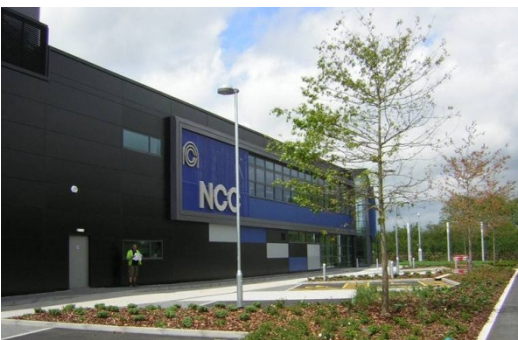
The National Composites Centre near Bristol aims to bring together design and manufacturing processes for industrial composite materials. It is 8,500m², and has mechanical ventilation but not cooling, and occupants have reported summer overheating. It has a 138 kW photovoltaic array, which is generating more power than anticipated. However, overall the building's electricity demand is much higher than expected.

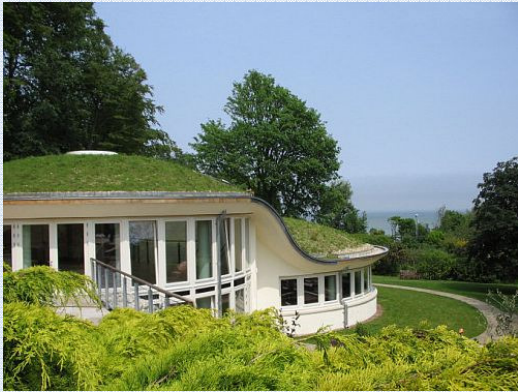
The Pines Calyx, Dover, is an earth-shelter building, and all walls are made from rammed chalk. It was intended to be the most sustainable events venue in Europe, and has a hybrid heat pump-solar heating system that includes 3.8 kW of PV. The project team viewed it as an 'experimental' building because virtually every aspect, from the structure to services and energy systems, was innovative. They anticipate 30% savings from 2014 to 2015.

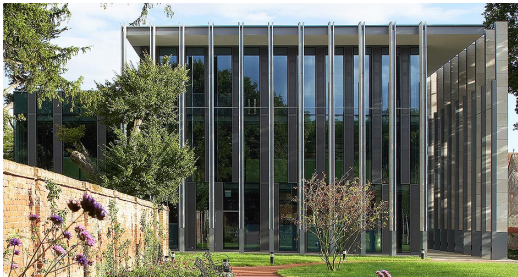
Bourne Hill Offices in Salisbury provide office space for Wiltshire Council. They consist of a refurbished listed building, 1,500m², and a modern extension, 2,360m². The new extension has a concrete frame with glass curtain walling, and a green roof. Both buildings have conventional services, with no renewables, but there is rainwater harvesting. The extension has stack effect ventilation, and uses night-cooling.

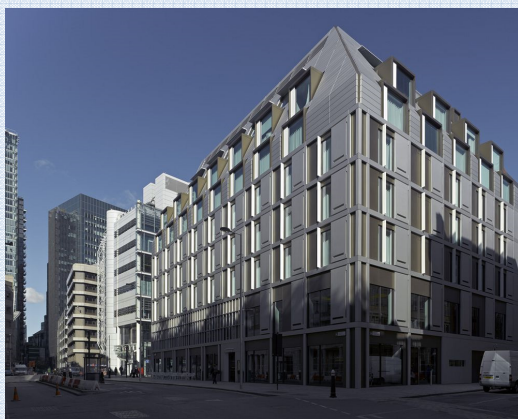
South Place Hotel in London has 80 bedrooms and two restaurants. It has mechanical ventilation and cooling, with fan coils providing heating and cooling in bedrooms. It has a combined heat and power system, which seems to have saved about 5% of carbon emissions. The hotel has high electricity use, partly because it is pitched as a high-end luxury hotel.

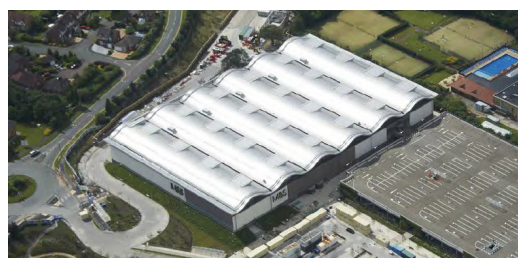
Cheshire Oaks on the Wirral is Marks & Spencer's second-largest store, at 19,400m². It uses CO₂ as a refrigerant to cool food, with heat recovery from the refrigeration. It also has a biomass boiler for use in winter (a gas boiler functions in summer), displacement ventilation linked to earth-duct cooling, pre-fabricated lime-hemp wall panels, rainwater harvesting, and a 300m² 'living wall' beside the car park. Energy use compares well with benchmarks.

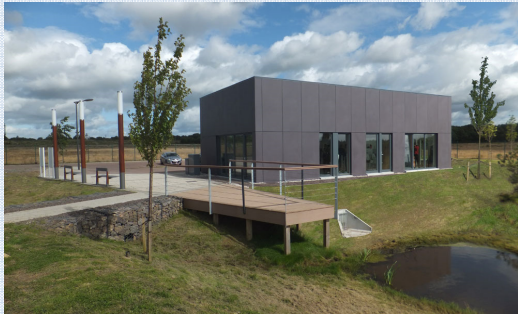
The **BRE Scotland Innovation Park Visitor Centre**, is a single-storey building to showcase the future of Scottish housing. It is highly insulated, with good airtightness, an air-source heat pump, solar electric panels, solar water heating, heat-recovery ventilation, and efficient lighting. However, there were problems with ventilation and heating which meant the heating had to be replaced. Energy use was also higher-than-expected.

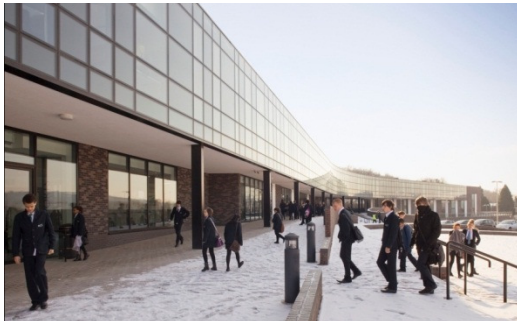
Brighton Aldridge Community Academy is a two-storey 10,588m² concrete framed school, built on the site of previous high school, for a total of 1150 pupils. The construction is generally very traditional, with a focus on natural ventilation and good daylighting, with a biomass boiler (now unused) and a solar hot water array. It has excellent air tightness. Part of the *POE Feedback into School Design* project, with Thamesview School.

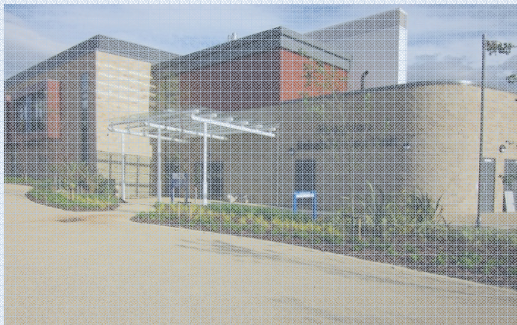
Dartington C of E Primary School in Devon consists of four clusters of single-storey buildings. The total floor area is 1,990m². It has underfloor heating from air-source heat pumps, and solar electric and solar thermal panels. It also has rainwater harvesting. Value engineering late in the programme resulted in sacrifices in mechanical and electrical engineering. Energy use rose from the first to the second year of occupation – partly due to a colder winter.

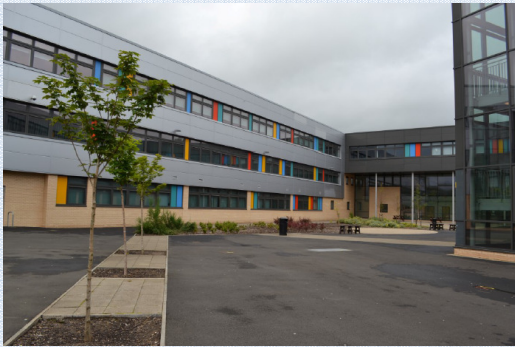
St Peter the Apostle secondary school, in Glasgow, was a PFI school built for 1500 pupils but currently has 1600. The floor area is 16,185m², spread across four three-storey blocks. It has reversible heat pumps that are able to provide heating and cooling, and gas boilers for heating. It has a mixture of under-floor heating, radiators and radiant panels to deliver heat. There are some issues with controls and the BMS, and over-reliance on electric light increases energy use.

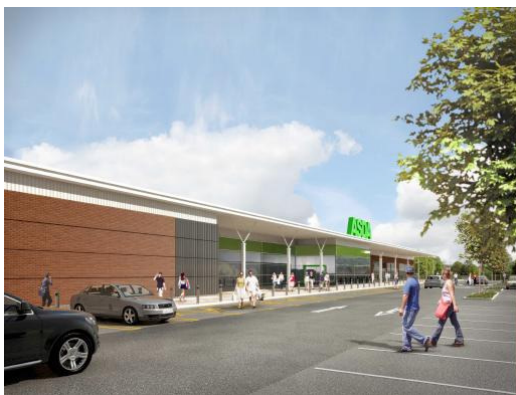
Asda Langley Mill supermarket is a 6,293m² building in Nottinghamshire with a sales area of 3,675m². It was intended as a test site for natural ventilation, and has a small amount of mechanical extract ventilation. Unlike other supermarkets, it has no mechanical cooling. The store reported 8% savings of the usual energy for ventilation and cooling, but this was offset by higher-than-usual heating energy. It also achieved very good occupant satisfaction

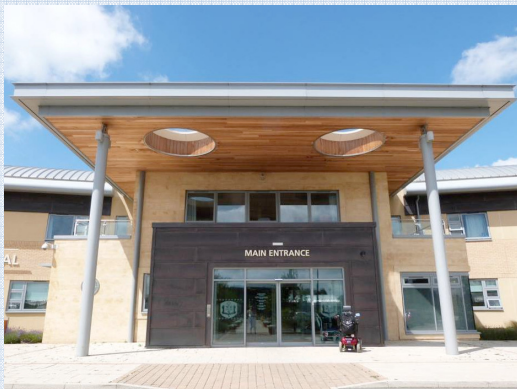
Vale and North Cotswolds Hospitals are two hospitals in Gloucestershire. They are similar sizes and have similar facilities and almost identical fabric and building services. They both have combined heat and power (used infrequently), solar water heating (unusual in hospitals), reversible heat pumps, and some solar shading. Both appear to be using more energy than they should, and report issues with thermal comfort – although both are liked by occupants. Both hospitals were economical to build.

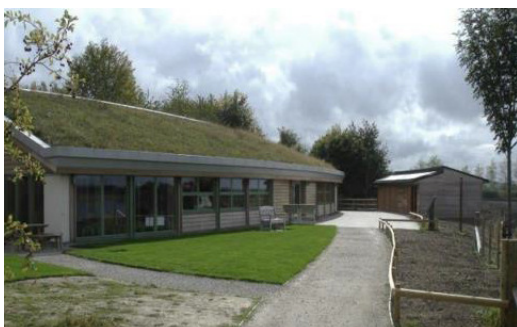
College Lake Visitor Centre in Tring, Hertfordshire, is a 362m² building with a single-storey section including a grass roof and a timer two-storey section. It has under-floor heating from two 12 kW air-source heat pumps, and a 3.4 kW solar electric array, providing 8% of the electric demand. Energy performance is good and (very unusually) close to the design estimates. The heat pump coefficient of performance was calculated at 1.9. The BPE helped to resolve issues with wasteful water and space heating

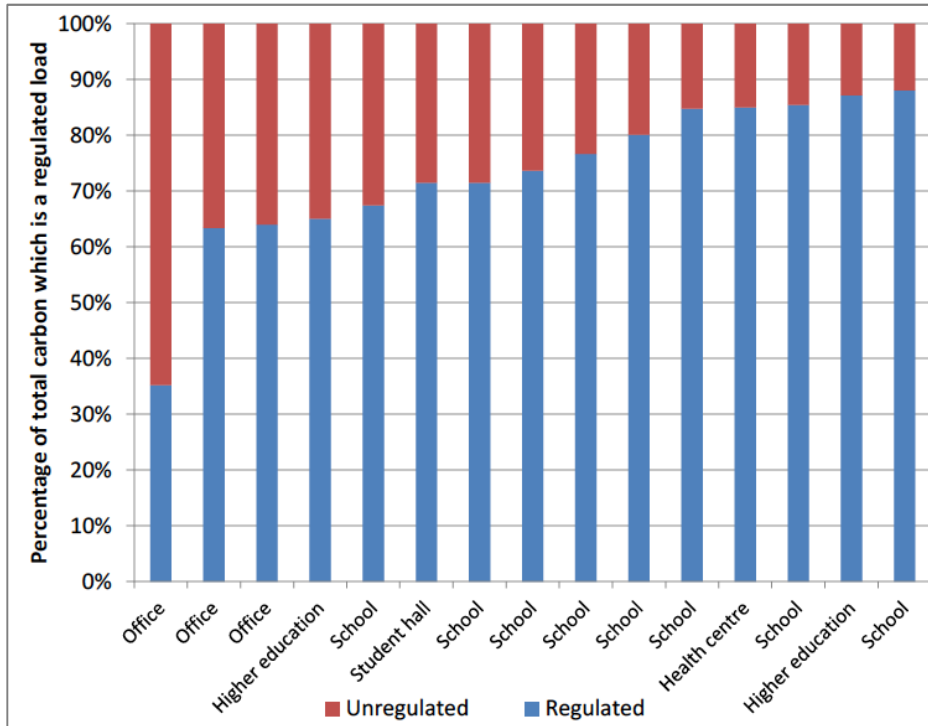
Unregulated energy use can be as much as 65% of total actual energy use (Source: Cohen, 2013)

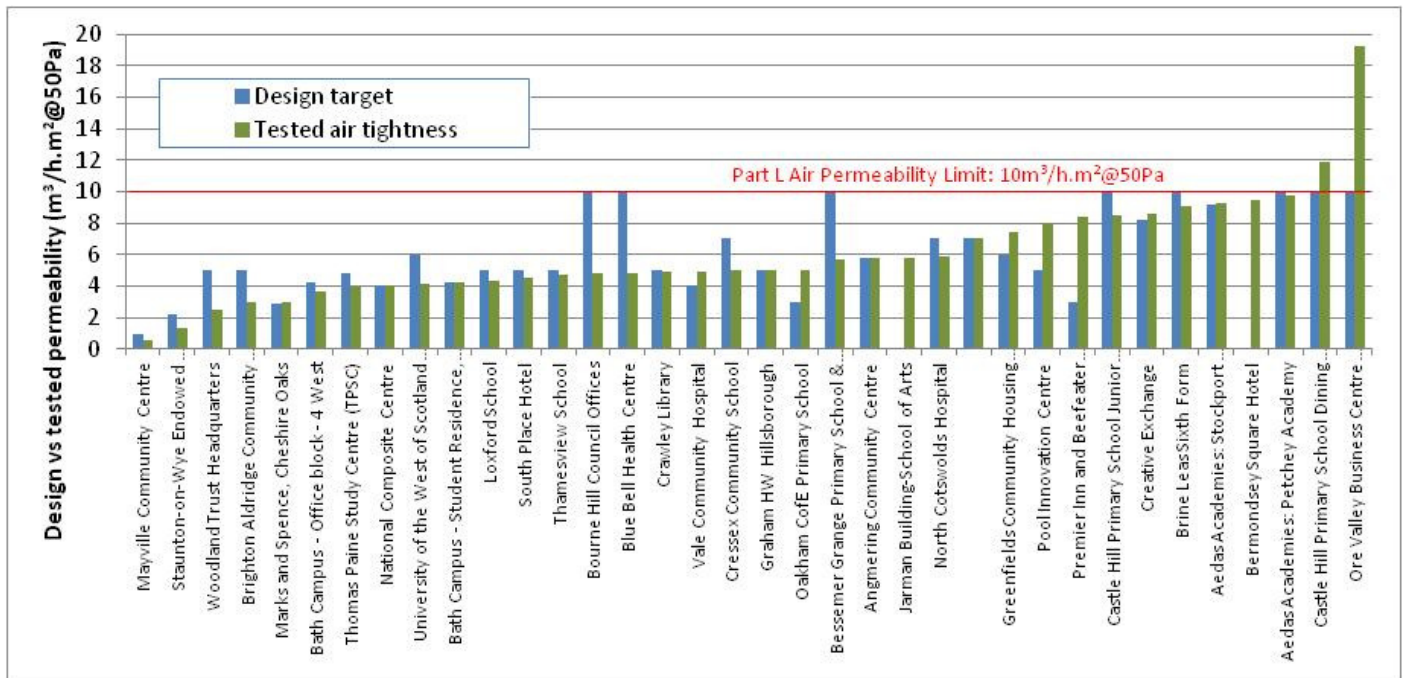
Broadly, the buildings with the best air tightness (to the left in this graph) are those with the toughest design targets. However, many of those with unexceptional targets (in the middle) achieved test results much better than their targets. The Ore Valley Business Centre, with poor air tightness measured at $19.27 \text{ m}^3/\text{h.m}^2@50\text{Pa}$ - equivalent to an air change rate of 6 air changes per hour – had much better air tightness for individual rooms, but the whole building was affected by settlement and there are serious leaks, especially in the basement.

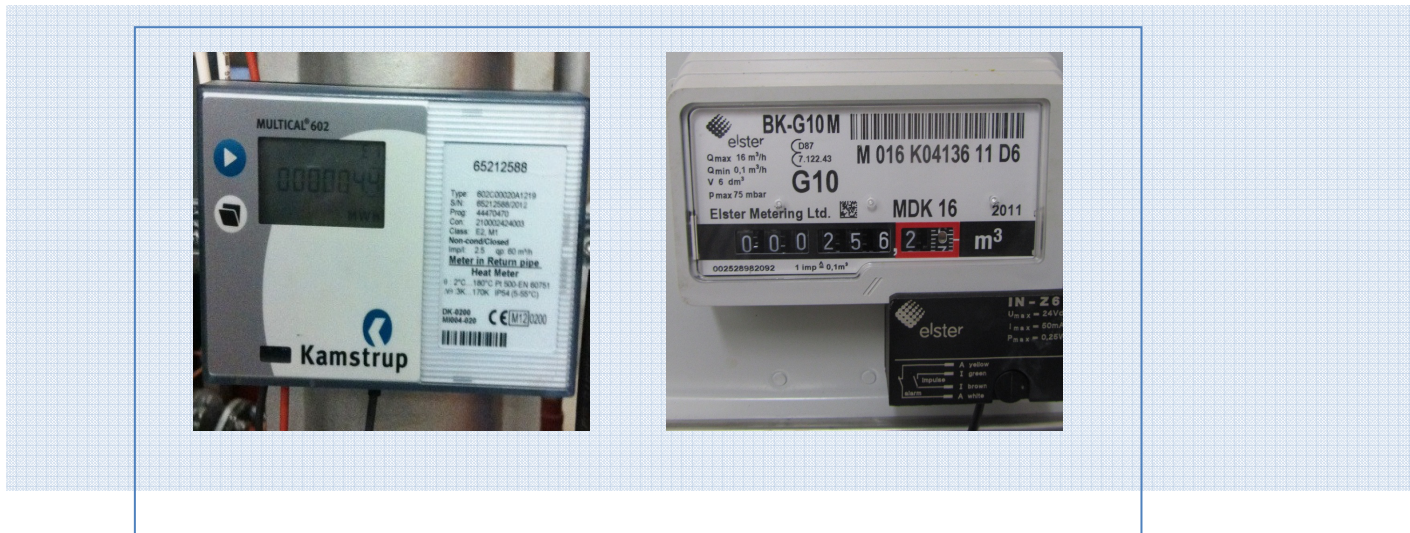
Heat and electricity meters can take many different forms, and they are often hard for non-specialists to interpret
