Bermondsey Square

This document contains a Building Performance Evaluation report from the £8 million Building Performance Evaluation research programme funded by the Department of Business Innovation and Skills between 2010 and 2015. The report was originally published by InnovateUK and made available for public use via the building data exchange website hosted by InnovateUK until 2019. This website is now hosting the BPE reports as a research archive. As such, no support or further information on the reports are available from the host. However, further information may be available from the original project evaluator using the link below.

Innovate UK project number	450063
Project lead and author	Urbanism Environment Design (for igloo Regeneration Ltd)
Report date	2014
InnovateUK Evaluator	Robert Cohen (Contact via www.bpe-specialists.org.uk)

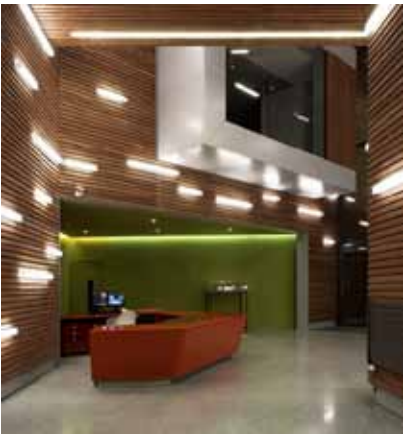
Above: Office spaces before and after occupation.
 Left: Reception area, including building manager's office, shared between office spaces and residential block.
 Below: Detail showing typical external wall construction at office block floor junction, with potential thermal bridge of steel structure.

Though the fabric of the building was not a key focus of the study, a thermal imaging survey was undertaken to assess the performance of the buildings - to identify whether there are any particular problems with air-tightness or thermal bridging. While some potential issues were identified, particularly around areas of glazing or the steel structure of the building, these were not beyond what would have been expected given the designed performance and the post-completion air-tightness test results - which achieved a result of 9.52 m³/m².hr @ 50pa. (See Q6 report for further details).

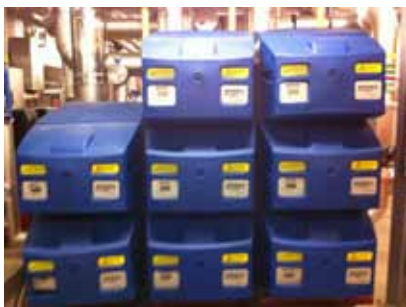
Boiler Specification
 Manufacturer: Hamworthy Heating Ltd.
www.hamworthy-heating.com
 Model: Wessex Modumax
 Description: High efficiency fully modulating condensing pre-mix boilers
 Seasonal Efficiency (BRegs): 93%
 Total Duty: 2MW
 Arrangement: 2 sets 250/750c, 1 set 250/550c (8 units total).

Above: Bank of condensing boilers to district heating system in rooftop plant room.

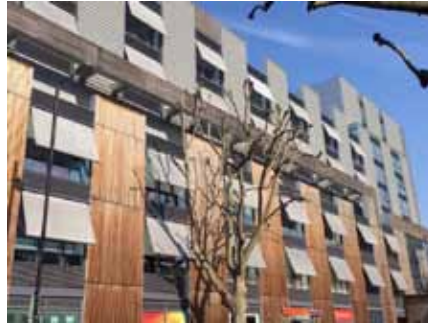
Above: External motorised blinds formed part of the integrated environmental design strategy.

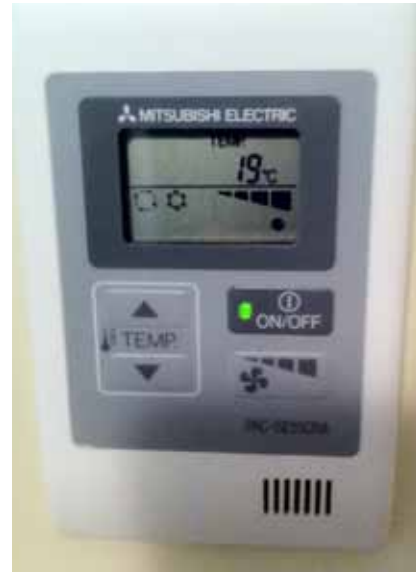
Right: In room control panel for individual hotel room AHUs.

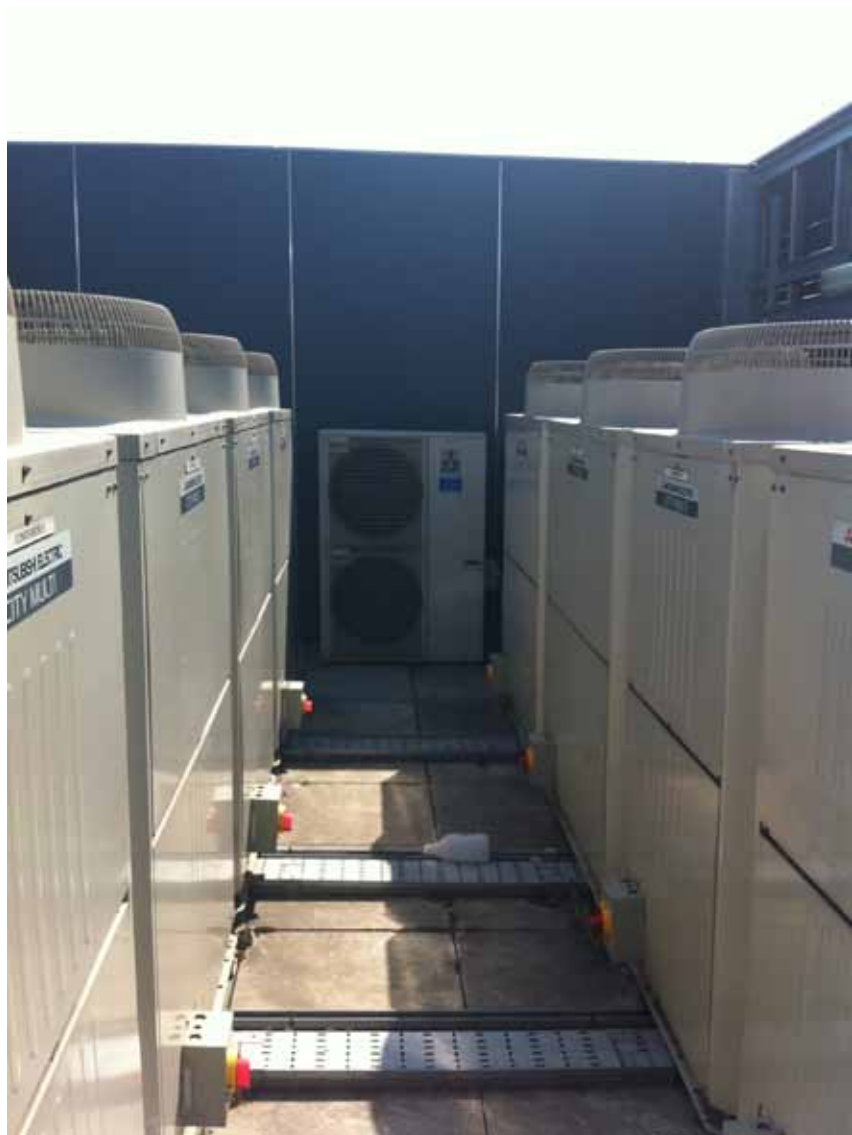
Below: Photograph of roof-mounted central air conditioning plant to hotel.

The system in the hotel contains two levels of air-conditioning. There is a roof-top mounted centralised air-conditioning system, which runs through ducts to each of the individual bedrooms and common areas within the hotel. This is controlled via the BMS unit in the main roof-level plant room of the hotel. This is complemented by individual air-conditioning units within each hotel bedroom, mounted to the facade and controlled using a small digital panel by the doorway in each room, giving hotel guests a good degree of control over their environment. This unit is designed to only be 'on' when a key-card is inserted in the slot, which also controls the circuits for the lights and appliances. Most of the hotel bedrooms, other than those with private balconies, do not have opening windows, so this is the users' only means of controlling their environment. In addition to this there are large commercial extraction units in the kitchen/restaurant area, and additional independent air-conditioning units to the hotels central internet TV and server rooms.

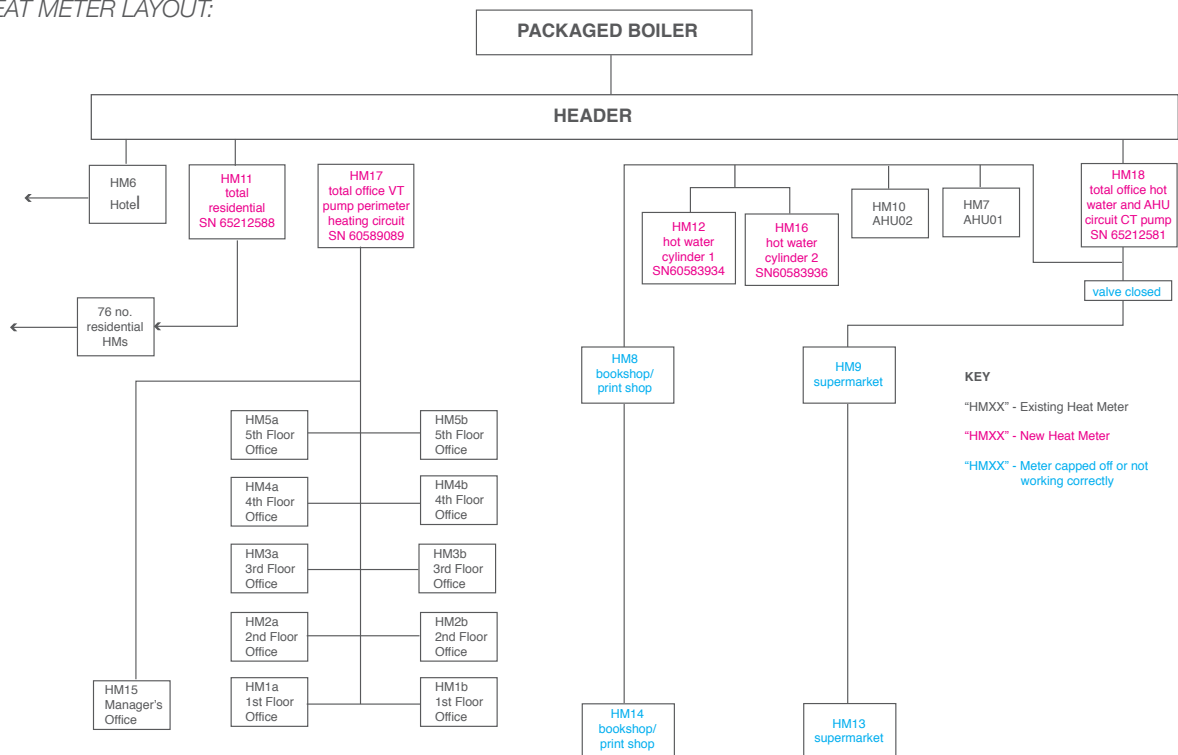
HEAT METER LAYOUT:

Heat meters: As the district heating is a key focus of this study, it was important that metering was in place that allowed us to understand which individual units were using heat energy, but also where the biggest losses were occurring in the system. Whilst the first element of this was nominally in place at the outset of the study - with each office floor, apartment, shop unit and the hotel being separately metered - we found that some of these meters were malfunctioning and some had been capped off. We also found that due to the sub-division of the office floors into smaller units, and some spaces remaining unoccupied, finding the exact locations of heat energy use was tricky. However, the bigger issue was the lack of 'totalising' meters on several legs of the system - in particular the office perimeter heating circuit and the residential circuit. This was addressed as part of this study.

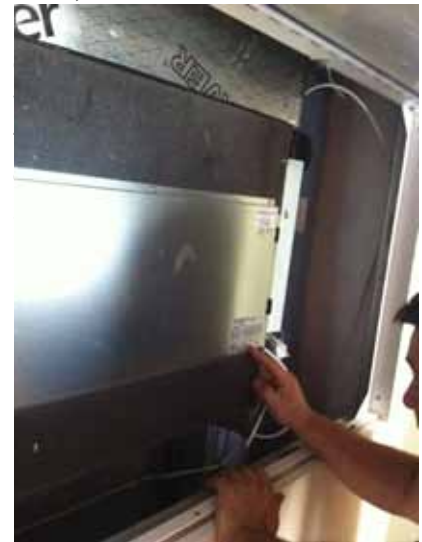
Above: In room individual air-handling units, vented to building facade and directly controllable by hotel guests.

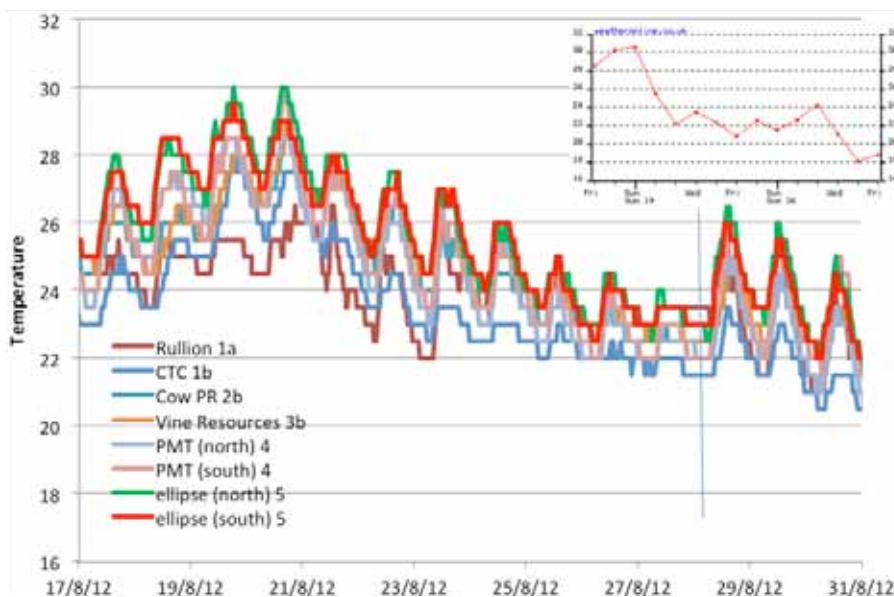
Both the BUS analysis and the thermal comfort diaries highlighted that overheating in the office spaces was a significant issue, with the majority of users reporting that summer conditions within the building were very uncomfortable. This is supported by evidence from dataloggers which showed that during July and August 2012, the average temperature across all the office spaces was around 24°C, with a minimum temperature of 20°C (even when offices were unoccupied), and a maximum temperature of 30°C, which was reached on the 4th and 5th Floors - well above the average external temperatures here.

Below: Graph showing internal temperatures in the office spaces in August 2012. The green and red lines are the 5th floor office space (ellipse). The pink and blue lines are the 4th floor offices (PMT).

The malfunctioning AHU was repaired in August 2012, resulting in a slight drop in average internal temperatures.

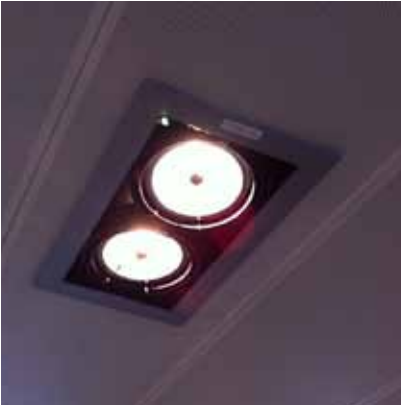
- Halogen lights installed by tenant in 5th floor office, since replaced with LEDs.

- Tenant fit-out and sub-division of offices: Every floor of the office space has undergone some form of sub-division. It is not clear whether this was allowed for in design assumptions, and this may have an affect on the functioning of the ventilation system.
- Tenant fit-out, light-fittings: One of the tenants had installed a number of large halogen lights as part of their own office fit out. These lights generate a significant amount of heat, and may have made some contribution to over-heating - especially as lights tend to be on all day in this office, as blinds are drawn to prevent glare. These have since been replaced with LED fittings.

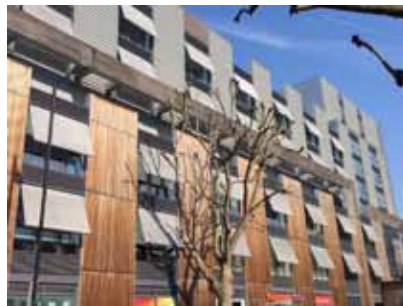
*Above left: Solar blinds in operation on Tower Bridge Road
 Left: User's adapted solar shading in first floor office.
 Below: Blinds down lights on condition in 4th floor offices, summer 2012.*

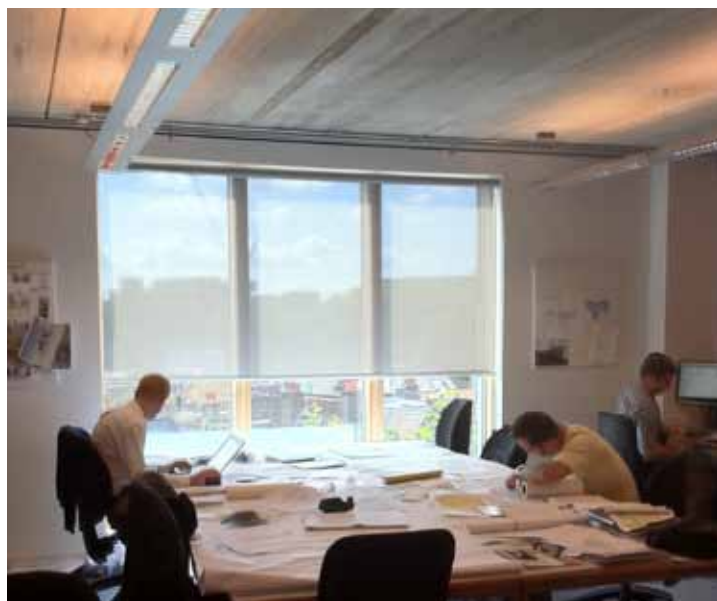
In the initial walk-throughs of the building undertaken by the study team, it was noted that a 'lights on blinds down' condition was present in many of the office spaces. Problems with glare from the sun and sky were also identified in the BUS survey. Whilst this is unfortunately a common issue in office buildings, it is disappointing to see it in a recently completed purpose-designed office building with decent environmental aspirations. The external blinds designed as part of the buildings systems to combat glare in the office spaces were not working in 2012. The blinds cannot be used on days when it is both sunny and windy, and it is not clear how closely this was considered at design stage. Though designed to be automatically controlled, via a light sensor and an anemometer, the controls had been manually overridden, leading to the blinds becoming damaged in high winds.

Two suggestions have been made as to why this might have happened. The first is that the trees planted alongside the building on Tower Bridge Road had grown enough to begin to interfere with the operation of the blinds, so the building management at the time switched off the automatic controls to prevent the blinds from descending. The alternative suggestion was that during sunny but windy conditions, following complaints from people in the

offices about glare and over-heating, the automatic controls were overridden and the blinds were extended, leading to them becoming permanently damaged. The people responsible have all since moved on, so it is not possible to find out for sure which scenario is correct, though both seem plausible, and both perhaps bring into question the robustness of the original designs. The local authority are responsible for pruning the trees along Tower Bridge Road, and they have been pruned back significantly - though they are still quite close to the fully extended blinds.

The external blinds on the building have now been repaired, and are being operated by the automatically controlled systems as originally designed.

Again, the length of time during which this study is undertaken has allowed us to see what response the building management have made to these issues over a 12-18 month period. The external blinds on the building have now been repaired and are back in working order.

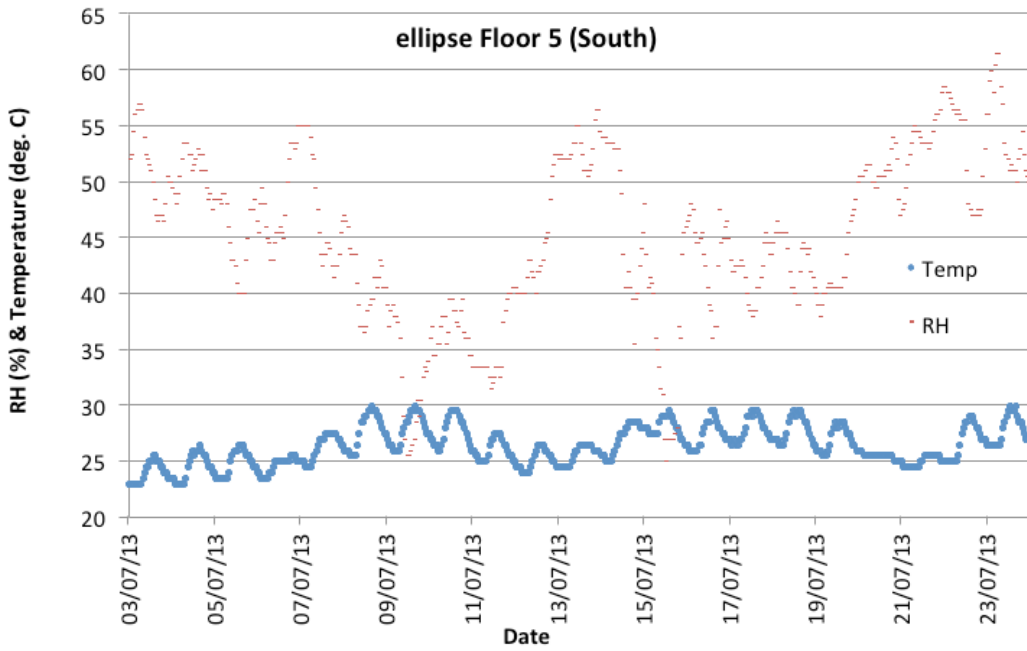
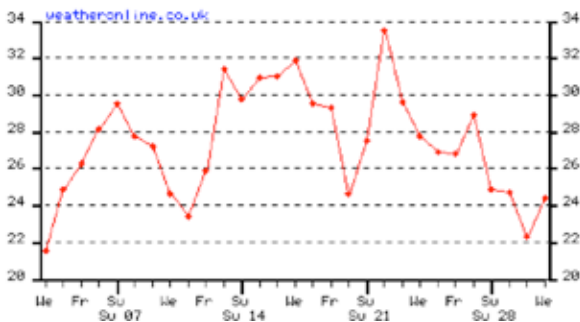
Above and left: Graphs showing the internal temperatures in the 5th floor office space and external temperatures during the same period.

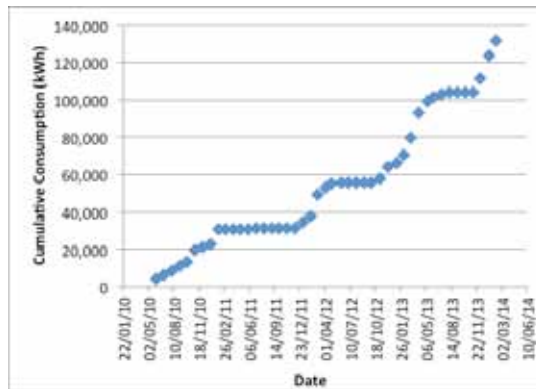
Left: Graph showing cumulative energy consumption for AHU1

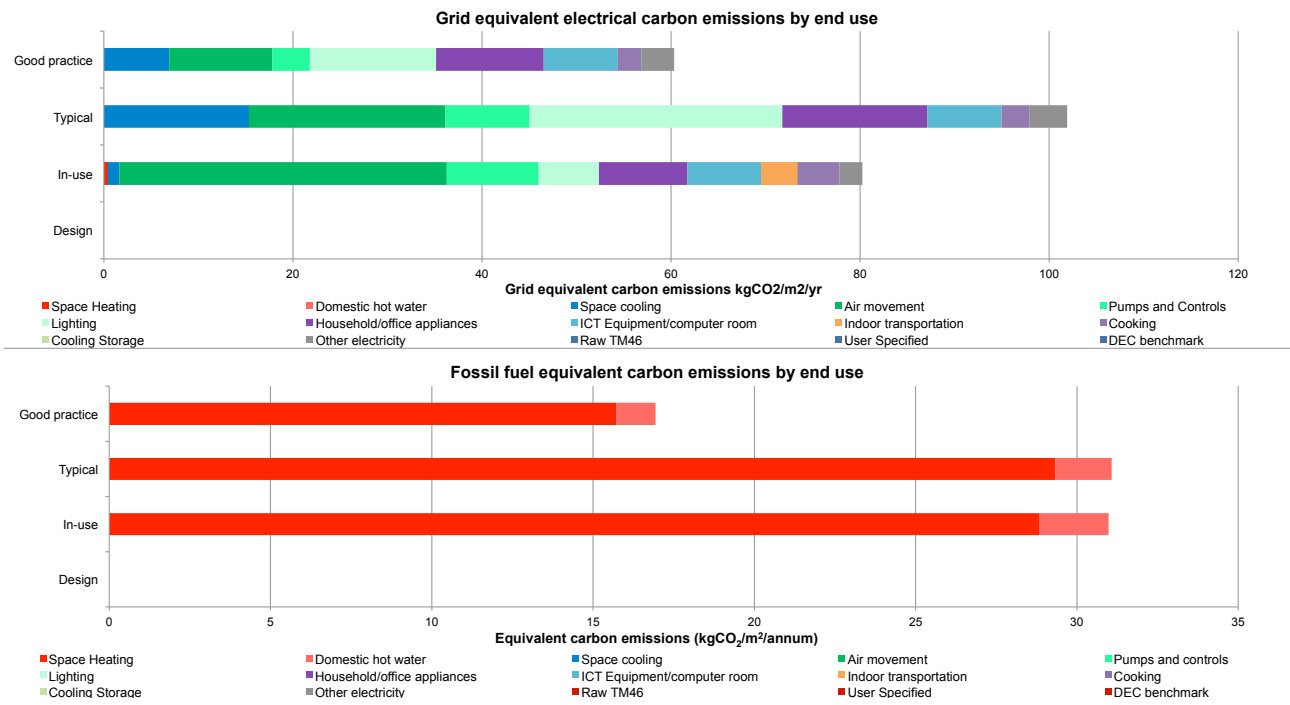
Above: Graphs showing ECON19 carbon benchmarking from TM22 tool for the office spaces only, using 'Type 3' conventional air-conditioned offices as benchmark.

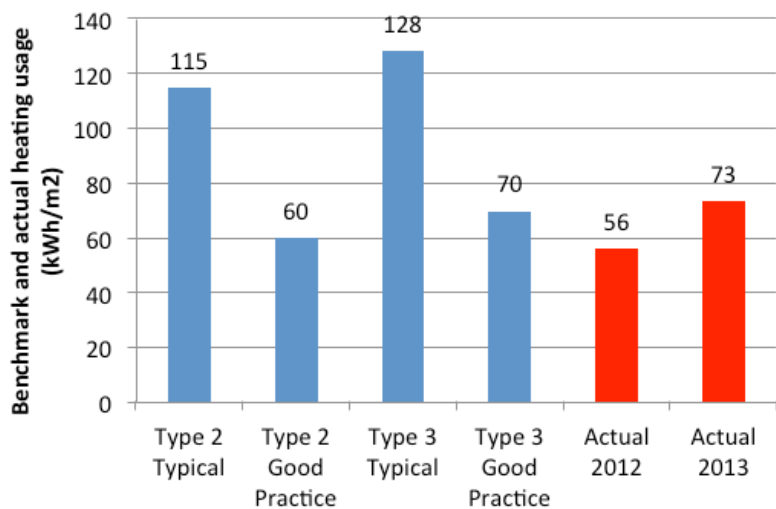
Offices benchmark and actual heating energy use:

The heating energy use in the office spaces sits at around the 'good practice' benchmark. Again, this may be surprising given the findings above relating to controls and the district heating system. However, given the other information available on overheating and the malfunctioning of the ventilation

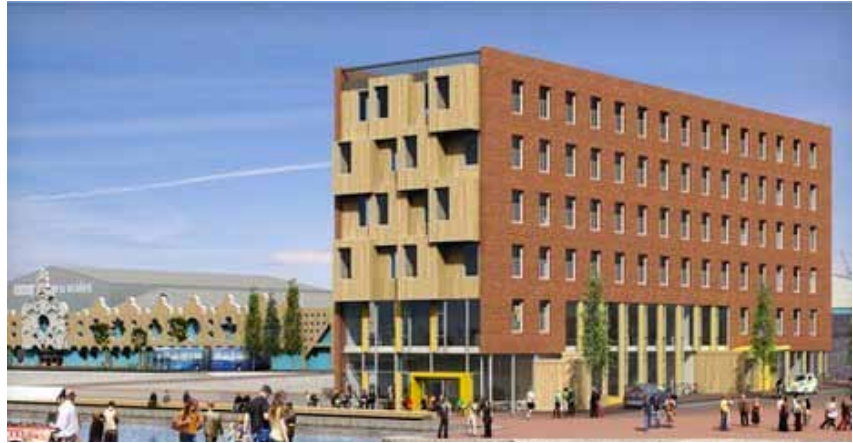
Above: The CCI building/ 'Gloworks' at Cardiff Bay, recently completed by igloo. Learning some of the lessons from Bermondsey Square has meant the adoption of simpler building services systems, well metered and monitored and easier to understand. This building is naturally ventilated by opening windows, with thermal mass to support cooling. Heating is provided by a separately metered gas boiler on each floor, and each floor is also separately metered for water and electricity, with further sub-metering possible.
