Bessemer Grange School Children's Centre

Innovate UK project number	450001
Project lead and author	Architype
Report date	2014
InnovateUK Evaluator	Roderic Bunn (Contact via www.bpe-specialists.org.uk)

Purpose of evaluation

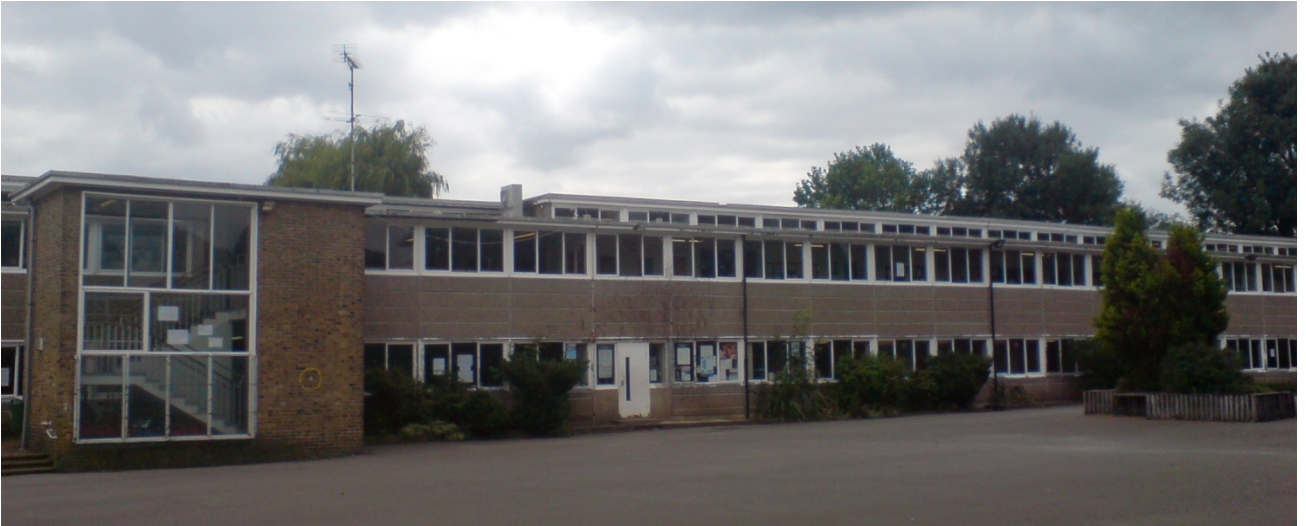
Fig 2.2.2 - Photograph of the Old Building prior to the erection of the New Building. The image shows the large expanse of tarmac which formed the main playground as well as the 'dreary' concrete panel façades.

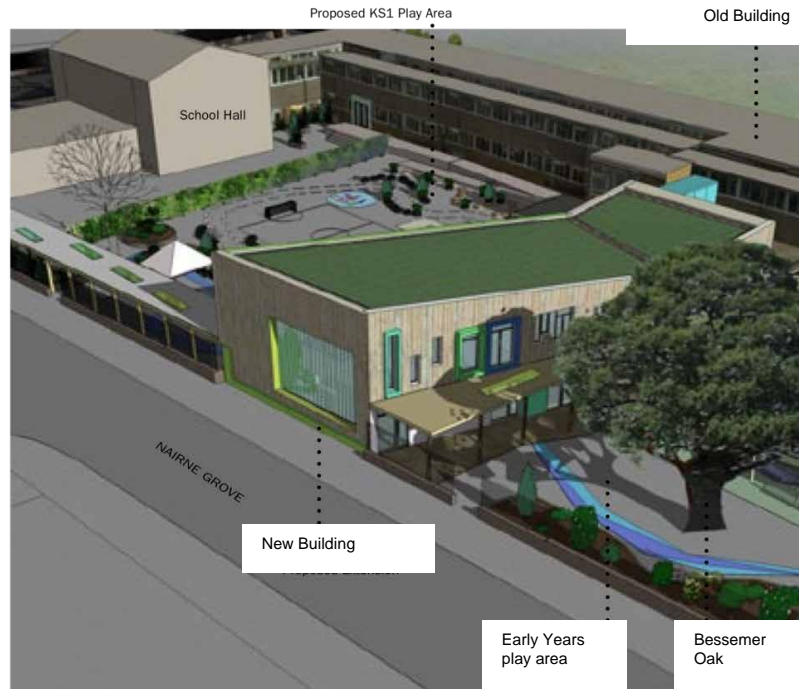
Fig 2.7.1 - A 3D visualisation of the New Building showing how its siting helps divide the expanse of tarmac in the playground outside the Old Building in order to create a more diverse outdoor play environment.

There was also a strong desire to create a vibrant new profile to a somewhat tired school with a dwindling roll. The design had to be an advertisement of 'change' and was design to act as a beacon and hub for the local community. To achieve this, it was felt that the New Building should be clearly differentiated from the existing school; very contemporary in appearance with bold, fun, colours and clad in softer materials such as timber to act as a counterpoint to the 'dreary' concrete appearance of the existing school. See Fig.2.2.2 and 2.7.4. This thinking also led to the idea that the New Building should face directly onto the road, with the back of the building connecting to the existing school to ensure internal connectivity. See Fig.2.7.2. Another key aim of placing the building in this location was to separate the huge expanse of tarmac that was formerly the KS2 play area into two more intimate play areas; one for the Foundation Centre and the other for KS1. See Fig.2.7.1

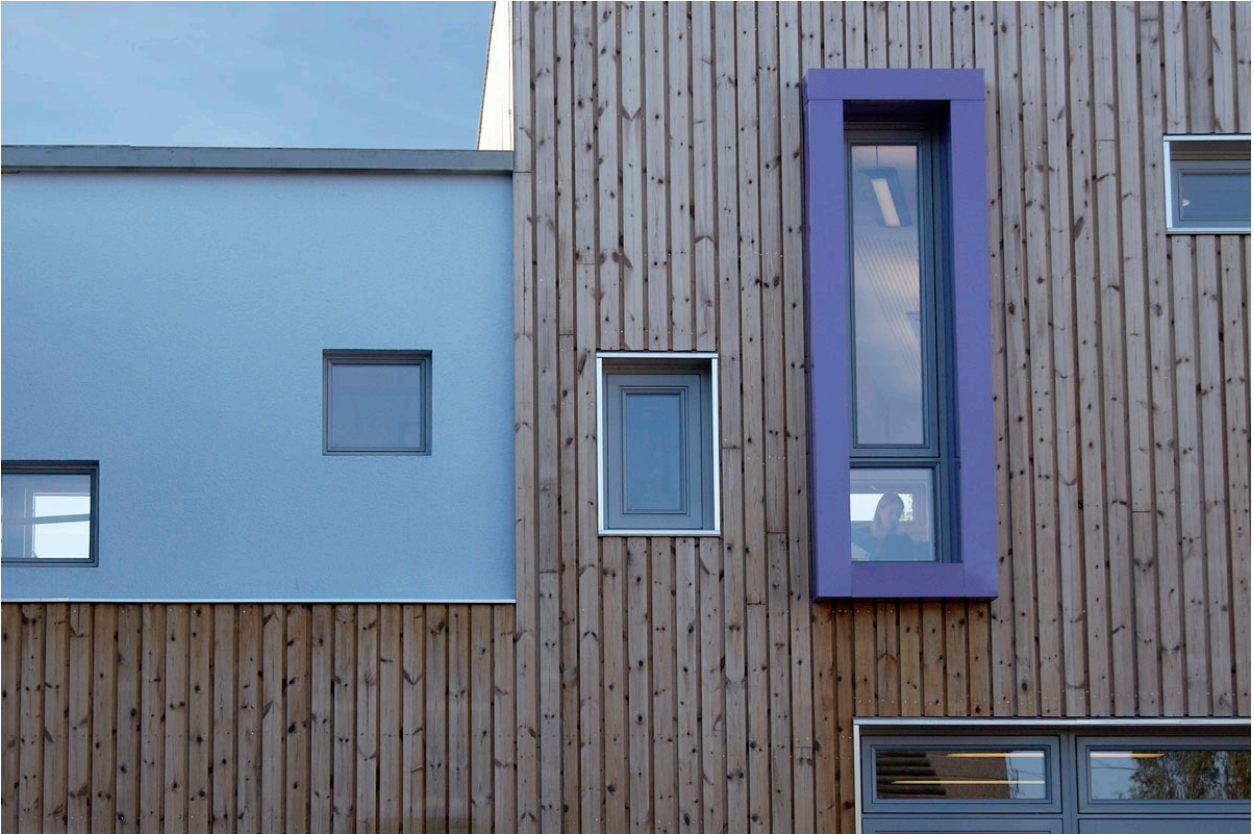
Fig 2.7.3 – A photo showing the expressed timber materiality of the project.

Sustainability was a key concept, both in terms of operational energy use, materials specified and the creation of a healthy environment. Architype designed an aesthetic that showed its use of natural materials through the use of expressed timber. See Fig.2.7.3. Further details of materials are given in section 2.8.

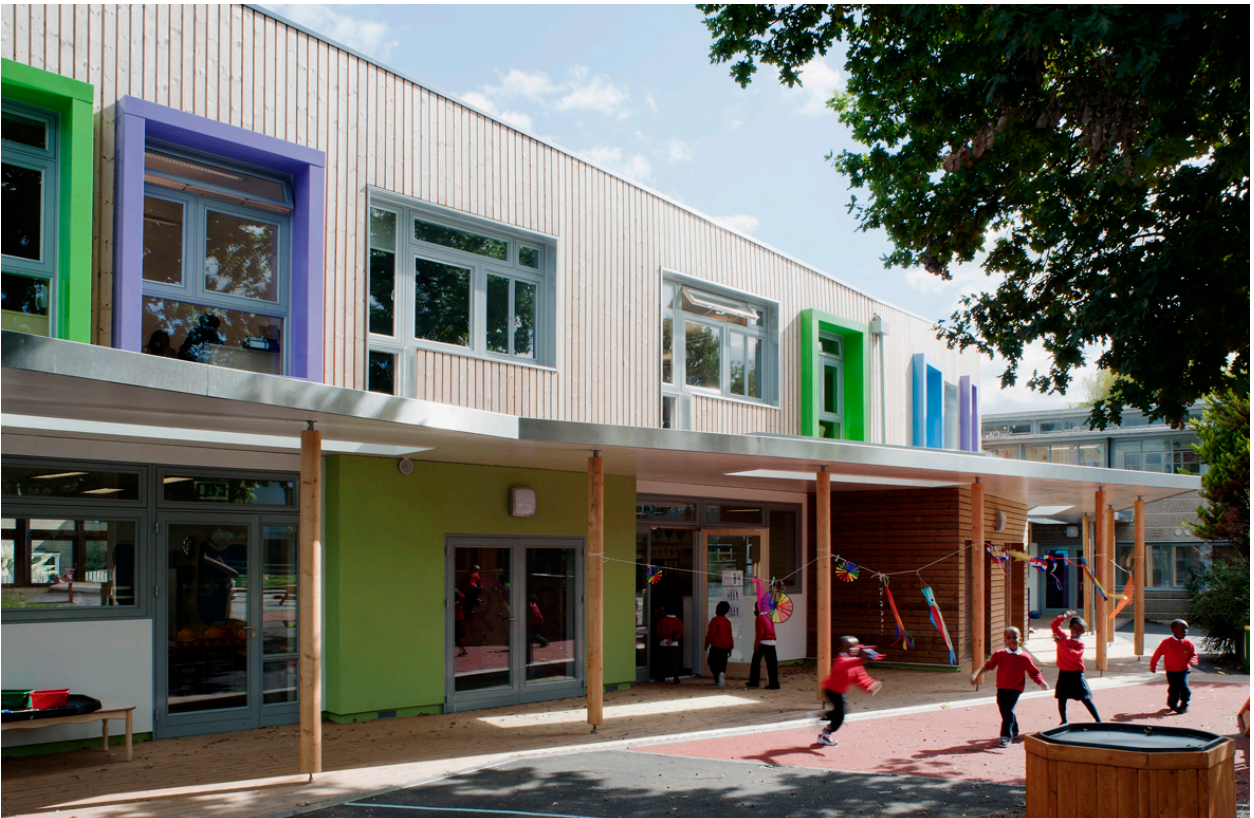
Fig 2.7.4 – A photo showing the external South-West facing canopy which creates an outdoor classroom. The bright colours and use of timber create a bold and welcoming aesthetic.

Where the accommodation faced into the Early Years play area, the West facade was opened up at ground level, but covered by an extensive and deep canopy containing roof lights. This area was made into a real feature so that it became an inviting entrance to the Foundation Centre as well as an exciting 'outdoor classroom', allowing external play to take place at all times of the year. See Photo in Fig.2.7.4. At first floor level, windows were set into deep reveals in the external fabric, or set back into projecting boxes to control solar gain.

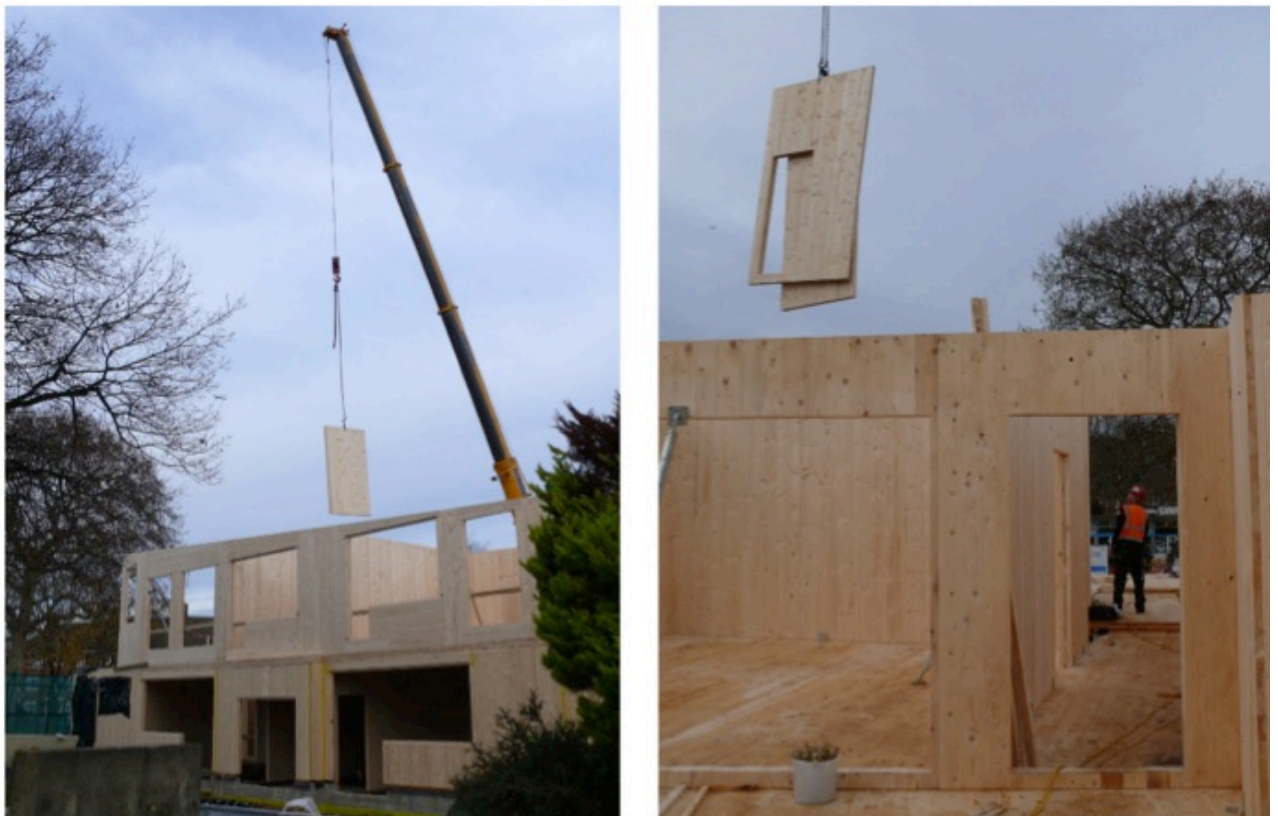
Fig 2.10.1 – Photographs showing the erection of the cross laminated timber frame in panel form. Due to off site manufacture the entire frame was erected in 10 days.

The New Building at Bessemer was almost entirely constructed from timber and natural materials. The primary structure was formed using a cross-laminated timber frame manufactured in Austria by KLH Ltd. See Fig. 2.10.1. This included timber walls, floor, roof, partitions and glulam beams to support large spans. Cross laminated timber, also known as Glulam, is a type of structural timber product comprising a number of layers of dimensioned timber, bonded together with durable, moisture-resistant structural adhesives (*Wikipedia, 2013*). This method of construction was selected because it promised to improve quality control, increase speed of erection and reduced embodied energy.

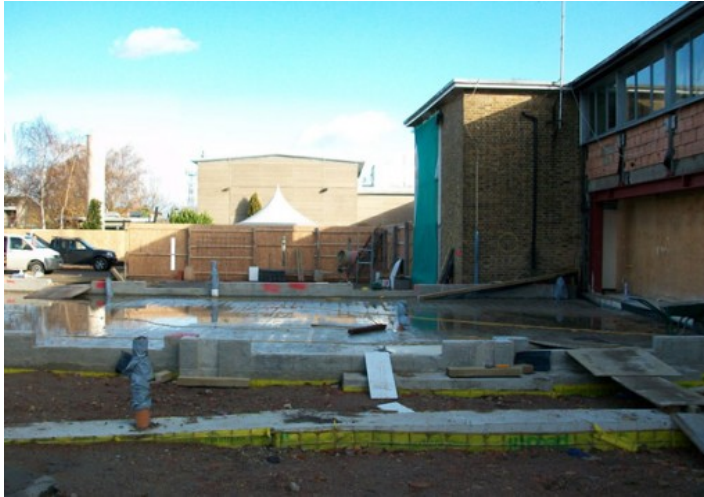
Fig.2.12.1- September 2009: The building was formed on a piled suspended slab. The original plan to use an in situ concrete slab was abandoned when soil investigations identified poor ground conditions.

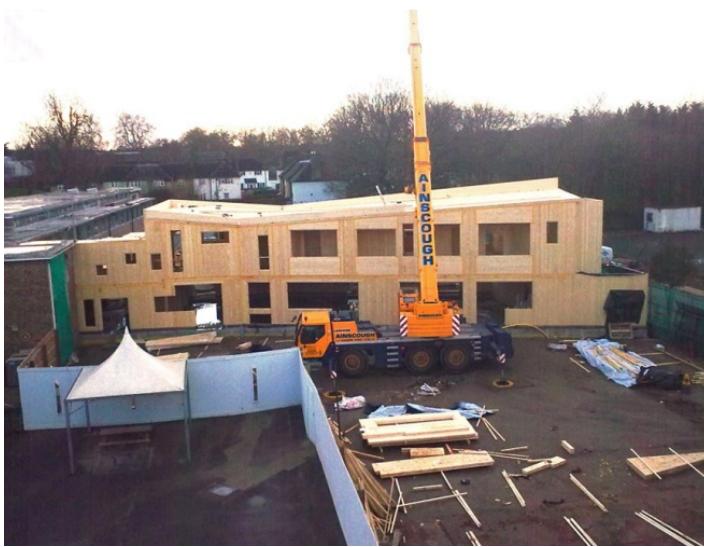
Fig.2.12.2 - December 2009: Photo showing erection of cross-laminated timber frame- This was erected in 10days. Works were delayed due to heavy snow over the Christmas period

Panel shown left in foreground. Note some 'visual grade' panels were later found to be damaged.

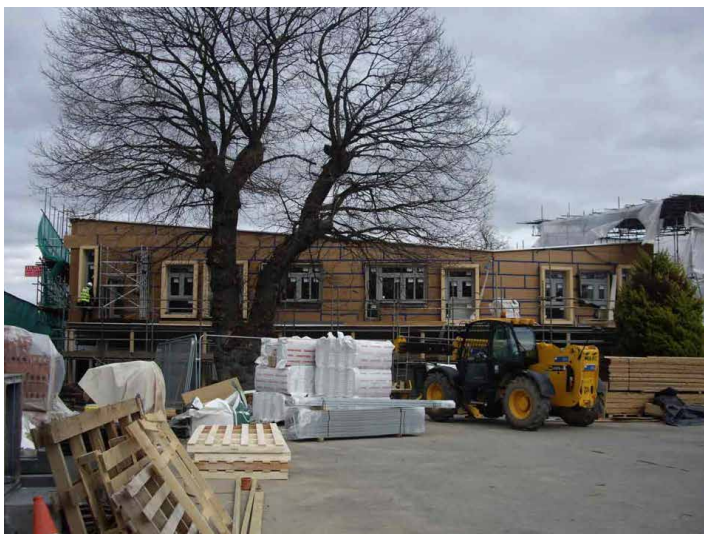
Fig.2.12.3 - January 2010: Photo showing external wood fibre insulation and Rational windows installed.

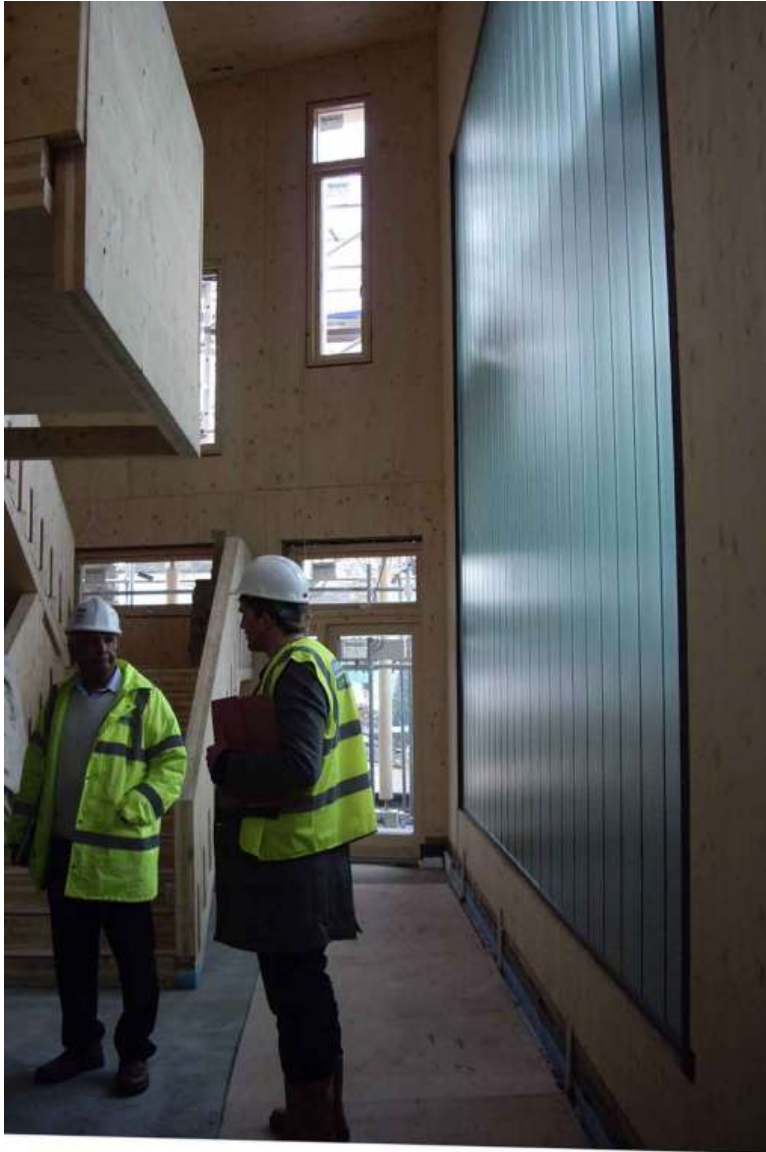
*Fig.2.12.4- March 2010:
Photo showing Reglit glazing and Rational window
installed.*

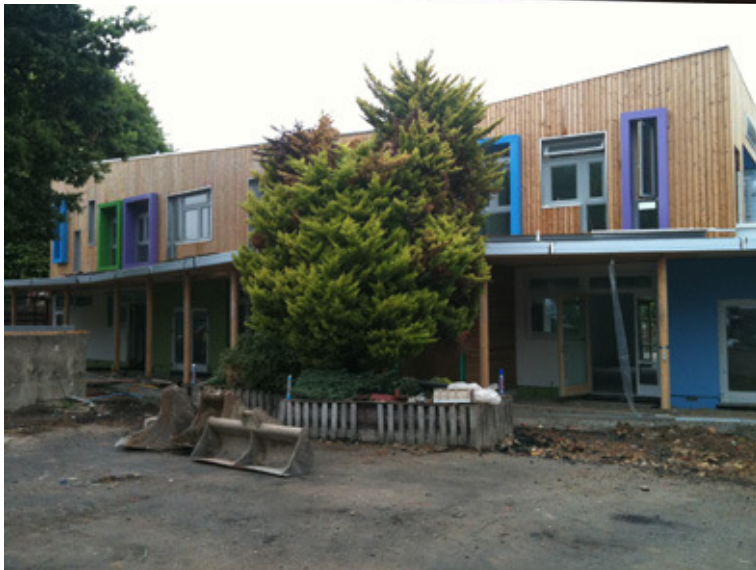
*Fig.2.12.5- July 2010:
Photo showing cladding completed. Landscape
works progressing.*

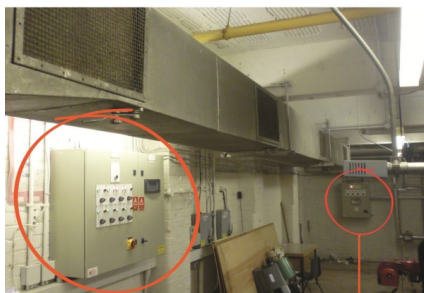
Main Control Panel

Control Panel for Childrens Centre

Fig.3.2.6 Control panels for Old Building and the New Building- in the main plant room

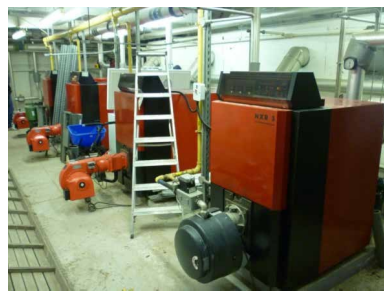
Fig.3.2.7 The four boilers in the Old Building plant room

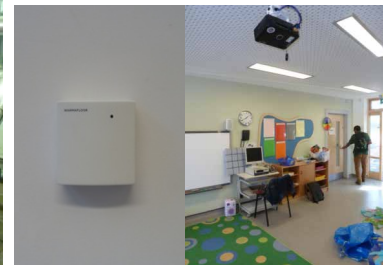
Fig.3.2.8 Reference classroom in the New Building used for setting temperature control in the heating control panel

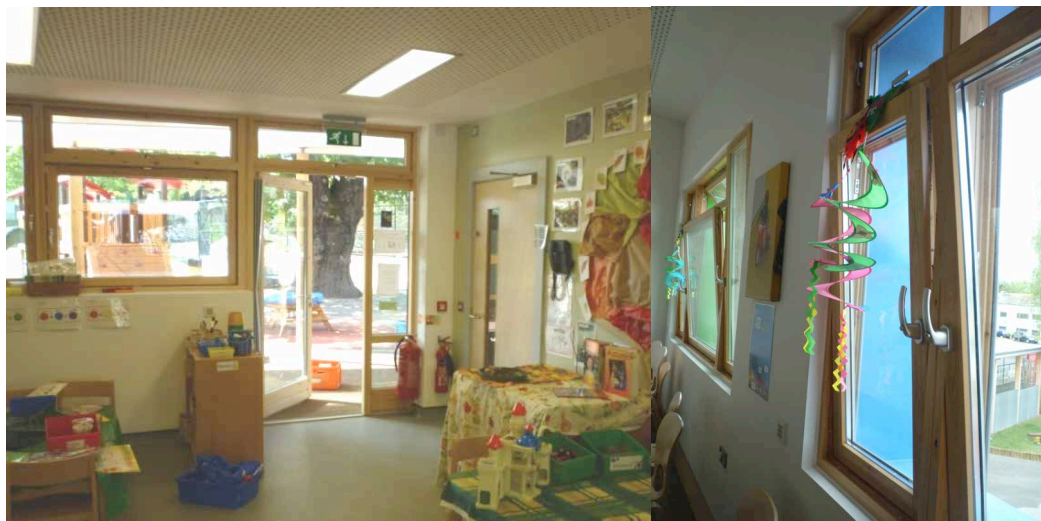
The main windows are manually operated with restrictors allowing 100mm opening; high-level windows have electronic actuators, see Fig. 3.3.1. Problems associated with these windows are discussed further in section 8.4 of this report.

*Fig 3.3.1– Doors and windows in the New Building ground floor classroom (left-hand image).
New Building First floor windows showing restricted opening (right-hand image)*

Difficulties operating actuators made opening high level windows difficult. At the time of the first residency visit, end users had not yet received training on how to operate the manual or automatic windows. No instruction labels were displayed on the windows or wall controls and their operation was counter-intuitive for some users. Better signage and labelling would have improved usability for the end-user along with general orientation training for users.

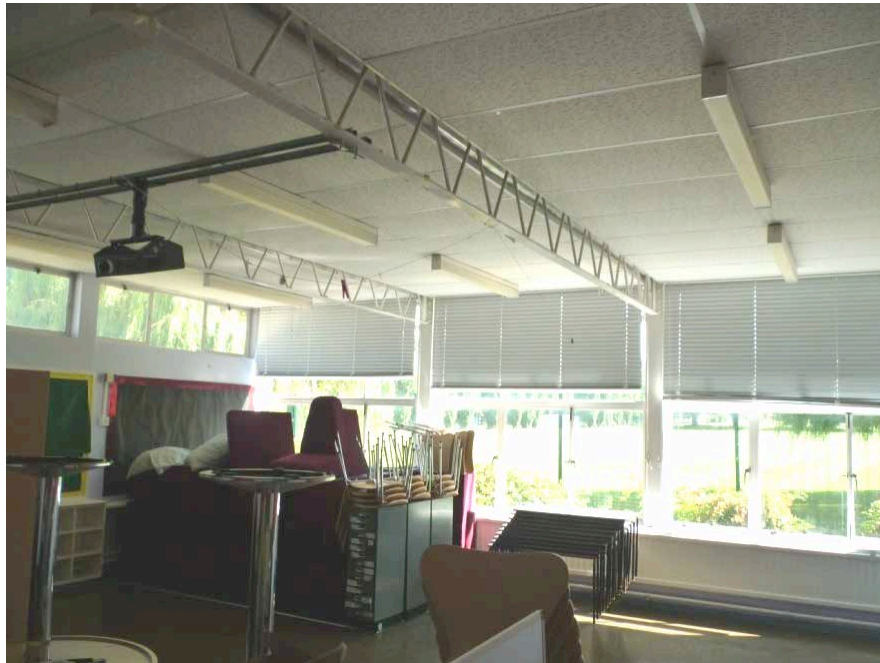
The 1950's building is single-glazed. The photograph in Fig. 3.3.3 shows the main windows on the right and high-level clerestory windows on the left.

Windows are fitted with bolts and traditional casement stays to ensure the safety of small children. The clerestory windows act as high level vents to exhaust hot air in the summer and are opened and closed by facilities staff.

Fig 3.3.3 - Classroom windows in the Old Building

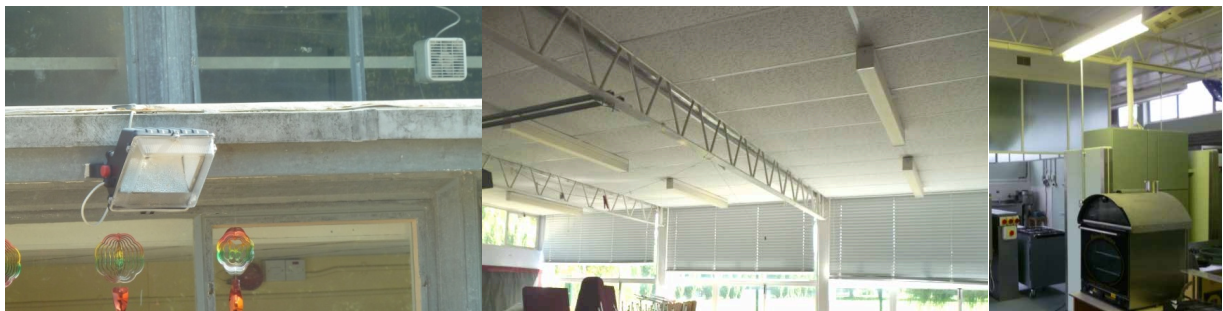
Exterior lighting is via halogen floodlights controlled by a timer. It is manually altered by facilities staff depending on the season and the onset of darkness. See Fig.3.5.2.

Fig 3.5.2 – Lighting in the Old Building - left: external Halogen Flood Light; middle: internal T5 lamps in classroom; right: T5 lamps in main kitchen

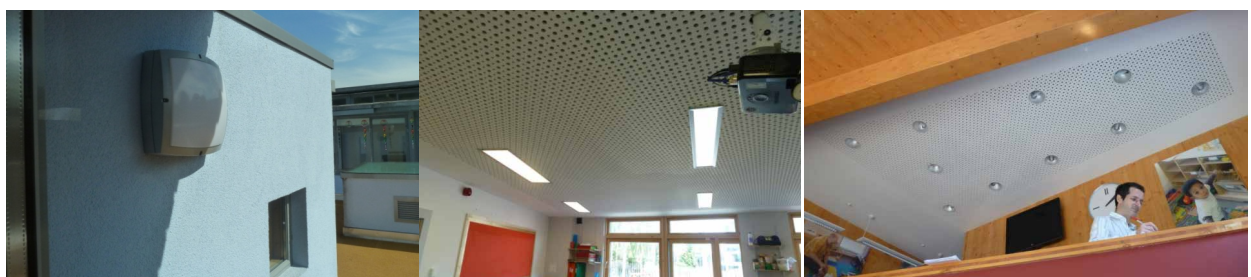
Fig 3.5.3 – Lighting in the New Building - left: low energy external lighting; Centre: ground floor classroom with acoustic ceiling and recessed T8 luminaires; right: high concentration of lighting fixtures in the first floor lobby/reception area

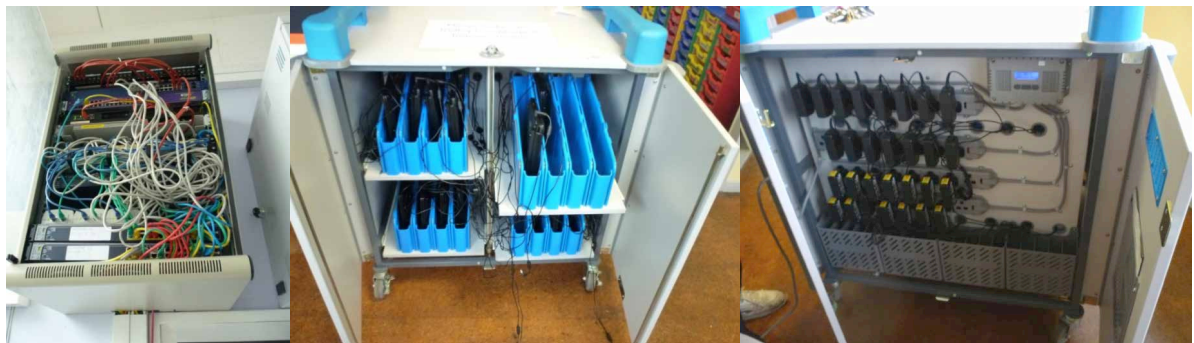
Fig 3.6.1 - Left: servers in ground floor circulation corridor, middle and right: Portable laptop charging stations

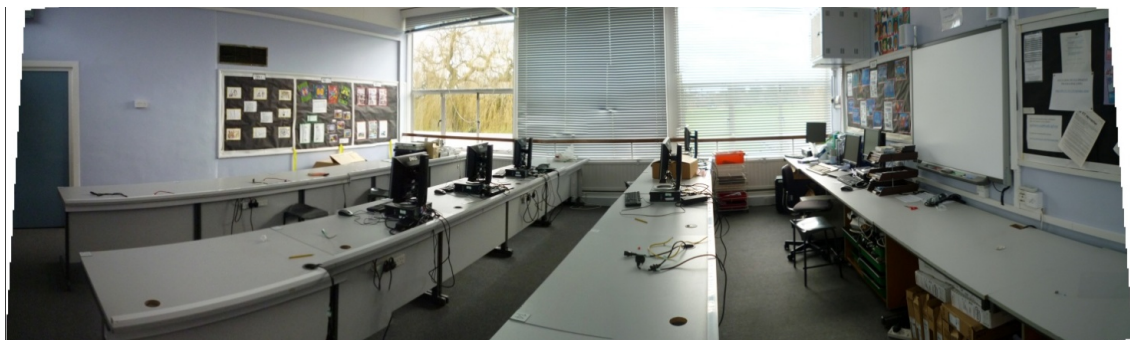
The main ICT room in the Old Building is also used for lessons and has 8-9 fixed computers and portable laptop docking stations to allow for flexibility, see Fig 3.6.2.

Fig 3.6.2 - Photo of main ICT room in the Old Building

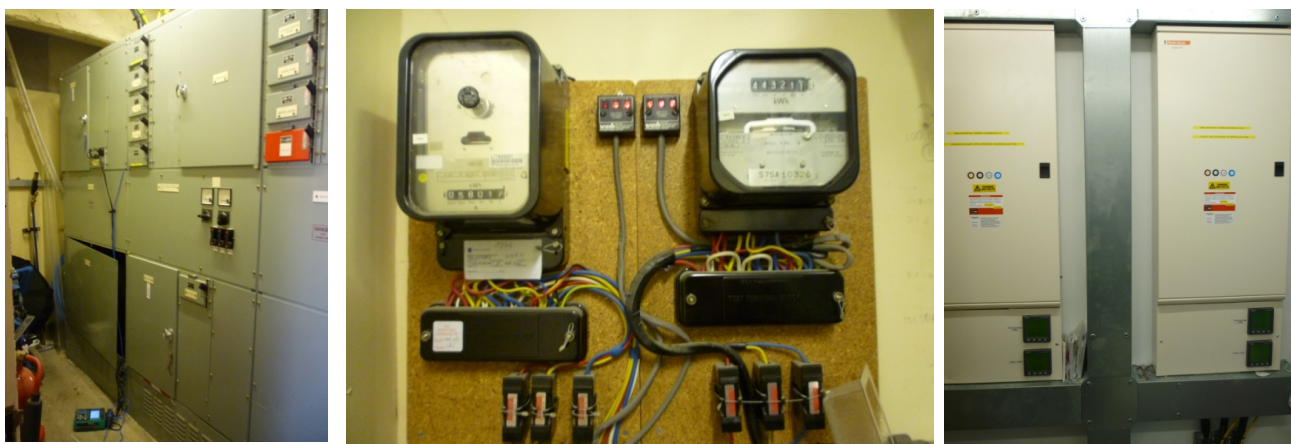
Fig 3.7.2 -
Left: Electrical room in the Old Building;
Middle: main utility meters in electrical room;
Right: distribution boards in New Building plant room

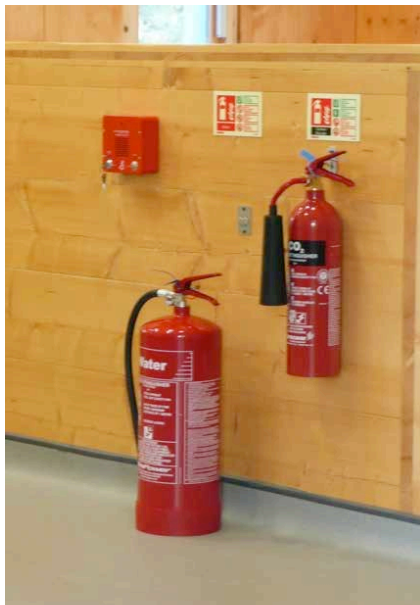
Keys left in the disabled refuge alarm

Fig 4.4.1 - Examples of issues identified during the Residency.

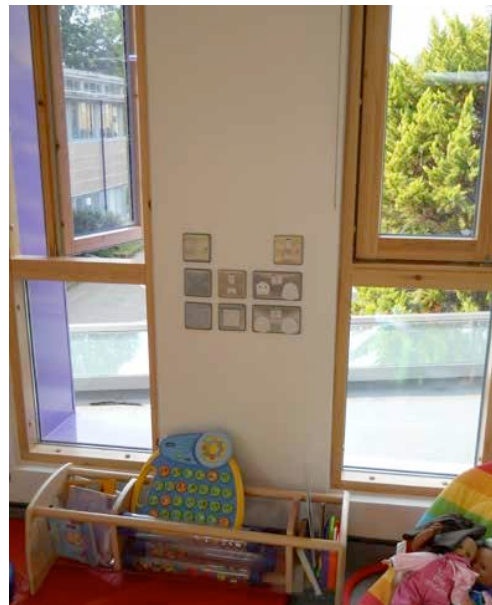
Excess of outlet sockets in the creche areas

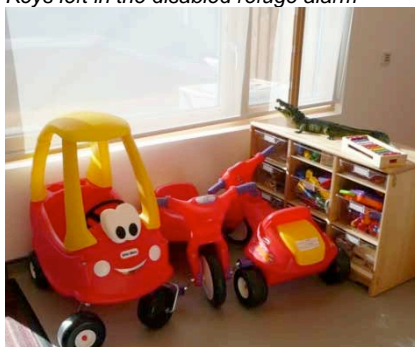
Low level windows

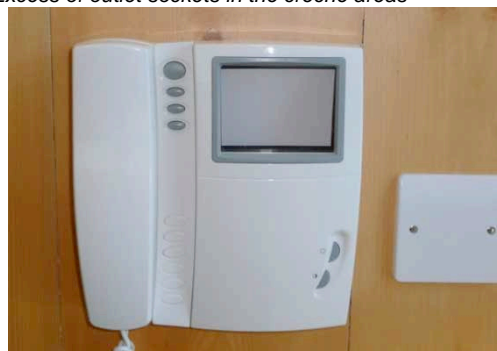
Answerphone with no labelling

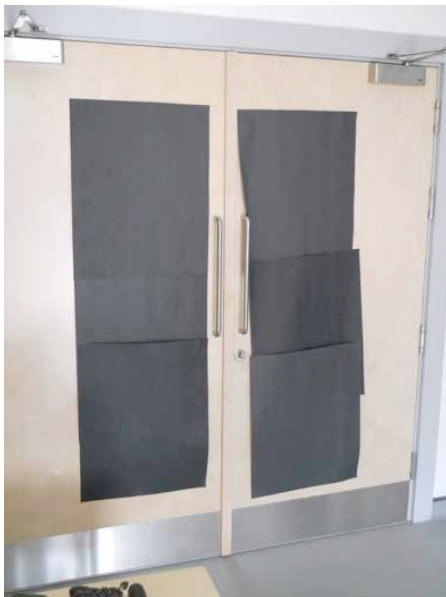
The crèche and the Training Room are adjacent and connected with a glazed double door. If the children can see their parents in the Training Room, the babies tend to cry and the parents cannot focus on their work. During the second week of occupation, the research team noticed that the double door had been blacked out with paper to avoid the distress. See Fig.4.4.4. However, an unfortunate effect of blocking this glazing was that any baby or toddler in the way of the doors would not be seen when the doors swung open into the crèche. A blind or reflective film may have resolved this problem but there was a disagreement between the school and local authority as to who was responsible for providing this item. A small post occupancy contingency fund would have been very useful for resolving minor items such as this.

Fig 4.4.4 - Photo showing window covered up between the Crèche and training room.

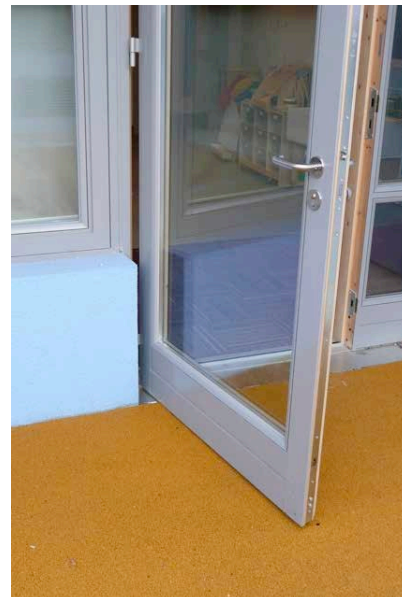
Fig 4.4.5 - Photo showing external doors prior to a friction stay being fitted.

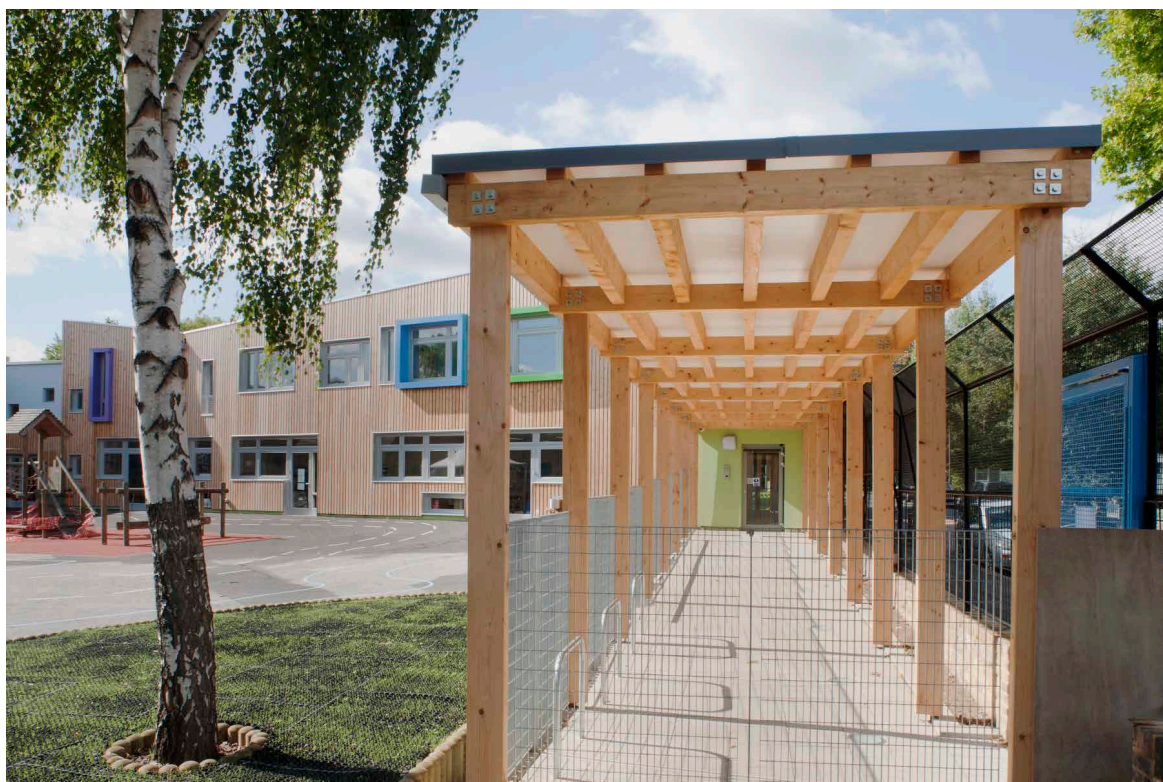
Fig.5.0.1 - The covered pergola to the Children's centre. This entrance provided an attractive and welcoming entrance to the building. Sheffield stands were fitted to allow visitors to secure buggies - however these were later considered insufficient and a separate store was retrofitted. See Fig.5.5.11.

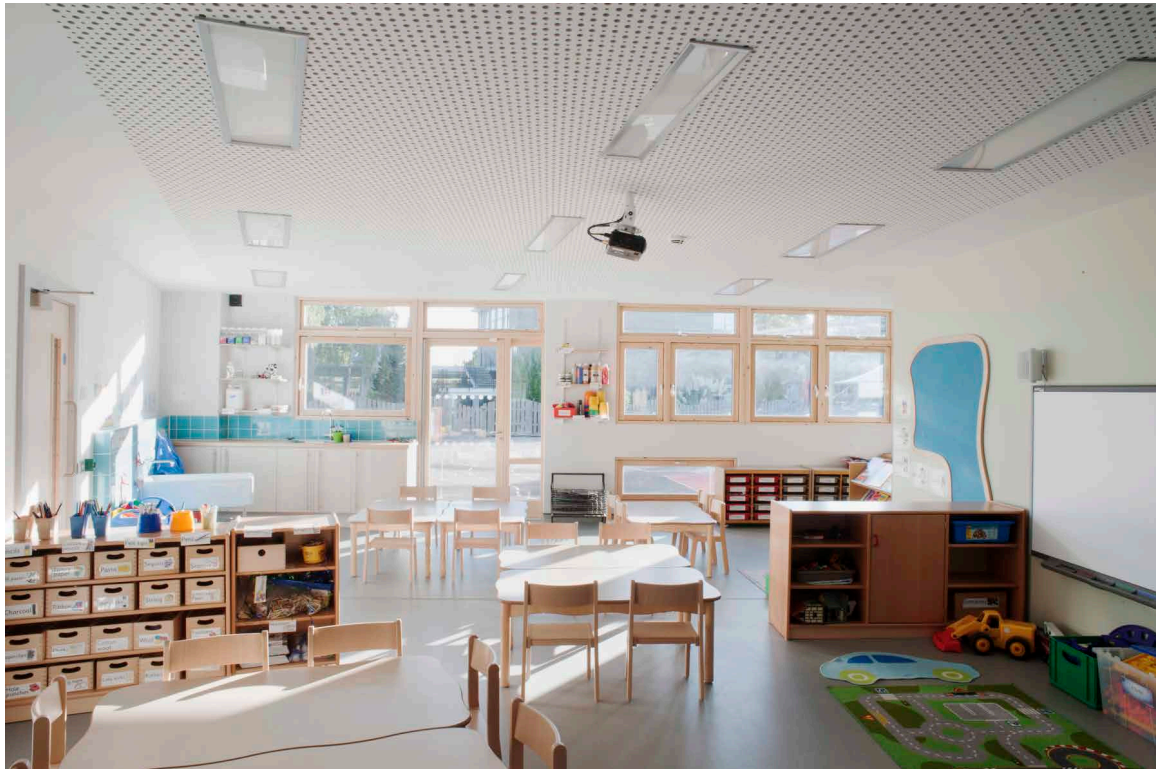
Fig.5.5.1- Photo of the ground floor reception classroom 2012. This was popular with staff for it's free flow layout and connectivity with the adjacent classroom. However most storage for these classrooms is located within freestanding units or beneath the sinks- which was criticised.

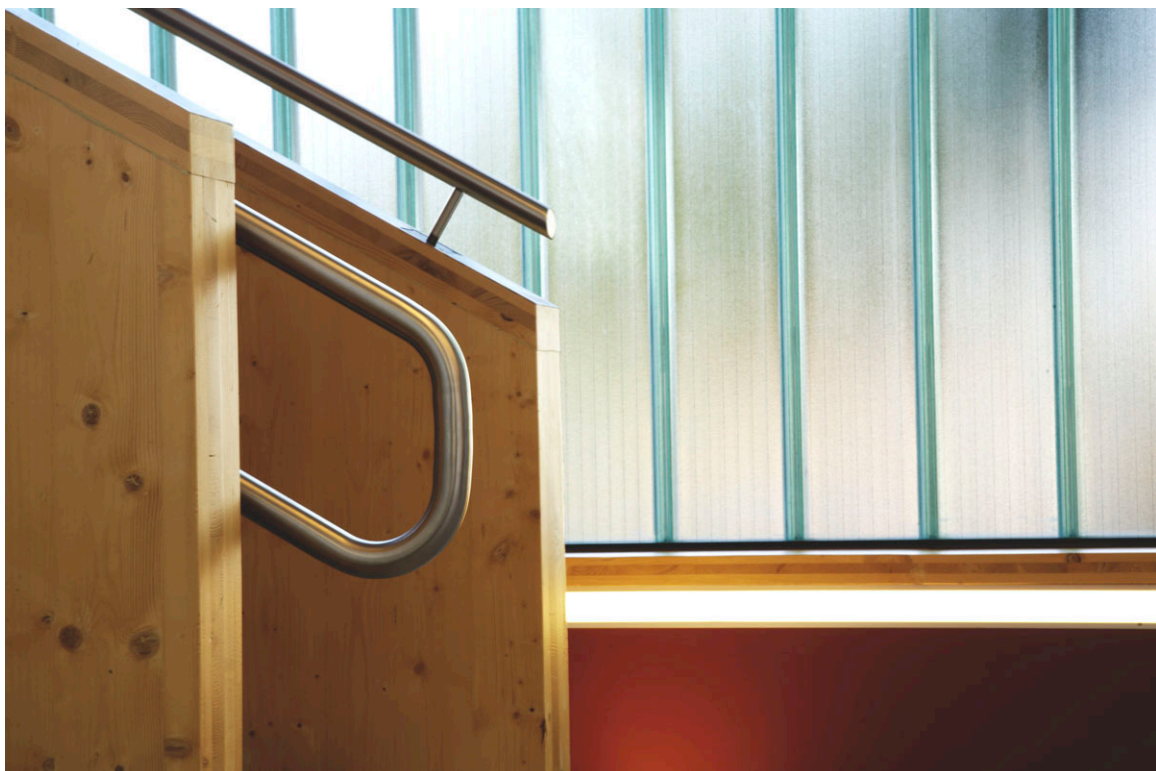
Fig.5.5.2- Photo of the Children Centre stair care 2012 – The palette of materials for the New Building included expressed cross laminated timber, natural lino cladding on walls, stainless steel and large windows for good natural light. The appearance of the building was highly prized by users.

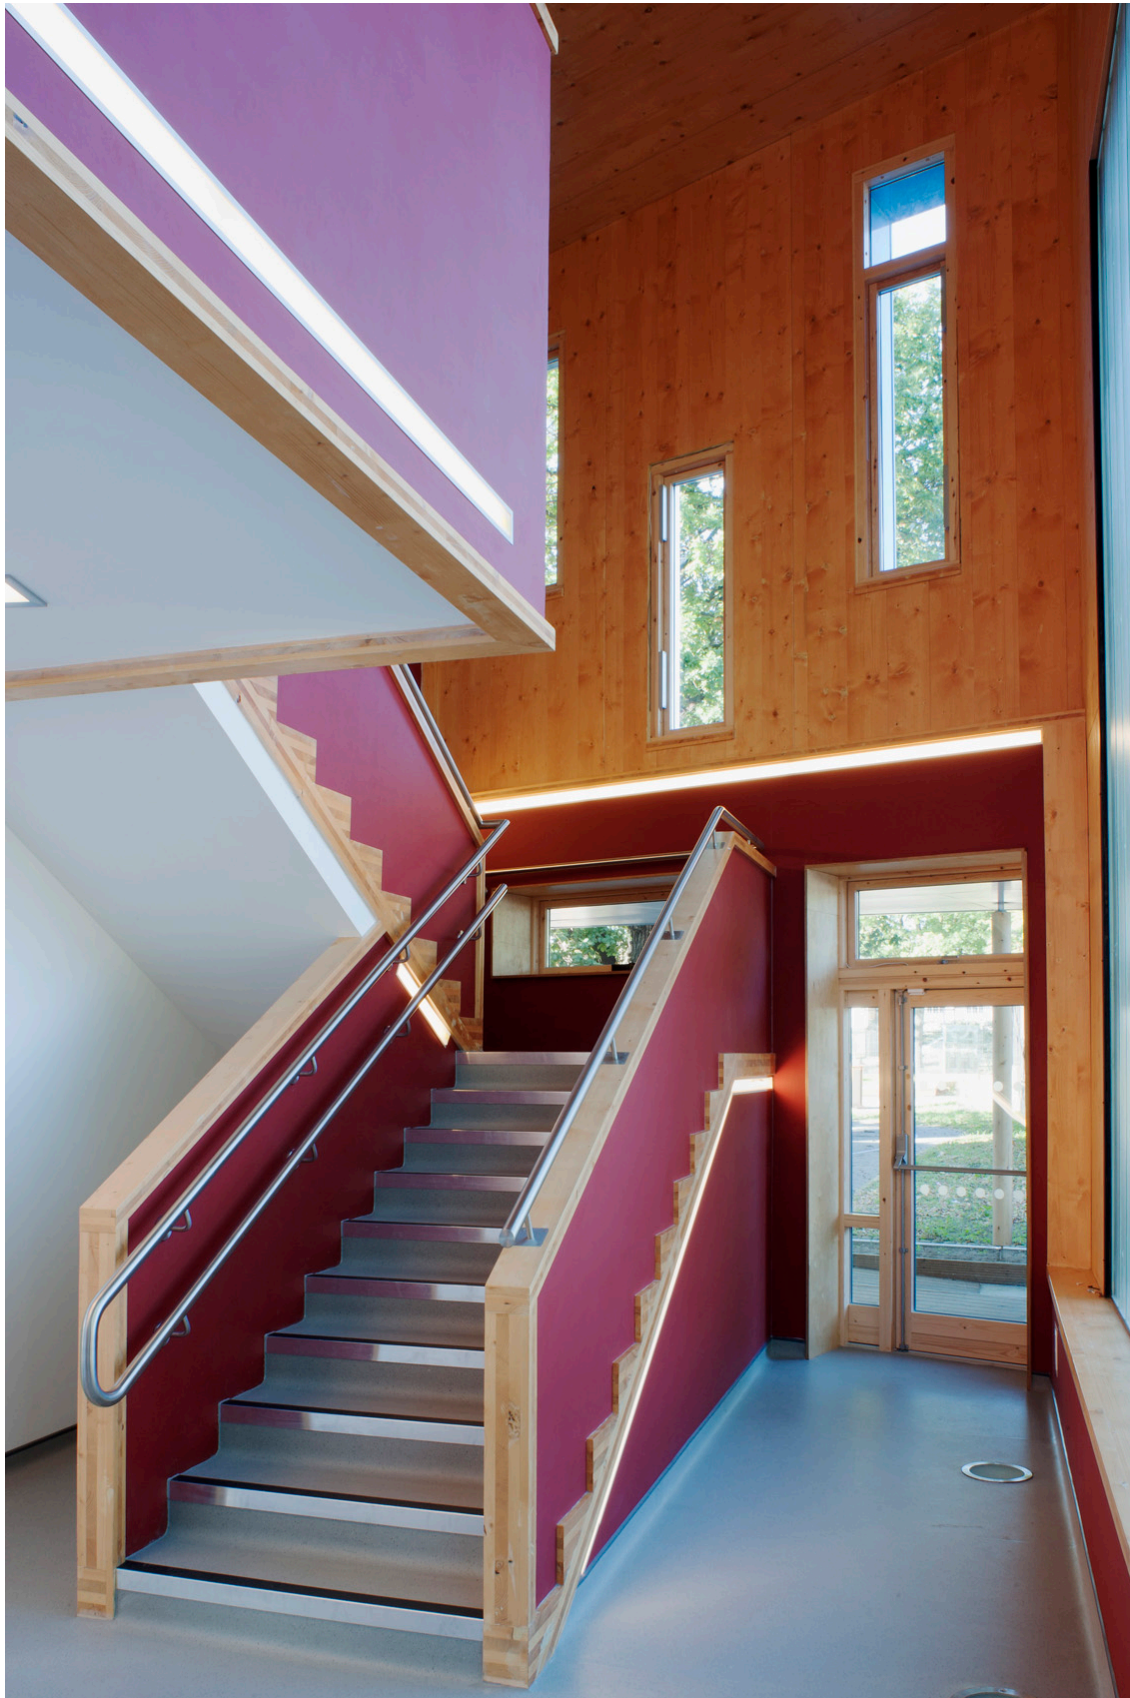
Fig.5.5.3- Photo of the New Building's feature staircase – 2012. This dynamic entrance which expresses the materiality of the construction helped create the New Building's positive image. However the new headteacher criticised it saying some features such as recessed lighting were expensive to maintain and were not sufficiently robust.

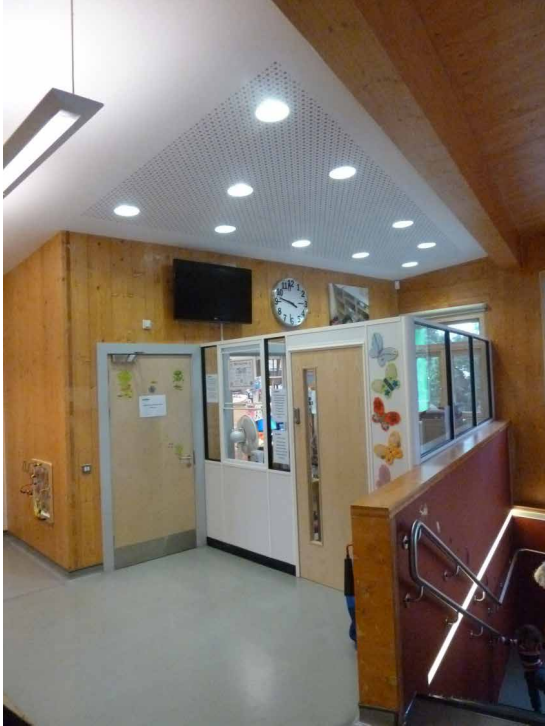
Fig.5.5.4- A less than satisfactory reception area was retrofitted by the Children's Centre once funding was secured for a full time receptionist.

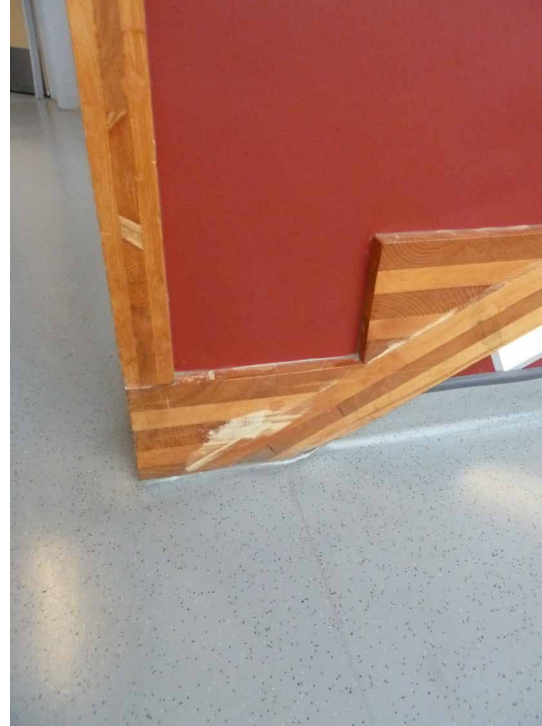
Fig.5.5.5- Defects in the manufacture of cross laminated timber were visible in some locations. The fire retardant coating caused the timber to yellow overtime, which was disliked by many.

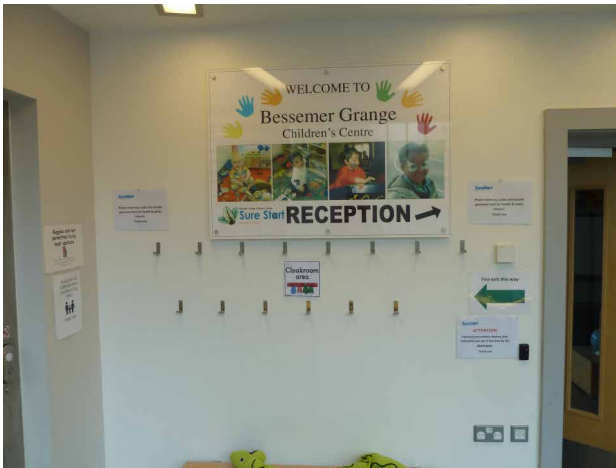
Fig.5.5.6 - Photo of the wall in the ground floor lobby of the Children's Centre. The design of signage was taken on by the client and not included in the main contract. This has led to a lot of unco-ordinated signs being fitted, which adds visual clutter to the spaces.

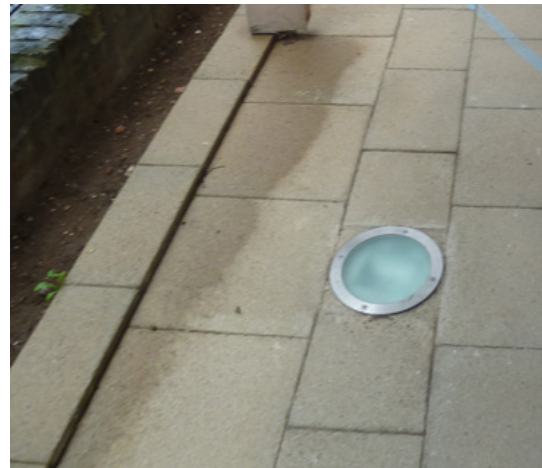
Fig.5.5.7 - Problems were experienced with external recessed lighting - with water leaking into fittings. These were replaced by the contractor but facilities staff complained future repairs would be expensive - they state a preference for wall mounted fittings with cheap replacement parts.

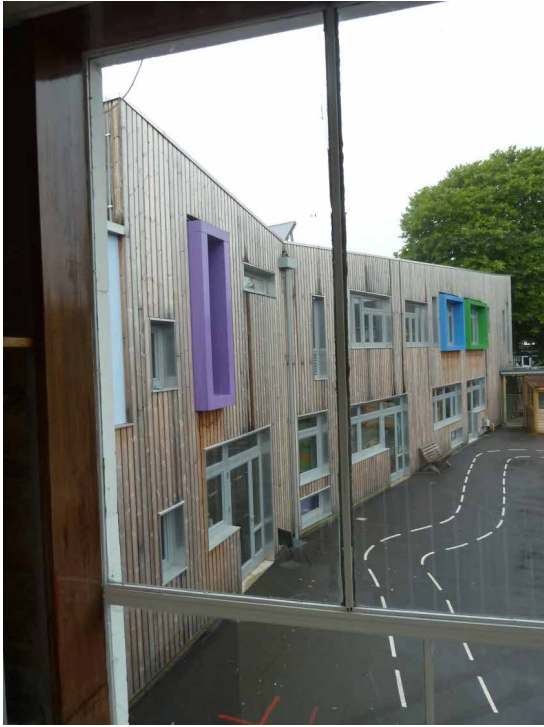
Fig.5.5.8 - Staining on the external cladding can be seen in vertical lines. This has been caused by water dripping from joints on the main capping. Remedial works were undertaken to improve this junction – however on future projects capping should have a greater fall toward the roof (away from the façade) and have a greater overhang to avoid this issue.

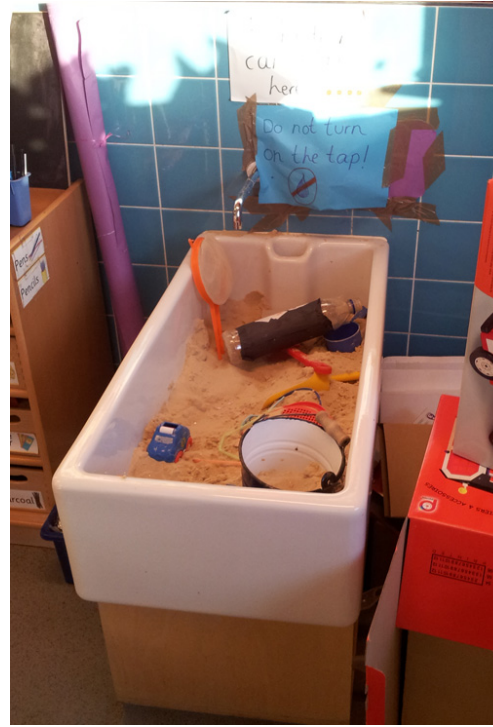
Fig.5.5.9 - Bespoke play sinks were fitted in the classrooms of the New Building. These were very popular with staff.

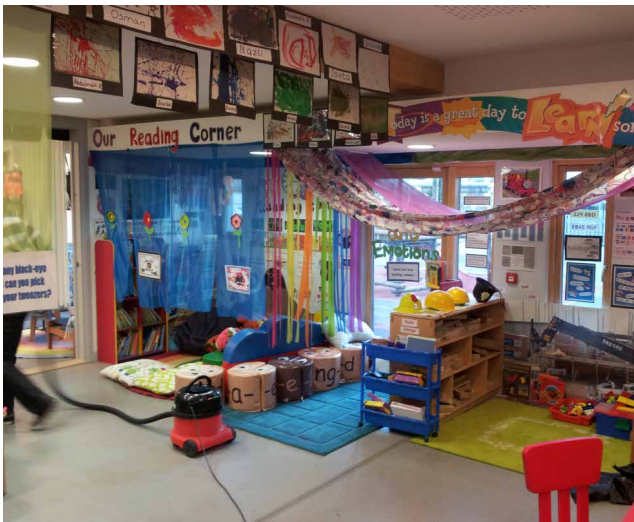
Fig.5.5.10 - Photo of ground floor nursery classroom in the New Building. The teachers fitted out the space with hanging and posters. More storage for this material was requested.

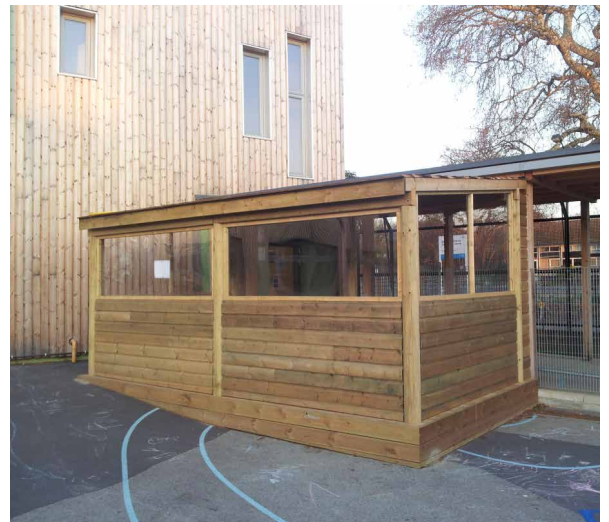
Fig.5.5.11 - A timber shed buggy store was retrofitted to the scheme by the end user as the provision for buggy storage provided was seen as insufficient.

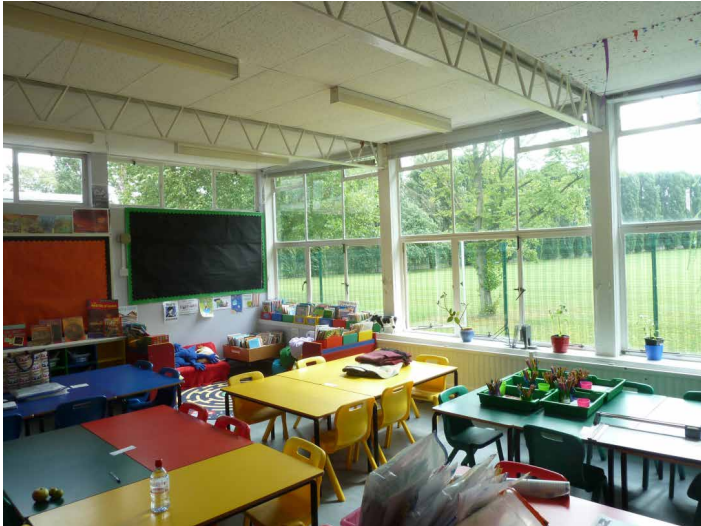
Fig.5.5.12- Large rectilinear classrooms in the Old Building were popular with staff (2013) – despite being hot in the summer and cold in the winter

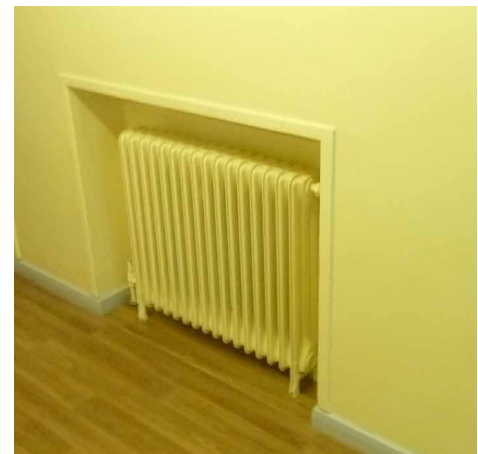
Fig.5.5.15- Recessed radiators and large underground service ducts were other examples of the Old Building's pragmatic and integrated design. (2013)
