Bessemer Grange School Children's Centre

Innovate UK project number	450001
Project lead and author	Architype
Report date	2014
InnovateUK Evaluator	Roderic Bunn (Contact via www.bpe-specialists.org.uk)

Purpose of evaluation

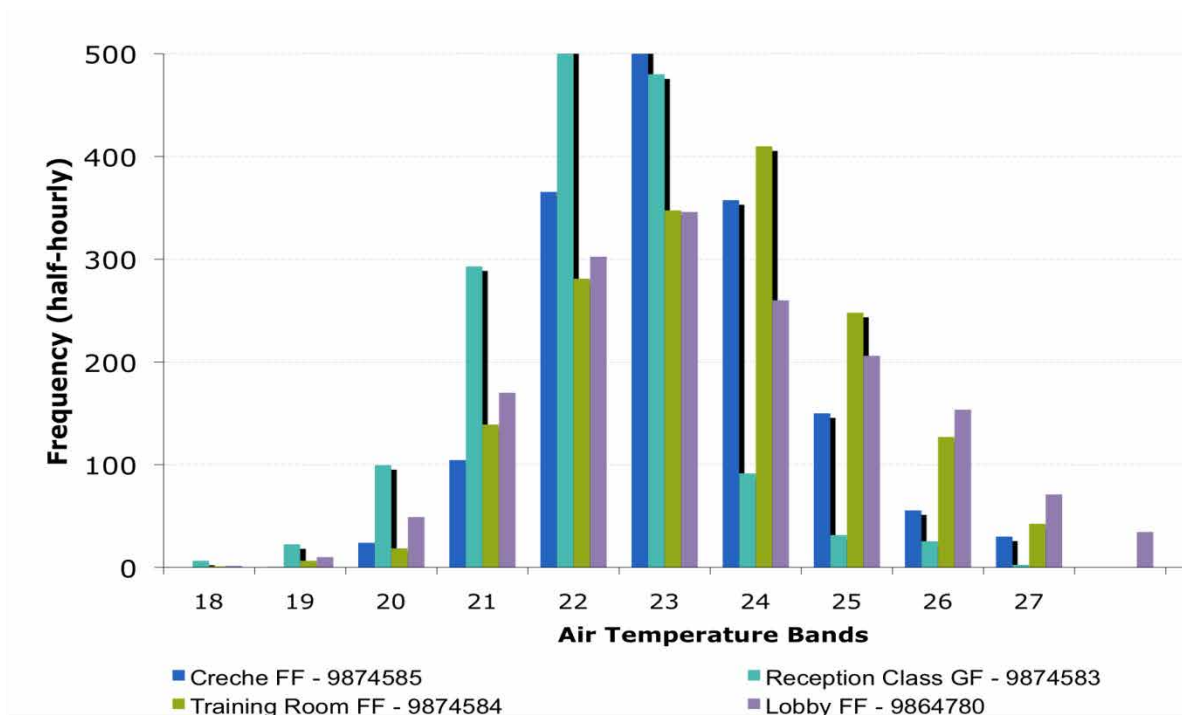
Fig 5.6.1 – Frequency of Temperatures Occurring over a year (every half hour) in Various Spaces in the New Building

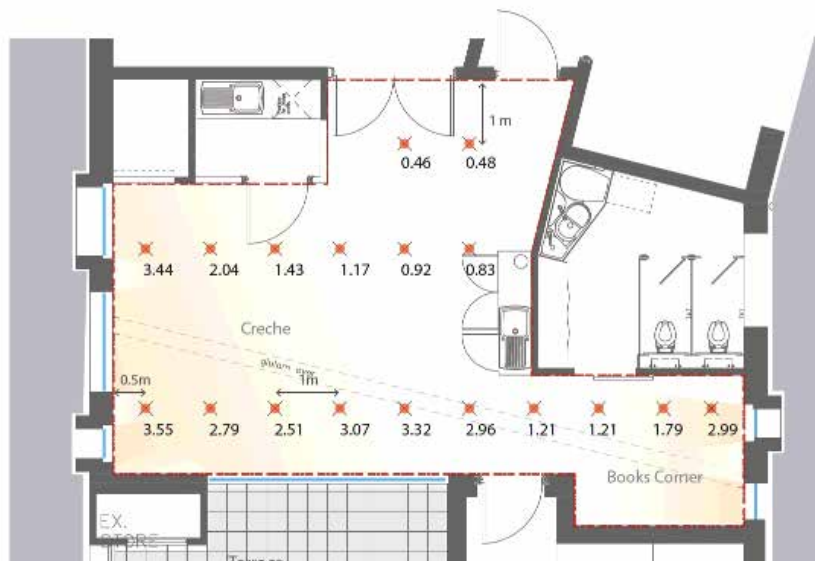
Fig 5.8.3 - First Floor Crèche Daylight Factor (%) mapped onto plan of room – showing a better level of uniformity than achieved on the ground floor.

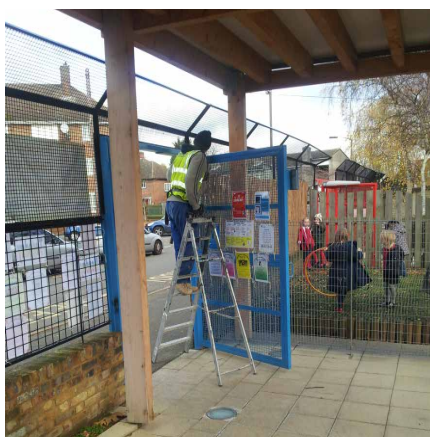
Fig. 5.1.1- Sub-contractor installing new gate closer – after the original closer failed.

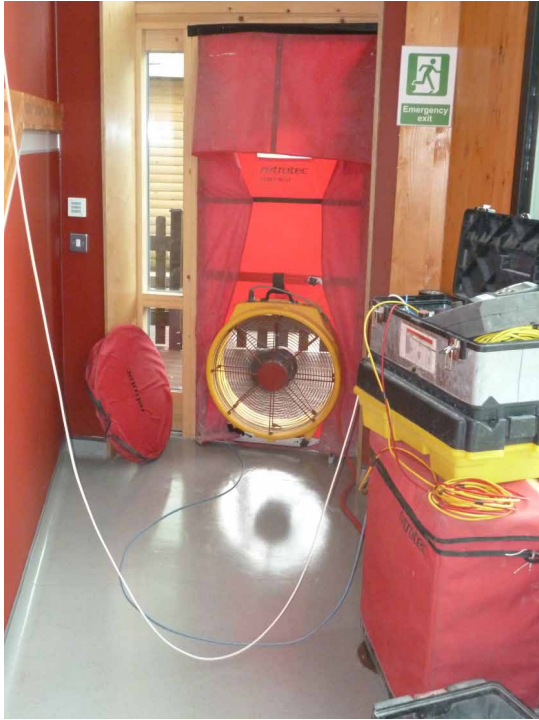
Fig.5.12.2- photo of the air pressure testing equipment installed.

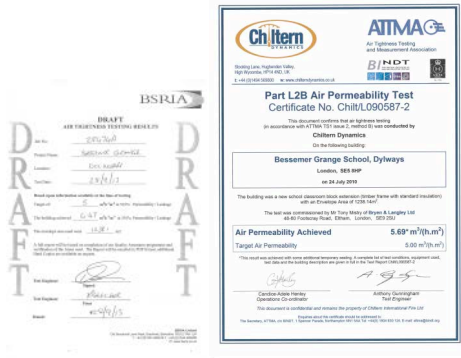
Fig. 5.12.4- Copies of the air pressure testing certificates.

Interestingly, when the building's air tightness was retested as part of the BPE study in 2013, it only achieved a final score of $6.47 \text{ m}^3 / (\text{m}^2 \cdot \text{h})$ at 50 pa Permeability/leakage. See Fig.5.12.2 and 5.12.4. However, two extract ventilation units on the high level roof of the first floor adult & accessible WCs were unable to be accessed (due to the height) and these units were estimated to be leaking. Additionally, it was unclear whether the original test had sealed off the connection to the existing building or not. Therefore a direct comparison was difficult to make and the difference may not be as significant as it first seems.

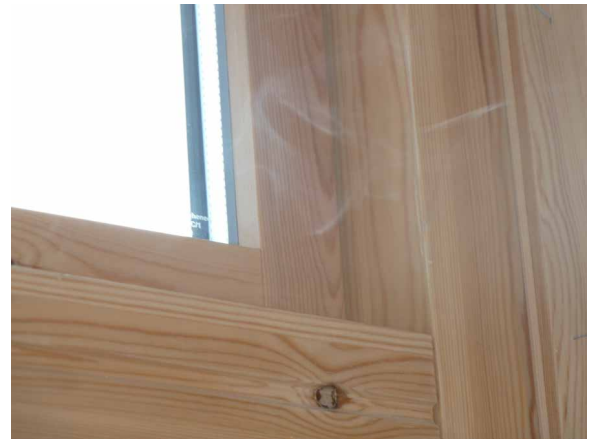
Fig. 5.12.5- Smoke tests showed that the windows were a major source of air leakage.

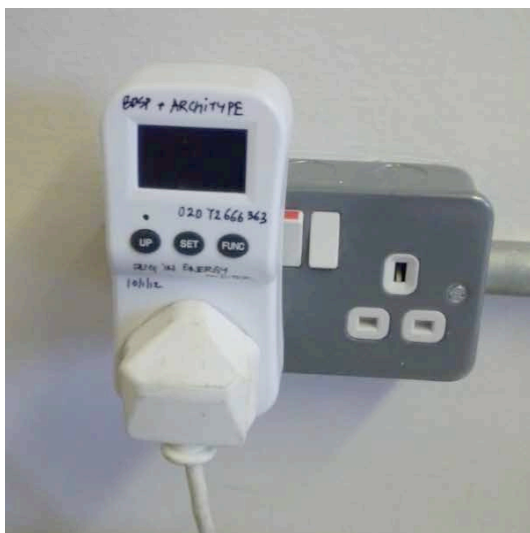
Fig.6.2.1 - Photograph of a portable plugin meter used to help the BPE team calculate electrical loads for electrical equipment as part of the TM22 analysis.

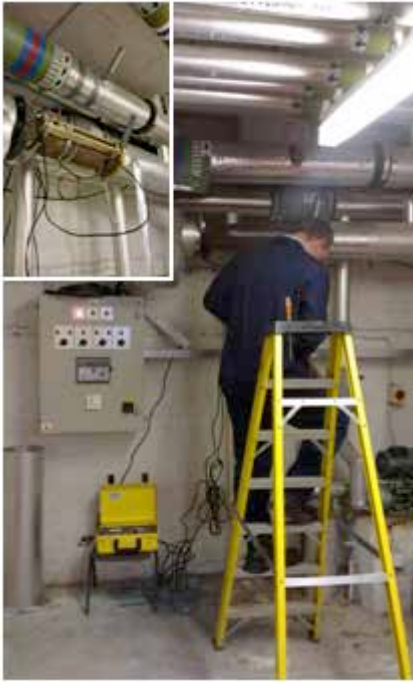
Fig. 6.3.2 – Installation of ultrasonic ‘clamp-on’ heat meters as part of two-year energy performance monitoring. Following temporary removal of a small section of pipework insulation, the meter is clamped to the outside of a straight section of bare pipe to measure flow rate, with temperature probes on flow and return pipes.

A series of problems were experienced with the clamp-on heat meters due to a faulty data logger module (i.e. a manufacturing defect). This required substantial correspondence with the equipment suppliers and testing and many additional site visits to finally resolve. This resulted in loss of data due to intermittent monitoring during the first year of the project. The equipment supplier subsequently agreed to loan a second heat meter free of charge to the BPE team during the second year of monitoring.

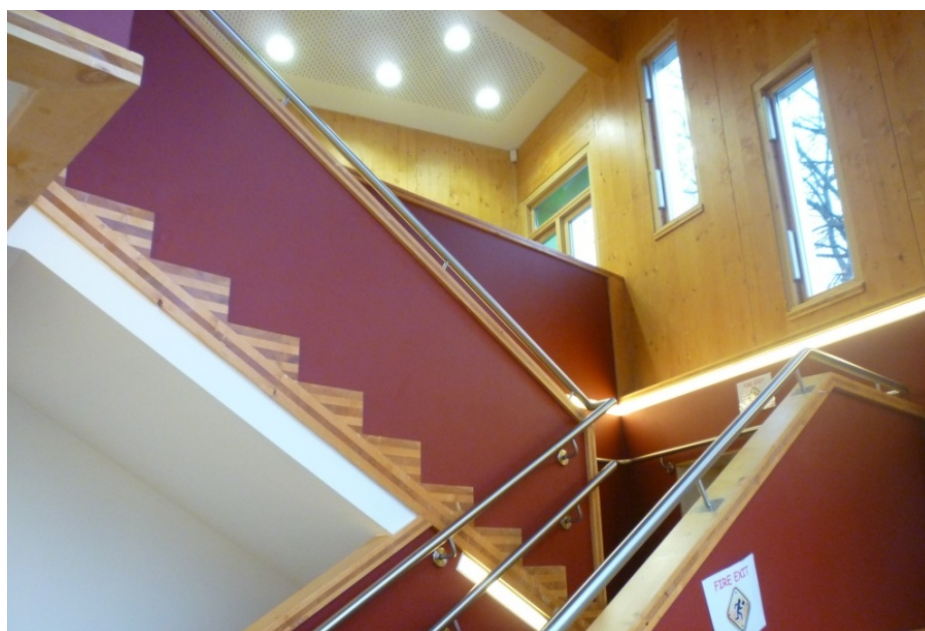
Fig 8.1.2 – Photo of feature lighting and ceiling lights turned on in the Children Centre's despite good daylight levels.

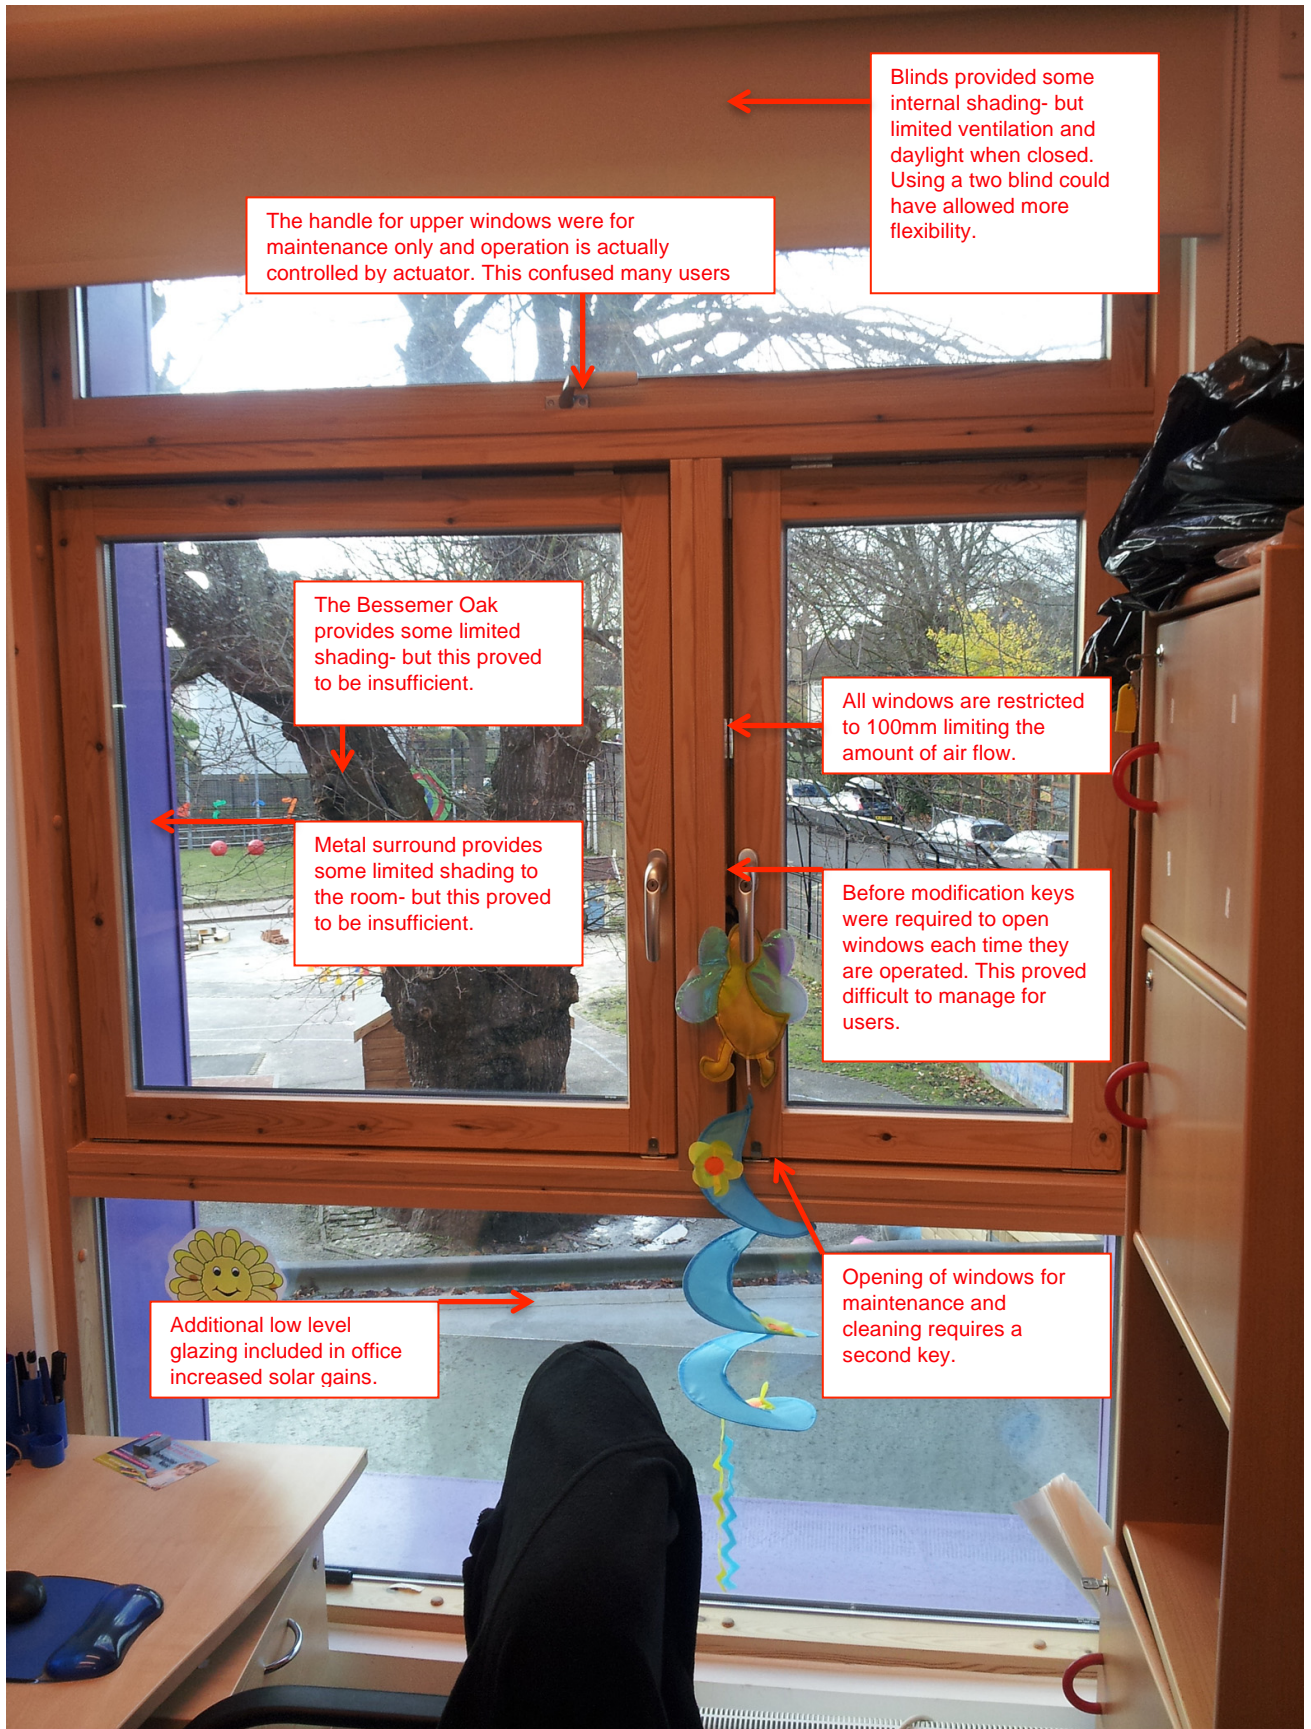
Fig.8.4.1 - New Building - first floor office window- a fairly typical arrangement of windows.

Generally, the designed natural ventilation did not fully function because the windows had several problems. See Fig.8.4.1. The main opening elements of windows were controlled by handles and were restricted to 100mm to prevent children from falling out. This significantly reduced the available ventilation. Also, handles were on key controls as had been requested by the previous facilities manager. This meant that each time a member of staff wished to open a window they had to insert a key. This was onerous but functioned in classrooms, which were regularly occupied, because the teachers had keys. In the Children's Centre (on the first floor), where occupancy is variable, users had to ask the reception staff for keys. In reality, this does not happen and as a result some rooms become too warm.

To address this, the BPE team liaised with the window manufacturer Rational who suggested that plastic plugs could be used to disable the window locks, as shown in the Fig.8.4.4. Unfortunately, this solution only worked in side-hung windows and did not work for some of the larger windows. Further discussion with the manufacturers confirmed that non-locking handles could be provided for approx. £15 each (excluding VAT, delivery and installation). This option was put forward to the school but was not undertaken at the time of writing. In retrospect simple handles with no key locks should have been used.

The office, which is a small room approx. 8m² located, includes desk space and facilities for approximately two people to work. See Fig.5.3.2. It has a large South-West facing window. See Fig.8.4.1, which is manually operable and shaded both by a 400mm reveal and the Bessemer Oak directly in front. Fig.8.5.1 below shows the resulting temperatures that are clearly higher than intended and uncomfortable in the height of summer.

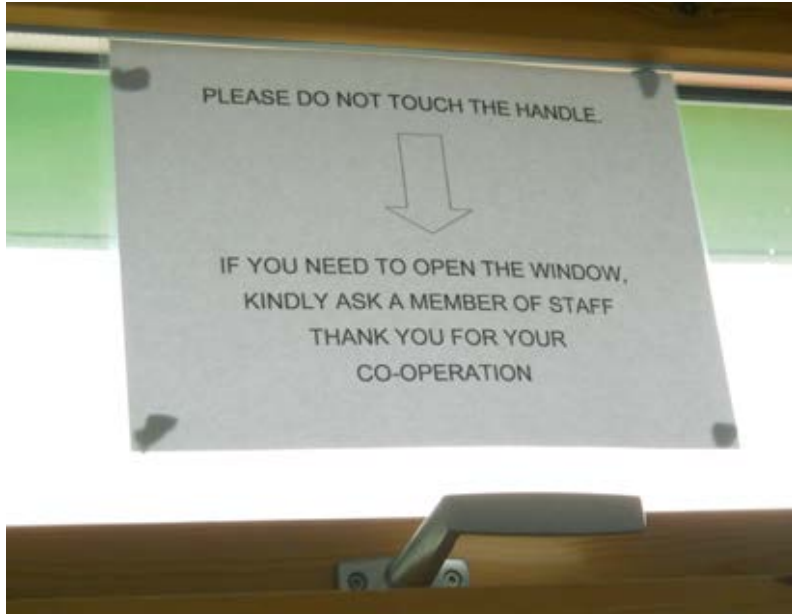
Fig 8.4.2 - Signage produced by the user to stop people incorrectly using the automatic window handle.

The majority of windows also have an operable upper pane, which is controlled via an automated actuator as the handles are well above the 1400mm recommended (UK Government, 2006, Building Regulations: Part M1-4.30) height to allow disabled users operate window controls. The model of actuator installed had a handle to open the windows for maintenance. Many users were not aware that the actuator control switch on the wall operated the window and instead, intuitively reached up and opened the window with the maintenance handle. See Fig.8.4.2. This unfortunately disengaged the motor of the actuator and required resetting. This has created a maintenance burden for the facilities staff and is clearly unsatisfactory. In retrospect, avoiding the need for actuators by lowering the window heights, or by finding an alternative more intuitive actuator product without this handle, would have been a better approach.
