# Bourne Hill Council Offices

<b>Innovate UK project number</b>	450113
<b>Project lead and author</b>	Wiltshire Council and the Centre for Sustainable Energy
<b>Report date</b>	2014
<b>InnovateUK Evaluator</b>	Tom Kordel (Contact via <a href="http://www.bpe-specialists.org.uk">www.bpe-specialists.org.uk</a> )

<b>Building sector</b>	<b>Location</b>	<b>Form of contract</b>	<b>Opened</b>
Offices	Salisbury	Traditional	2010
<b>Floor area (GIA)</b>	<b>Storeys</b>	<b>EPC / DEC 2013</b>	<b>BREEAM rating</b>
1498 m <sup>2</sup> & 2357 m <sup>2</sup>	Various	B (50) / D (86)	Excellent

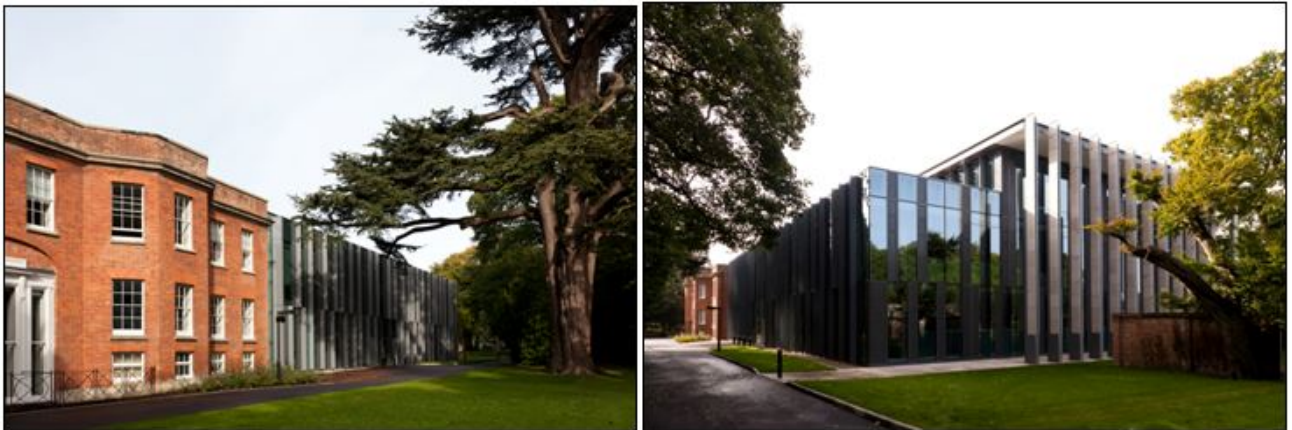
Figure 1: (Left) Photograph of the existing listed building and the new extension

Figure 2: (Right) Photograph of the new extension

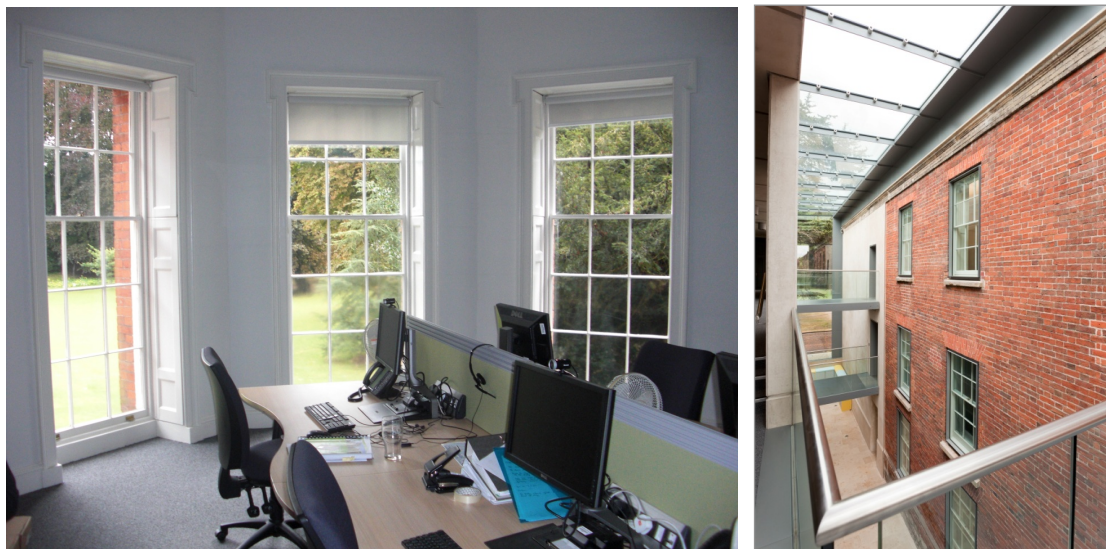
**Figure 3: (Left) Inside one of the office spaces within the original building**

**Figure 4: (Right) View across glazed link, which connects the two parts of the building**

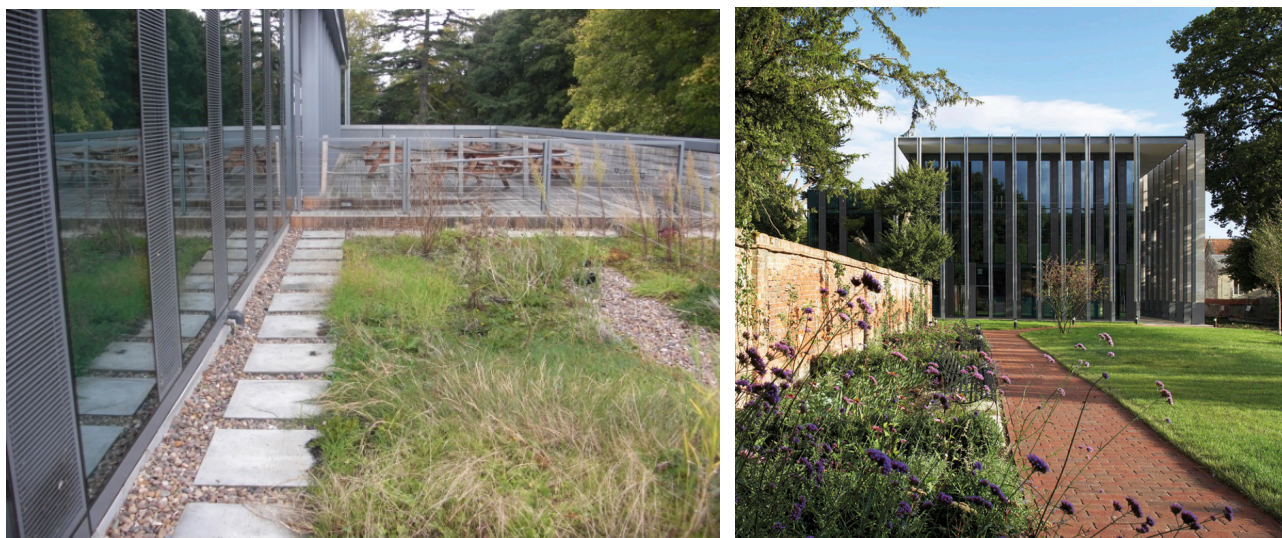
In the design for the extension, considerable attention was given to maximising the use of passive features to temper the internal environment in order to eliminate the need for high levels of space heating and/or air conditioning (except within the server room). The extension has a concrete frame, designed for high thermal mass, and is clad in aluminium-framed glass curtain walling (see Figure 6). The extension also has a green roof over some areas (see Figure 5).

**Figure 5: (Left) The green roof and external seating area**

**Figure 6: (Right) Elevation of new build extension**

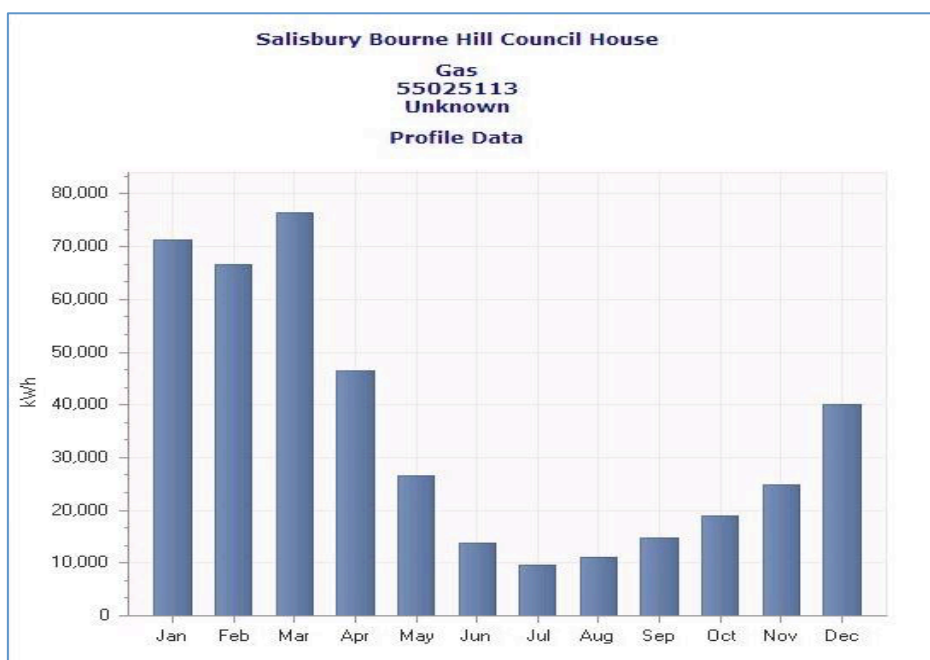
The chart below (Figure 15) breaks down the total gas consumption figure on a month by month basis for the year 2013. These figures are based on the half-hourly data collected via the AMR unit and stored on the Council’s SystemsLink software (hence the TM22 HH module was considered to be surplus to requirements in this case).

Figure 15: Monthly gas consumption during 2013

This pattern of usage is in line with expectations, with demand peaking during the colder months when more energy is required for space heating, and falling as the weather becomes warmer. If it can be assumed that little, if any, gas should be consumed for the purpose of space heating during the hottest months, then the lowest consumption level may be an approximate indicator of hot water use within the older part of the building (as previously noted). In July 2013, 10,194 kWh gas were used, which would equate to a demand of around 4.3kWh/m<sup>2</sup> during that month (note that whilst July shows the lowest level of gas consumption, August was actually the warmest month in 2013. One possible cause of the slight increase in consumption in August may be that more people may have been making use of the on-site showering facilities during this period). It is unlikely that the amount of gas consumed for heating water at Bourne Hill would fluctuate to a great extent throughout the year. The relationship between the amount of energy consumed and the weather is demonstrated in Figure 16 below.

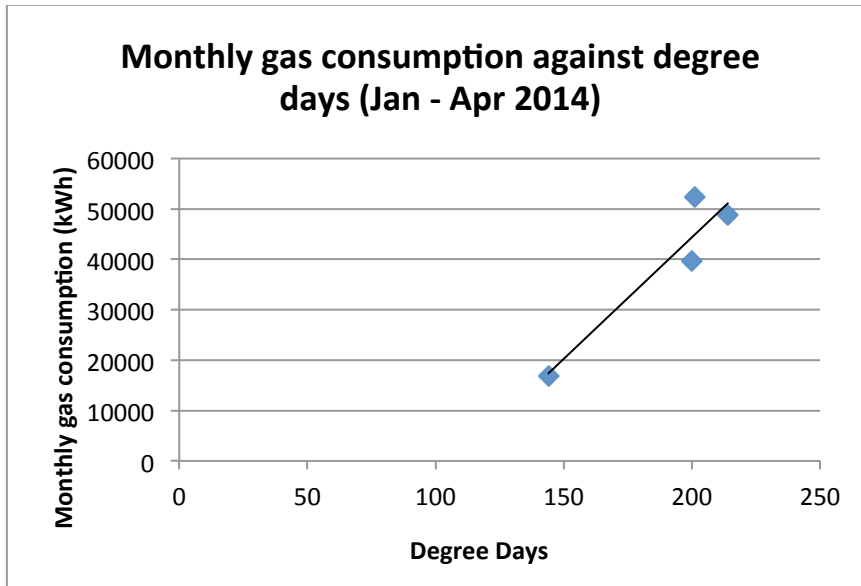
Figure 20: Monthly gas consumption against degree day data between January and April 2014

The new trend line intercepts the vertical axis at -52071kWh. The minus figure could indicate that the base temperature used for standard degree day calculations is no longer appropriate to the building (published degree days in the UK are normally calculated to a base temperature of 15.5°C). This may be a result of the high level of glazing to the façade of the extension and the building’s high thermal mass, meaning that the building does not require additional heating until a certain number of degree days has been reached. It is difficult to fully interpret this change without being able to further split gas consumption between the original part of the building and the extension. It would also be advisable to repeat the analysis in the future with more than just the data from these 4 months in order to even out the impact of any anomalies.

Monthly gas consumption figures from January 2014 to the end of April 2014 (i.e. after the change to the hot water settings) were then plotted against degree day data, and produced quite a dramatic shift in the location of the intercept (see chart below).

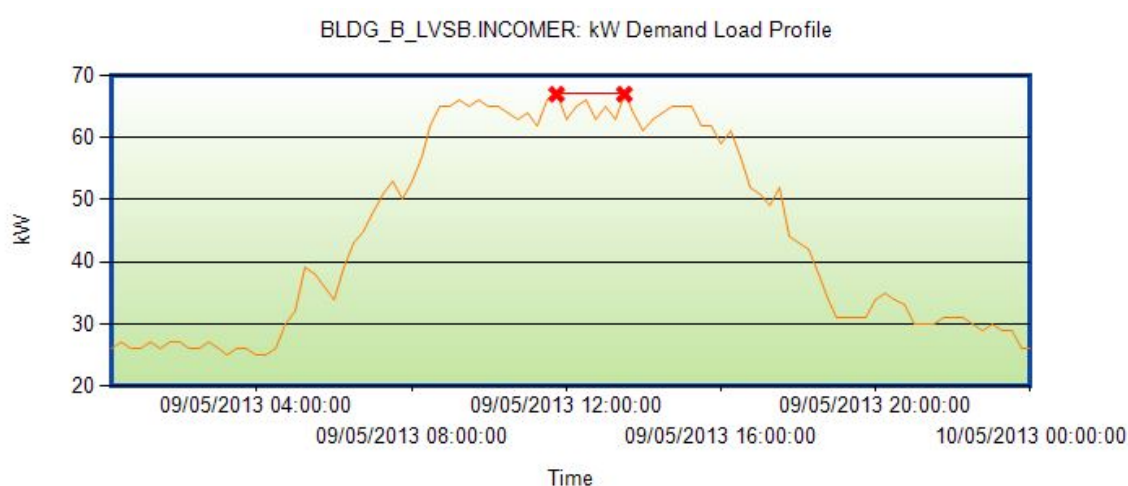
Figure 21: ION output showing load profile for whole building

The graph indicates a baseload of approximately 27 kW, which begins to increase from about 04.00am, peaks during the lunchtime period, and then falls gradually until midnight. A closer look at the individual end use load profiles indicates that the server room cooling plant makes up a large proportion of the base demand (cycles with peaks of between 8 and 10 kW), and that the timing of the external lighting coincides with the increase in consumption outside of core hours (i.e. 04.00am to 08.00am and 19.30pm to 24.00pm). In addition to this, IT room power and back up power (which includes both the server room and the UPS system) are both high (above 6kW) throughout the day.

The graph below (Figure 21) provides an example of a typical load profile ION output for a weekday (in this case a Thursday) for the whole building.

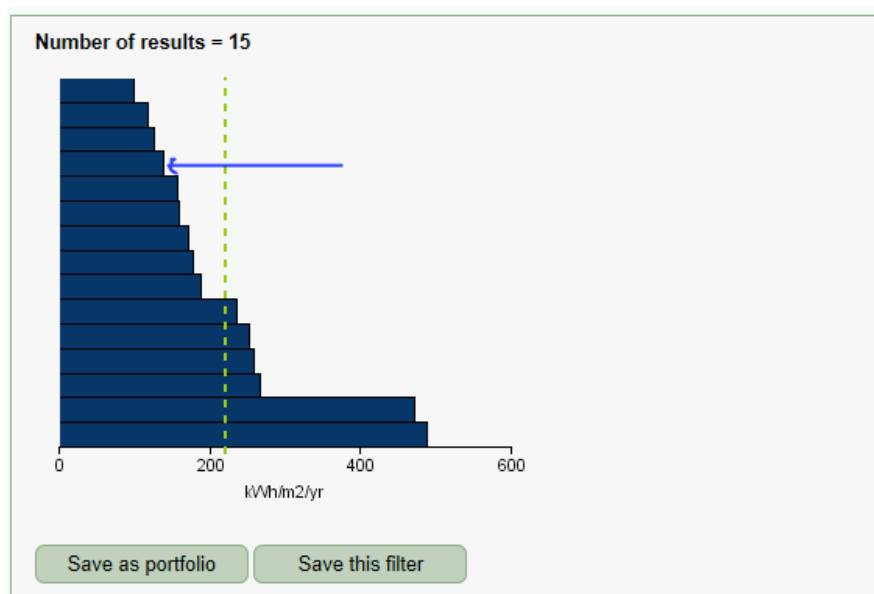
At the time of writing there are 96 naturally ventilated 'general office' buildings within the Carbon Buzz database in total, although only 14 of these include in-use data and are published on the website. The chart below (Figure 10) provides an overview of the energy performance of the 15 identifiable case studies (in terms of kWh/m<sup>2</sup>/yr), with Bourne Hill highlighted by the blue arrow. The chart indicates that Bourne Hill performs relatively well in comparison to other buildings of its type, despite part of the building being a traditionally-constructed listed structure. Whilst it is not explicitly stated on the website, the green dotted line appears to represent the CIBSE TM46 benchmark for a 'general office' building (95kWh/m<sup>2</sup>/yr for electricity plus 120kWh/m<sup>2</sup>/yr for gas), which less than half of the buildings exceed (i.e. perform worse than). The variation in performance highlights the difficulties in setting and applying benchmarks such as these.

Figure 22: Extract from Carbon Buzz website showing comparison of 15 identifiable case studies based on actual kWh/m<sup>2</sup>/yr

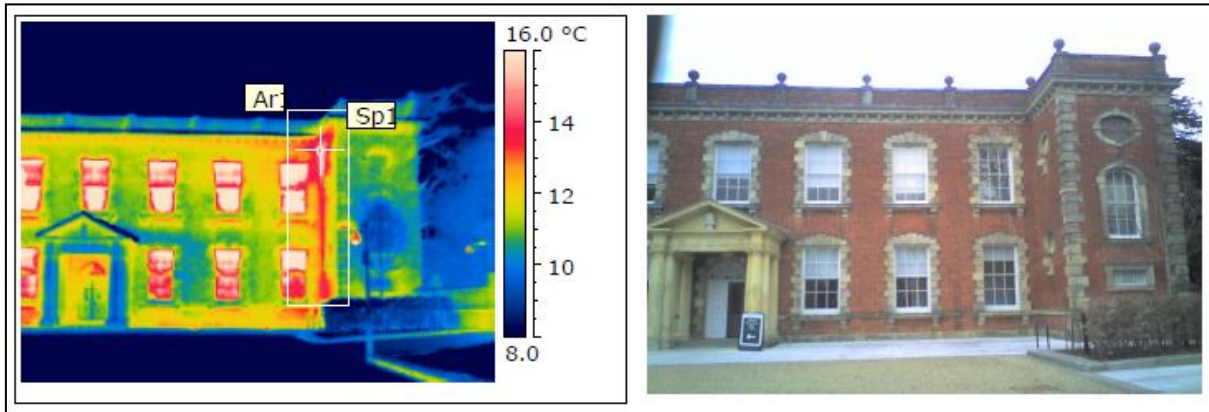
Figure 25: Thermal image of registry office entrance with weaker point highlighted in the corner
