This document contains a Building Performance Evaluation report from the £8 million Building Performance Evaluation research programme funded by the Department of Business Innovation and Skills between 2010 and 2015. The report was originally published by InnovateUK and made available for public use via the building data exchange website hosted by InnovateUK until 2019. This website is now hosting the BPE reports as a research archive. As such, no support or further information on the reports are available from the host. However, further information may be available from the original InnovateUK project evaluator using the link below¹.

Innovate UK project number	450077 Related CHP study: 450078 (Phase 1)
Project author	UCL and Crest Nicholson Operations for Crest Nicholson Plc
Report date	2014
¹InnovateUK Evaluator	N/A

This report provides the results of the in-use performance analysis and post-occupancy evaluation of three monitored dwellings constructed as part of the first phase of Centenary Quay development. The performance of the district heating system and the CHP plant installed was assessed as part of the Phase 1 study.

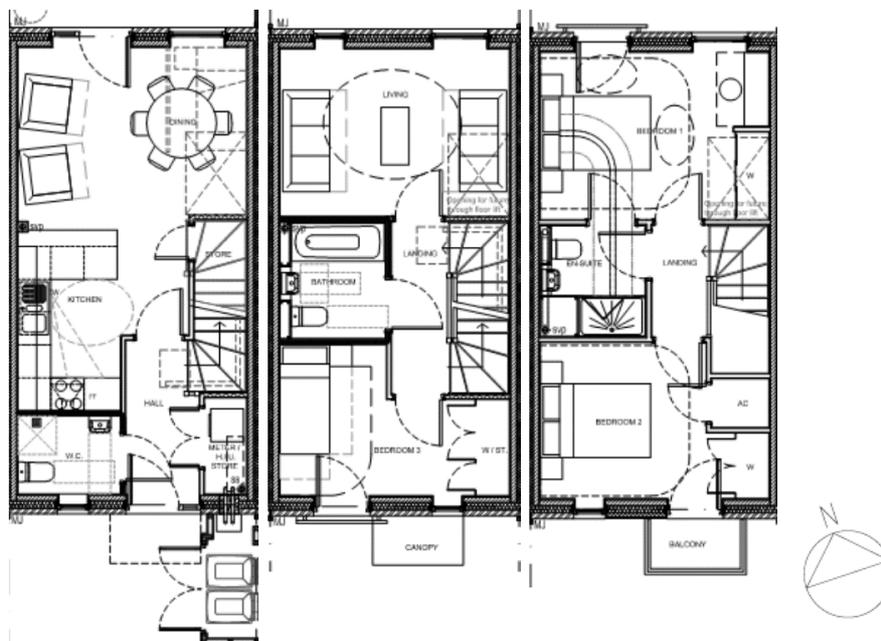
Figure 4 - Floor plans for Plot 118

The monitored dwellings are 3-bedroom, 3-storey mid-terraced houses with identical orientation. These houses form part of a terraced block from the first phase of the Centenary Quay project and were completed in 2012. They are identical apart from minor differences in the dimensions of openings, handedness of internal layout, the position of balconies and façade treatments. An elevation drawing of the three plots is shown in **Figure 3**. Layout plans for Plot 118, as a representative dwelling, are also shown in Figure 4. Bedrooms 1 and 2 are located on the second floor; Bedroom 3 and the living room are located on the first floor, while the open plan kitchen and dining area are located on the ground floor.

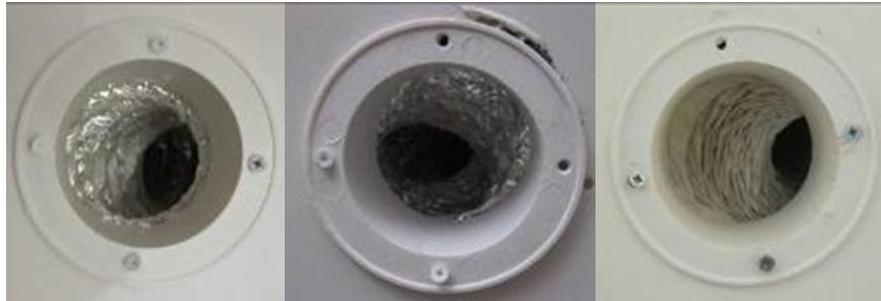
- Ventilation at Centenary Quay is provided utilising a centralised continuous Mechanical Extract Ventilation (MEV) system. Air is extracted via an MEV fan unit located in the loft through ceiling mounted air valves in the wet rooms (kitchen, toilet, & two bathrooms). The kitchens are fitted with a filtered re-circulating cooker hood above the hob. Fresh air is also provided by closable trickle vents integrated into the NorDan window frames. One of the findings of the construction review process was that there was extensive use of flexi-duct in the loft, especially at the connections to the fan unit. Whilst it is normal to use a small amount of flexible duct to make connections, the amount observed was excessive and had been laid in such a way as to form tight bends which would cause back pressure on the system and reduce the system performance compared to design assumptions. An examination of the flexible connections between the rigid duct and the ceiling vents showed that in many cases the flexible duct was constricted and not

properly aligned (Figure 5), which would increase back pressure and reduce system efficiency.

Figure 5 - Extract terminals with diffusers removed showing constrictions in flexible ducting

It was also noted that the MEV boost mode in WC and bathrooms, which was triggered by the lights switch, did not have an over-run function, and the system would revert back to trickle mode when the light switch is turned off. A humidistat would ensure that boost mode operated for a long enough period after the bathroom was vacated and the light turned off to clear moisture e.g. from a shower.

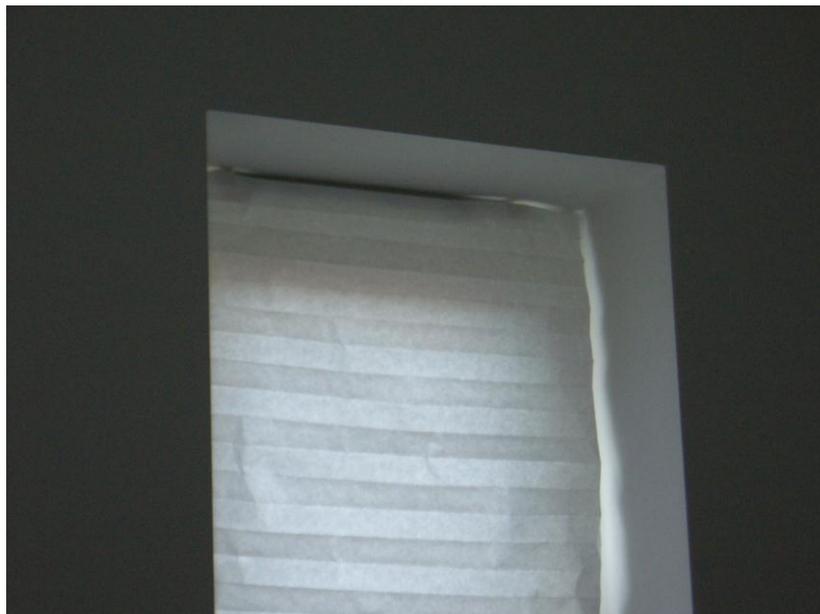
It was observed that occupants of Plot 119 had paper blinds on all windows. Self-adhesive tapes used to hang these blinds had led to all trickle vents being blocked. The occupants were unaware of this. They reported that they had never opened any of these blinds as they felt enough natural light could still come through.

Figure 6 - Paper blind installed on the window led to the trickle vent being blocked

One of the major findings of the interviews was that the trickle vents on window frames were permanently blocked in two dwellings with paper blinds and closed in another dwelling in winter to prevent draught. It is recommended that the critical role of trickle vents in maintaining good indoor air quality in new build dwellings is more specifically covered in home user guides and home demonstration in the future.

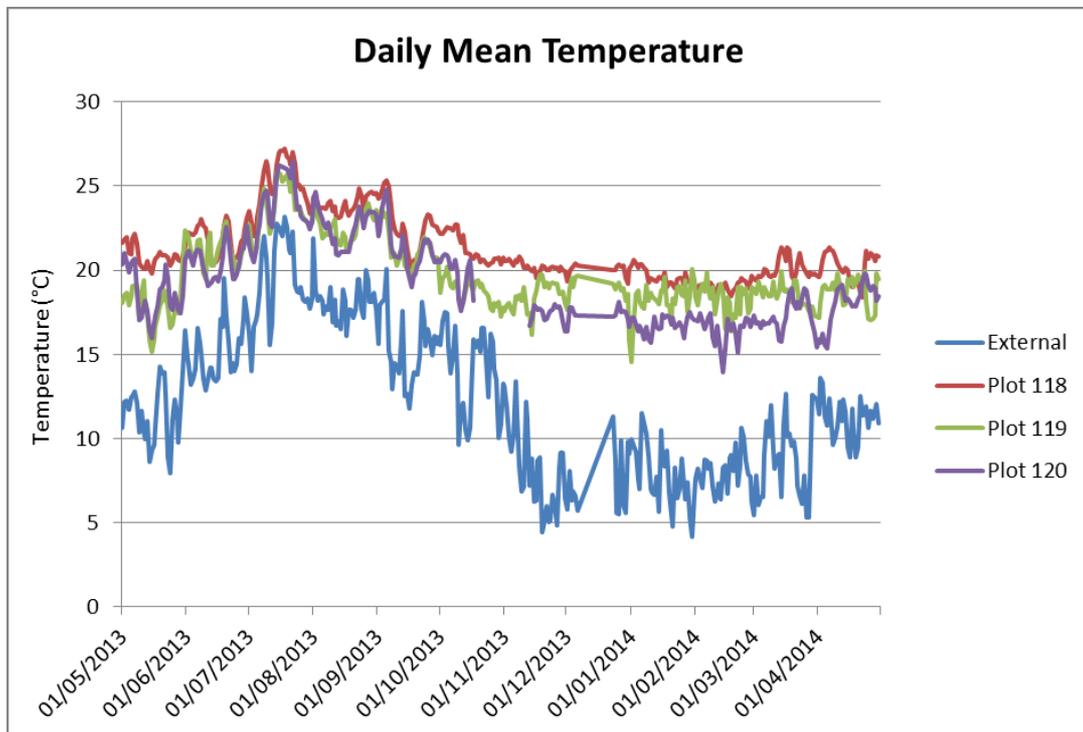
Figure 10 - Daily mean temperature in the monitored dwellings vs. external temperature

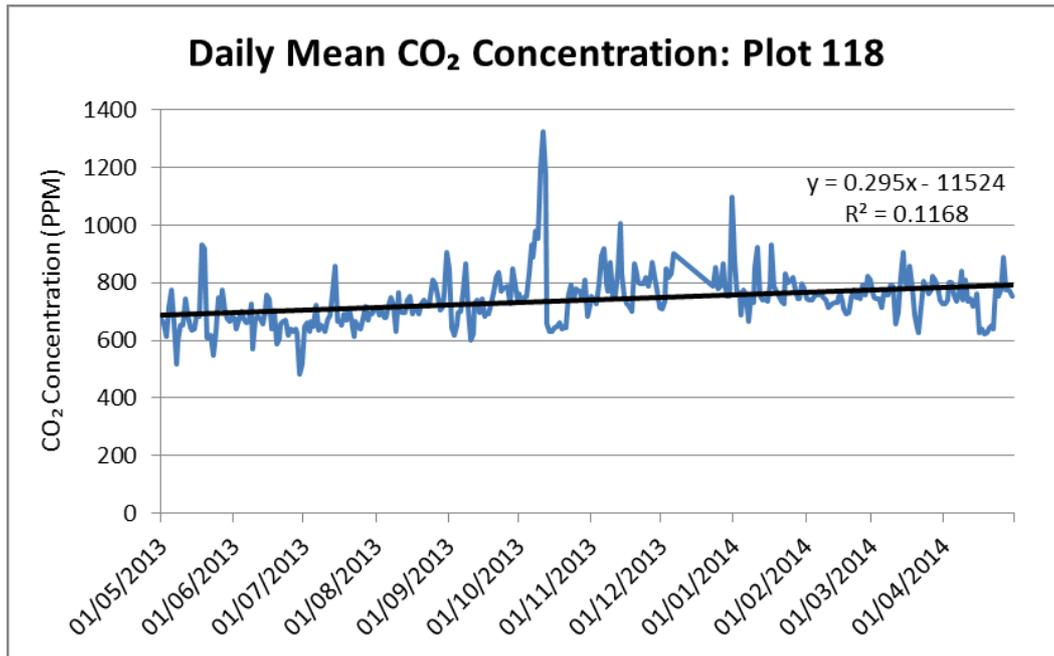
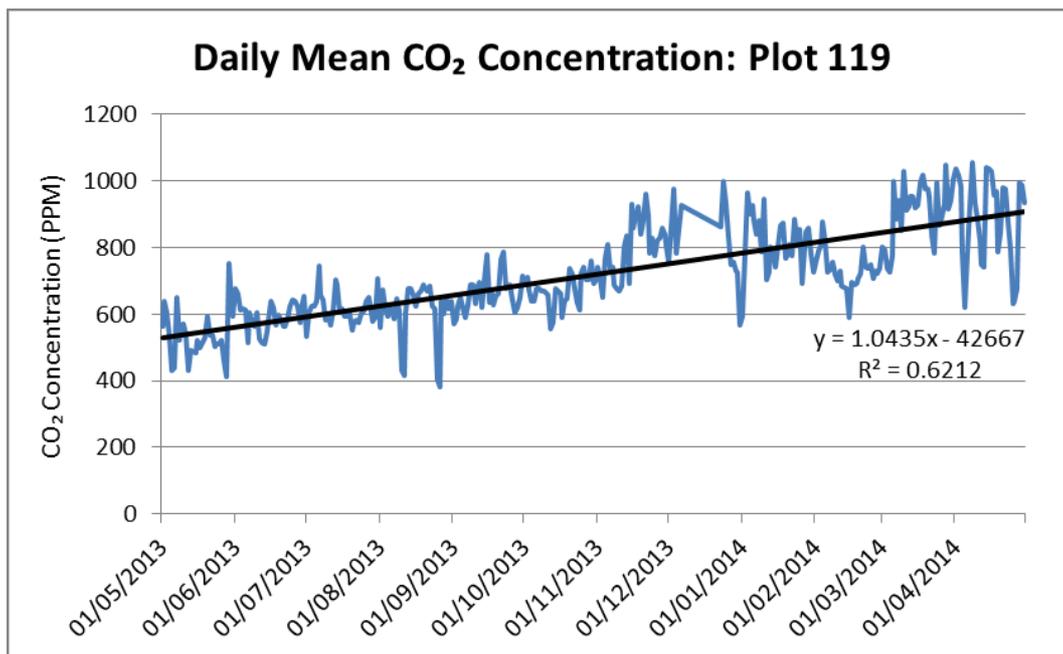
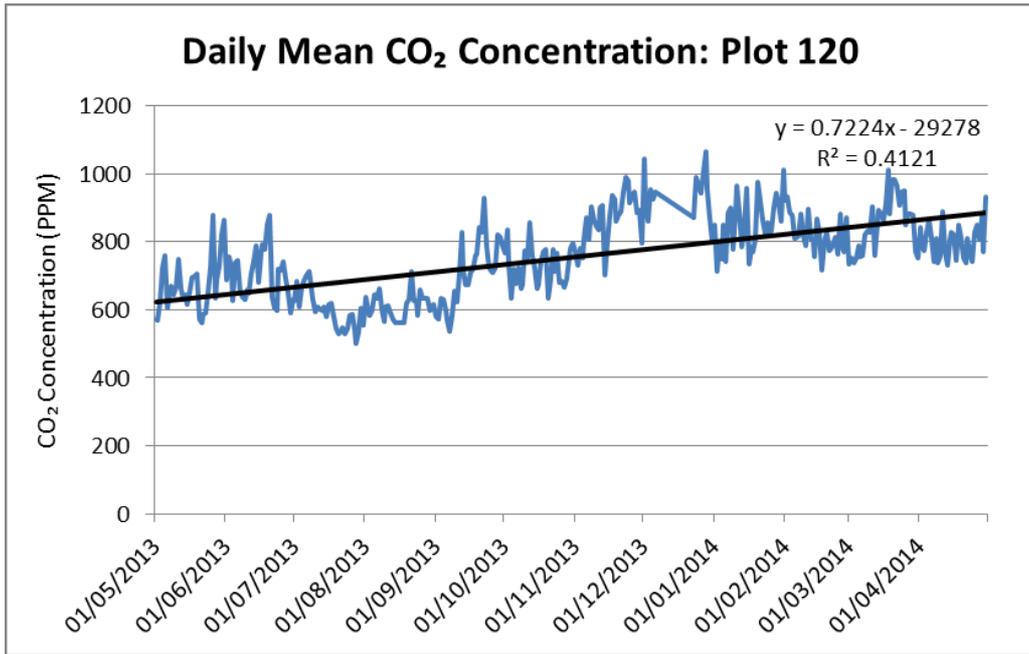
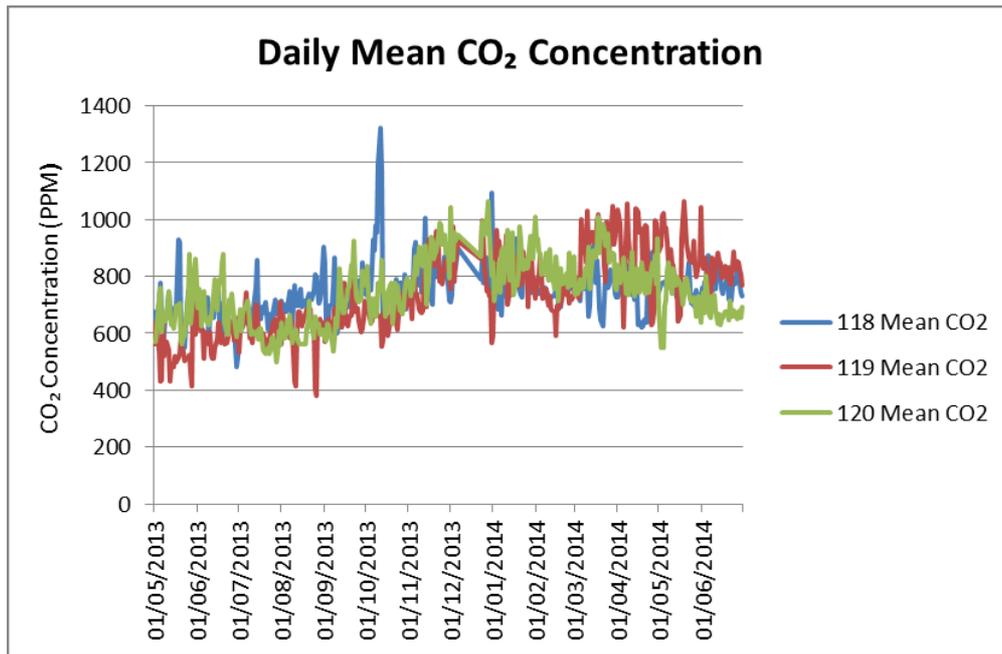
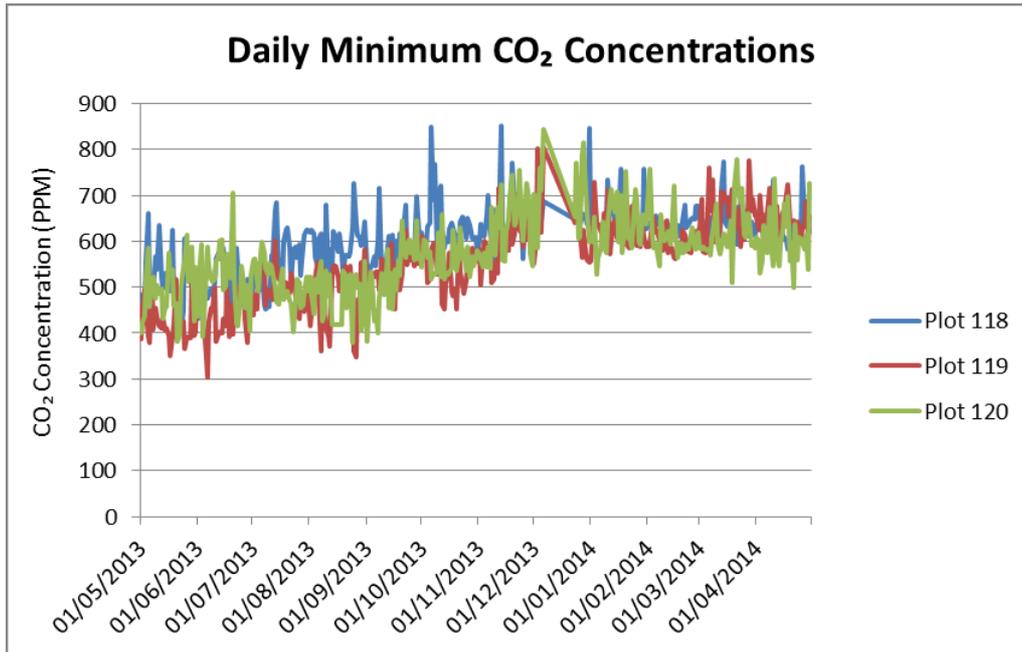
Figure 17 - Daily mean CO₂ concentration in Plot 118

Figure 18 - Daily mean CO₂ concentration in Plot 119

Figure 19 - Daily mean CO₂ concentration in Plot 120

Figure 20 - Daily mean CO₂ concentration in the monitored dwellings until June 2014

Figure 21 - Daily minimum CO₂ concentrations in the monitored dwellings

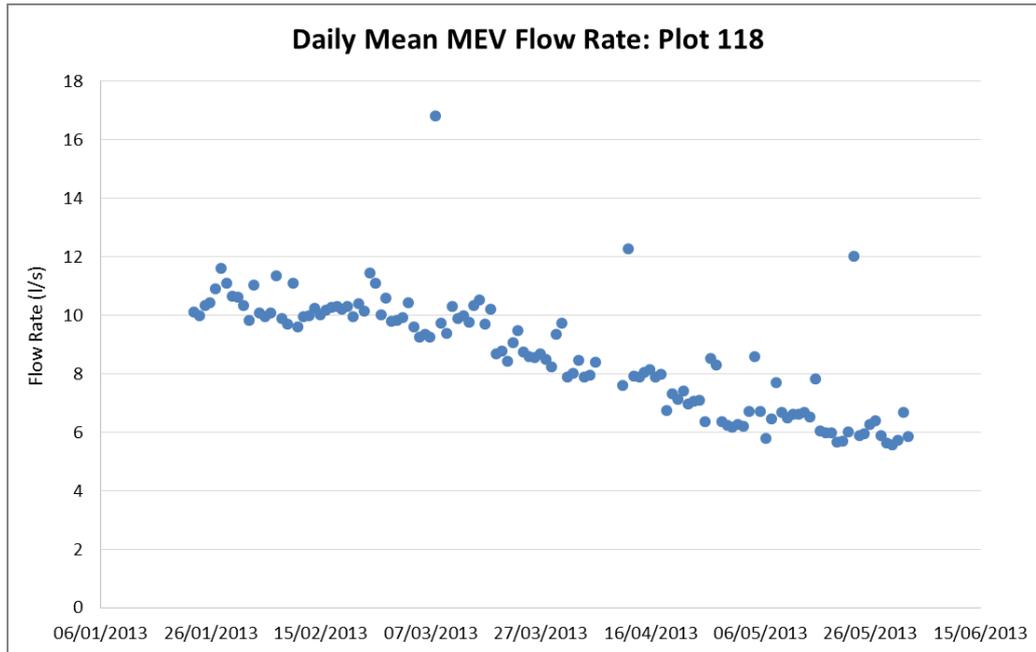
The flow rates inferred from the EE576 air velocity transmitters, installed in the ductworks as part of the monitoring kit, show a rapid decline in MEV flow rates in Plot 118 in the first six months of the monitoring programme (Figure 22). The exact root cause for the decline in the MEV flow rates is unknown, but could, for example, be due to a problem with the fan unit or build-up of dust in the ducts and air valves.

Figure 22 - Daily mean MEV flow rate in Plot 118

As a result of the Phase 1 performance test and Phase 2 monitoring data, Crest Nicholson is undertaking further research into the MEV system at one of the three monitored homes to understand whether certain interventions, such as introducing a humidstat, make any difference to the system and conditions within the home. This programme of monitoring will happen over one year, at Crest Nicholson's expense.

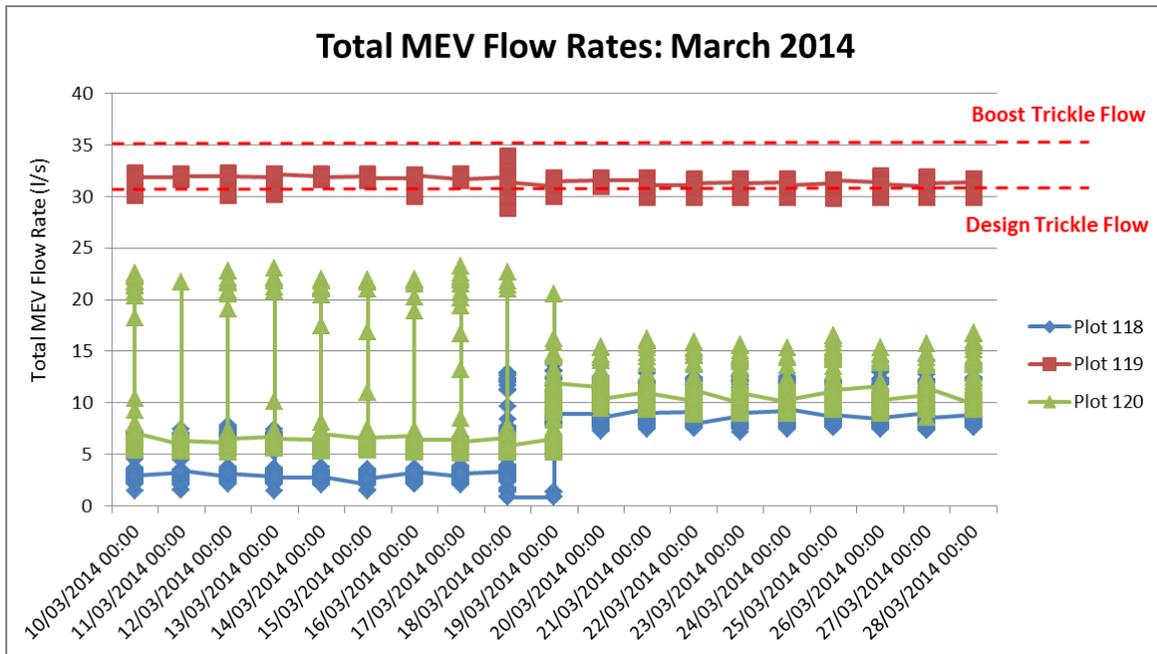
The monitoring data shows that Plot 118 and Plot 120 total MEV flow rates are significantly lower than design specification in both trickle and boost modes. Total MEV flow rate in Plot 119 is slightly higher than the design trickle mode but lower than the design boost mode. The continuous flow rate inferred for the kitchen and ground floor toilet in Plot 119 is around 14 l/s that is actually higher than the design specifications of 11.3 l/s for the kitchen and 5.2 l/s for the toilet. However, the bathroom flow rates are significantly lower than the minimum design flow rate of 7 l/s. The flow rates in the kitchens and all wet rooms of Plots 118 and 120 are also lower than the minimum design specifications.

Figure 23 - Total MEV flow rates in the monitored dwellings, March 2014

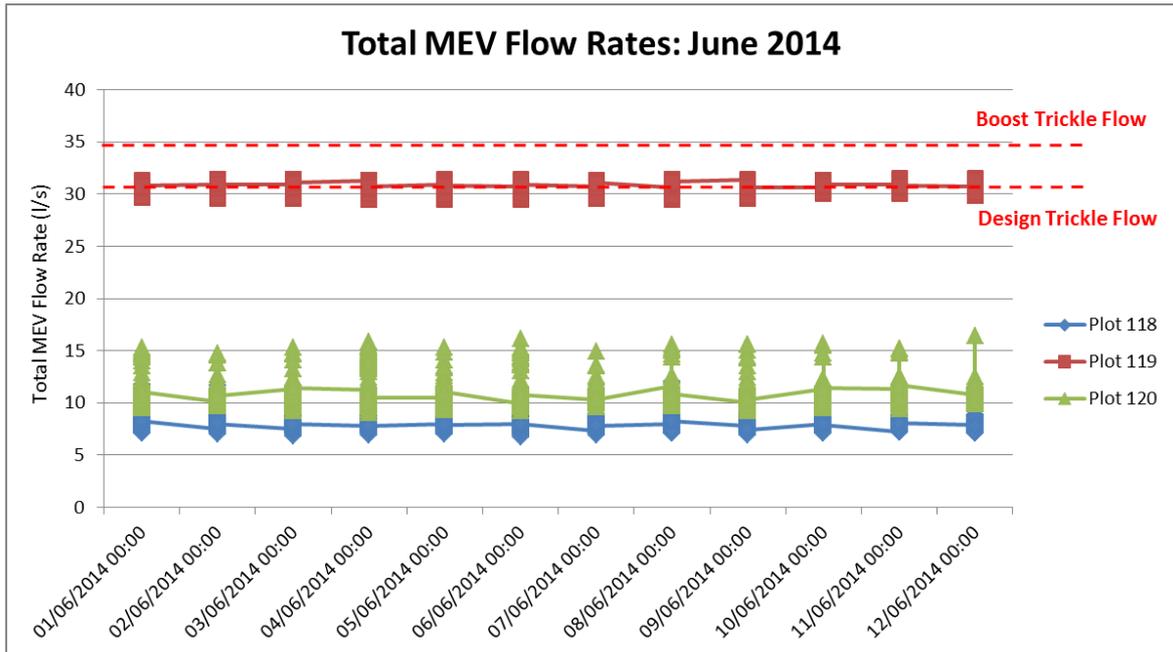
Figure 24 - Total MEV flow rates in the monitored dwellings, June 2014

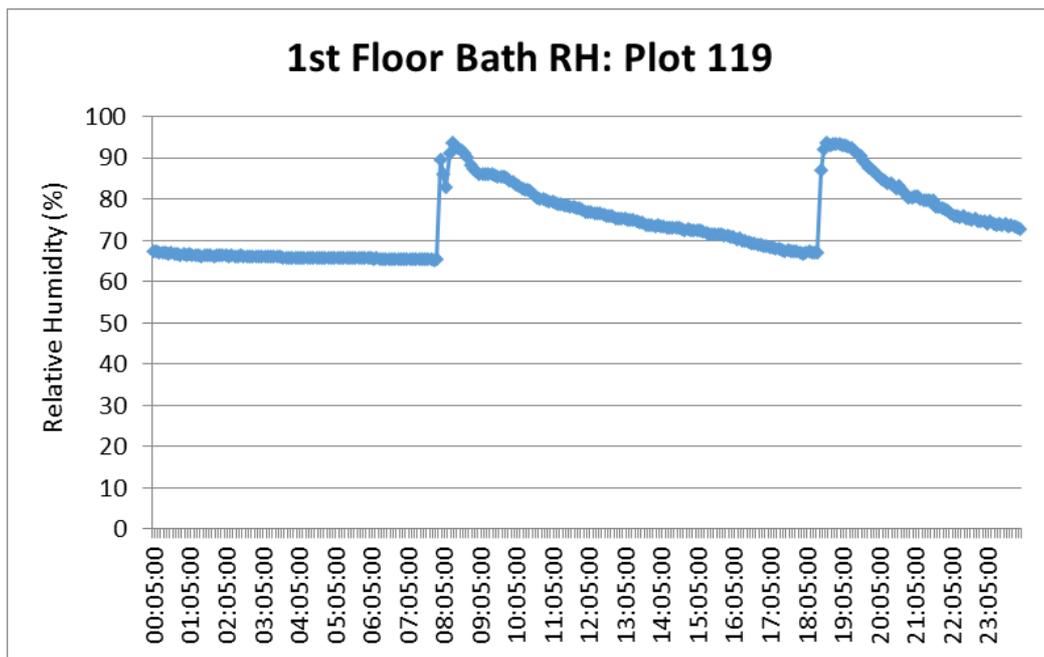
Figure 25 - Variation of relative humidity in the 1st floor bathroom in Plot 119, 4 June 2014

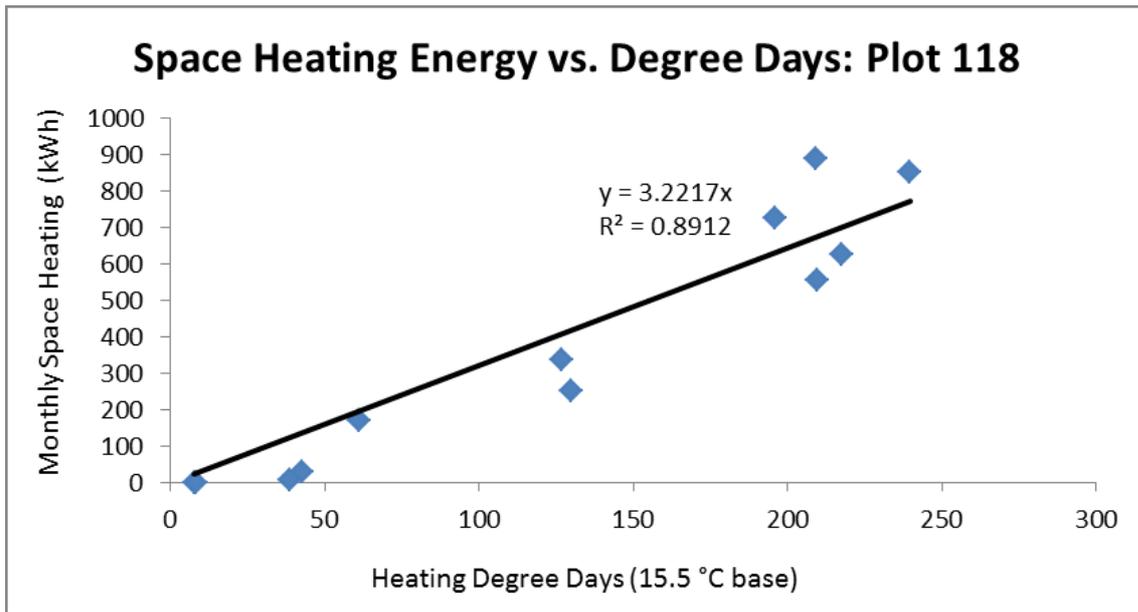
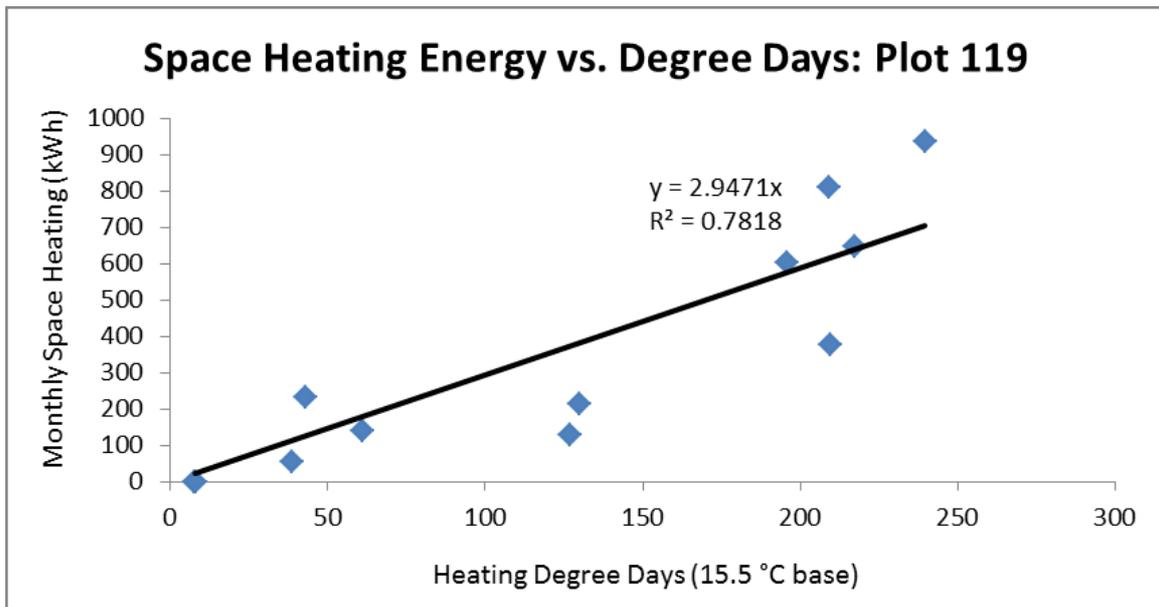
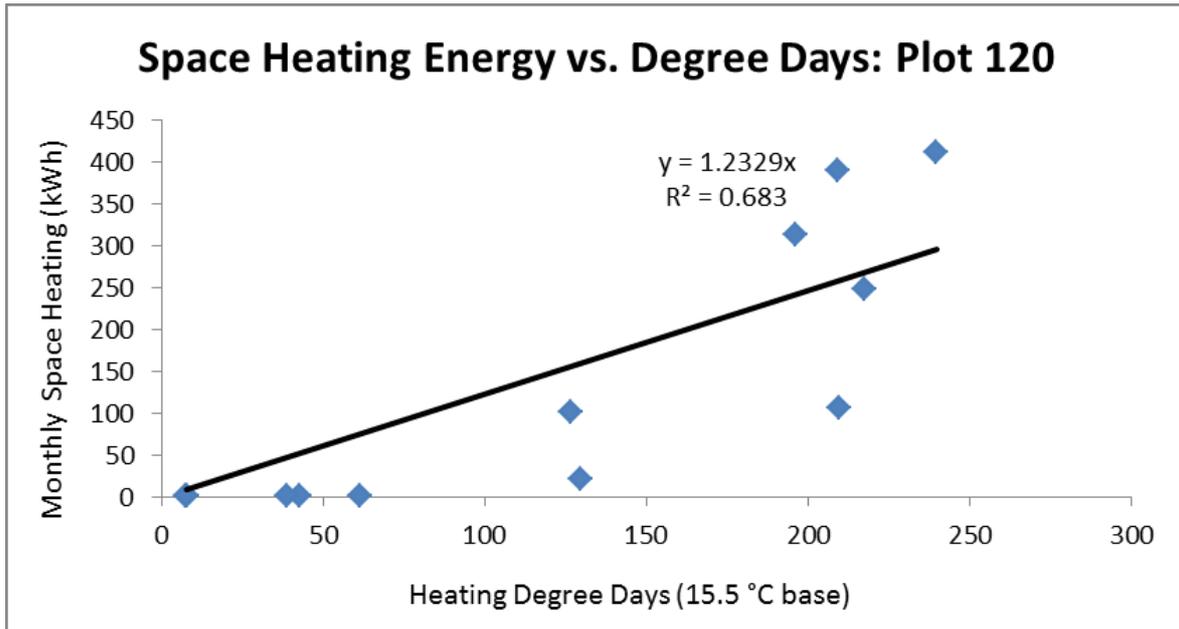
Figure 30-Figure 32 show the correlation between monthly space heating and heating degree days. The graph for Plot 118 shows the highest coefficient of determination which is indicative of good heating control. This is expected as the occupants interview found that the residents of this dwelling allow the heating to be managed by the heating control and thermostats with minimum tampering with the TRVs.

Overall, it appears that occupants in Plots 118 and 119 tend to use higher heating set points that lead to higher space heating energy use, but the operation of the heating system is strongly coupled with the external temperatures. Plot 120, on the other hand, has lower heating set points and energy use with a weaker correlation with external temperatures.

Figure 30 - Space heating vs. heating degree days in Plot 118, 1 May 2013 – 30 April 2014

Figure 31 - Space heating vs. heating degree days in Plot 119, 1 May 2013 – 30 April 2014

Figure 32 - Space heating vs. heating degree days in Plot 120, 1 May 2013 – 30 April 2014

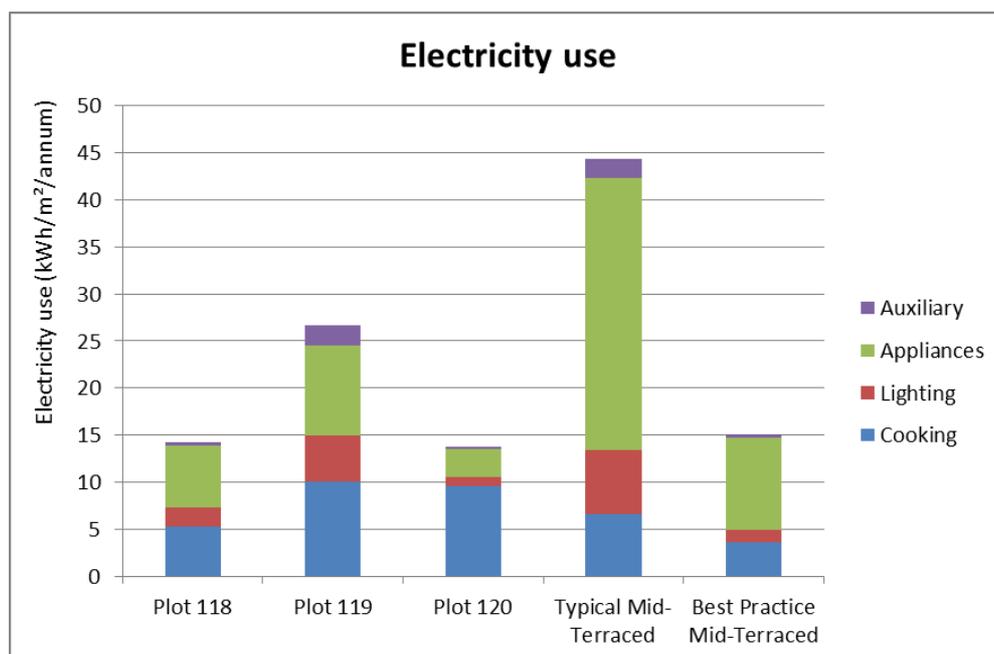
Figure 37 compares the annual electricity use of the monitored dwellings for the period 1 May 2013 to 30 April 2014 to the benchmarks given for mid-terraced houses in the DOMEARM tool.

Figure 37 - Electricity use of the monitored dwellings against benchmarks
1 May 2013 - 30 April 2014

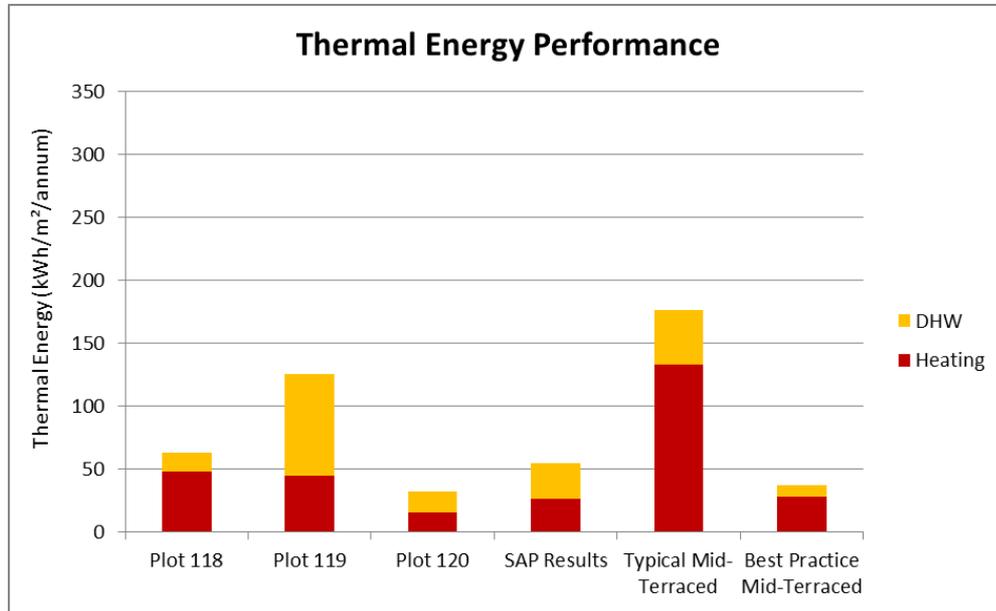
Figure 38 compares the thermal performance of the dwellings over the same measurement period with the outcome of the as-built SAP calculations and to the benchmarks derived from existing building stock (mid-terraced houses in the DOMEARM tool).

Figure 38 - Thermal performance of the monitored dwellings against benchmarks
(As-built SAP efficiency of the district heating and CHP plant: 87%)
1 May 2013 - 30 April 2014

The efficiency assumed for the district heating system and CHP plant in Figure 38 is identical to the as-built SAP calculations (87%). This is to neutralise the effect of district heating system and CHP plant in benchmarking and give an account of energy efficiency of the individual dwellings. Once the operational efficiency of the district heating system and CHP plant is established, it would be possible to benchmark the total energy performance (see 7.15).

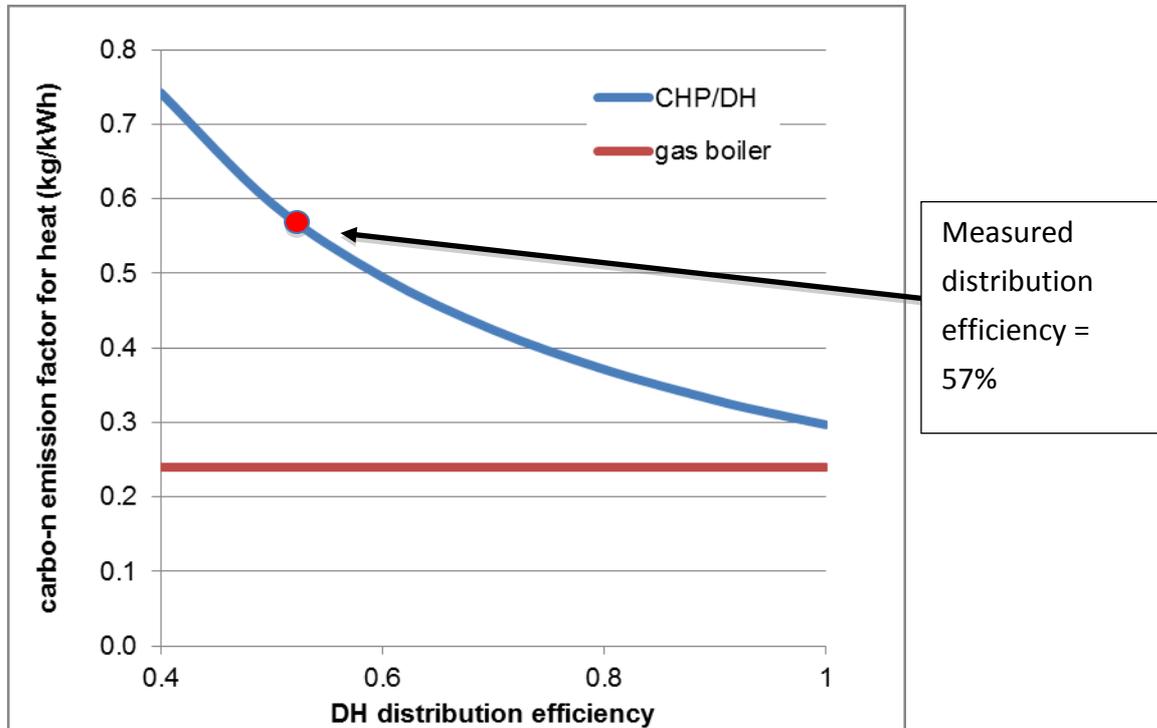
individual gas condensing boilers. The effect of different distribution efficiencies on the measured carbon emission factor are illustrated in Figure 39. It can be seen that even if it is assumed that the communal district heating system has no distribution losses, the carbon emission factor for delivered heat would still be higher than the carbon emission factor for an individual gas condensing boiler.

Figure 39 - Carbon emission factors for CHP district heating at varying distribution efficiencies using CQ measured performance data versus individual gas boiler at 87% efficiency

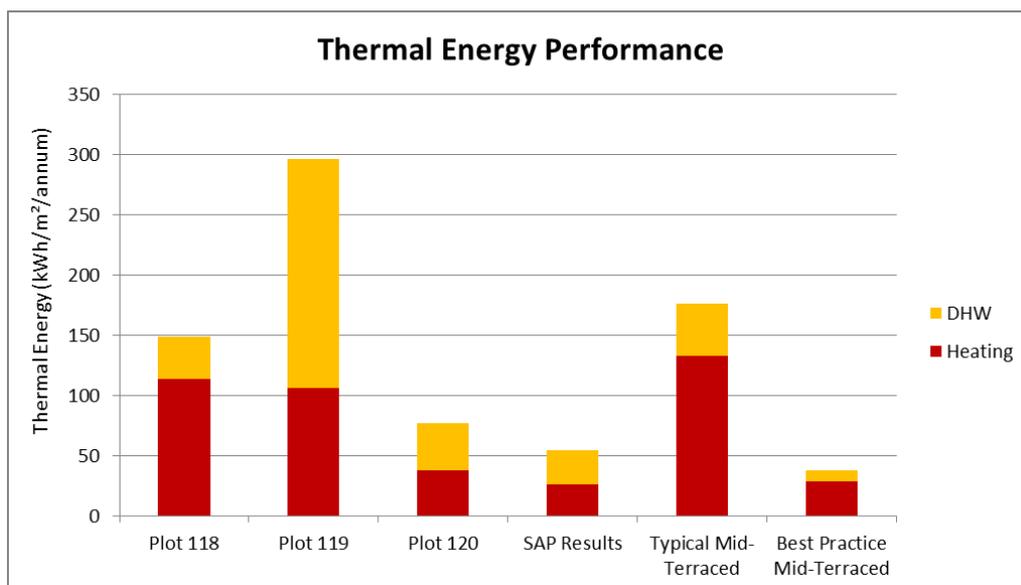
Assuming the overall system efficiency of 37% established for the district heating system and the CHP plant over the period 26 February to 17 June is representative of the annual performance, it would be possible to benchmark the total thermal performance of the monitored dwellings including the source efficiency. Figure 40 shows how the total thermal performance of the monitored dwellings is compromised by the low operational efficiency of the district heating system and the CHP plant.

Figure 40 - Thermal performance of the monitored dwellings against benchmarks (Operational efficiency of the district heating and CHP plant: overall system efficiency of 37%)
1 May 2013 - 30 April 2014
