This document contains a Building Performance Evaluation report from the £8 million Building Performance Evaluation research programme funded by the Department of Business Innovation and Skills between 2010 and 2015. The report was originally published by InnovateUK and made available for public use via the building data exchange website hosted by InnovateUK until 2019. This website is now hosting the BPE reports as a research archive. As such, no support or further information on the reports are available from the host. However, further information may be available from the original InnovateUK project evaluator using the link below¹.

Innovate UK project number	450077 Related CHP study: 450078 (Phase 1)
Project author	UCL and Crest Nicholson Operations for Crest Nicholson Plc
Report date	2014
¹InnovateUK Evaluator	N/A

Background to evaluation

This report provides the results of the in-use performance analysis and post-occupancy evaluation of three monitored dwellings constructed as part of the first phase of Centenary Quay development. The performance of the district heating system and the CHP plant installed was assessed as part of the Phase 1 study.

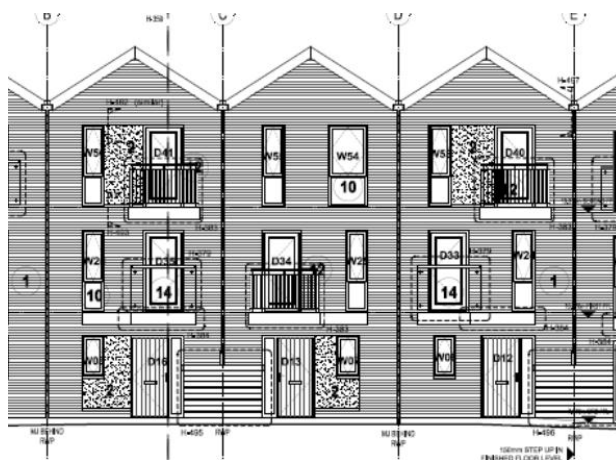
Figure 3 - Front elevation of Plot 120 (left), Plot 119 (middle) and Plot 118 (right)

The monitored dwellings are 3-bedroom, 3-storey mid-terraced houses with identical orientation. These houses form part of a terraced block from the first phase of the Centenary Quay project and were completed in 2012. They are identical apart from minor differences in the dimensions of openings, handedness of internal layout, the position of balconies and façade treatments. An elevation drawing of the three plots is shown in **Figure 3**. Layout plans for Plot 118, as a representative dwelling, are also shown in Figure 4. Bedrooms 1 and 2 are located on the second floor; Bedroom 3 and the living room are located on the first floor, while the open plan kitchen and dining area are located on the ground floor.

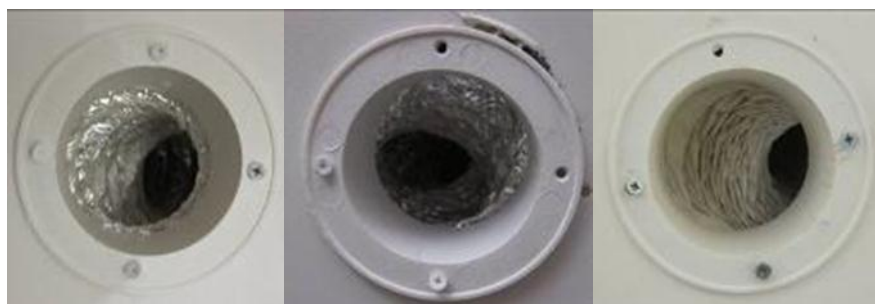
Figure 5 - Extract terminals with diffusers removed showing constrictions in flexible ducting

- Ventilation at Centenary Quay is provided utilising a centralised continuous Mechanical Extract Ventilation (MEV) system. Air is extracted via an MEV fan unit located in the loft through ceiling mounted air valves in the wet rooms (kitchen, toilet, & two bathrooms). The kitchens are fitted with a filtered re-circulating cooker hood above the hob. Fresh air is also provided by closable trickle vents integrated into the NorDan window frames. One of the findings of the construction review process was that there was extensive use of flexi-duct in the loft, especially at the connections to the fan unit. Whilst it is normal to use a small amount of flexible duct to make connections, the amount observed was excessive and had been laid in such a way as to form tight bends which would cause back pressure on the system and reduce the system performance compared to design assumptions. An examination of the flexible connections between the rigid duct and the ceiling vents showed that in many cases the flexible duct was constricted and not

properly aligned (Figure 5), which would increase back pressure and reduce system efficiency.

It was also noted that the MEV boost mode in WC and bathrooms, which was triggered by the lights switch, did not have an over-run function, and the system would revert back to trickle mode when the light switch is turned off. A humidistat would ensure that boost mode operated for a long enough period after the bathroom was vacated and the light turned off to clear moisture e.g. from a shower.

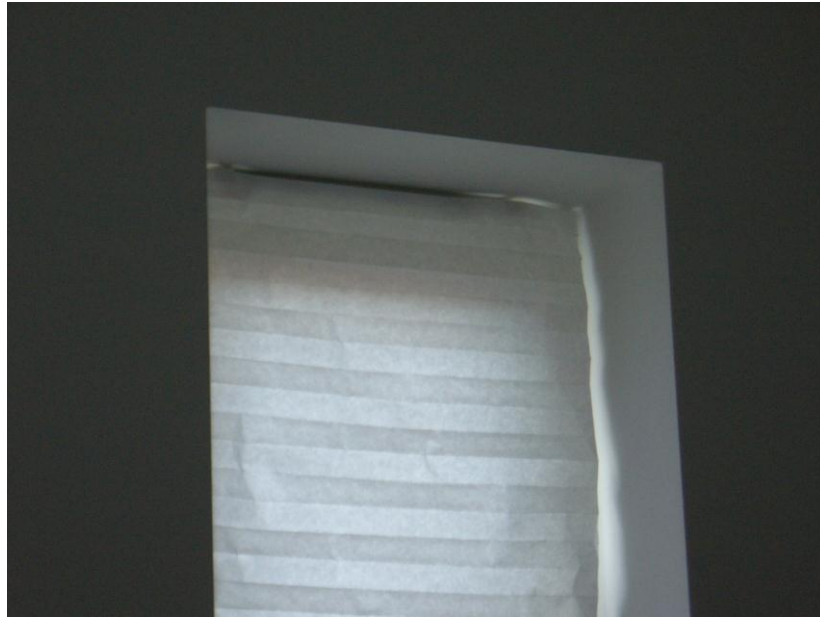
Figure 6 - Paper blind installed on the window led to the trickle vent being blocked

It was observed that occupants of Plot 119 had paper blinds on all windows. Self-adhesive tapes used to hang these blinds had led to all trickle vents being blocked. The occupants were unaware of this. They reported that they had never opened any of these blinds as they felt enough natural light could still come through.

One of the major findings of the interviews was that the trickle vents on window frames were permanently blocked in two dwellings with paper blinds and closed in another dwelling in winter to prevent draught. It is recommended that the critical role of trickle vents in maintaining good indoor air quality in new build dwellings is more specifically covered in home user guides and home demonstration in the future.

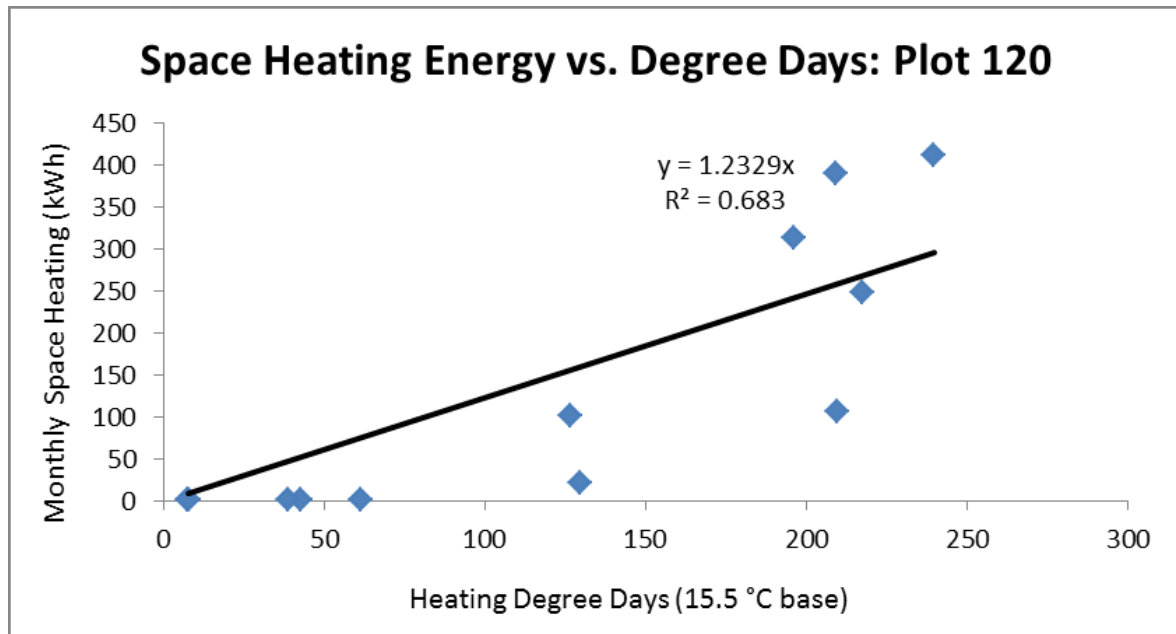
Figure 30-Figure 32 show the correlation between monthly space heating and heating degree days. The graph for Plot 118 shows the highest coefficient of determination which is indicative of good heating control. This is expected as the occupants interview found that the residents of this dwelling allow the heating to be managed by the heating control and thermostats with minimum tampering with the TRVs.

Overall, it appears that occupants in Plots 118 and 119 tend to use higher heating set points that lead to higher space heating energy use, but the operation of the heating system is strongly coupled with the external temperatures. Plot 120, on the other hand, has lower heating set points and energy use with a weaker correlation with external temperatures.
