Cressex Community School

Innovate UK project number	45018
Project author	XCO2 Energy Ltd (via BAM Construct UK)
Report date	2014
InnovateUK Evaluator	Roderic Bunn (Contact via www.bpe-specialists.org.uk)

Building sector	Location	Form of contract	Opened
School (secondary)	High Wycombe	N/A	2011
Floor area*	Storeys	EPC / DEC (2010)	BREEAM rating
11,624 m ²	3	31 (B) / 200 (G)	Very good

Cressex Community School is a secondary school in High Wycombe, Buckinghamshire. It was designed for high environmental performance and low energy use. Upon completion it achieved a BREEAM "Very Good" rating and a 'B' rated Energy Performance Certificate. This study examines how this achievement relates to the building's in-use performance and the possible reasons for any differences.

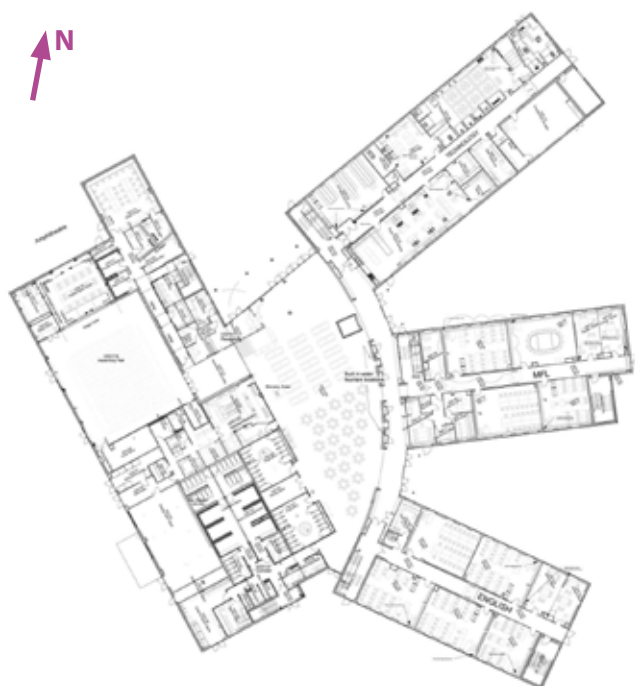
Figure 2.2: Building ground floor plan ventilation.

this is growing year on year. The 11,624 m² three storey, concrete frame school consists of four blocks all linked by the main atrium space (see Figure 2.2).

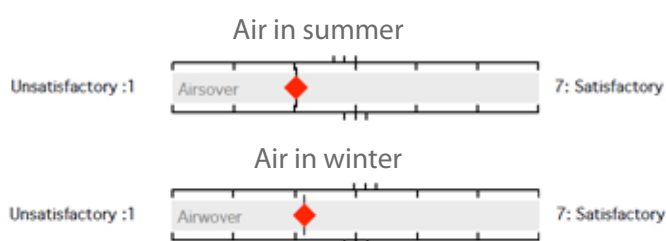
4.1.1 Air Quality

The questions relating to air quality covered seasonal air movement, humidity, freshness and odour. The overall results showed that occupants found the air quality more unsatisfactory than satisfactory in both summer and winter, as shown in the graphs against the ARUP schools benchmark dataset.

The majority of occupants who responded stated that the air is often too dry. In addition to this some occupants also noted they felt there was a lack of fresh air and attributed this to having no openable windows.

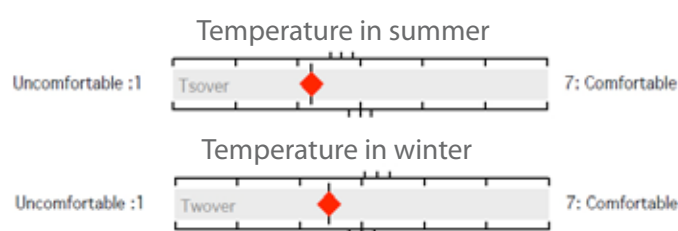
4.1.2 Temperature

Overall the occupants perceived the building temperature to be more uncomfortable than comfortable in both summer and winter months.

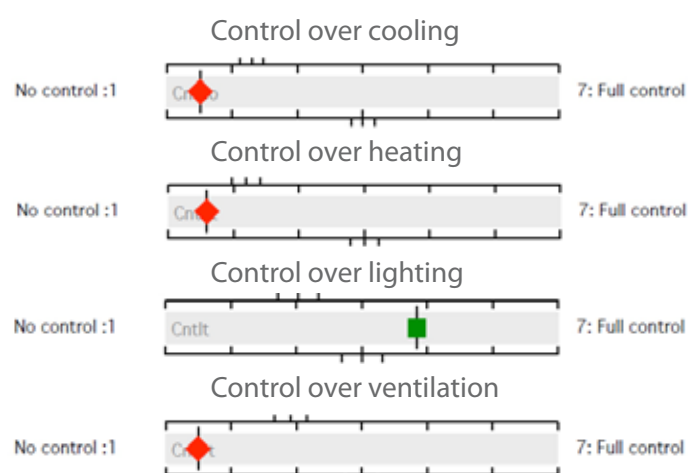
4.1.4 Controls

The occupants had a mixed response to their availability of controls. They found that their control over noise was adequate and control over the internal lights was more than adequate. However, the occupants felt they had no control over heating, cooling and ventilation. This response was expected since the building has few local controls for altering these conditions and instead this is carried out centrally via the BMS.

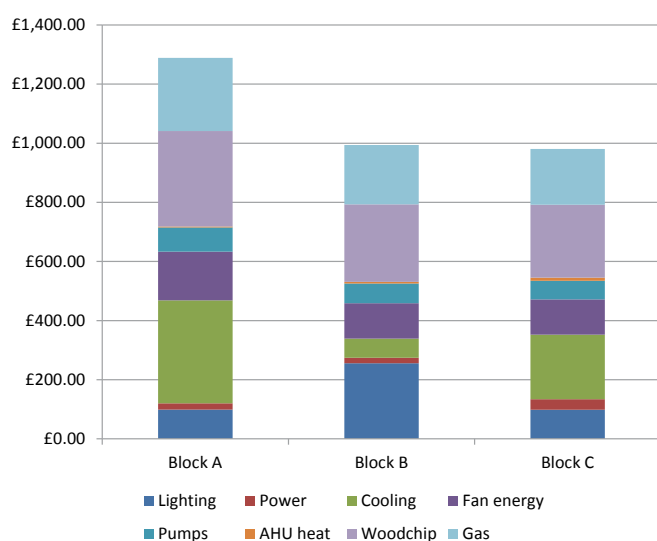
Figure 6.1: Running Cost per Month

A preliminary study estimated the breakdown of energy use within the building to be as shown in Figure 6.1 below. This was based on one month's metered data before the appointment of the Facilities Manager.

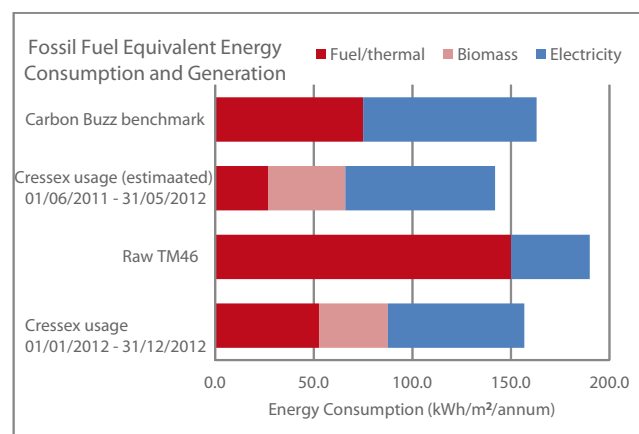
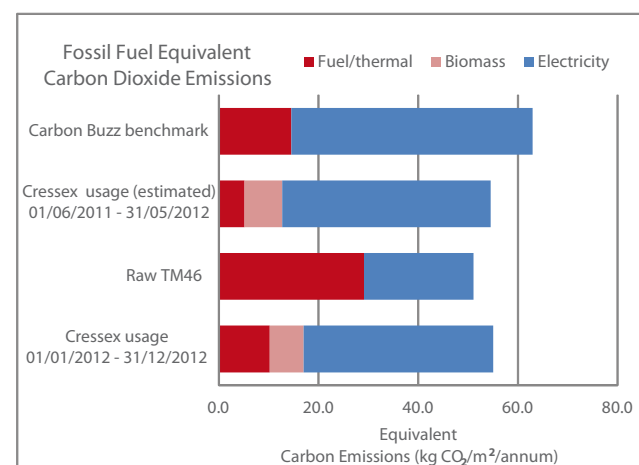
Figure 6.2: Energy and CO₂ benchmarking against Carbon Buzz and TM46 data based on a TM22 simple assessment.

The TM22 analysis was completed early on in the study and updated with 2012 data when it became available. The results of this analysis can be seen in figure 6.2. The bottom bar shows the most recent result for the school. The result is broadly comparable to the Carbon Buzz benchmark with slightly lower electricity usage and higher heating requirements. The Carbon Buzz benchmark comprises the median actual consumption data for 77 educational buildings which have been submitted to the website. By their

nature the buildings entered are generally recent builds, and may reflect more accurately typical usage in a modern school building. There is a marked

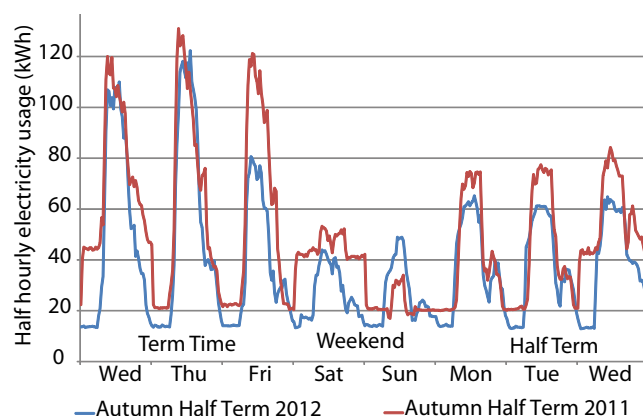
Figure 6.3: Actual Autumn electricity usage pre and post the appointment of the FM

of the facilities manager. Overnight minimums and half term usage have improved dramatically. Sunday usage has grown, but this is a result of the recent use of the school on Sundays by a local church.

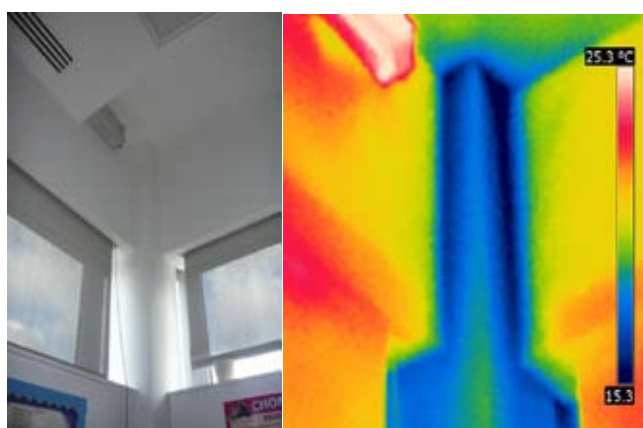
Given the size of the building and scope of the survey, very few clear thermal bridges or insulation defects were captured during the thermal imaging survey. From a construction perspective, the survey suggests that the building follows the detailed design drawings with no obvious deviations.

From a design perspective, the detailing around common thermal bridges (structural columns and wall to slab junctions) could be improved. However, in comparison to some other new buildings viewed by the surveyor, the detailing in general is of a good standard.

Figure 7.1: One of the few thermal bridges identified

The design team should also consider improving the detailing around non structural beams such as the aluminium channel discussed in the thermography report. For future projects the specification team may also want to consider thermally broken frame systems for windows and doors.

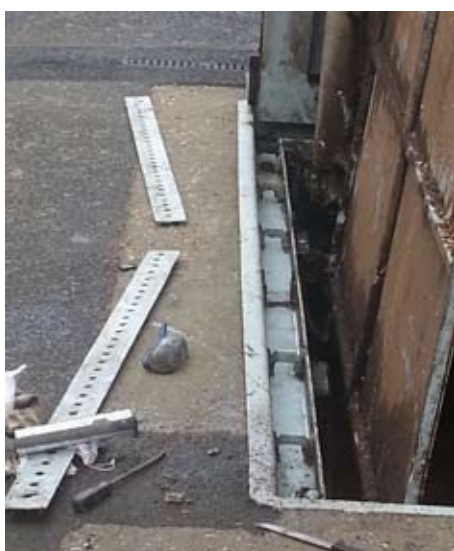
Since the school's occupation in September 2010, the biomass boiler has been non-operational for several protracted periods. This has been the result of moisture issues in the fuel store leading to fuel becoming unusable.

Figure 7.2: Channel hole widening in February 2012 showing the new drainage channel from measure 4 (top) and the debris covers from measure 1.

After the moisture issues manifested early on in the occupation of the school, a number of measures have been taken in an attempt to correct the problem:

1. Debris covers were installed over the drainage channels around the edge of the store to prevent woodchip and other debris from causing blockages.
2. The drainage outlet from the stores drainage channel was widened to increase the possible flow from the store and reduce the likelihood of it becoming clogged.
3. Rubber mats were installed around the edges of the store to stop water ingress from overground flow.
4. An additional drainage channel was installed uphill from the store to catch surface water

before it reaches the store.

5. Shortly afterwards the holes in the supports of the drainage channels were widened to improve the flow.

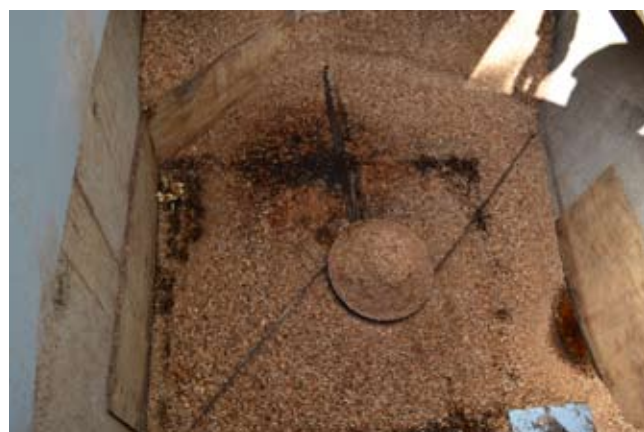
It remains to be seen whether the corrections have solved the moisture issue. The location of the fuel store, below a busy access route necessitated a complex design which is thought to have been more prone to leakage and moisture issues than simpler storage systems which might have been suitable in other locations.

Figure 7.3: Moisture issues in the fuel store

The biomass system at Cressex has been problematic, and this is mostly felt to be due to the location of the fuel store under an access road necessitating a highly complex design which was more vulnerable to problems. We would recommend that in future projects with a biomass system, careful attention is paid to the location and complexity of the fuel store so that a simple and more robust storage system can be used.

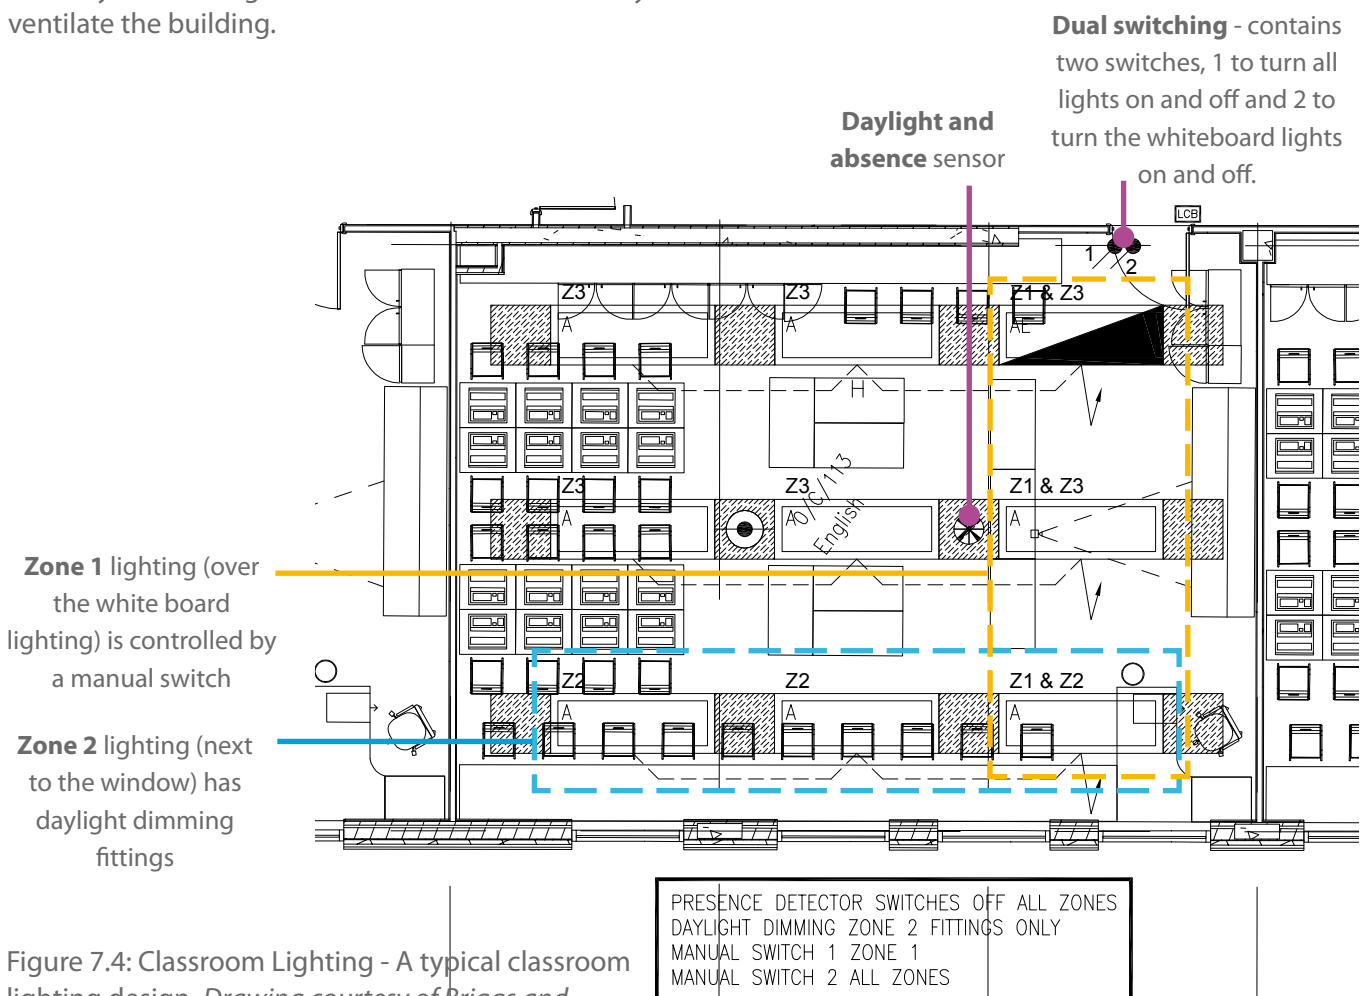
Figure 7.4: Classroom Lighting - A typical classroom lighting design. *Drawing courtesy of Briggs and Forrester*

Since discussions with the school regarding the light switching arrangements, the mechanical and electrical contractor has carried out the following work to adjust the daylight-linking set-points:

- South facing Windows in Zone 2 start to dim at 200 lux, fully dim at 400 lux.
- North facing Windows In Zone 2 start to dim at 170 lux, fully dim at 210 lux.

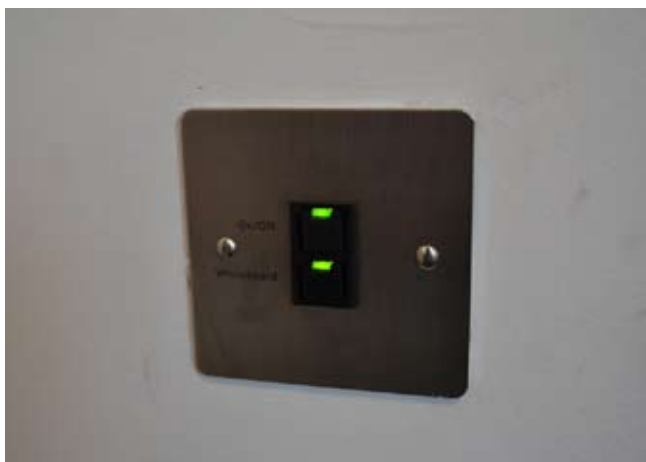
Figure 7.5: Classroom lighting controls. ‘Whiteboard’ switch could be misunderstood

The engineers also disabled the ‘OFF’ function so the lights will only dim down to 20% maximum to prevent call-outs from the client who may believe the lights have failed.
